# WATER SUPPLY AND WASTEWATER SYSTEMS MASTER PLAN FOR THE BEKAA WATER ESTABLISHMENT

## WATER ASSESSMENT REPORT

January 2014  
Updated May 2015

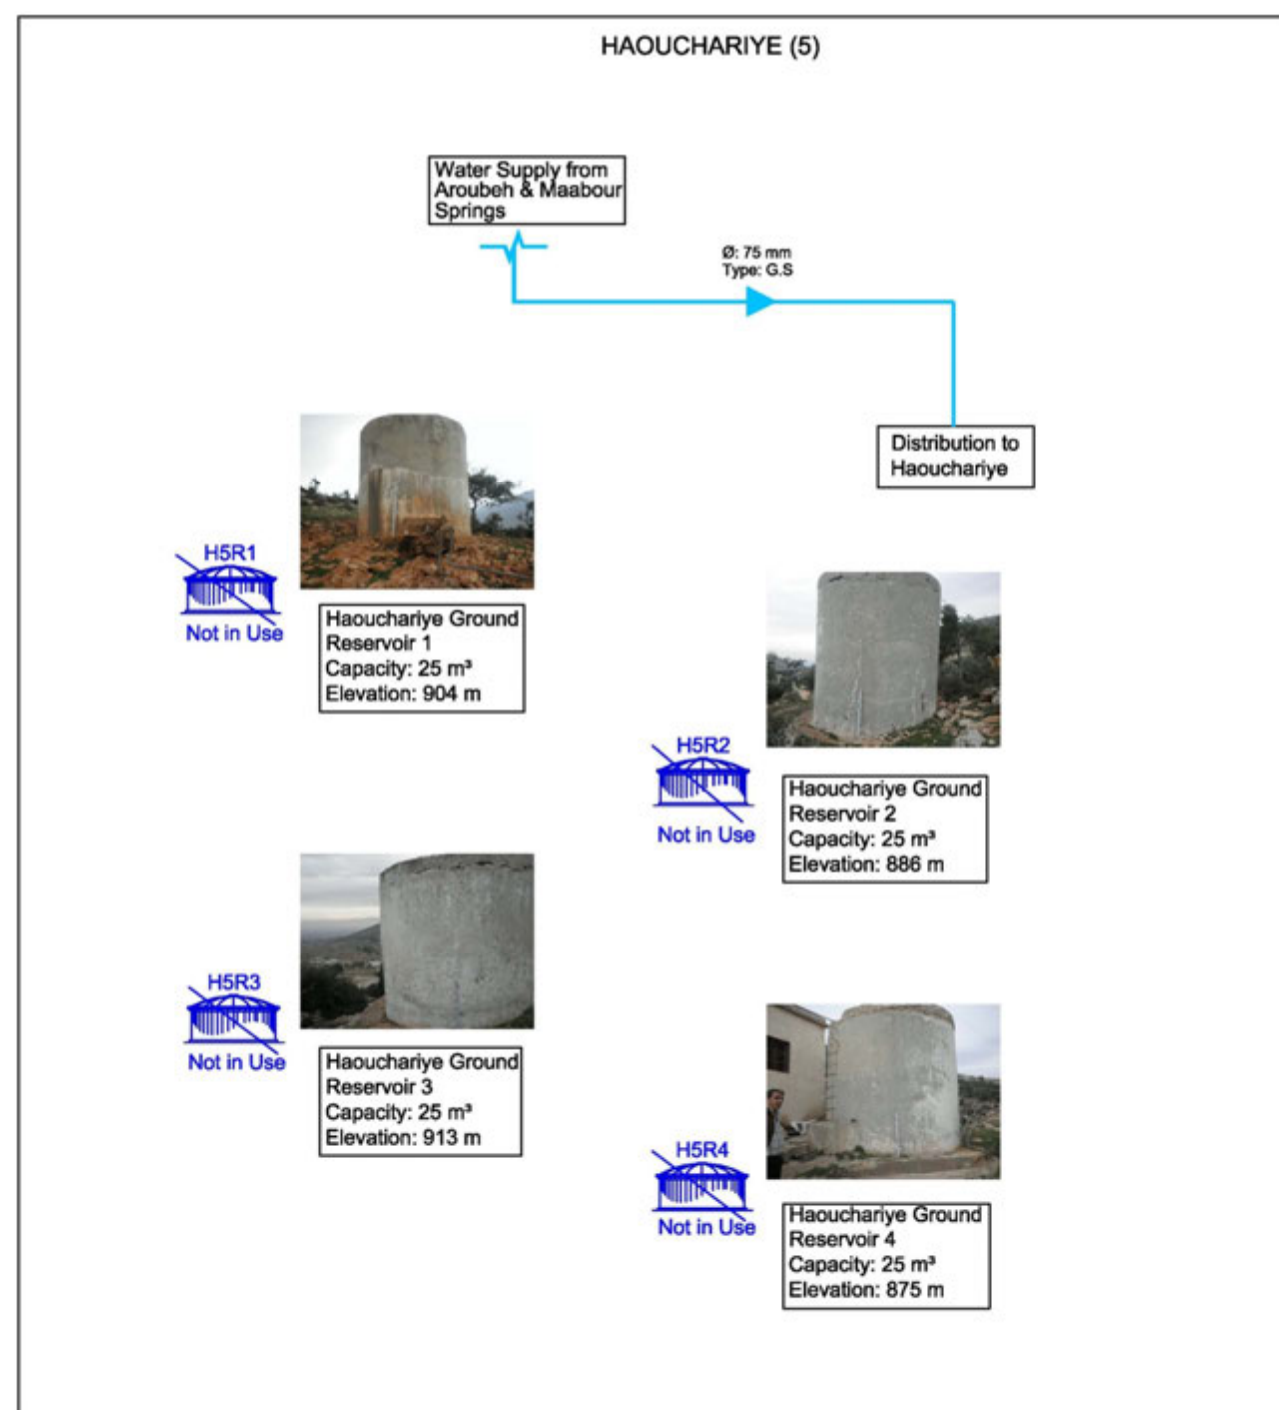
**Haouchariye (5)**

The existing network is unused (installed 50 years ago) and it is in a bad condition.

Reservoir H5R1 (25m³): Reservoir is very old and it is in bad condition. It needs rehabilitation or reconstruction. It is not in use.

Reservoir H5R2 (25m³): Reservoir is old but it is in acceptable condition. Its pipes are visible and valves are broken. This reservoir needs rehabilitation. It is not in use.

Reservoir H5R3 (25m³): Reservoir is in bad condition. It is subjected to heavy leakage. This reservoir is not connected to the main network. It needs rehabilitation or reconstruction. It is not in use.

Reservoir H5R4 (25m³): Reservoir is in acceptable condition. Its pipes are visible and valves are broken. This reservoir is not connected to the main network. It needs rehabilitation. It is not in use.

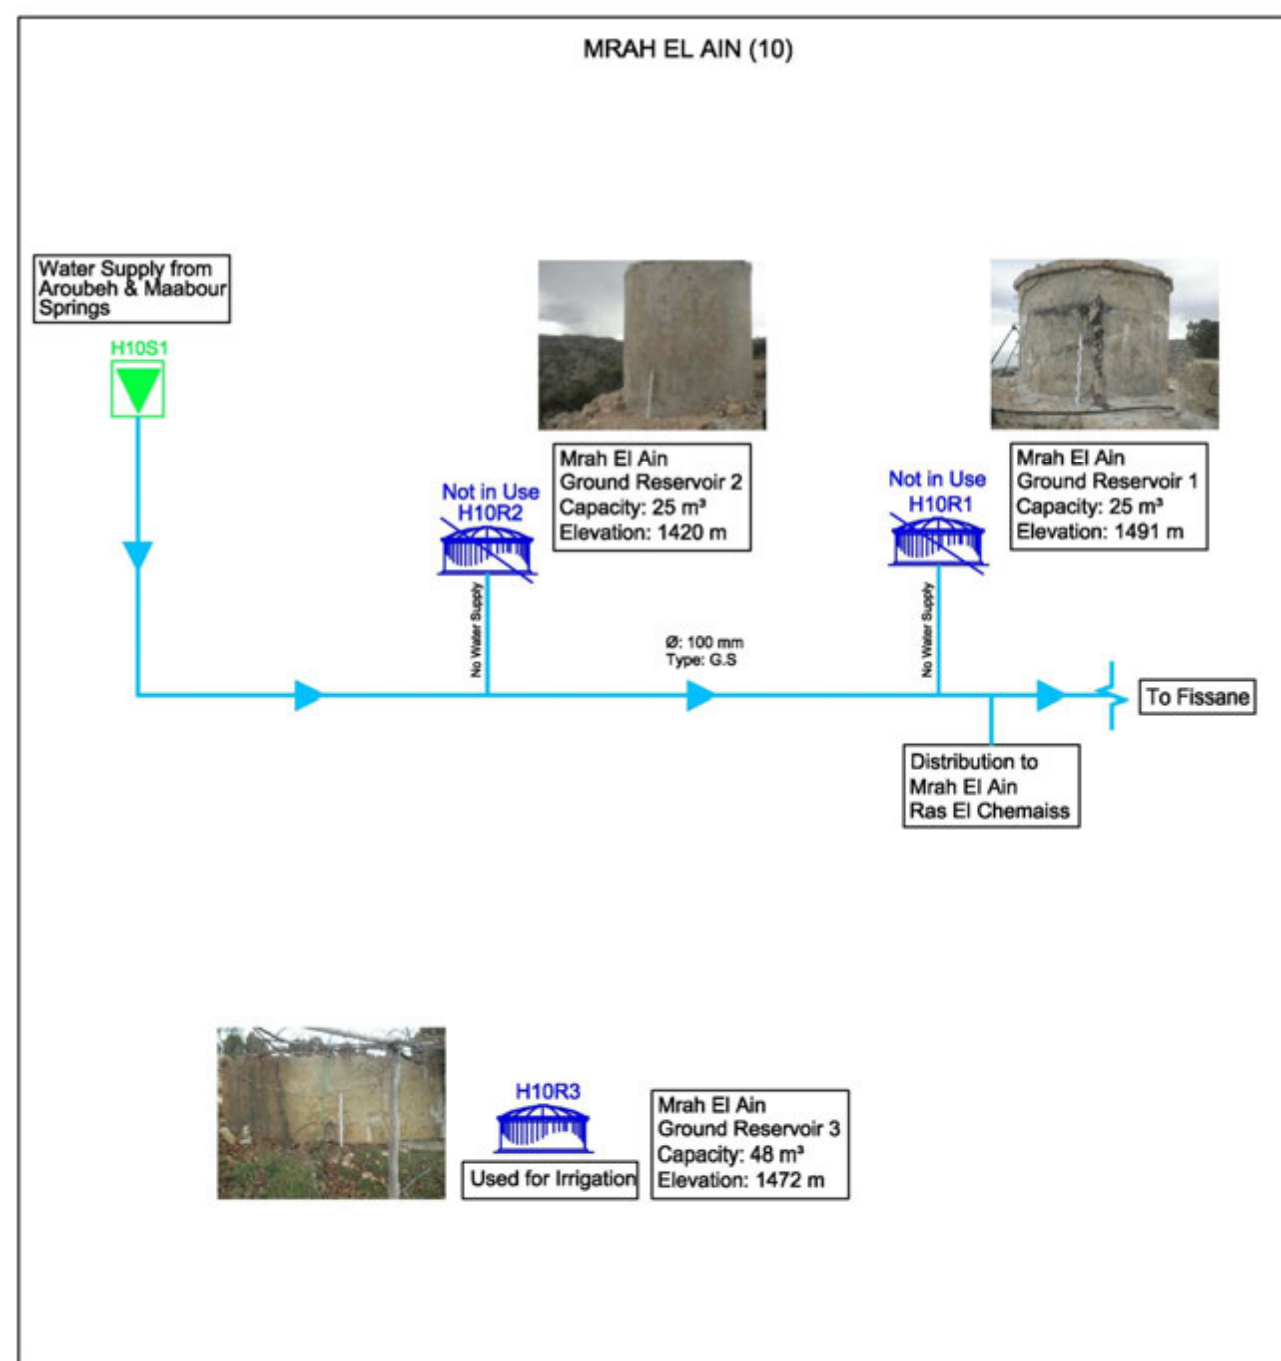
**Mrah el Ain (10)**

There is no available information concerning the water network of the town.

Reservoir H10R1 (25M³), H10R2 (25M³), AND H10R3 (48M³): Reservoirs are not in use and they are in bad condition. They are subjected to leakage. They need rehabilitation or reconstruction.

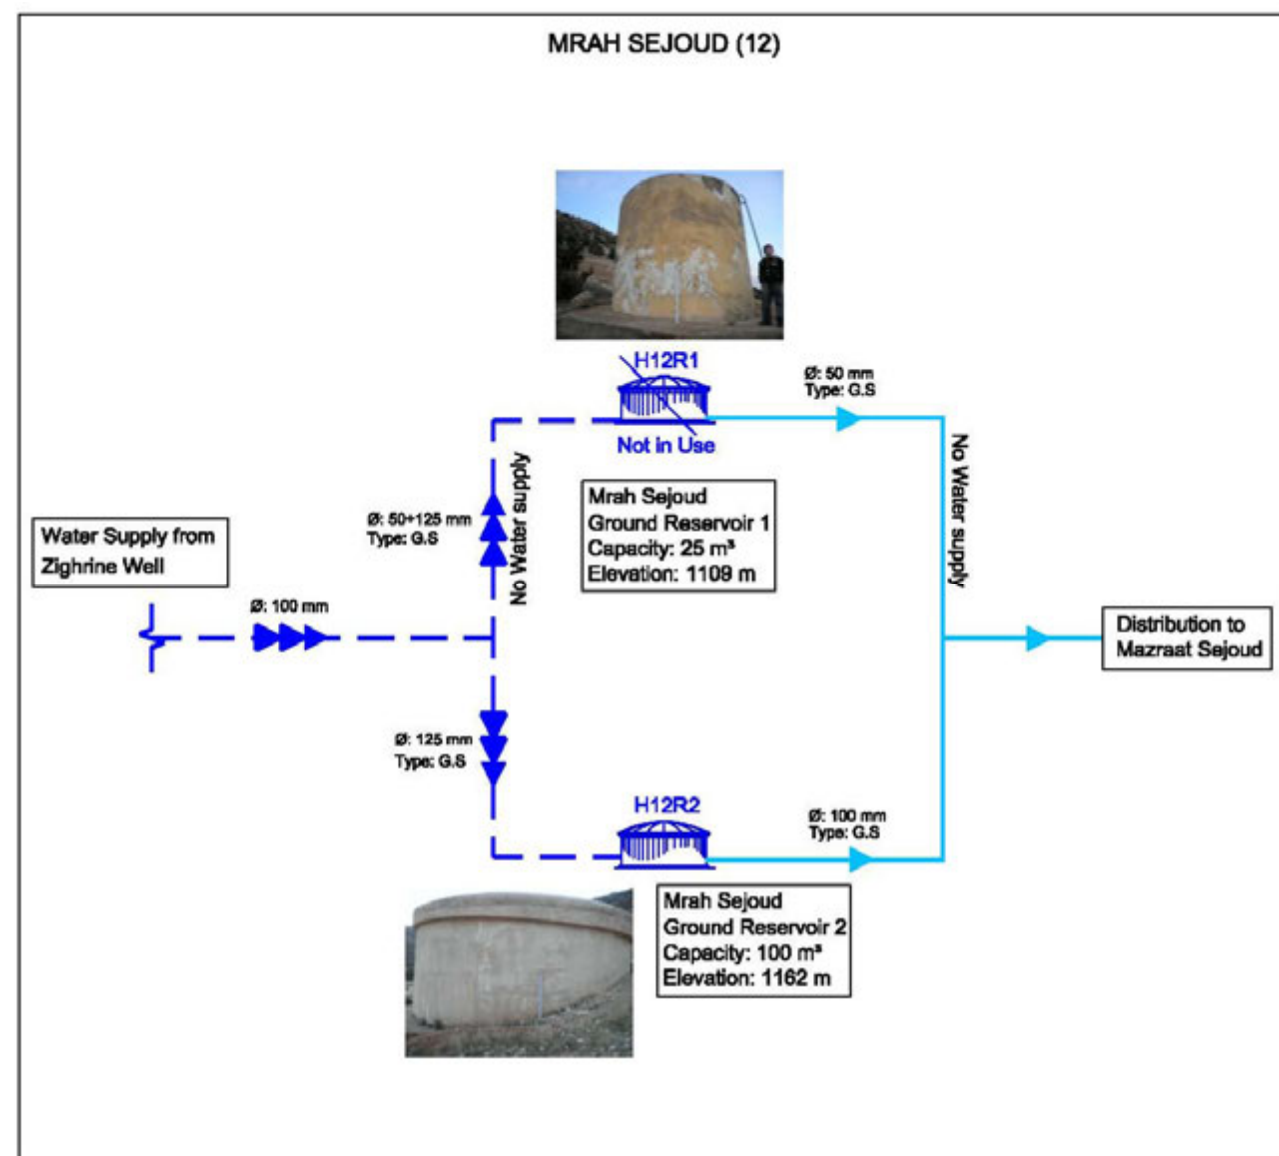
**Mrah Sejouid (12)**

There is no available information concerning the water network of the town.

Reservoir H12R1 (25m³): Reservoir is in bad condition and it is not in use. The inlet and outlet pipes are unfilled with water but there is no available information regarding their conditions. This reservoir needs rehabilitation or reconstruction.

Reservoir H12R2 (100m³): Reservoir is in good condition but valves are rusted. It needs minor maintenance.

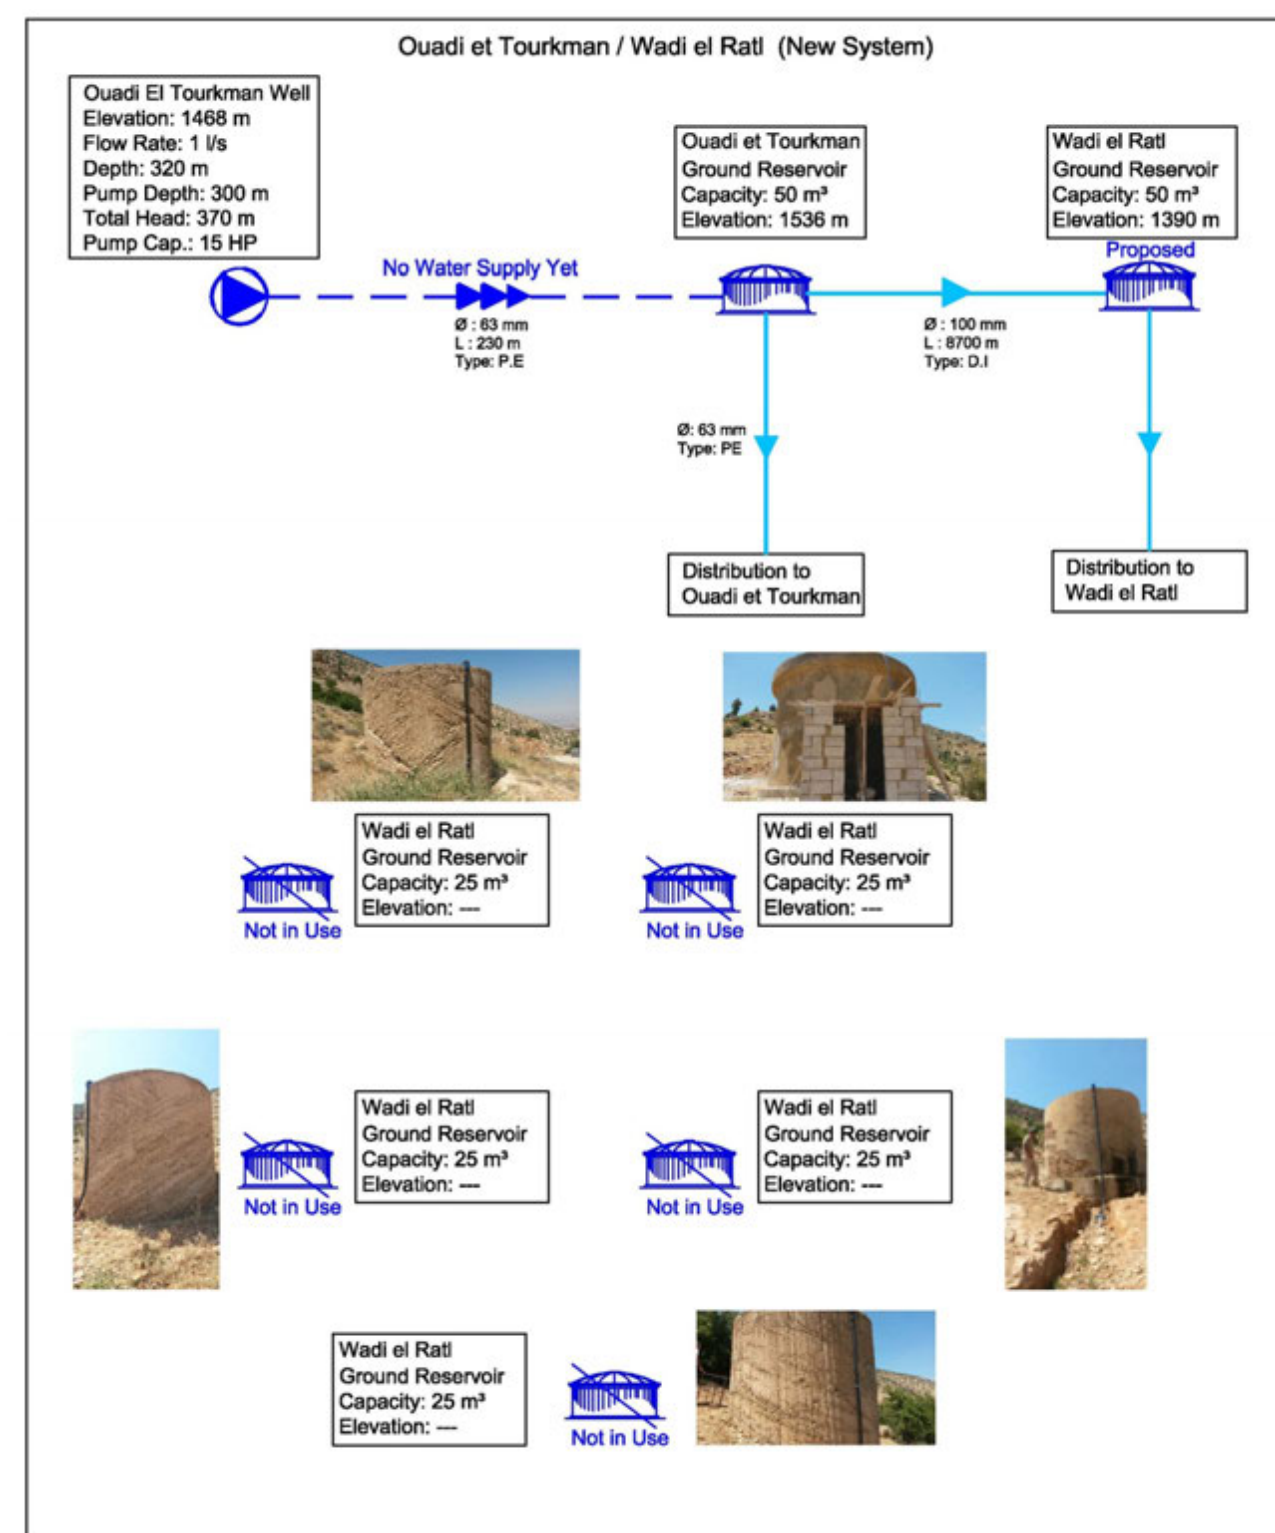
**Ouadi el Tourkman / Wadi el Ratl**

There is no available information concerning the water network of the town. The system is recently constructed. There are 5 very old reservoirs and they are not in use.

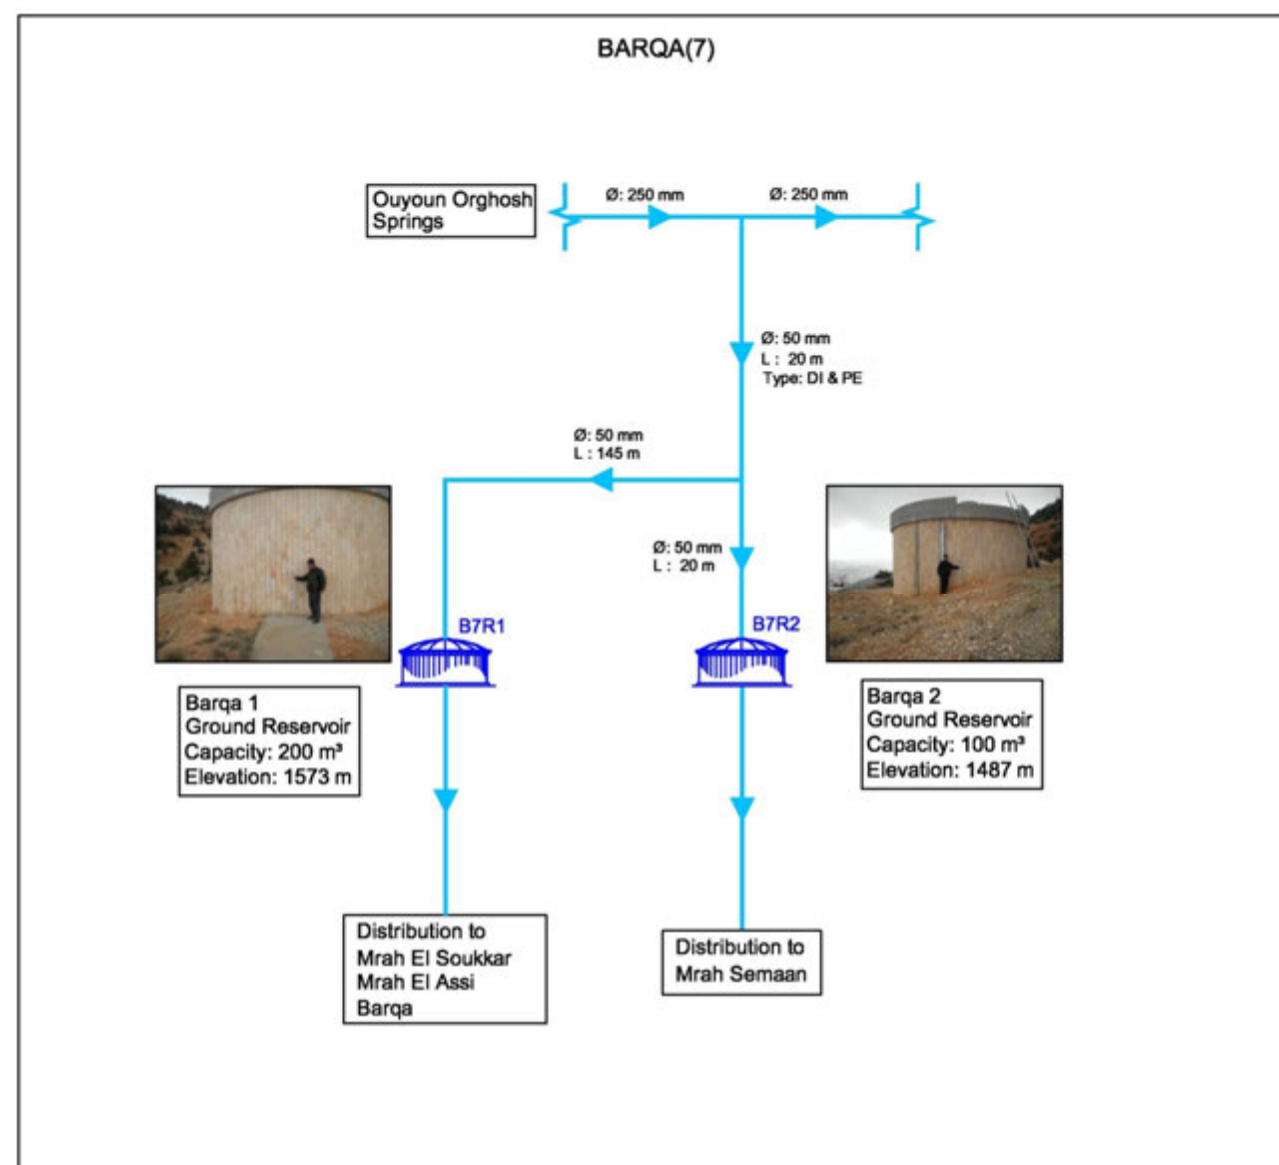
**Barqa (7)**

The existing water network is in bad condition and it has a length of around 4.3 km. It covers a very small part of the town.

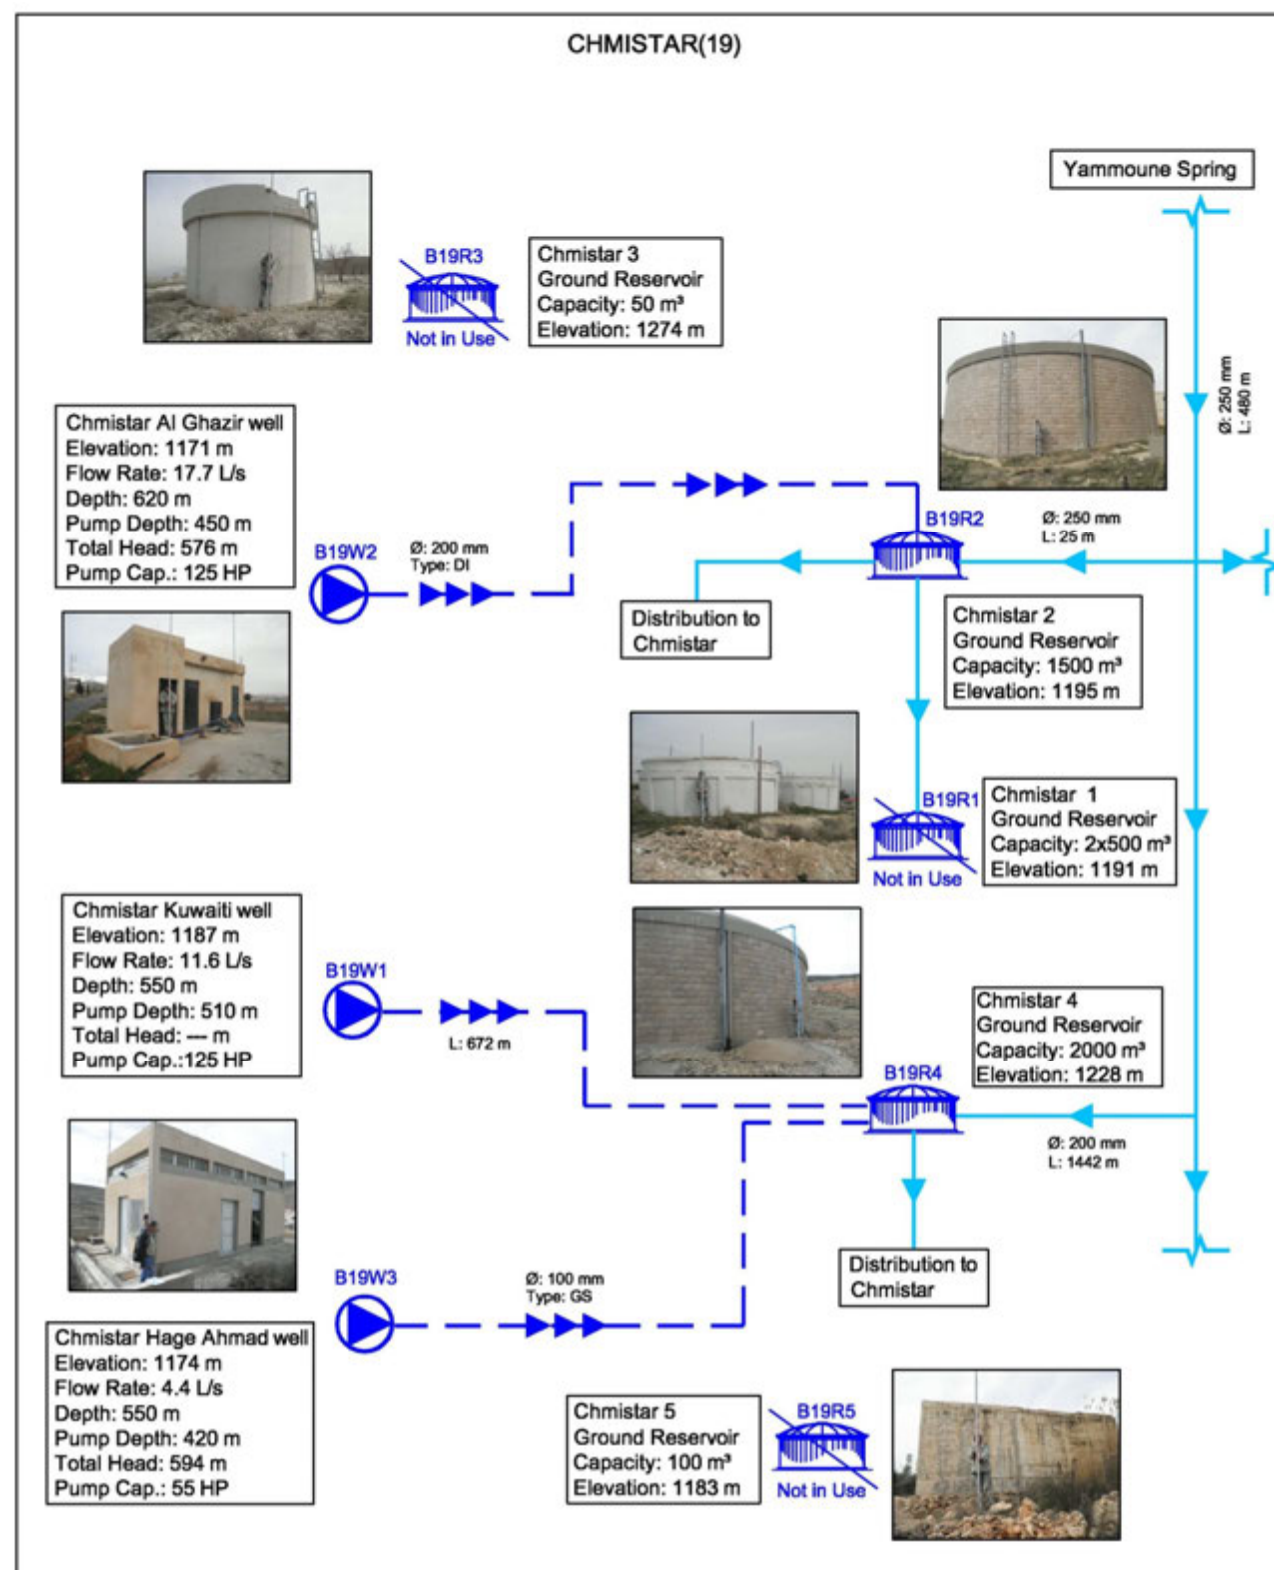
**Chmistar (19)**

The existing water network is in bad condition and it has a length of around 55 km. It covers a large area of the town.

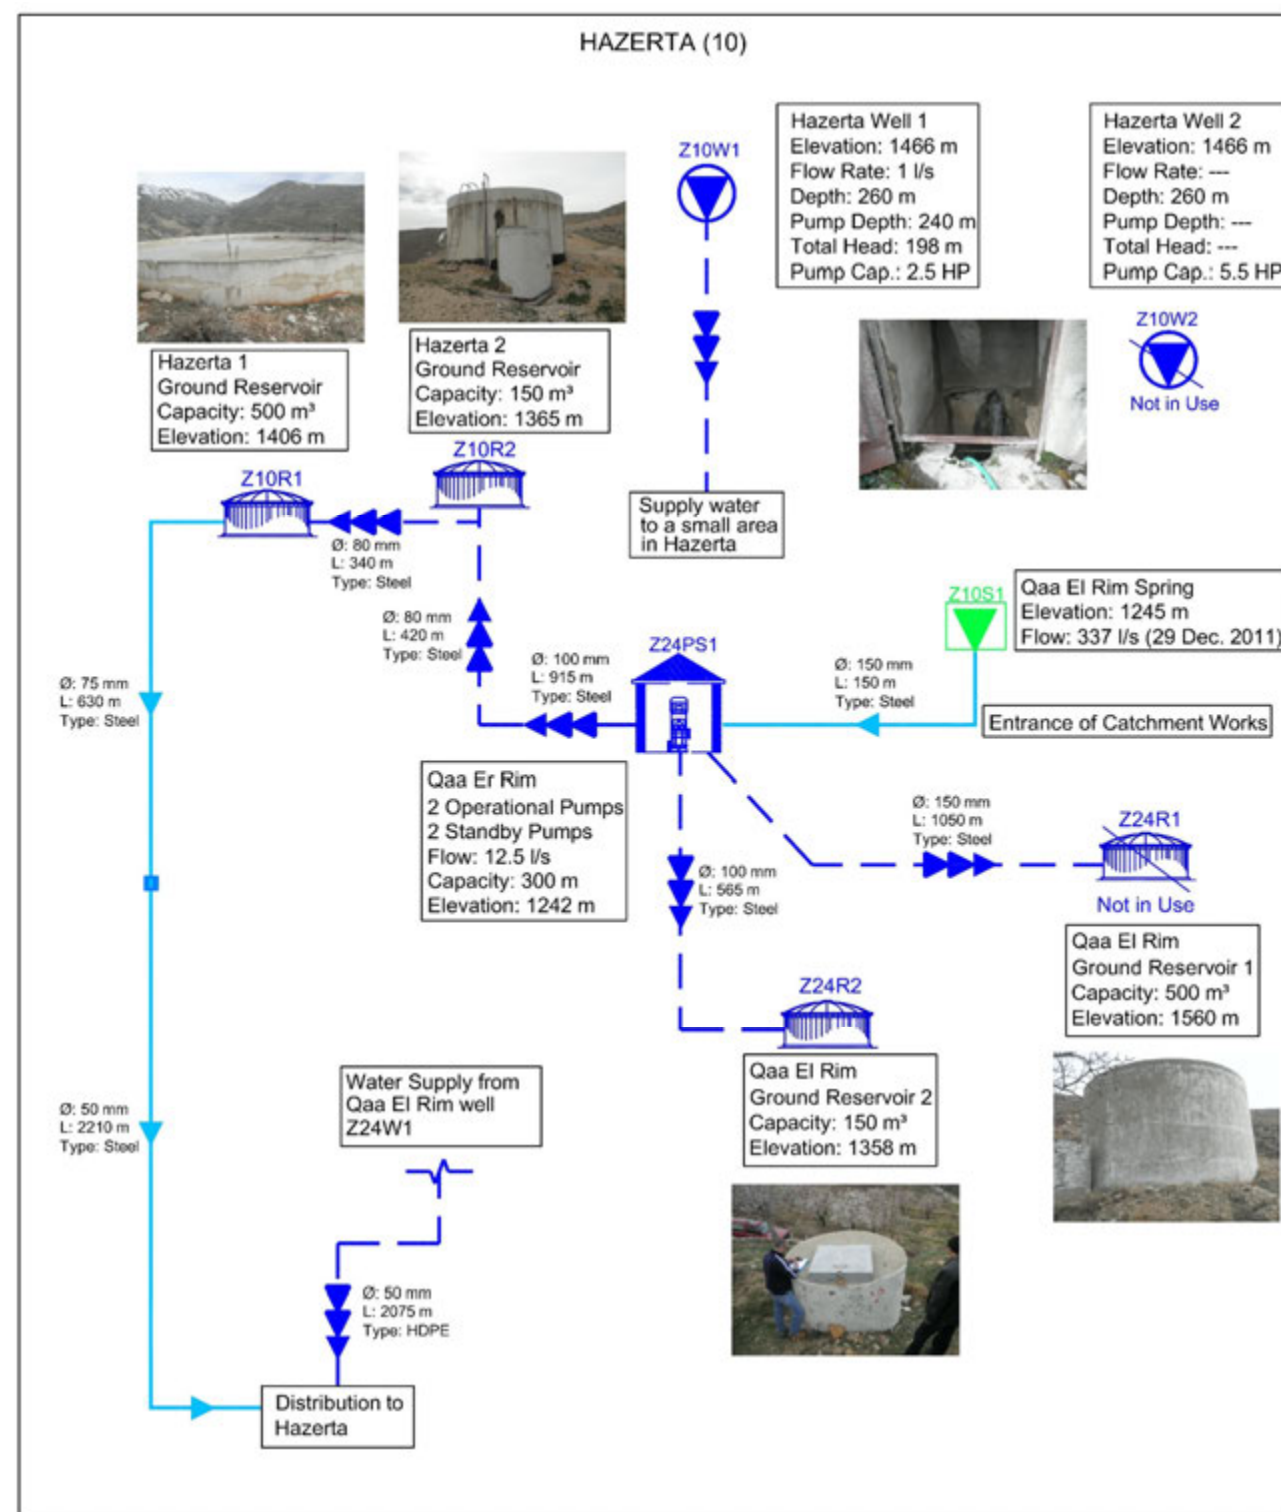
**Hazerta (10)**

The existing water network is in bad condition and it has a length of around 18 km. It covers a large area of the town.

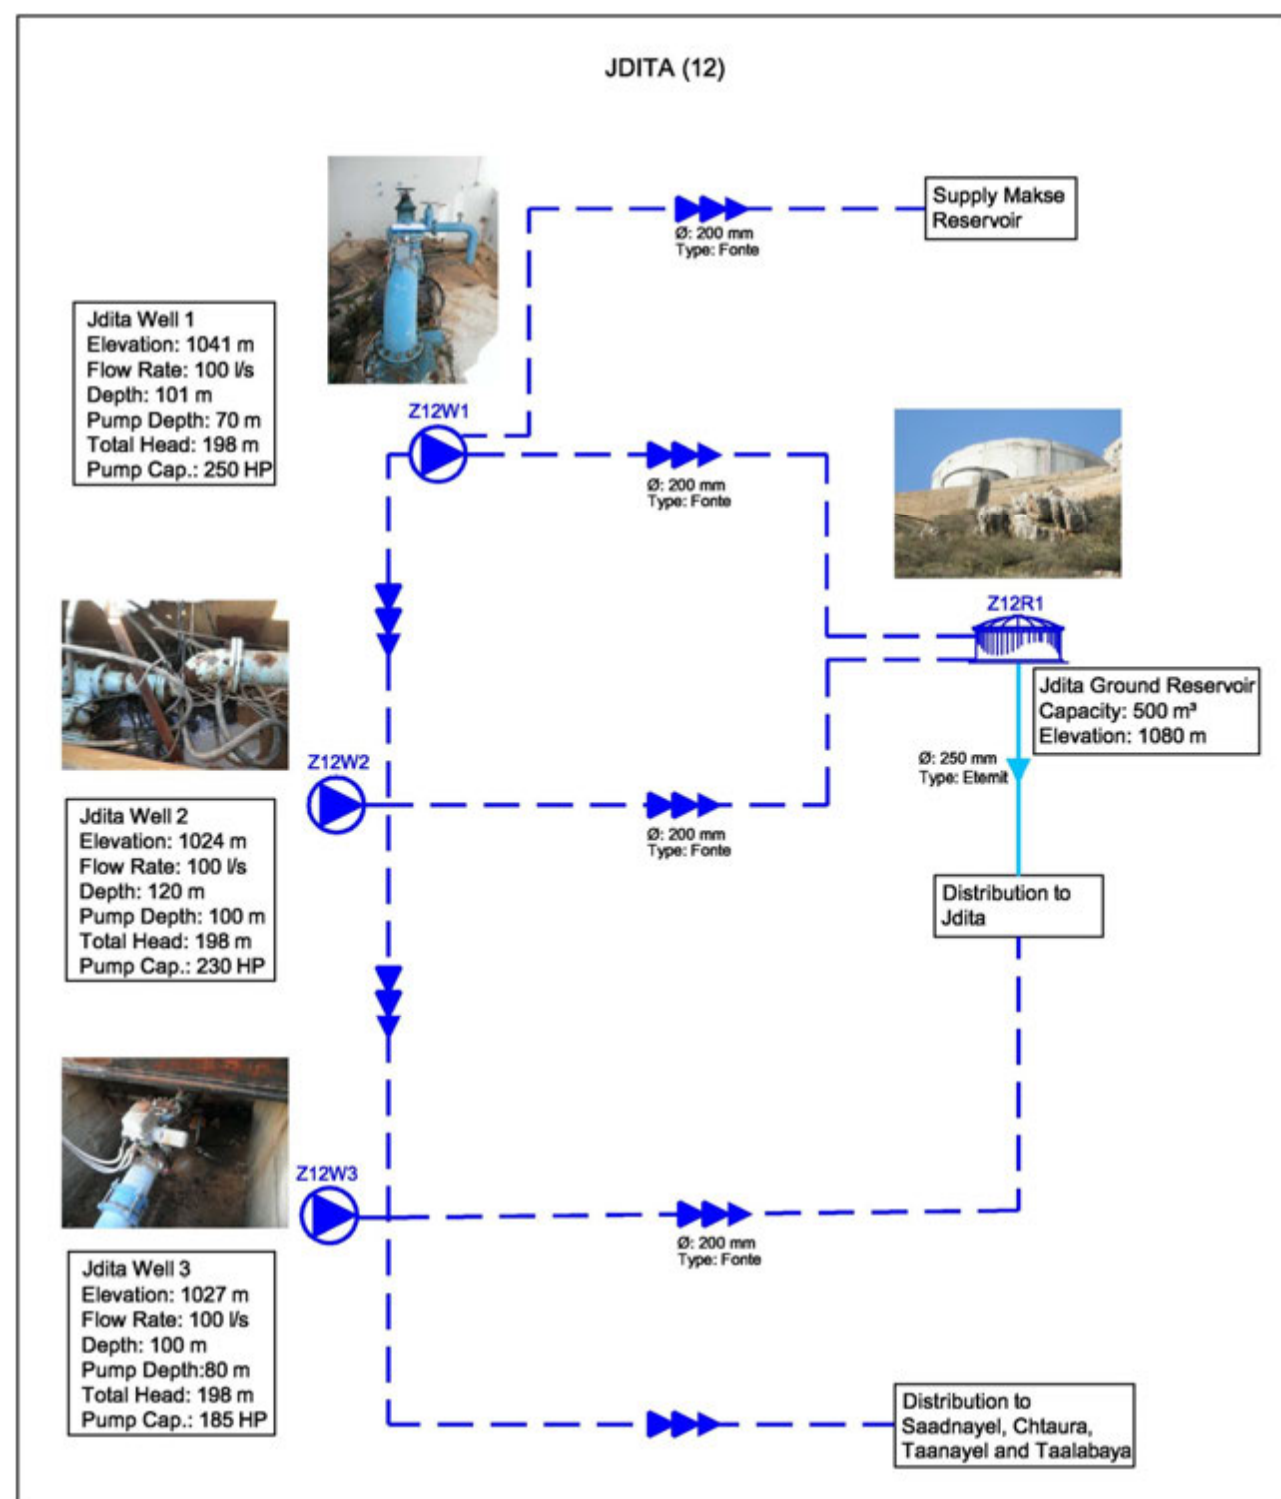
**Jdita (12)**

The existing water network is in bad condition and it has a length of around 14.5 km. It covers a large area of the town.

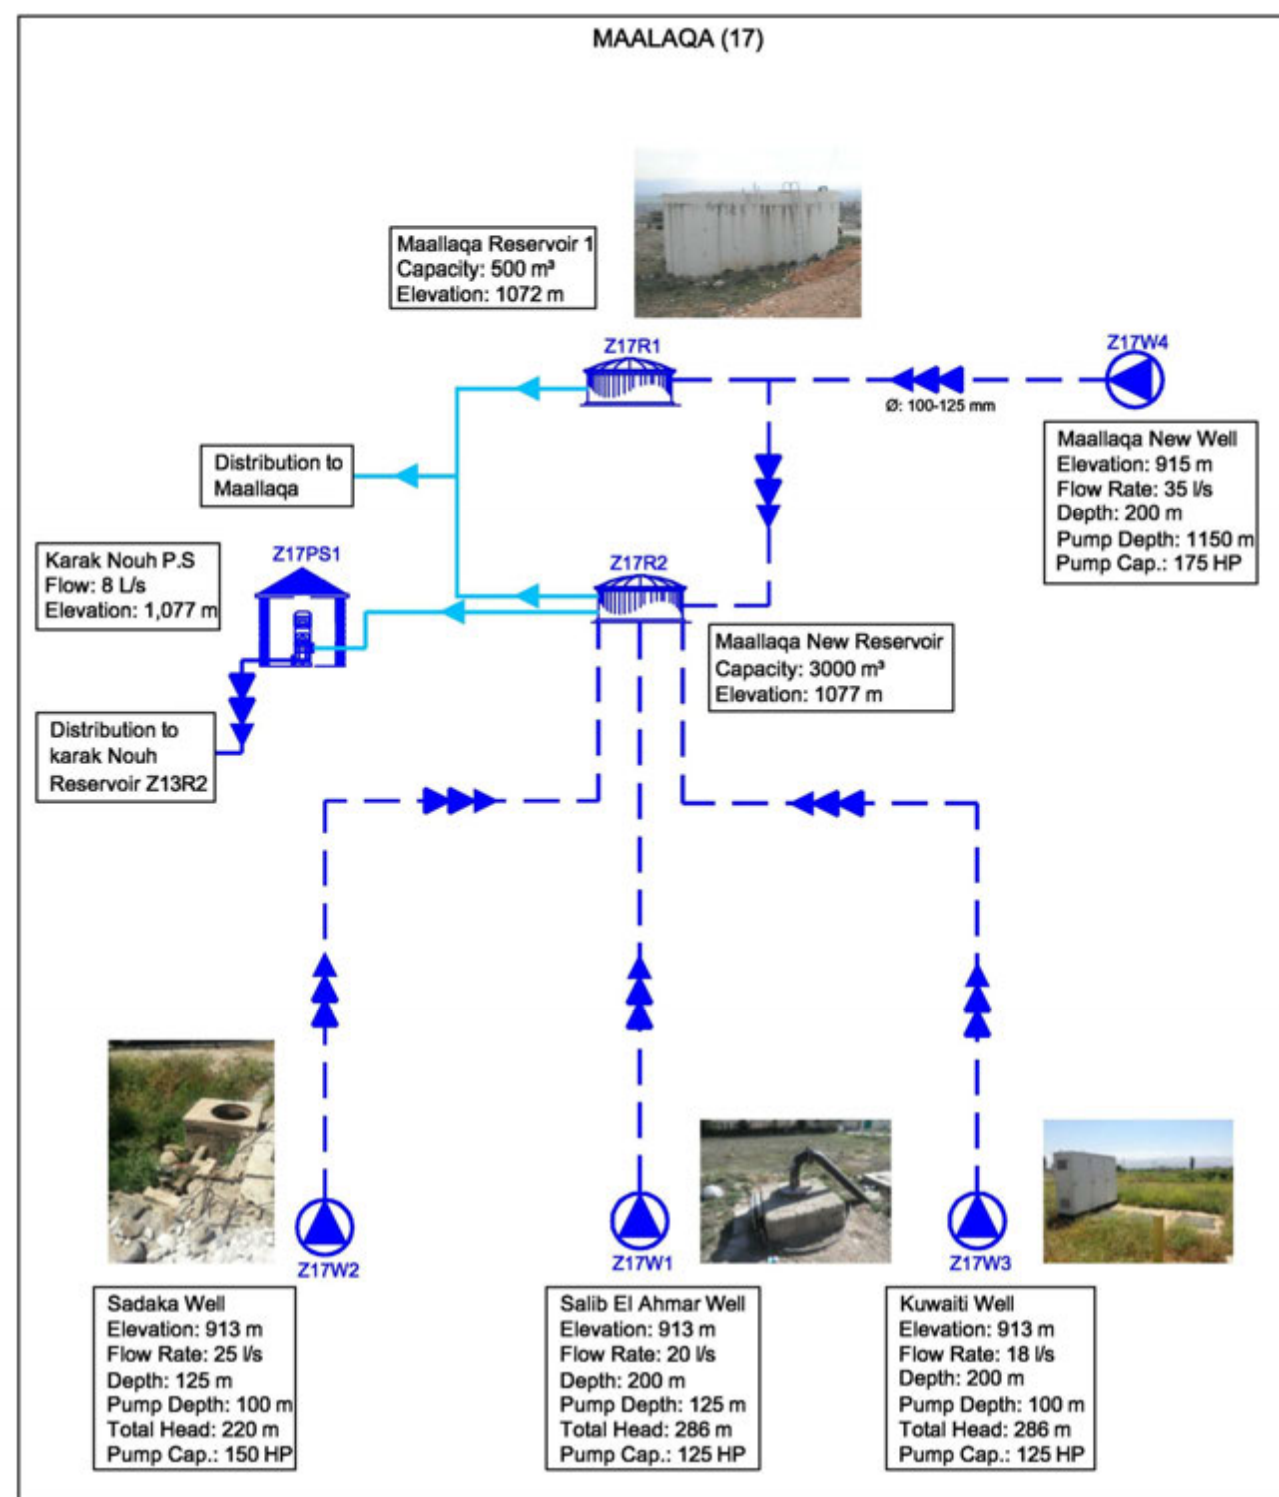
**Maalaga (17)**

The existing water network is in bad condition and it has a length of around 20 km. It covers a large area of the town.

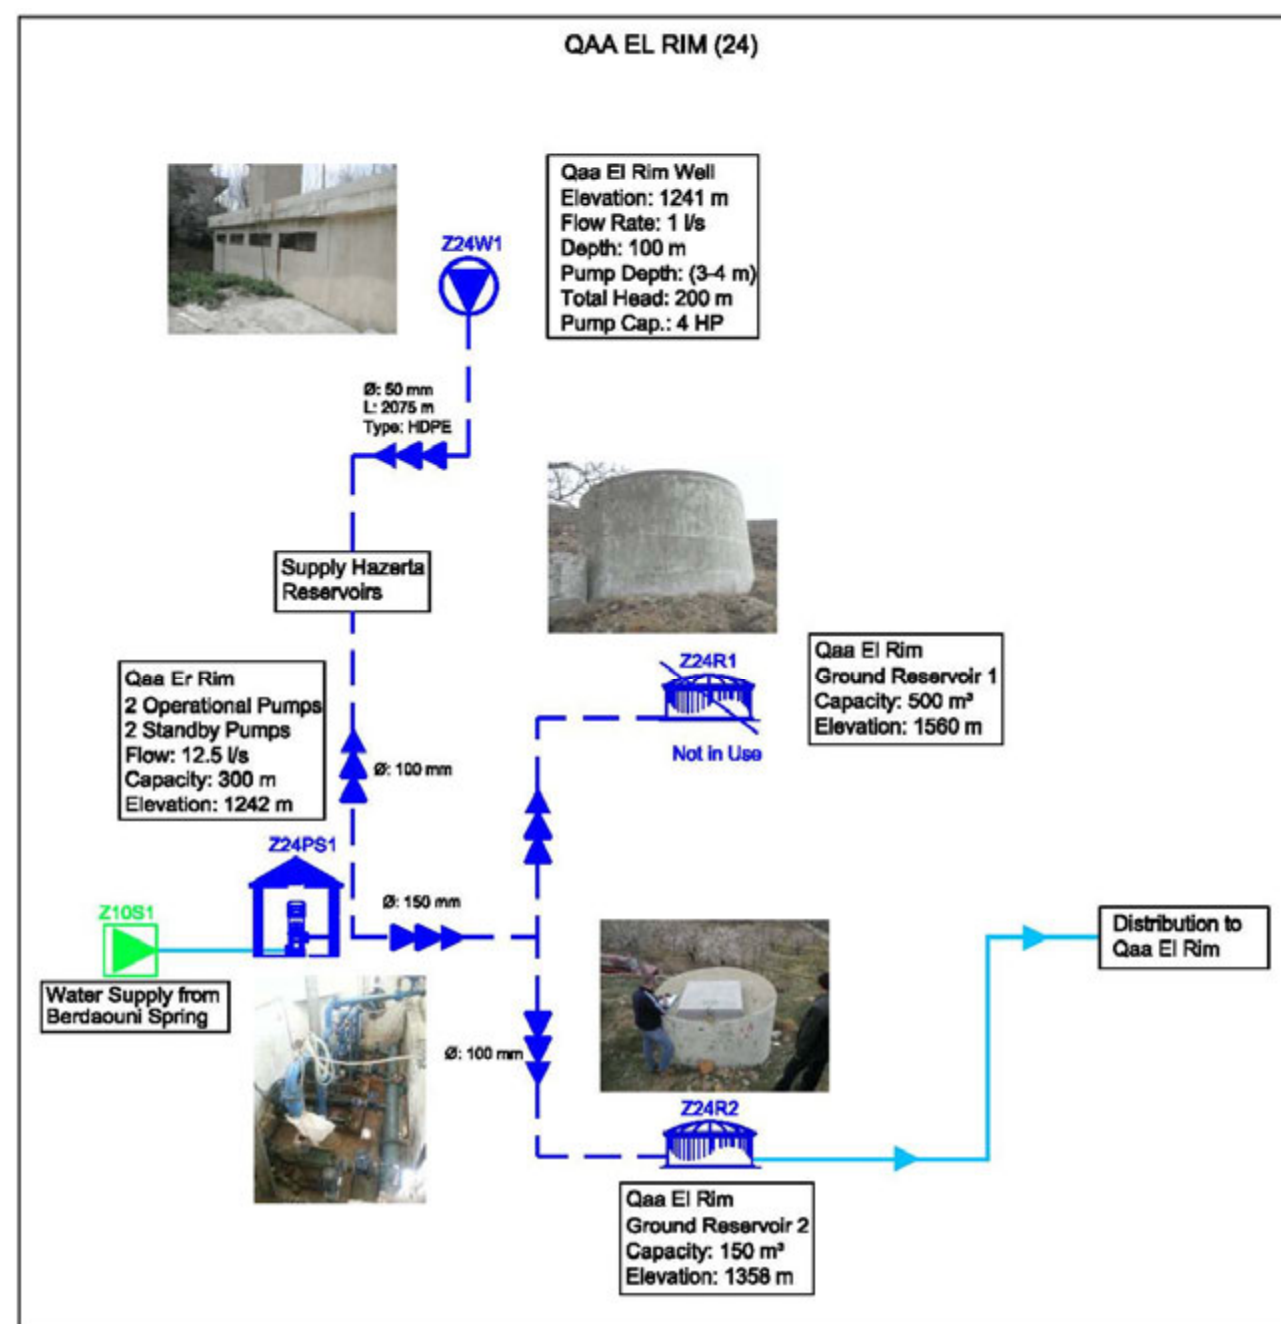
**Qaa el rim (24)**

The existing water network is in bad condition and it has a length of around 10 km. It covers a large area of the town.

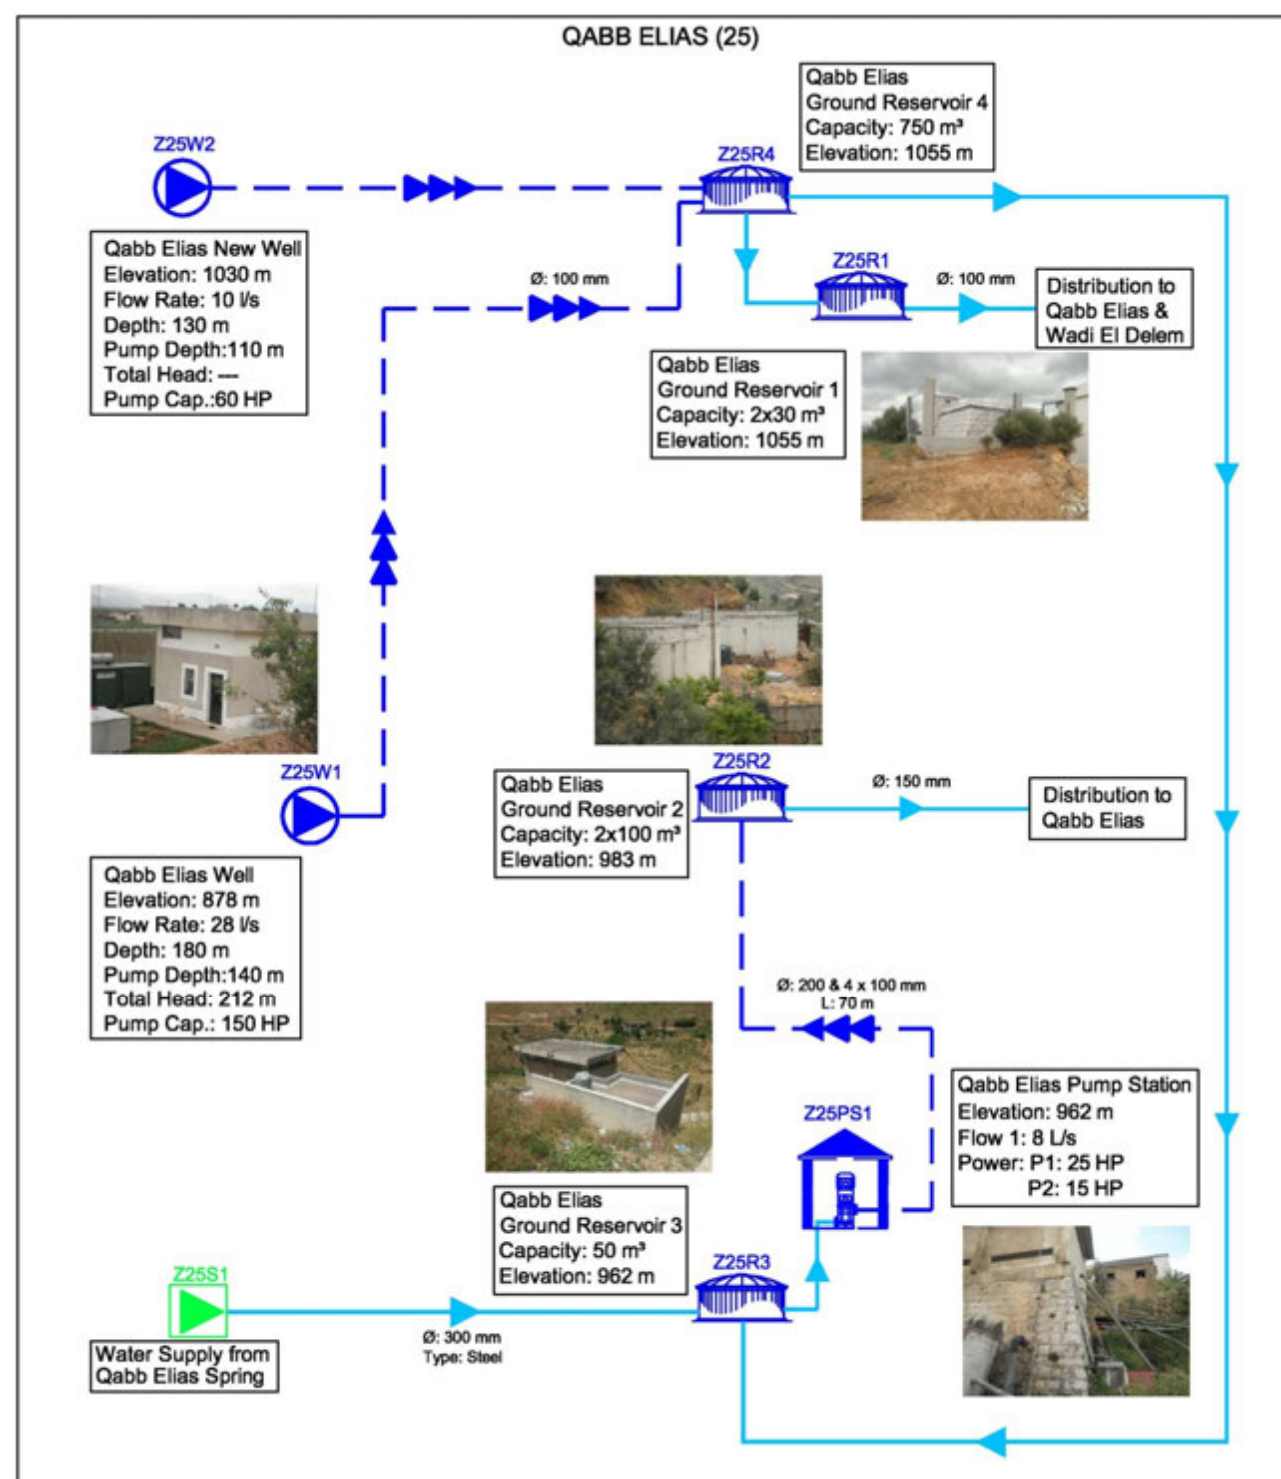
**Qabb Elias (25)**

The existing water network is in bad condition and it has a length of around 3.5 km. It covers a large area of the town.

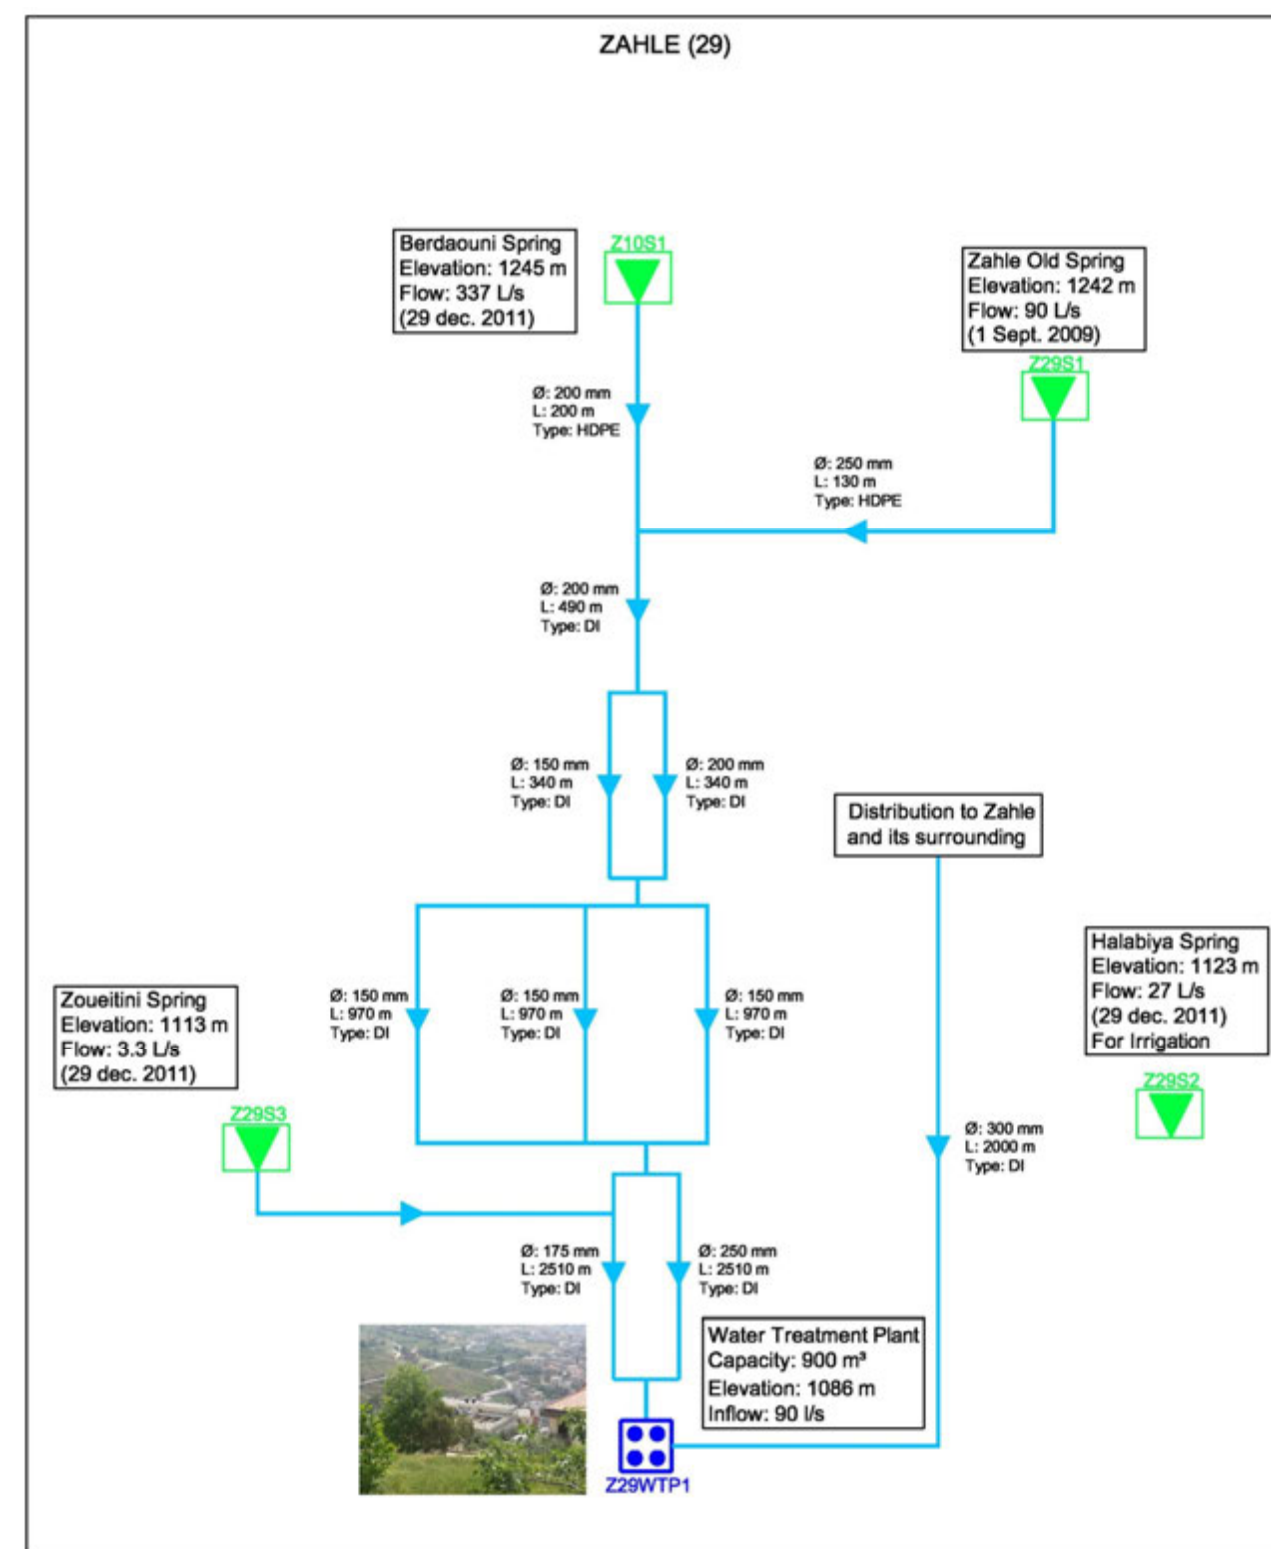
**Zahle (29)**

The existing water network is in bad condition and it has a length of around 218 km. It covers a large area of the town.
