# WATER SUPPLY AND WASTEWATER SYSTEMS MASTER PLAN FOR THE BEKAA WATER ESTABLISHMENT

## WATER ASSESSMENT REPORT

January 2014  
Updated May 2015

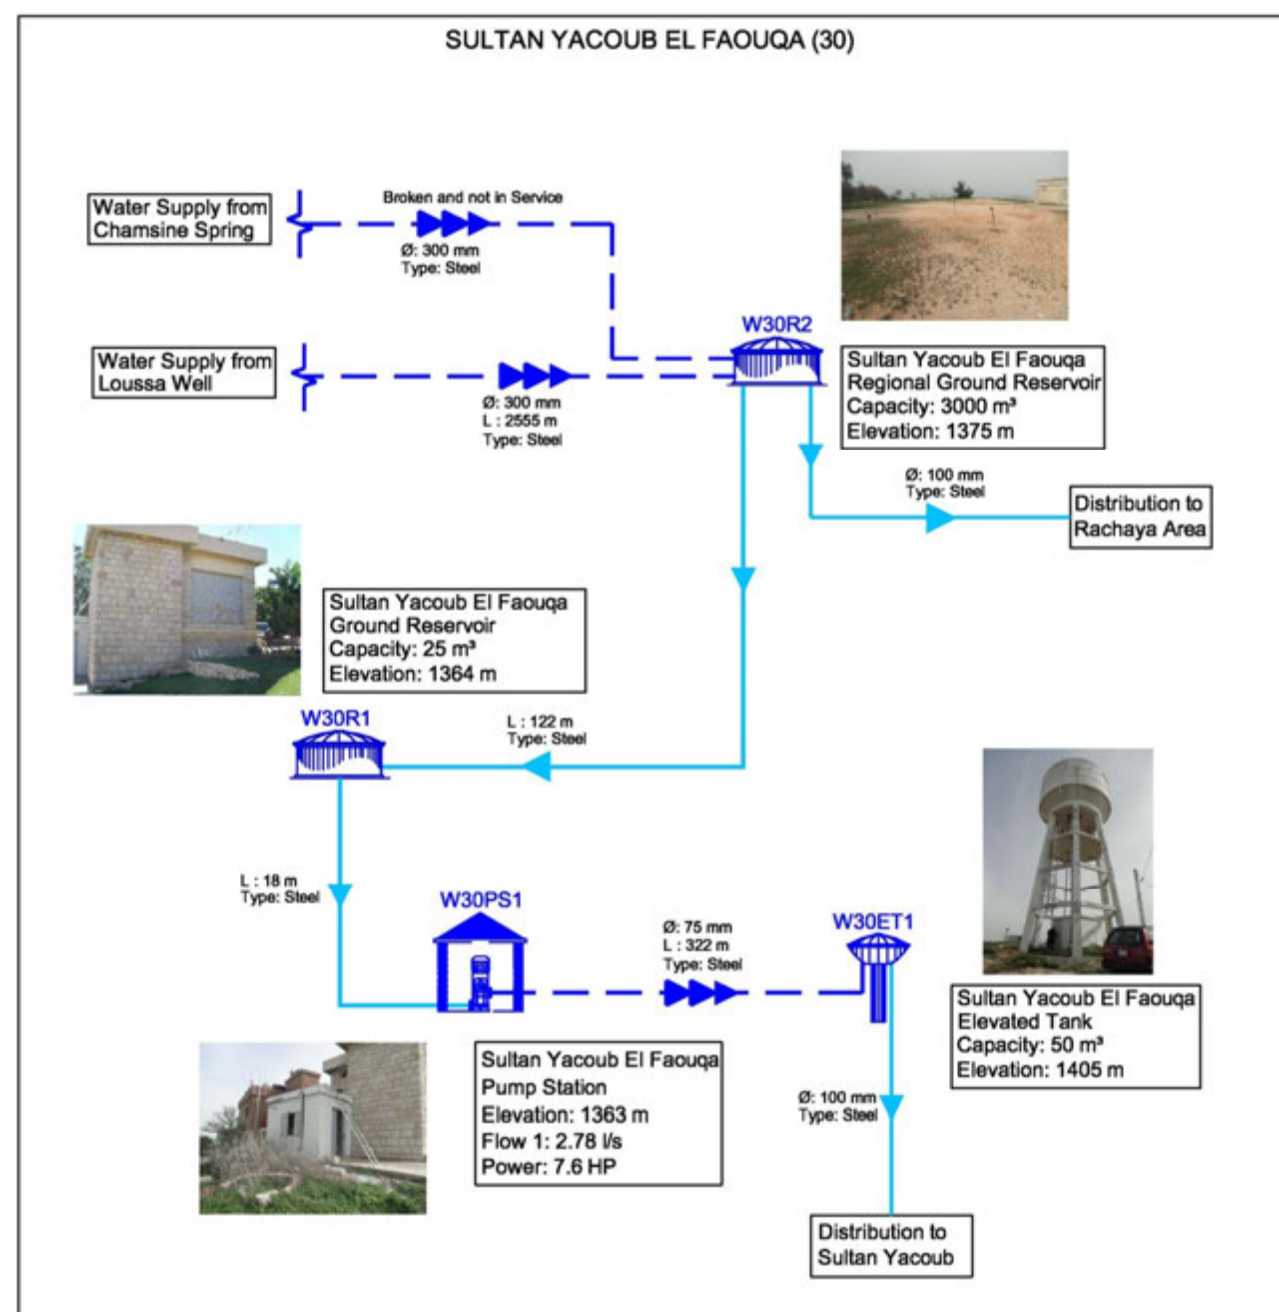
Reservoir W30R2 (55 years old; 3000 m³): Reservoir is in bad condition. It needs esthetical and structural rehabilitation.

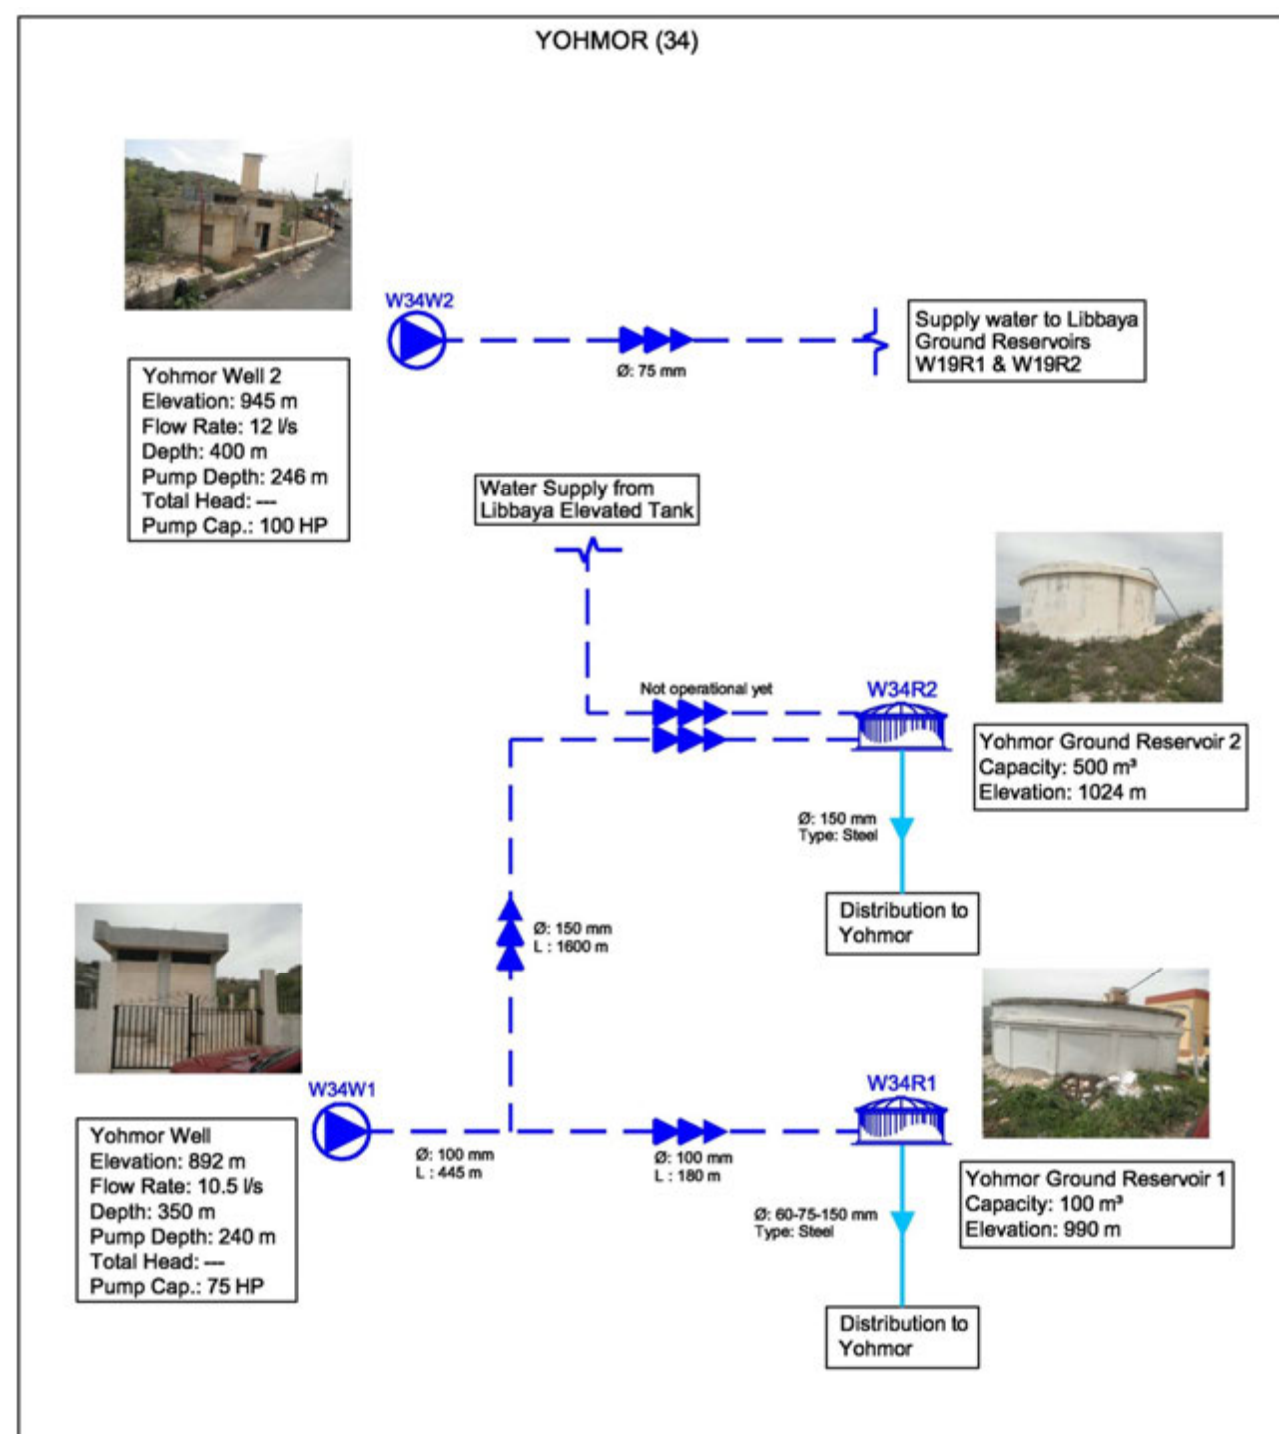
The existing water network is old (installed 18 years ago) and it is in bad condition.

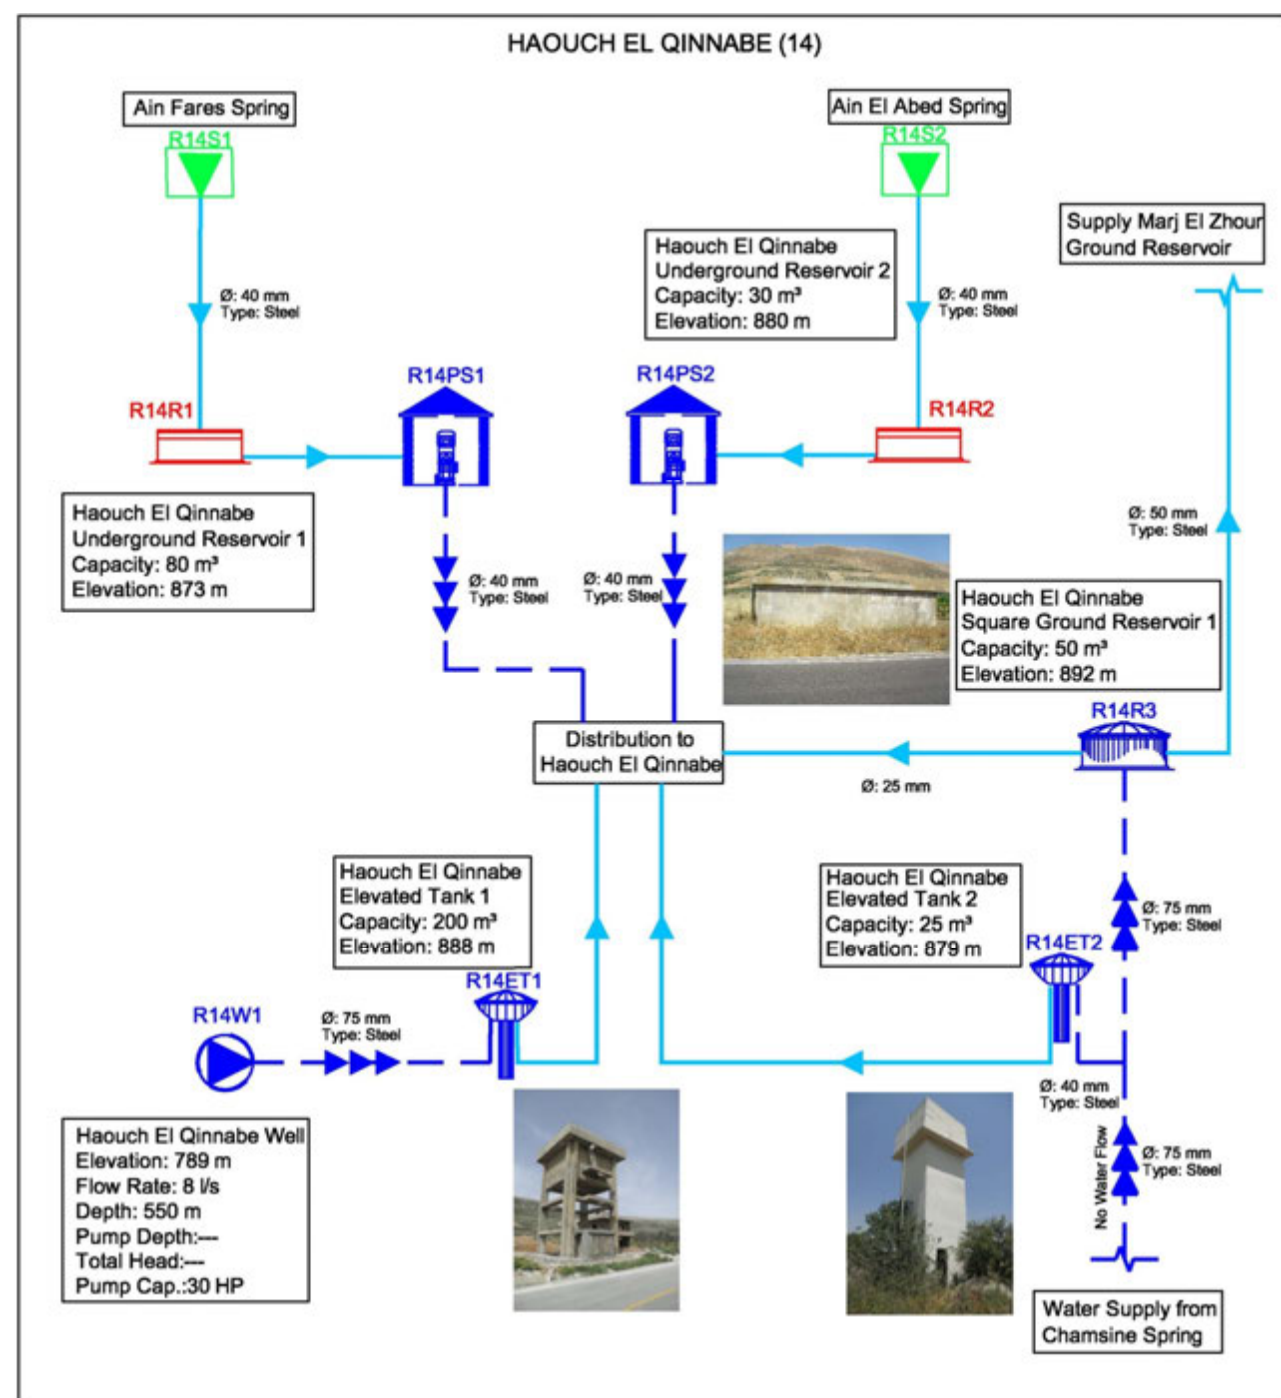
The existing water network is old and it is in a bad condition. The only water source in the town is Chamsine spring. A new line coming from Ain El Zarqa spring will supply this village once the system becomes operational. The specific layout could not be obtained.
