**THE MANAGEMENT OF SANITATION SERVICES:  
THE CASE OF MOSHI URBAN**

**ENVIRONMENTAL REGULATION**

**BY**  
**ELIZABETH PALELA**

**UNIVERSITY OF DAR ES SALAAM**  
**GEOGRAPHY DEPARTMENT**

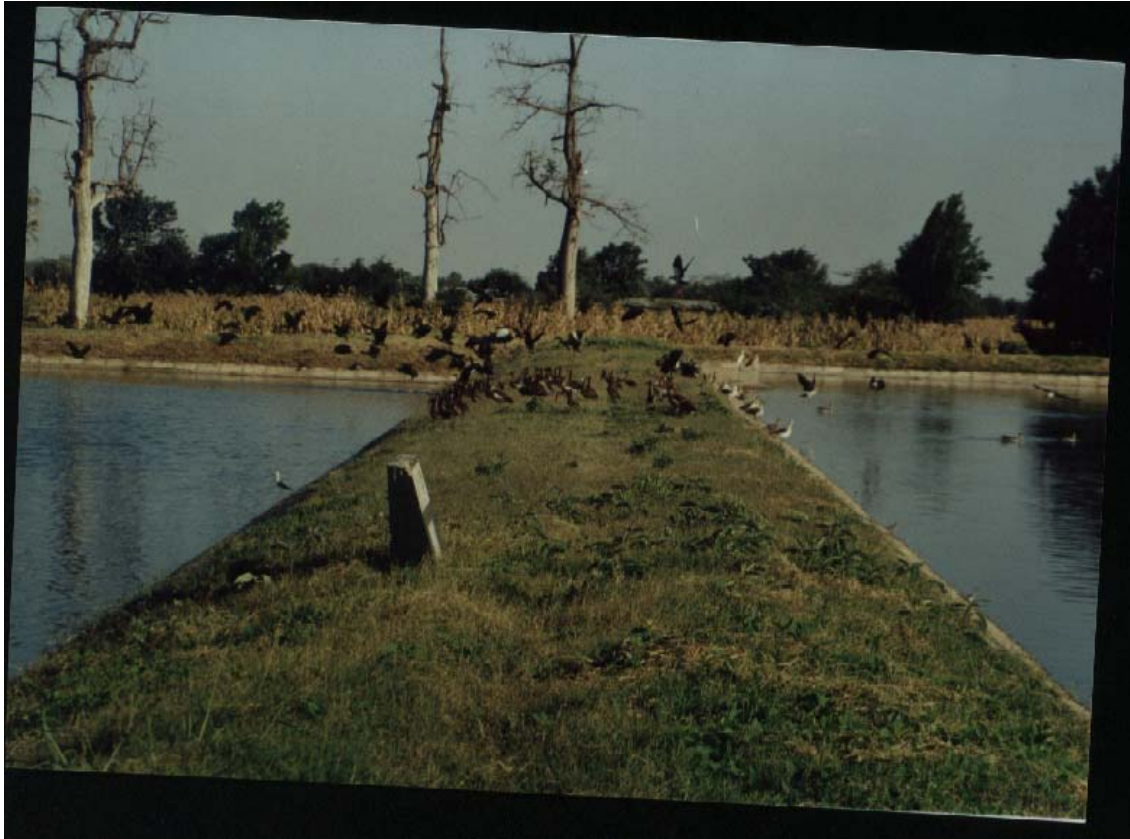
**Plate 1 Mabogini wastewater treatment ponds**

The system is directed southward of the town to stabilization ponds in Mabogini area where the effluent enters river Rau into the Pangani basin ending up in the Indian Ocean. There is no treatment, but rather natural stabilization of wastewater. (Plate 1)

The treatment plant is designed to receive 4,500 m<sup>3</sup> per day but it is now receiving only 2,592-3,456 m<sup>3</sup> per day depending on season. During the rainy season or when there is high consumption of water, the amount it receives increases. Septic tanks are disludged by cesspits, which is the responsibility of the Municipal Council. The cesspit tanks/or trucks make about 90-100 trips per month.

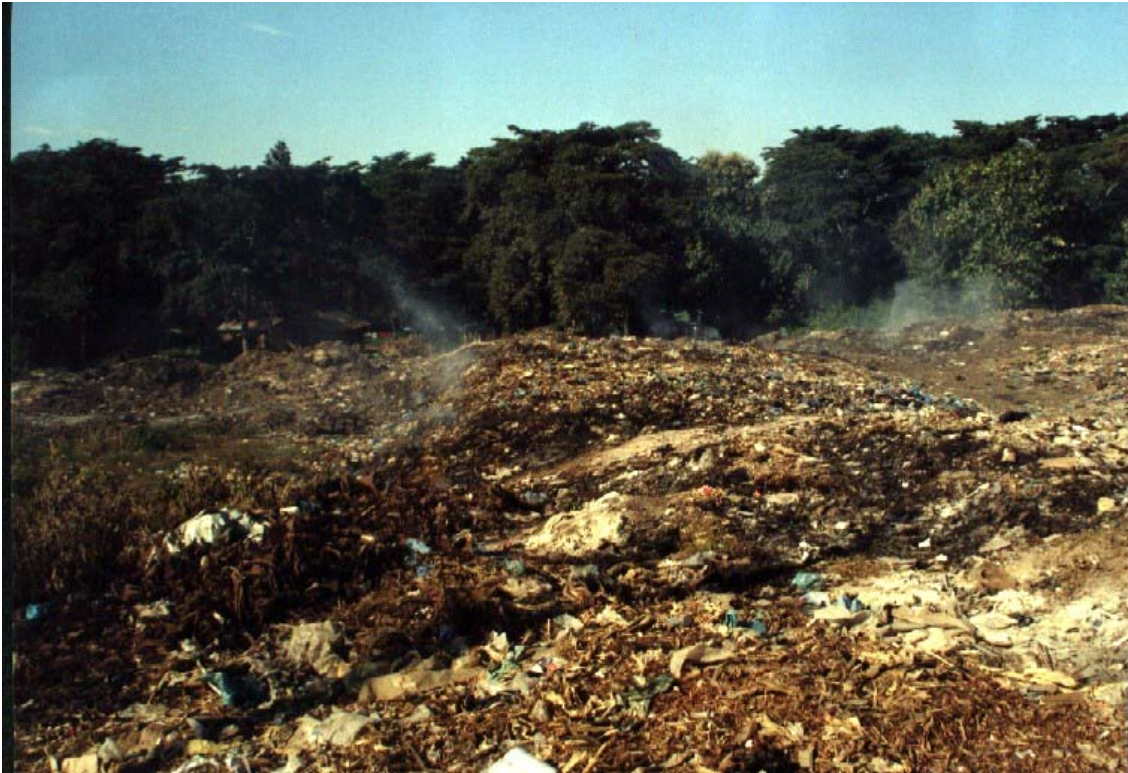
**Plate 2 Kaloleni dumpsite**

Haphazard waste disposal has been observed at the dumping site at Kaloleni, no separation of different categories of waste is done hence one would find metals, plastics, food stuffs, papers etc all piled up into the same area. Even some industrial waste is found in the area. This is a very dangerous method of waste disposal as observed also by the Moshi Environmental Profile of 1999. The report indicated that uncontrolled dumping leads to seepage, water contamination and the spread of water-borne diseases. Also incidental fires at the dumping site are likely to cause Upper Respiratory Tract (URT) and carcinogenic infections.

The dumping site is located near a residential area although the Health Municipal Officer pointed out that the dumpsite has been there for the past 30 years and that the people and the industries have encroached into the area much later. This situation creates risks to those who live near-by because scavenger birds tend to move from the dumpsite to the peoples' homes hence carrying along some items or garbage to the settlements. This causes the spread of diseases and if the scavenger is to land near or in a stream, for a drink then the water will also be contaminated.

The Municipal director pointed out that there is a crude dumping site in Kaloleni, which is now full, and in desperate need of replacement. The Municipal Director revealed that after trying unsuccessfully to secure land within the Municipal area, the Municipality finally was allowed to use a 4 hector piece of land earmarked as a dumping field at Bomang'ombe about 30 km away from Moshi. Preparations for this project though, are still underway.

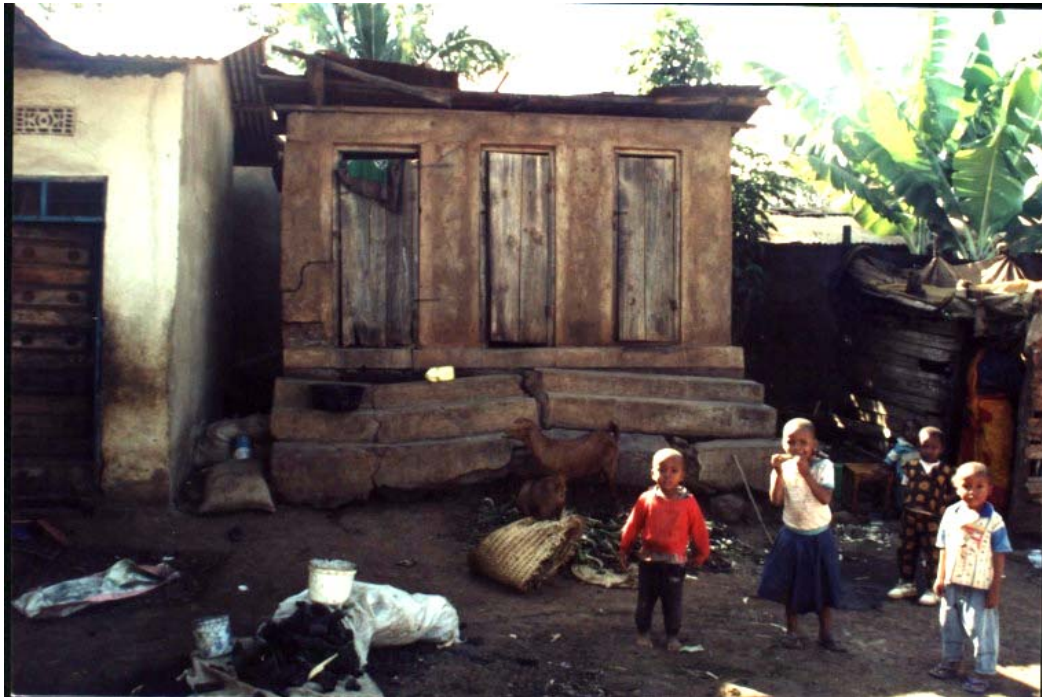
**Plate 4 at the background- an elevated pit latrine in the Njoro area**

Making matters worse, the Njoro area is on top of a rock, which makes it impossible (with the resources available) for the people in the area to dig deep latrines, septic tanks or even solid waste disposal pits. This being the case most pit latrines in this areas are built with the depth being established by elevating the latrines but in some cases even that is not affordable so the latrines are very shallow.(Plate 4)

The result of this practice is overflowing of these pit latrines especially during the rainy season. The overflow may also result from the fact that the latrines are filled up. This is dangerous health wise as it leads to outbreak of diseases such as diarrhoea, dysentery etc. But more dangerous is the fact too that once the outbreak takes pace people are not economically in a position to protect or treat themselves and with their already poor diet, recovery is also very difficult.

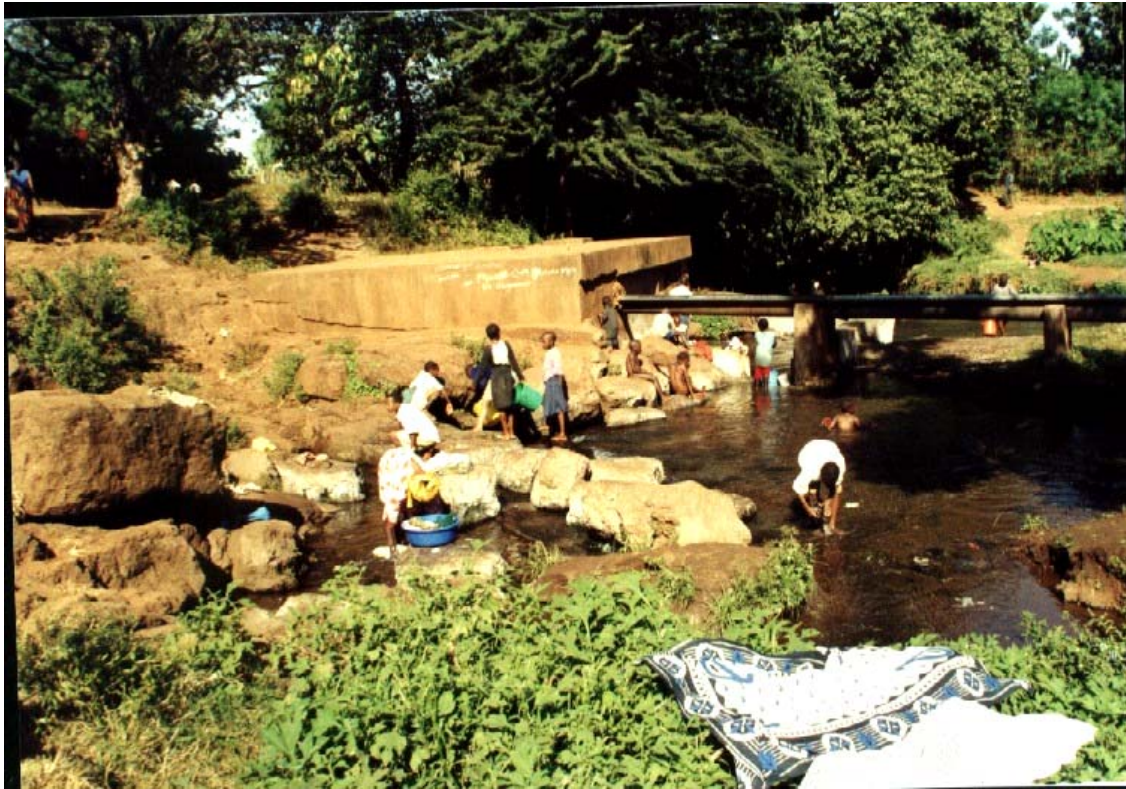
**Plate 5 washing and bathing taking place in the Njoro spring along Njoro river. (viewed in the back ground is a shut down water pump.)**

Solid waste disposal in areas like Njoro, include throwing garbage on the banks or within the river Njoro and even a greater portion of the solid waste is dragged into the river from the surrounding settlements especially during the rain season. (Plate 6) This, plus the overflowed latrines create a very dangerous health hazard to those using the water of this and any other river, experiencing the same situation. This situation is a result of not having waste collecting services in these areas the one municipal skip basket was spotted at the Njoro market but due to the inaccessibility of the more interior parts (where the situation is critical) this services is not available letting the people use autonomous alternatives.

The unfortunate fact is that the people who use these rivers are the same ones who are responsible for this contamination. The rivers provide water for domestic use and to some extent small-scale agriculture. But this could be more a result of lack of clean water supply (tap water) as MUWSA has not been able to cover all areas with this service. It could also be a result of inability to pay for the service large part of urban Moshi has functioning water-meters for every customer.

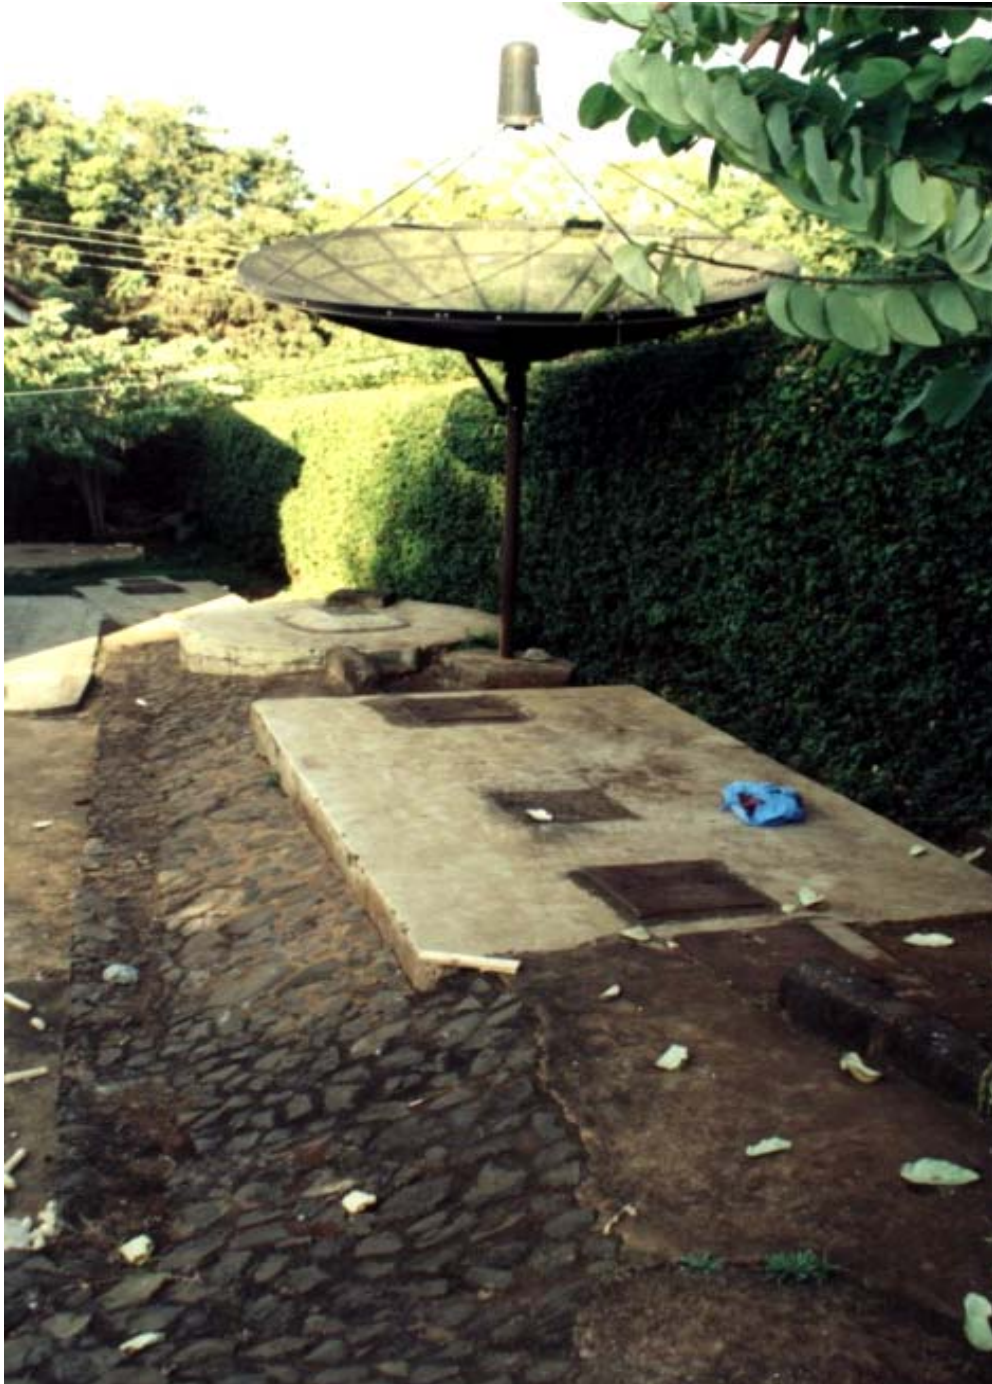
**plate 7 septic at a house in shanty town .the satellite dish is a sign wealth**

Also observation reveals that areas with medium to high income status, such as, Shanty town have a much different approach to sanitary management. In some cases those which are near to the CBD are connected to the central sewerage system (these are very few) but for those who have to connected, or are living in the unplanned areas of the municipality, they tend to use more decent or favourable kinds of sanitary practices including construction of septic and seepage tanks which indicates that even their toilets are more modern, such as flush toilets and the like. These are in most cases facilitated by Municipal Cesspit trucks, which are responsible for the emptying of these septic tanks. The individual pays for the service. (Plate 7)

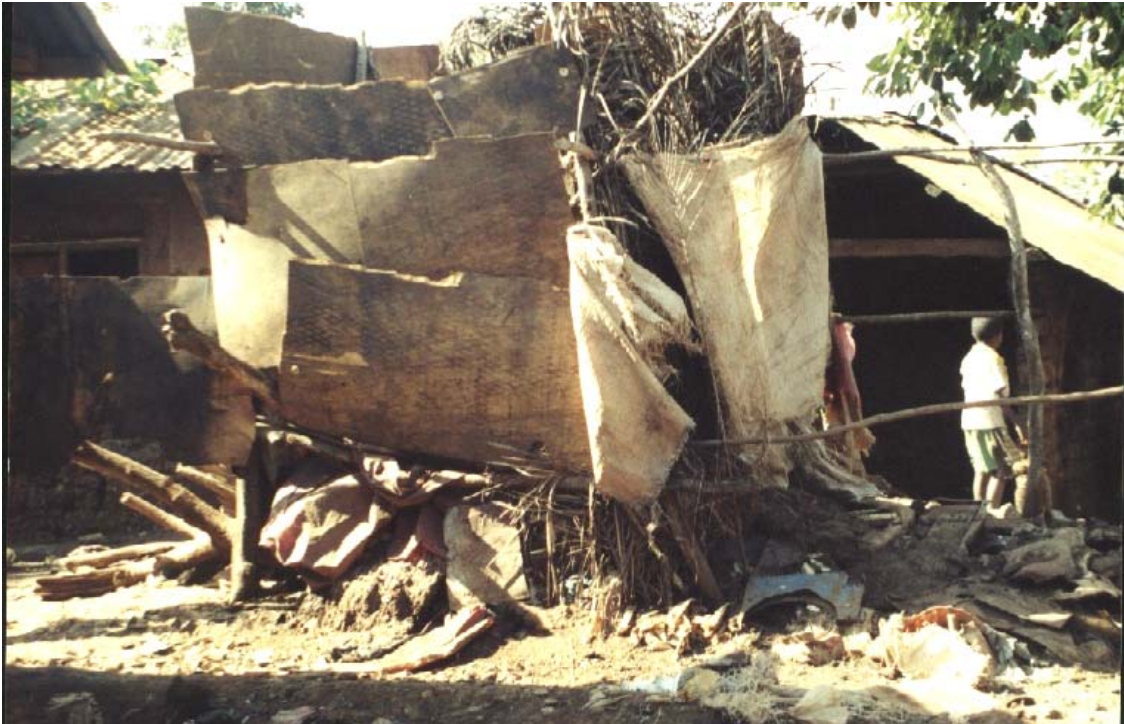
**plate 8 A soil pit built from a mixture of available materials.**

Hence, these autonomous builders tend to build through experience or in other worse cases such as construction of soil pits no experience is even considered. It is just a matter of digging a hole (depth of choice or convenience) and constructing a shed over it and covering the hole with materials such as wooden boards, iron sheets and any other materials that may seem suitable. This is not only dangerous environmentally and hygienically, but could also be catastrophic to life if the covering materials are not stable enough.(Plate 8).

Environmentally, This haphazard habit of construction of autonomous sanitary facilities could lead to the contamination of underground water, out break of diseases. According to the District Medical officer communicable diseases are most common in the low-income areas. Revealing that in the year 2000 there were 2,702 reported cases of diarrhoea and 3,354 cases of intestinal worms. be this being the case, this situation needs to be seriously considered as always this impact has far more reaching effect, Wright (1997) clearly explains this phenomenon by pointing out that, “human and domestic waste from any area has the potential to contaminate not just the local environment, but also groundwater, lakes, and rivers used by many others for supplies of fresh water. Thus the sanitary crisis cant take a toll on all city residents, on the national freshwater resources of developing countries.”
