# Concerns about corrosion and the quality of handpump components in Burkina Faso and beyond

*Dr Kerstin Danert  
29 July 2019*

Danert, K (2019) **Concerns about the quality of handpump components in Burkina Faso and beyond**, Skat Foundation, St Gallen, Switzerland

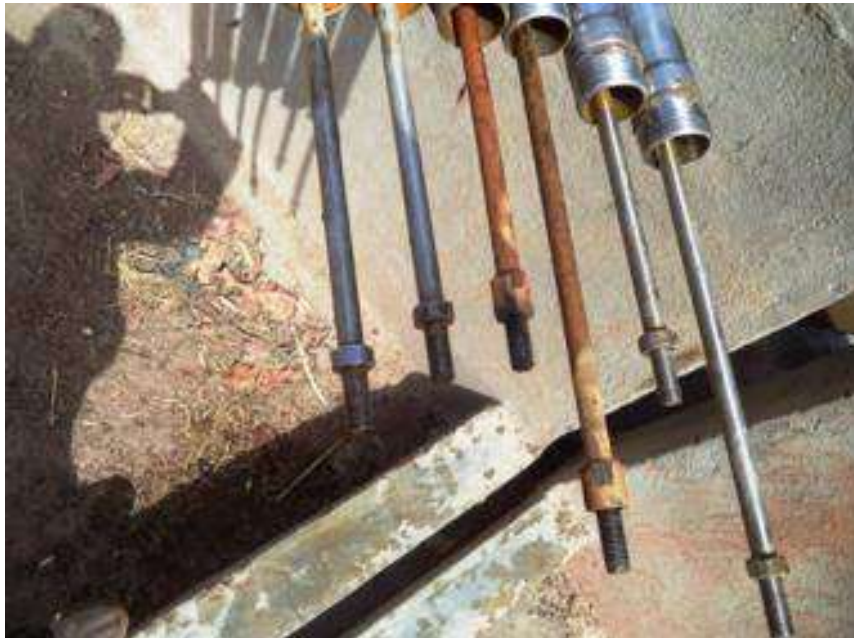
#### **Frontispiece**

Corroded rising mains being photographed as part of a physical audit of water facilities in Burkina Faso

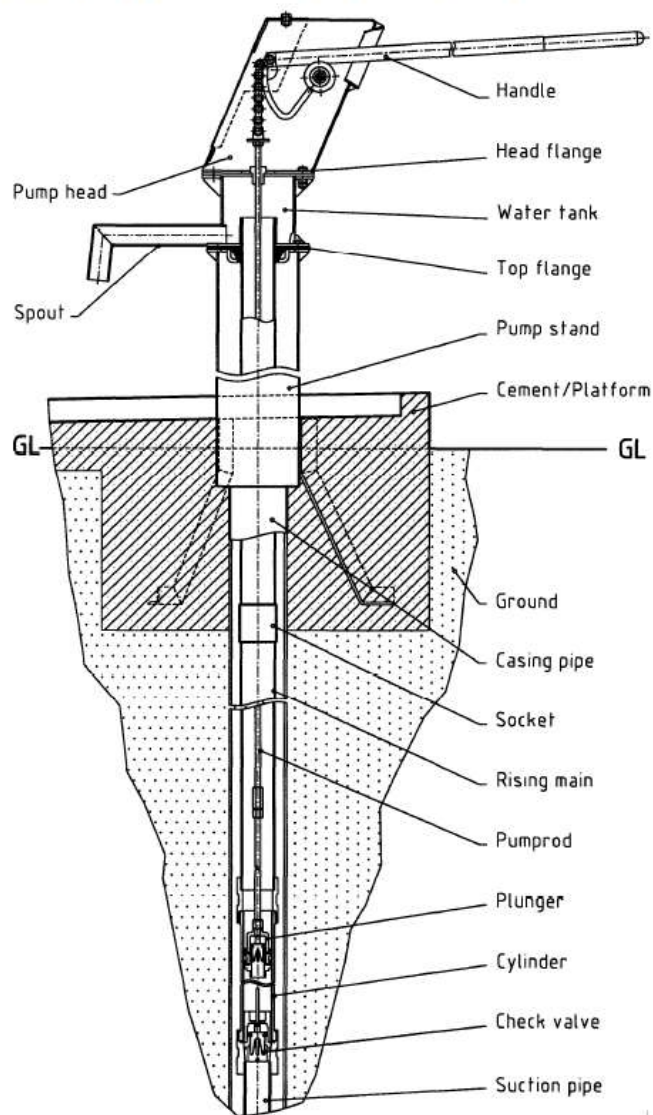
**Figure 1 Drawing of an India Mark III pump installed in a borehole**

**Drawing of an India Mark III Pump installed on a Borehole**
