# WATER SUPPLY AND WASTEWATER SYSTEMS MASTER PLAN FOR THE BEKAA WATER ESTABLISHMENT

## WATER ASSESSMENT REPORT

January 2014  
Updated May 2015

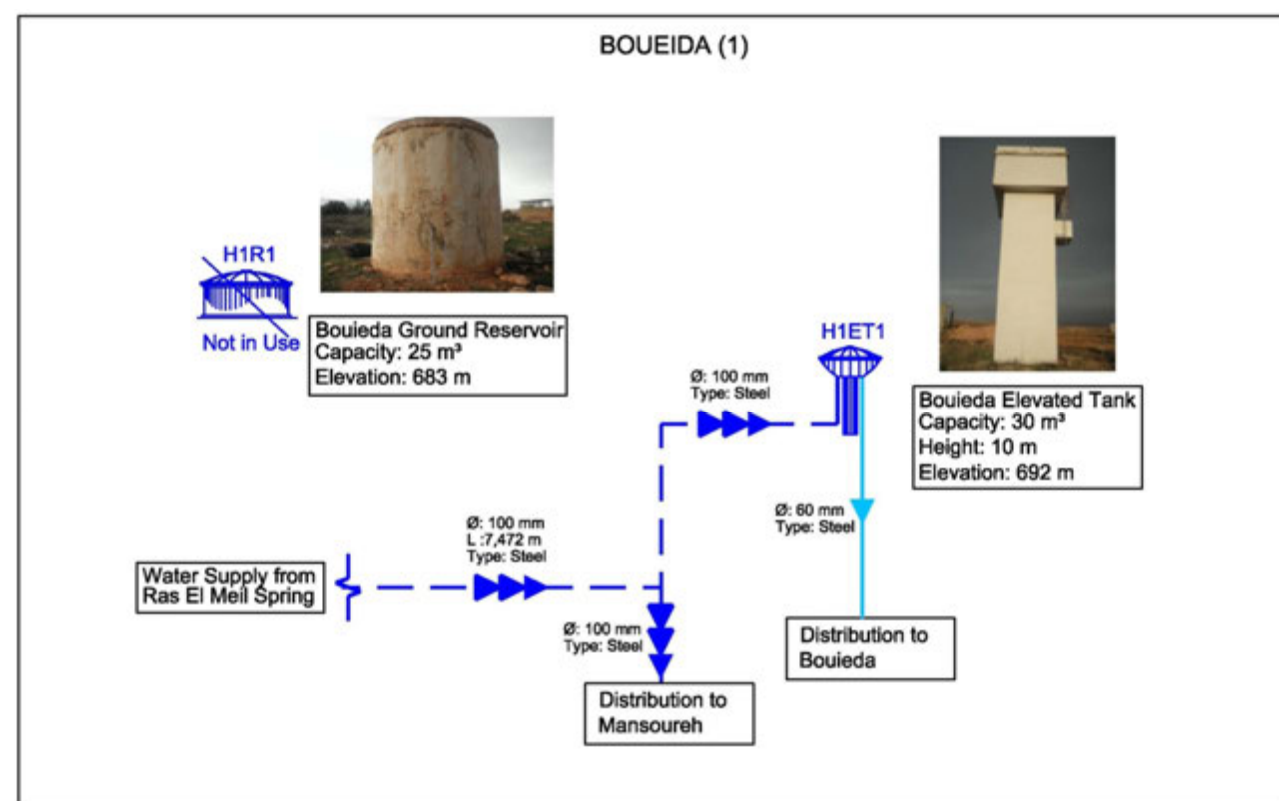
**Boueida (1)**

The existing water network is very old and it is in bad condition.

Reservoir H1R1 (25 m³): Reservoir is very old and it is in bad condition. It is not in use.

Elevated tank H1ET1 (30 m³): Elevated tank is very old and it is in bad condition. It needs rehabilitation.

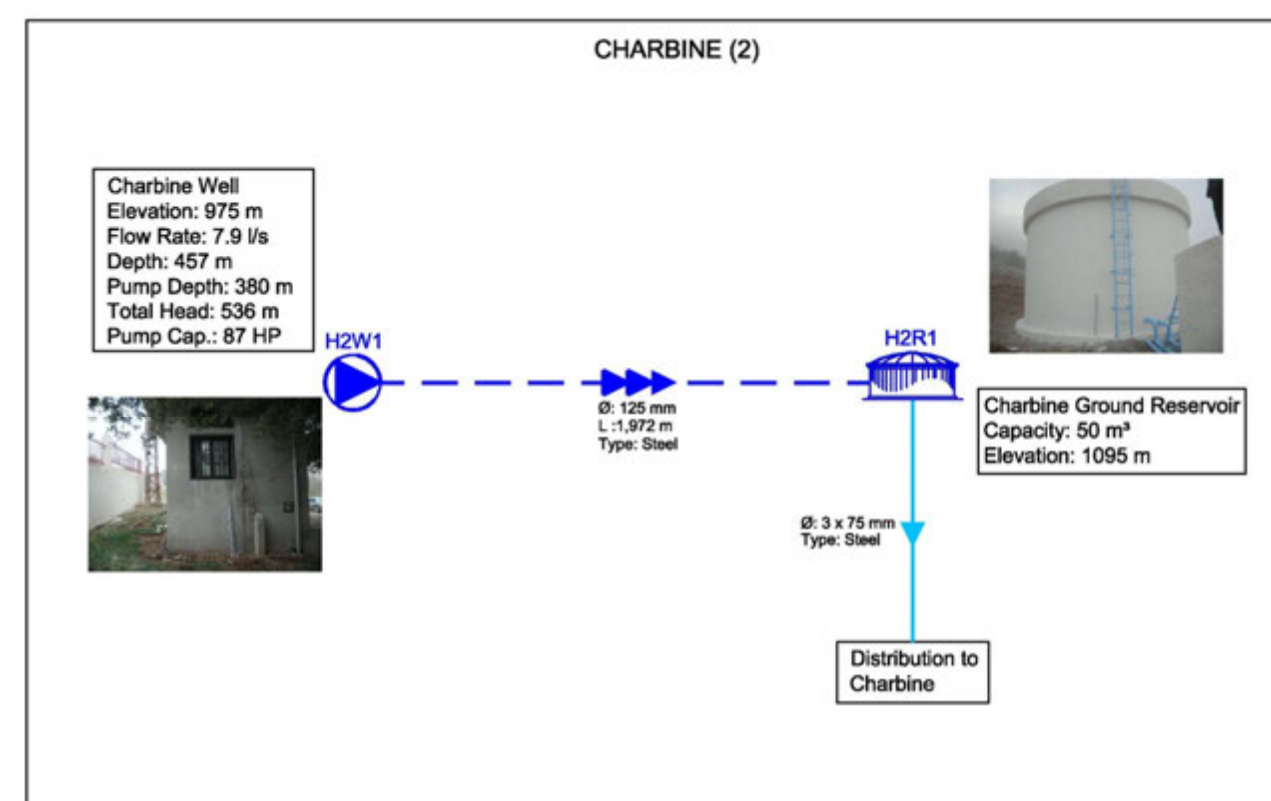
**Charbine (2)**

The existing water network is in bad condition and it has a length of around 2.3 km. It covers a part of the town.

There is some question mark about the reported well data as the listed head is not sufficient to supply the reservoir with water from the well.

Well H2W1 (15 years old): Well is in good condition. It includes power generator and small but non-functioning chlorination room. Generator is not always operating.

Reservoir H2R1 (50m³): Reservoir is in good condition.

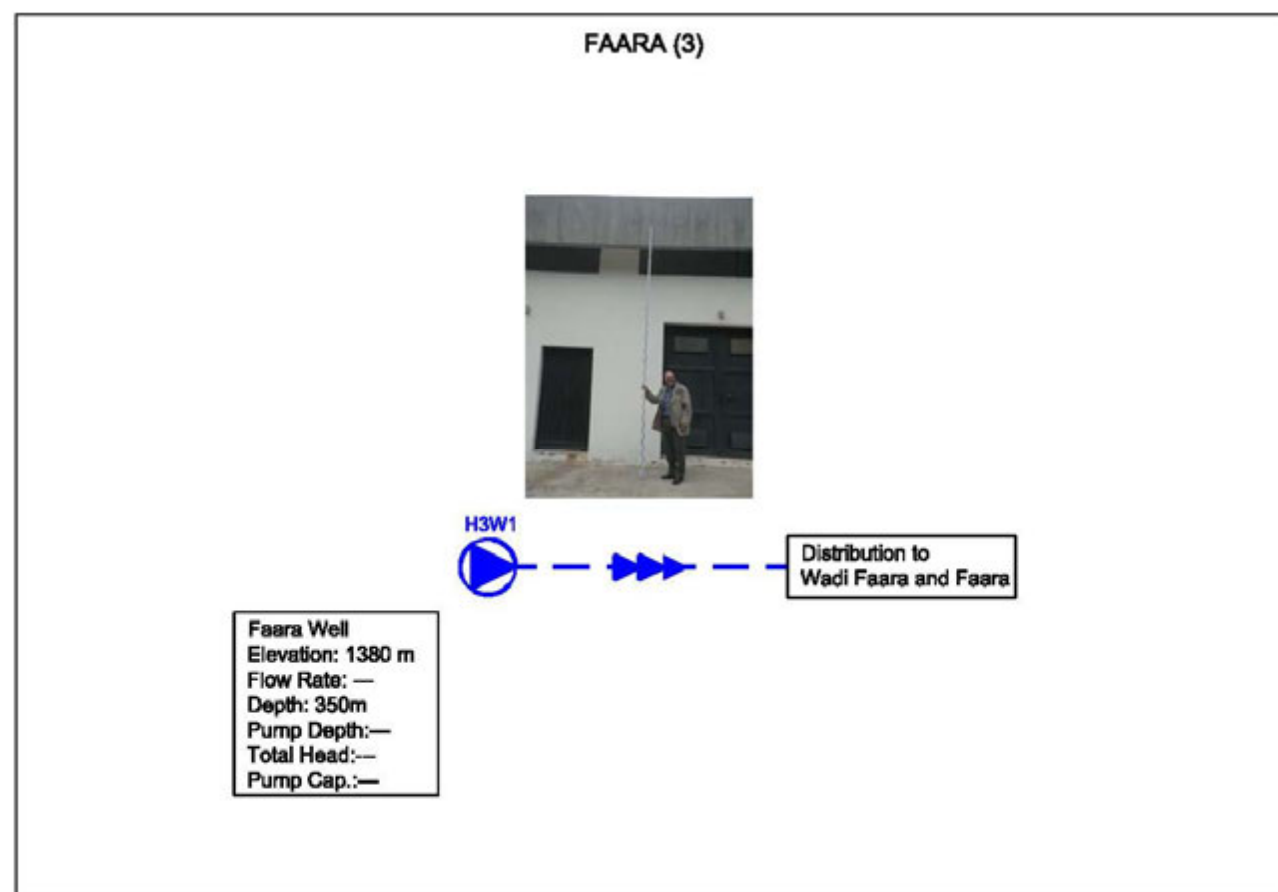
### Faara (3)

There is no available information concerning the water network of the town.

Well H3W1: Well is inaccessible. No more available information.

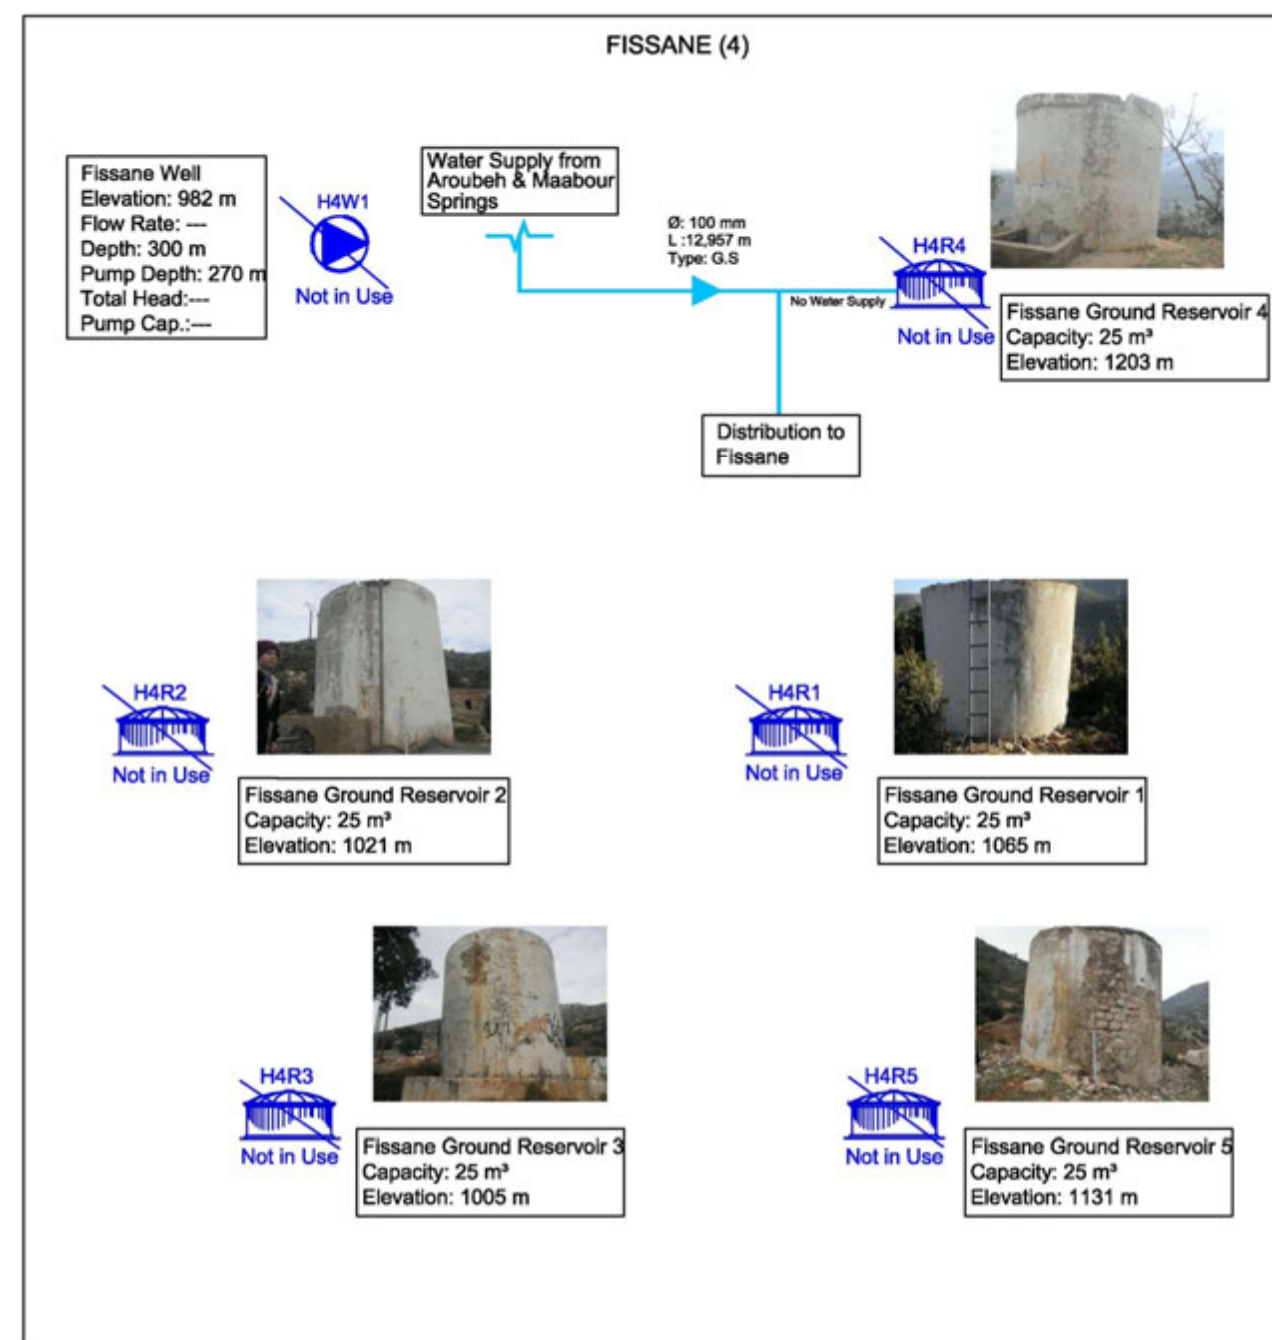
### Fissane (4)

No available information concerning the existing water network.

Well H4W1 (20 years old): Well is not in use.

Reservoir H4R1, H4R2, H4R3, H4R4 & H4R5 (25m³): Reservoirs are not in use. They are broken or in very bad conditions. They need rehabilitation or reconstruction.

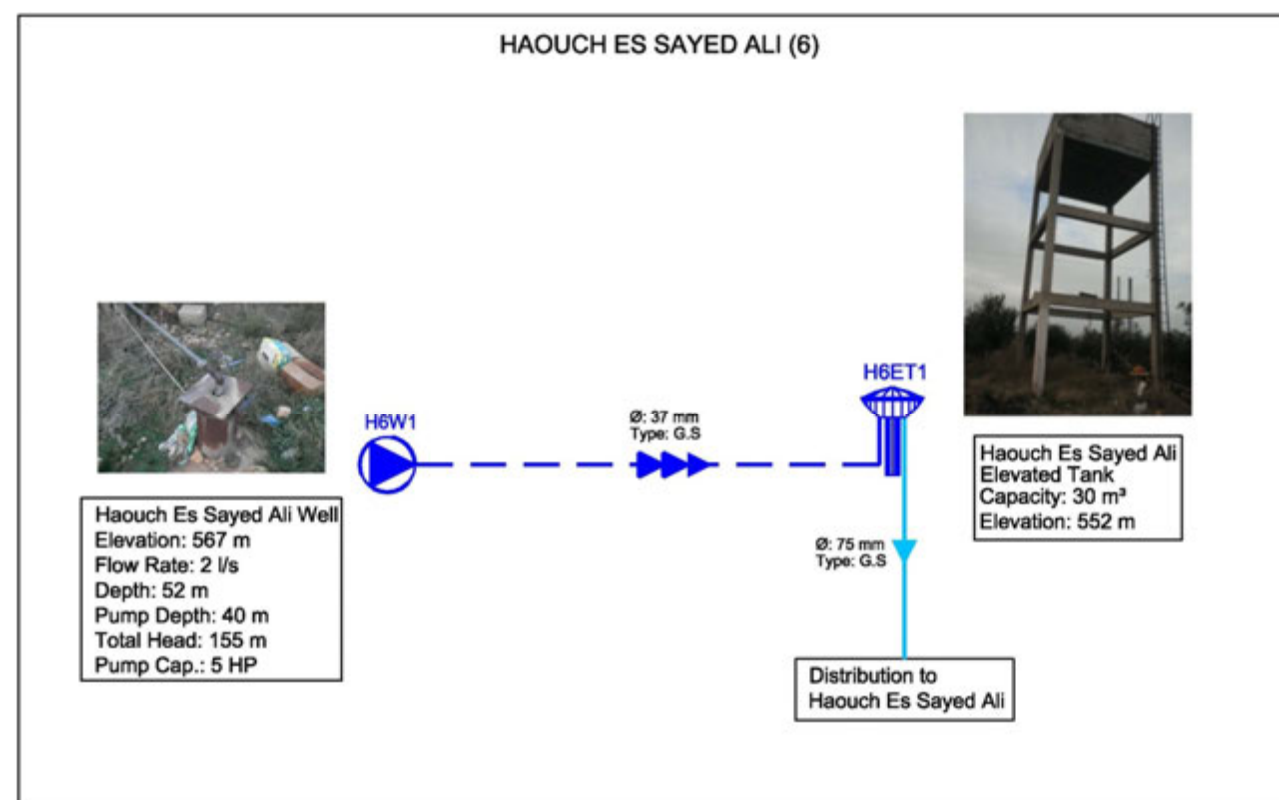
**Haouch es Sayed Ali (6)**

No available information concerning the existing water network.

Well H6W1 (15 years old): Well suffers from a shortage of electric power. This well is in bad condition and needs rehabilitation.

Elevated tank H6ET1 (30m<sup>3</sup>): Elevated tank is very old and it is in bad condition. It needs structural and esthetical rehabilitation.

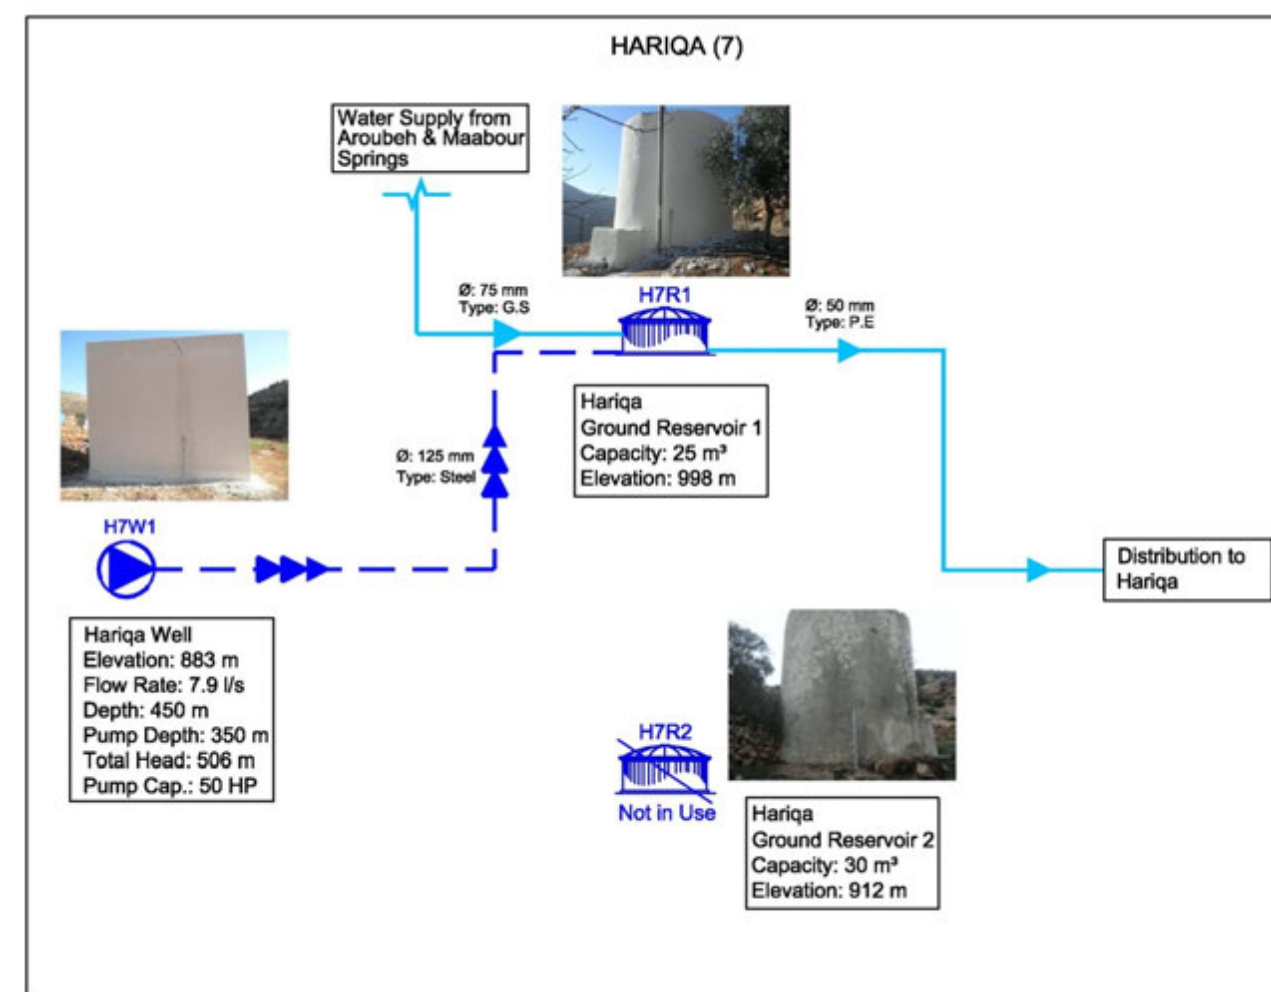
**Hariqa (7)**

There is no available information concerning the water network of the town.

Well H7W1 (<15 years): Well is new and it is in good condition.

Reservoir H7R1 (25m<sup>3</sup>): Reservoir is old but it is rehabilitated lately. It is in good condition.

Reservoir H7R2 (30m<sup>3</sup>): Reservoir is very old and it is in bad condition. This reservoir is not in use and it needs reconstruction.

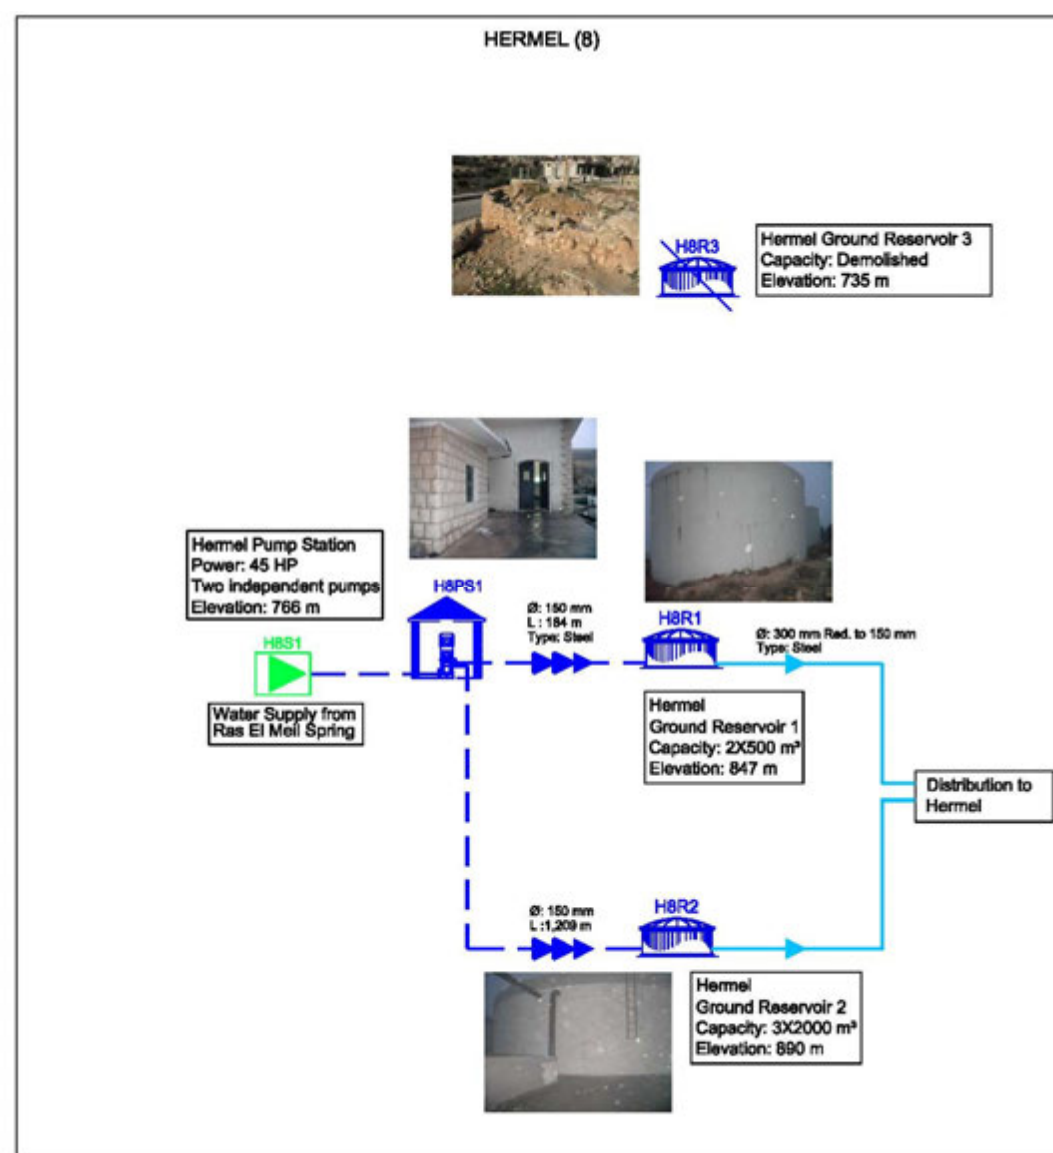
**Hermel (8)**

The existing water network is in bad condition and it has a length of around 61.6 km. It covers a part of the town.

**Pump station H8PS1:** Pump station is old and it needs rehabilitation. There is a chlorination unit but it is non-functional.

**Reservoir H8R1 (2x500 m³):** Reservoirs are old but they are in an acceptable condition. Their valves are rusted and they need to be replaced. These reservoirs need some minor maintenance.

**Reservoir H8R2 (3x2000 m³):** Reservoirs are new and they are in a very good condition.

**Spring H8S1:** Spring runs into an open concrete channel until it reaches a 150mm pipe diameter which is linked to a pump station. No more available information.

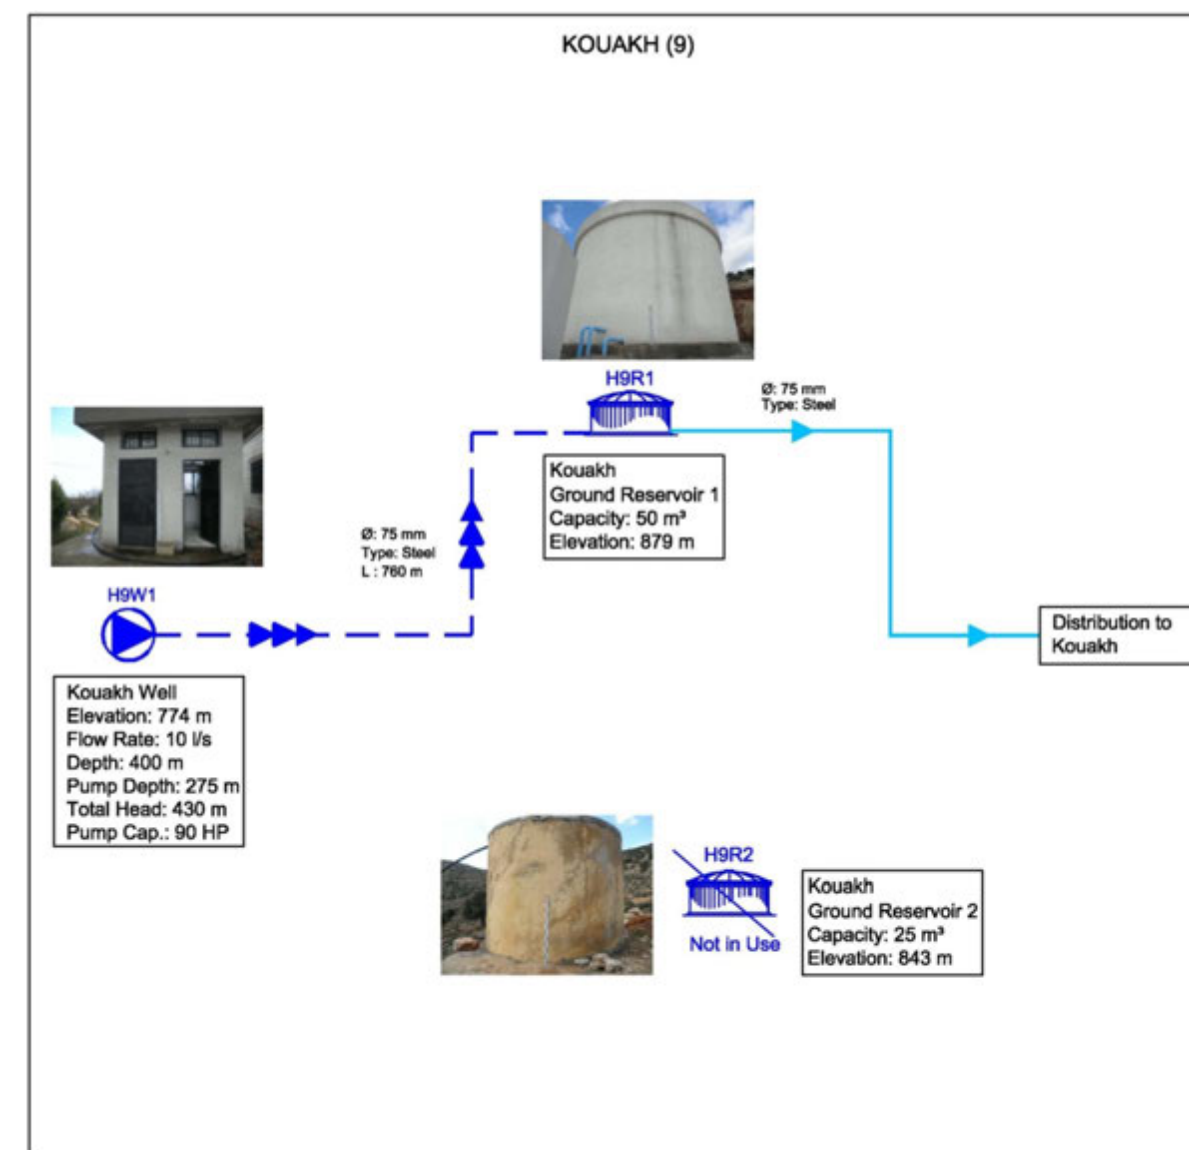
**Kouakh (9)**

The existing water network is in bad condition and it has a length of around 3 km. It covers a part of the town.

**Well H9W1 (20 years old):** Well is in good condition. A small chlorination unit exists but is not functioning. Generator is in good condition.

**Reservoir H9R1 (50m³):** Reservoir is in good condition.

**Reservoir H9R2 (25m³):** This reservoir is not in use and its structure is in very poor condition with large cracks and bullet marks appearing along its length. Rehabilitation is needed.

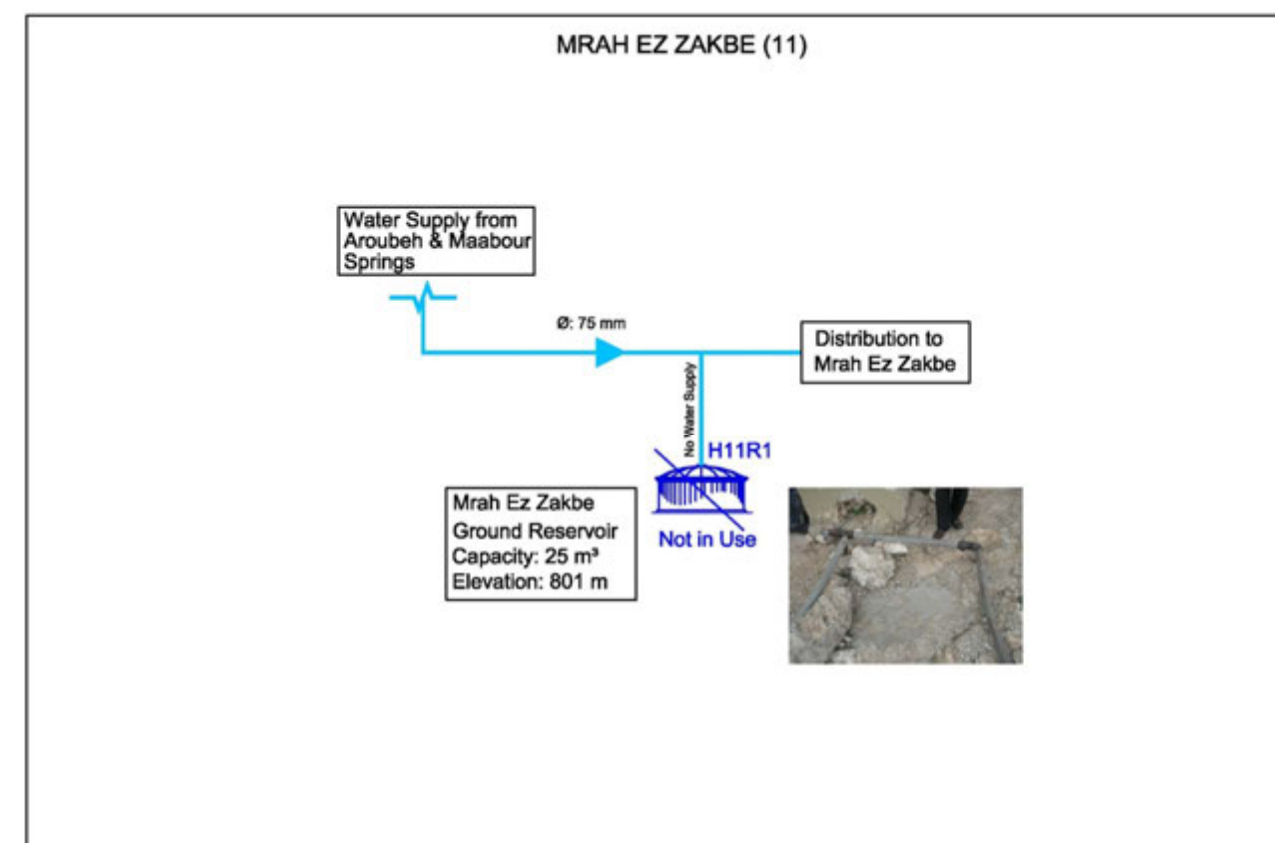
**Mrah ez Zakbe (11)**

There is no available information concerning the water network of the town.

Reservoir H11R1 (25 m³): Reservoir is very old and it is not in use. There is a diversion next to it. No more available information.

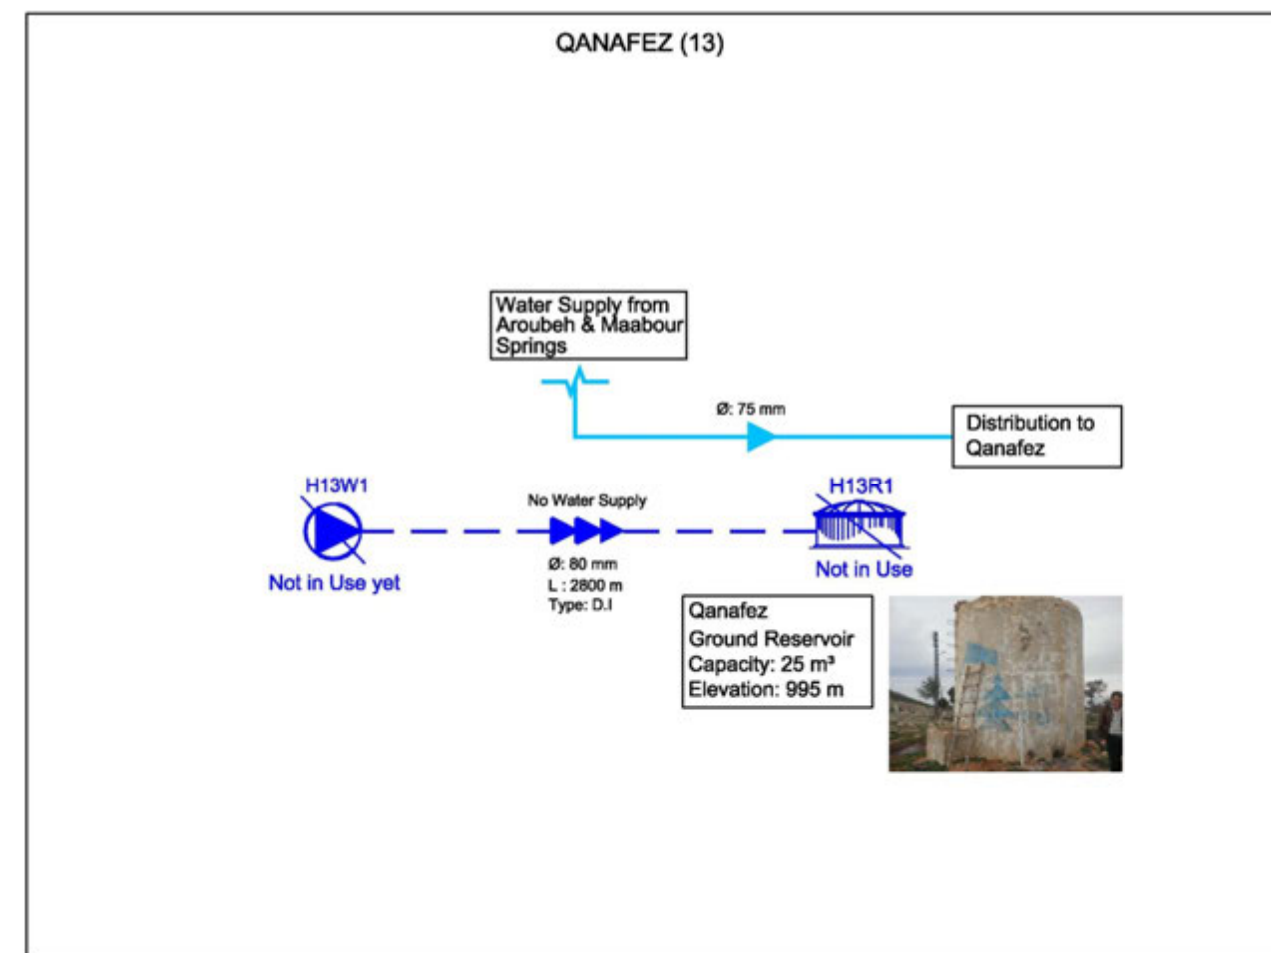
**Qanafez (13)**

The existing network is not in use (installed 50 years ago) and it is in very bad condition. Actually, people are supplied with water from a private small reservoir located in a school inside the town

Well H13W1: A new well is under construction. It is not in use yet.

Reservoir H13R1 (25m³): Reservoir is not in use. It is in bad condition but it will be rehabilitated soon.

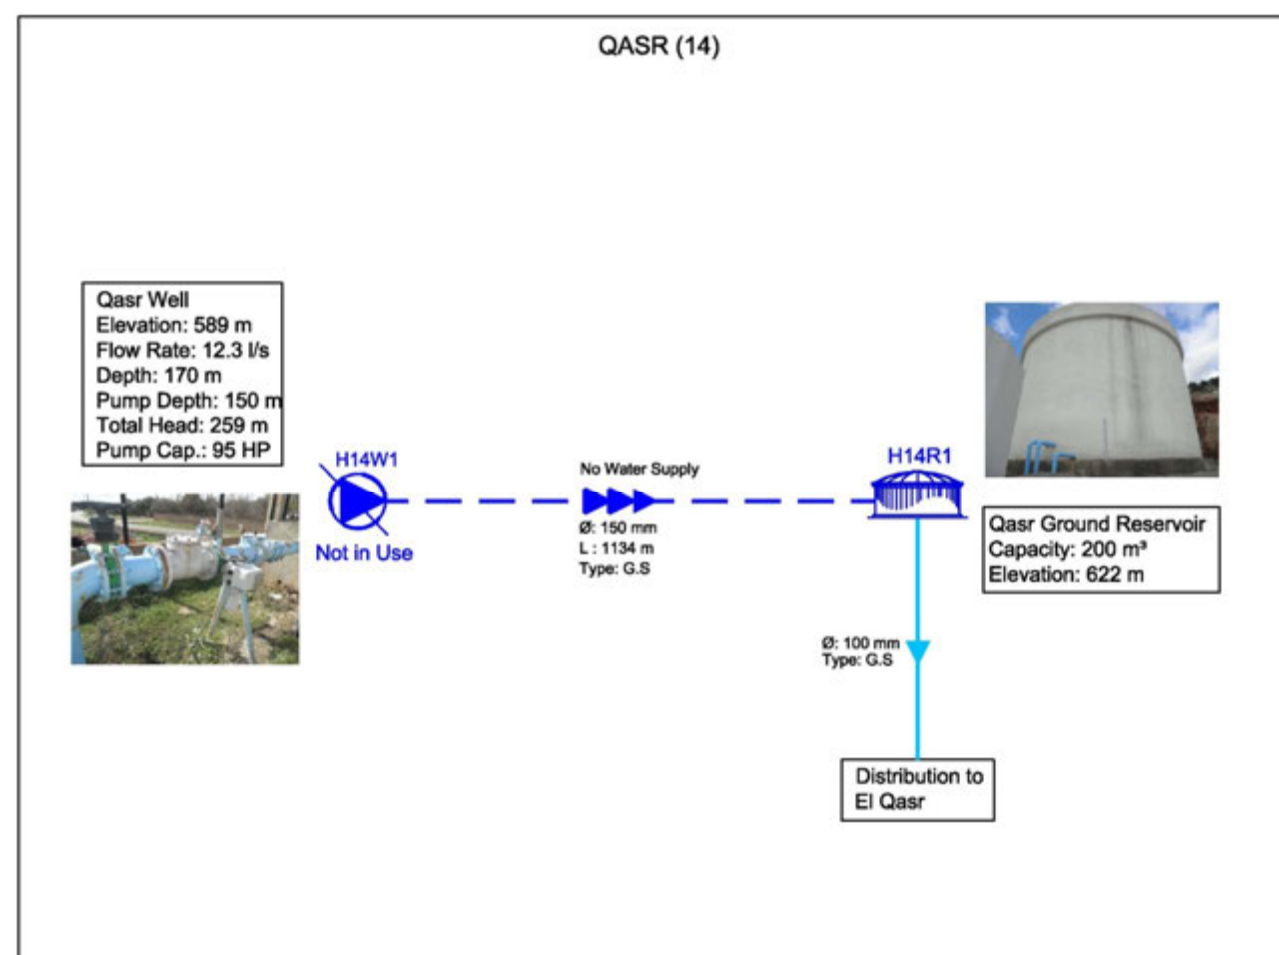
**Qasr (14)**

The existing water network is in bad condition and it has a length of around 38 km. It covers a large area of the town. This town has around 1200 private wells.

Well H14W1 (15 years old): This well is not in use during visit time because its electrical components are stolen. Well suffers from a shortage of electric power. There are two generators, one new and the other one is old. Also there is a chlorination unit but it is non-functional. This well needs rehabilitation.

Reservoir H14R1 (200 m³): Reservoir is in good condition but it is not equipped for use and not connected to any network.

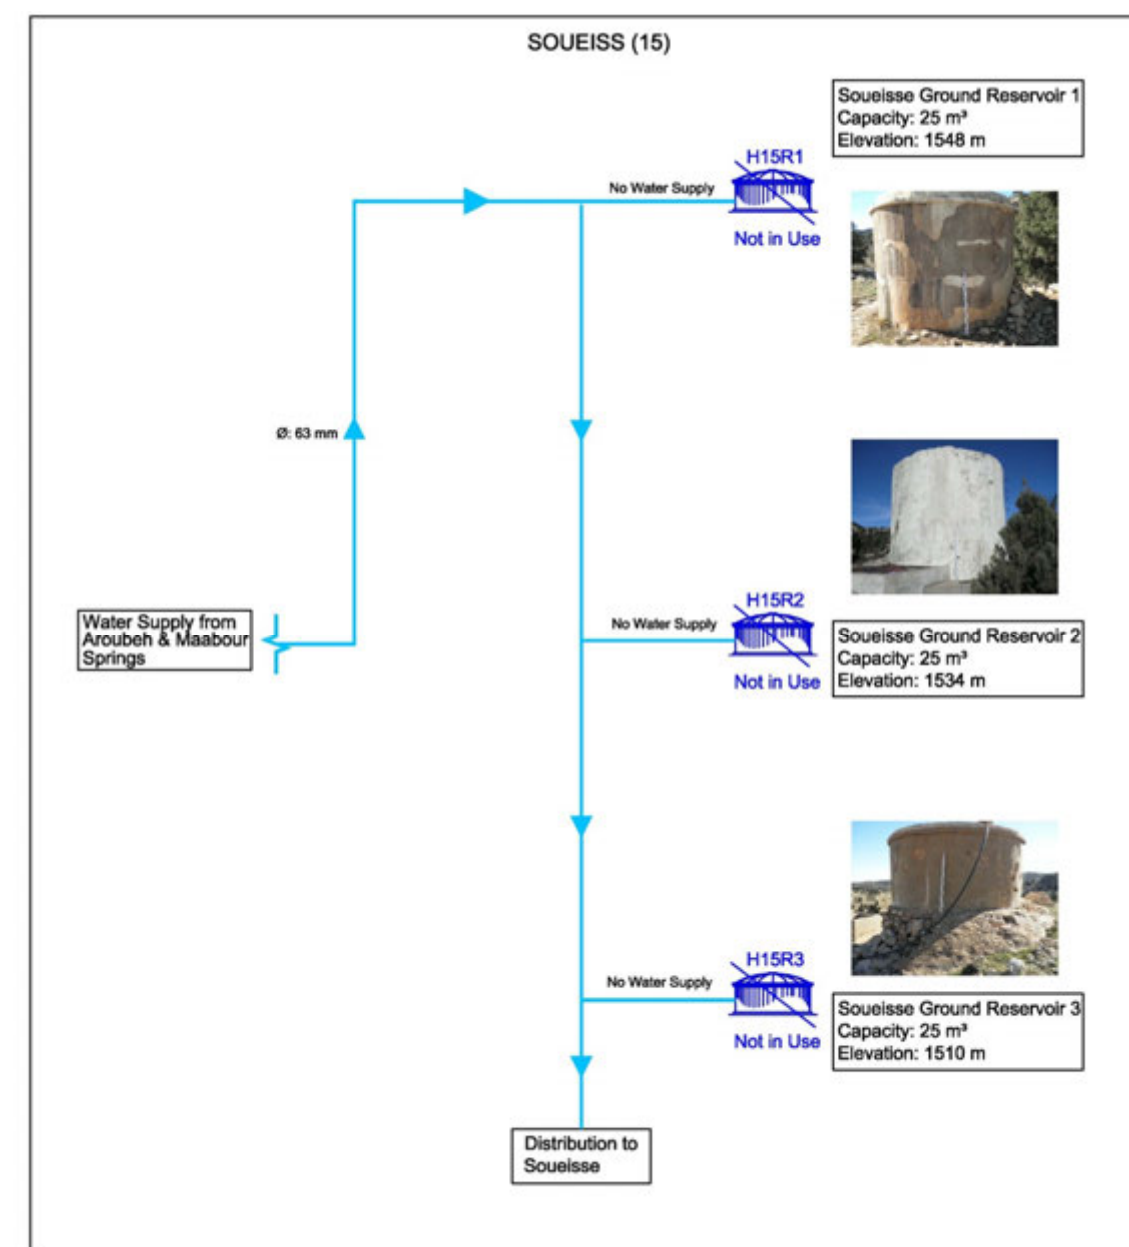
**Soueiss (15)**

There is no available information concerning the water network of the town.

Reservoir H15R1 (25 m³): Reservoir is not in use. It is in very bad condition. The inside cannot be accessed as the steps are missing. This reservoir needs reconstruction.

Reservoir H15R2 (25 m³): Reservoir is not in use. It is in very bad condition. The structure is damaged and the pipe intakes openings are destroyed. It needs reconstruction.

Reservoir H15R3 (25 m³): Reservoir is not in use. It is in very bad condition. The inside cannot be accessed as the steps are missing. This reservoir needs reconstruction.

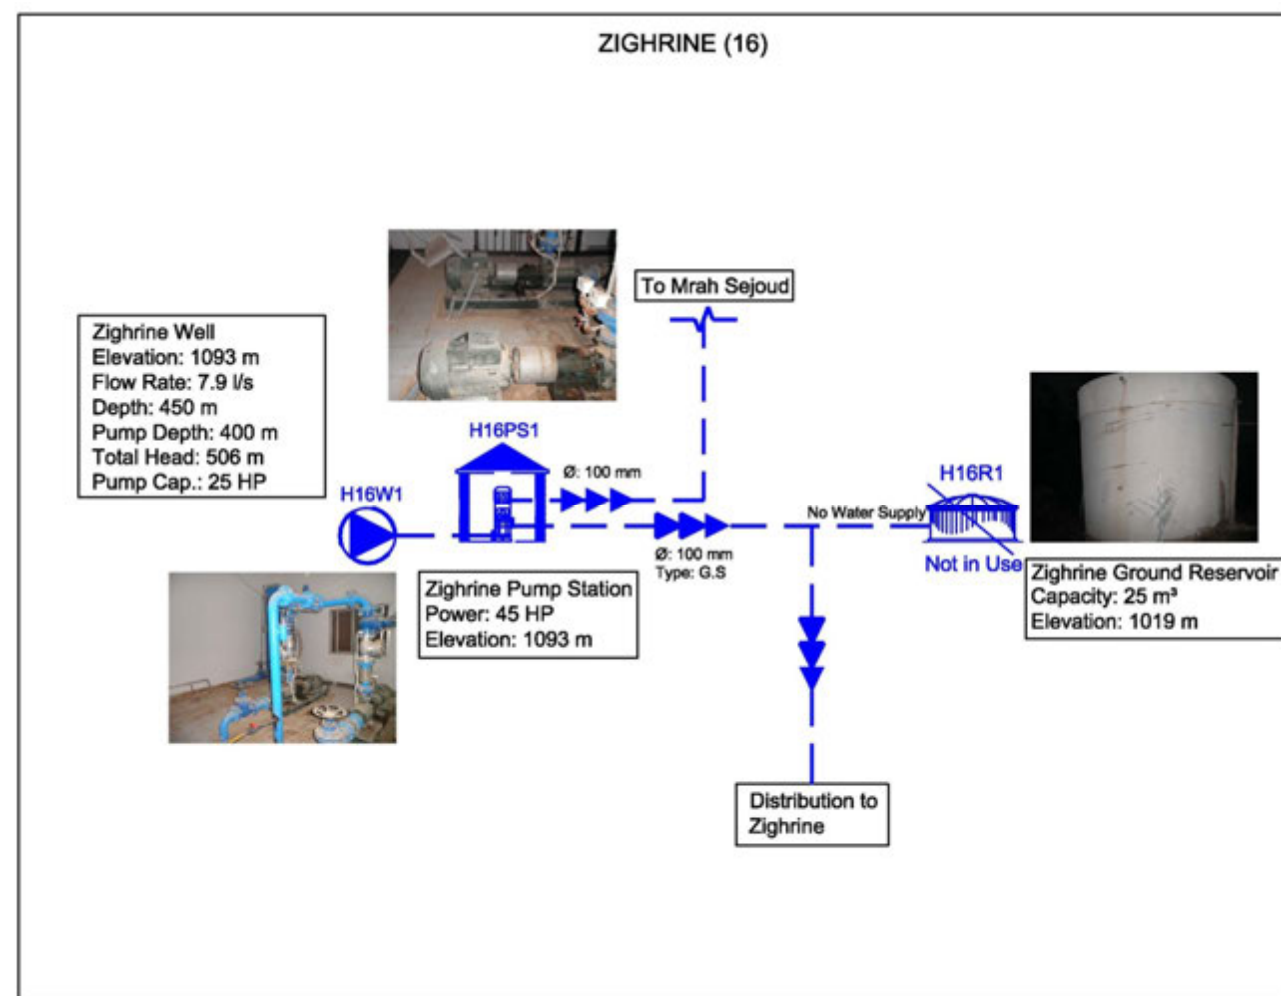
**Zighrine (16)**

There is no available information concerning the water network of the town.

Well H16W1 (>15 years): Well is in good condition but it suffers from a shortage of electric power. Also there is a small chlorination unit but it is non-functional.

Pump station H16PS1: Pump station is in good condition. No more available information.

Reservoir H16R1 (25 m<sup>3</sup>): Reservoir is in good condition but it is not in use. No more available information.

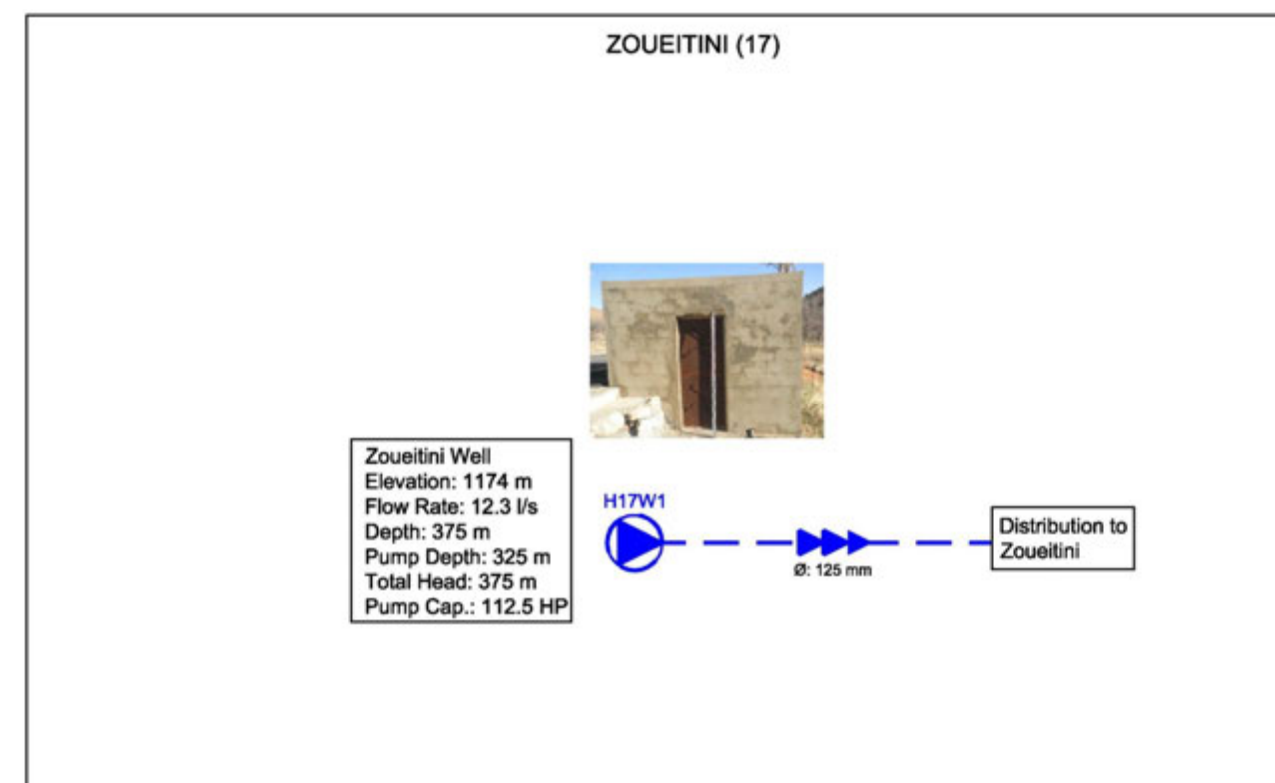
**Zoueitini (17)**

There is no available information concerning the water network of the town.

Well H17W1 (15 years old): Well is in acceptable condition but it is not in use.

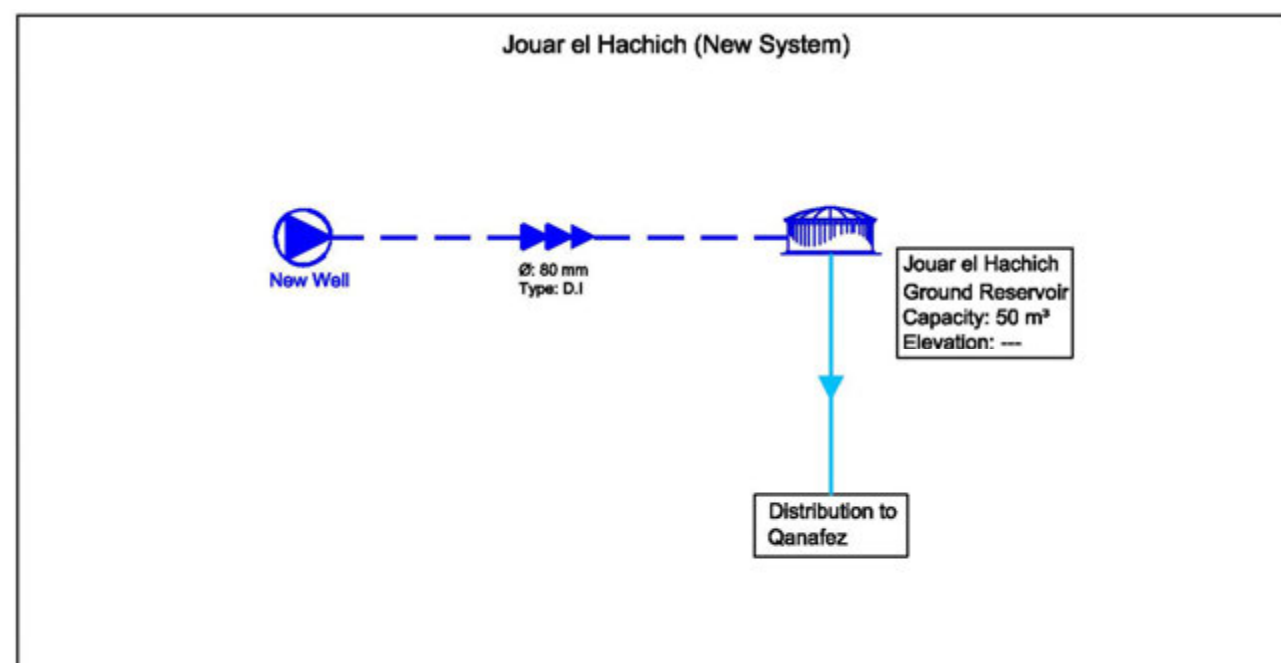
**Jouar el Hachich**

There is no available information concerning the water network of the town.

Well (<2 years old): Well is in good condition.

Reservoir (50 m³): Reservoir is new and it is in good condition.

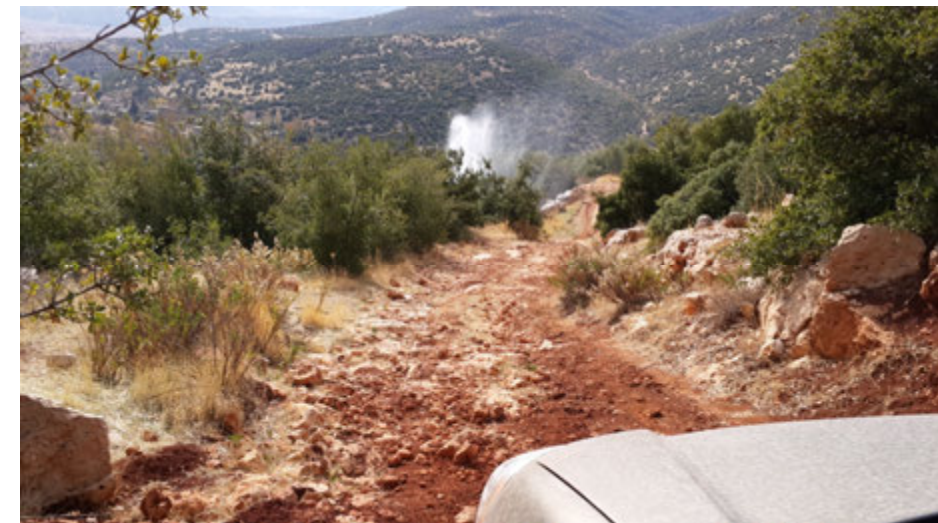
PHOTO 3-5: FLAQUI WTP - ROAD TO THE PLANT

- 1- Carry out civil works to repair the road and make the plant accessible.
- 2- Build a small structure (room + toilet + kitchen) for an operator.
- 3- Install a chlorination unit.
- 4- Provide the plant with a generator of 1.4kva for lighting at night.
- 5- Repair the punctured HDPE pipe that was discovered during the site visit and which is causing a huge water loss.

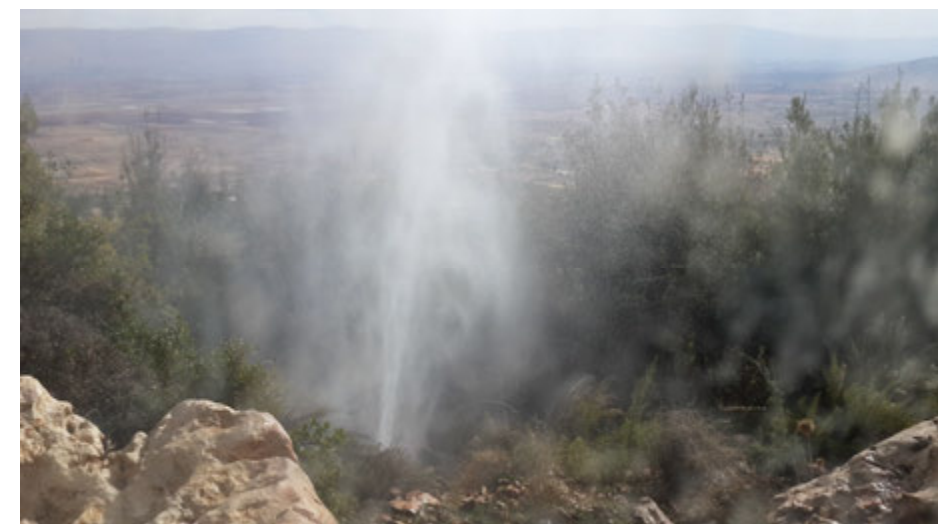
PHOTO 3-6: FLAQUI WTP - PUNCTURED HDPE PIPE

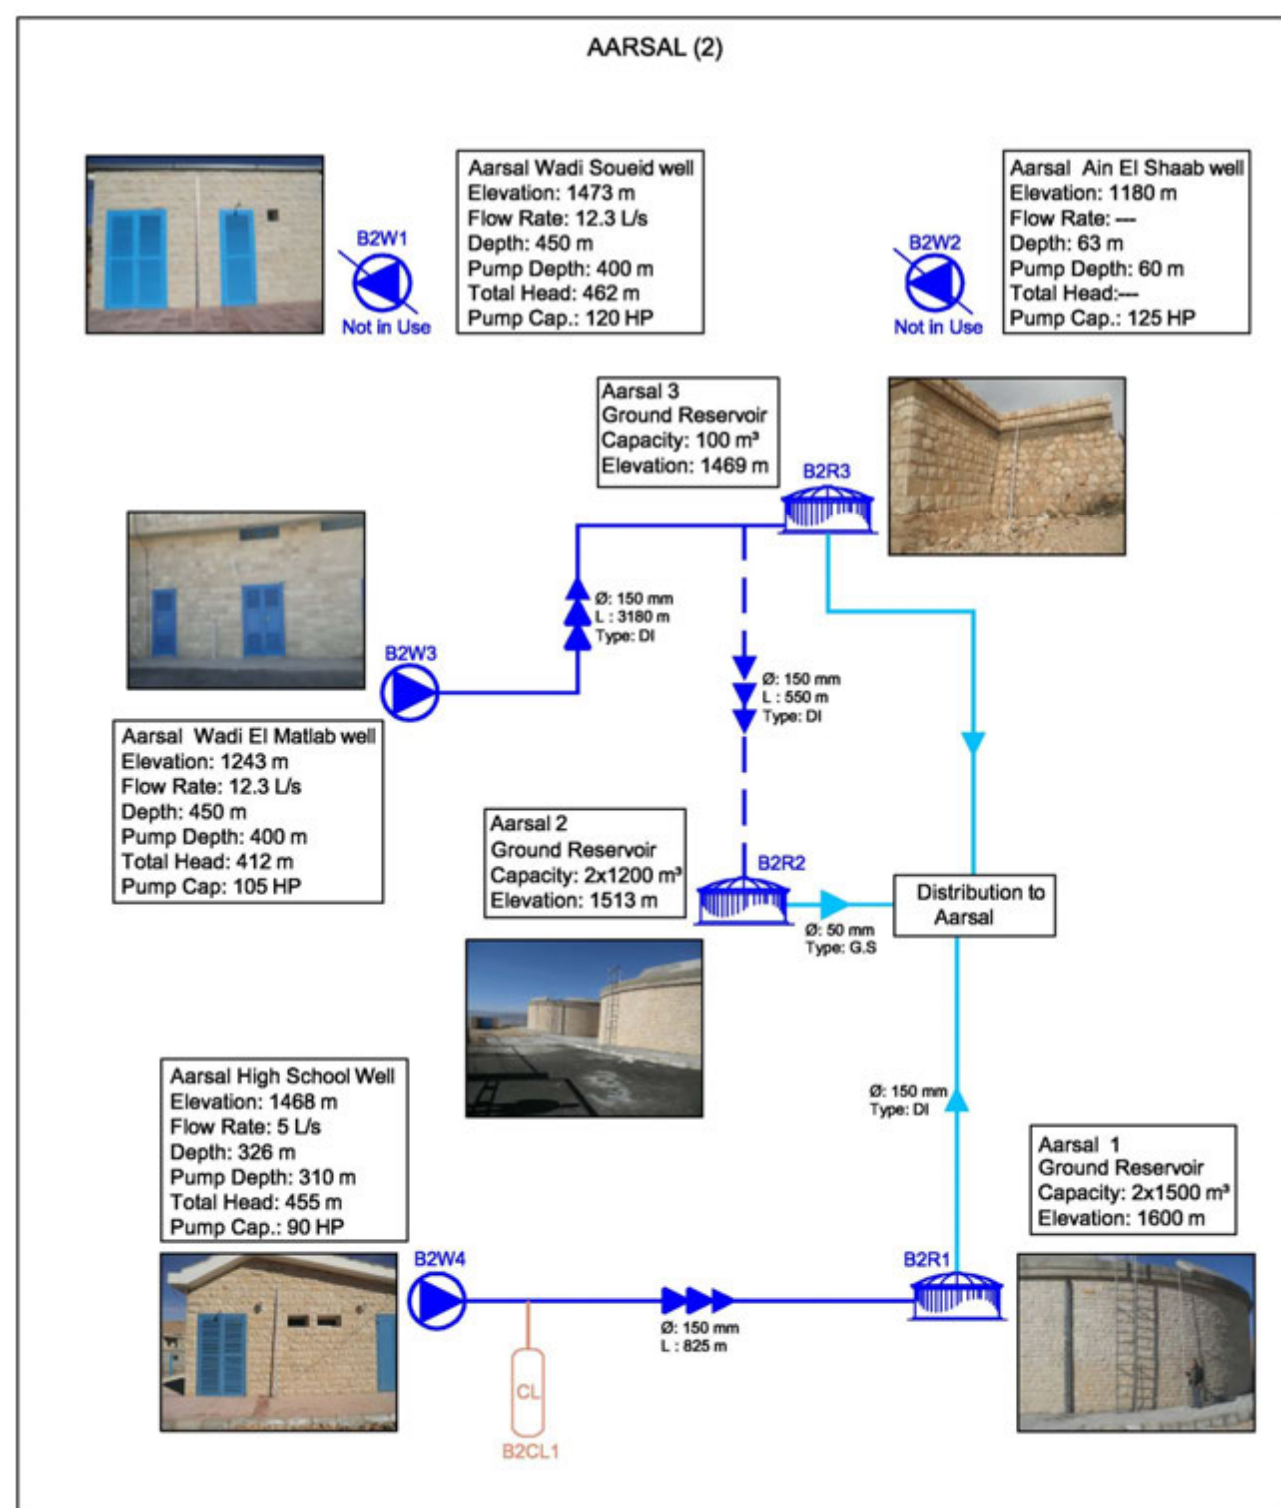
**Aarsal (2)**

The existing water network is in very good condition and it has a length of around 98 km. It covers a large area of the town.

Well B2W1 (10 years old): The well is new and in good condition but it is not in use.

Well B2W4 (20 years old): The well is new and in good condition but it suffers from a shortage of electric power.

Reservoir B2R1 (10 years old; 2x1500 m<sup>3</sup>): Reservoir is new and it is in good condition. The pipes and valves are rusted and they need maintenance

Reservoir B2R2 (10 years old; 2x1200 m<sup>3</sup>): Reservoir is new and it is in good condition.

Reservoir B2R3 (100 m<sup>3</sup>): Reservoir is old and it is in bad condition. It needs esthetical and structural rehabilitation or reconstruction.
