# WATER SUPPLY AND WASTEWATER SYSTEMS MASTER PLAN FOR THE BEKAA WATER ESTABLISHMENT

## WATER ASSESSMENT REPORT

January 2014  
Updated May 2015

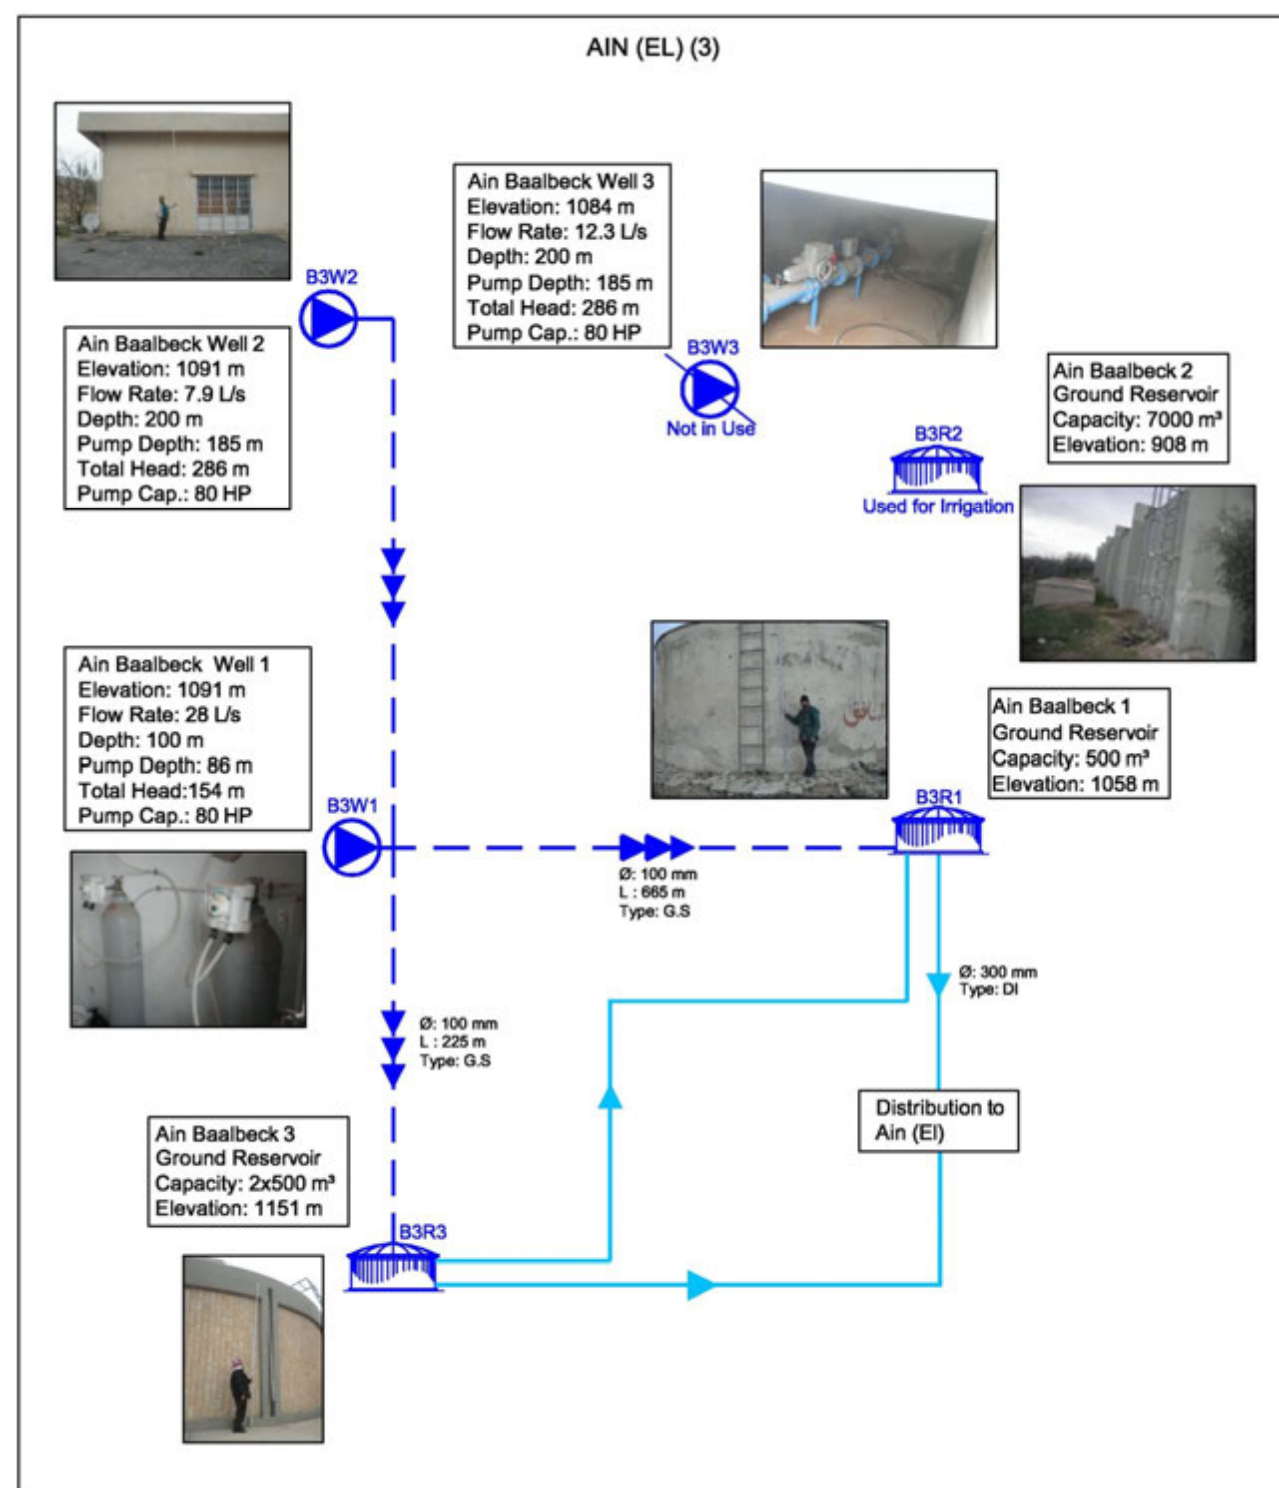
**Ain (EI) (3)**

The existing water network is in very good condition and it has a length of around 46 km. It covers a large area of the town.

Well B3W1 (<40 years): Well suffers from a shortage of electric power. A chlorination room with equipment is present and operational. This well is old but it is in acceptable condition.

Well B3W2 (>10 years): It has a chlorination room and a power generator. This well is in good condition.

Well B3W3 (15 years old): This well is located in Aarsal region. It shares the same power generator with well b3w2. It is a standby well and it is not operational. This well is in good condition.

Reservoir B3R1 (40 years old; 500m³): Reservoir is old and needs rehabilitation. The pipes and valves are rusted and they need maintenance

Reservoir B3R2 (7000m³): Reservoir is in good condition. It is open-top reservoir and is mainly used for irrigation. Water source is unknown but it is more probably from rainwater.

Reservoir B3R3 (>10 years; 2x500m³): Reservoir is new and it is in good condition.

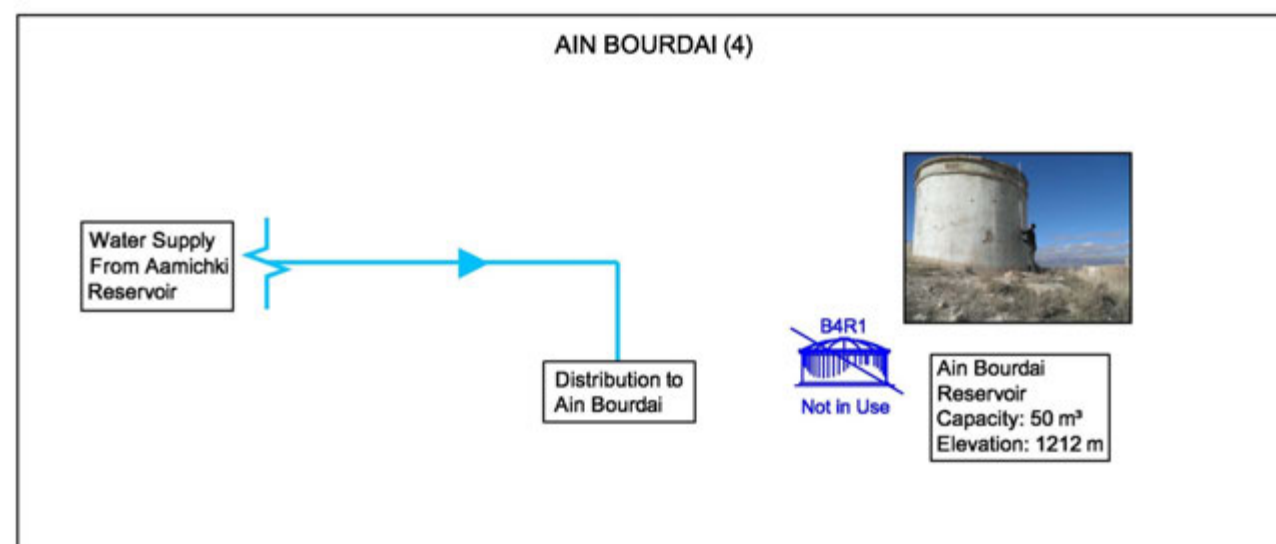
**Ain Bourdai (4)**

The existing water network is in very good condition and it has a length of around 15 km. It covers a large area of the town.

Reservoir B4R1 (50m³): Reservoir is old and is not in use. It needs structural rehabilitation or reconstruction.

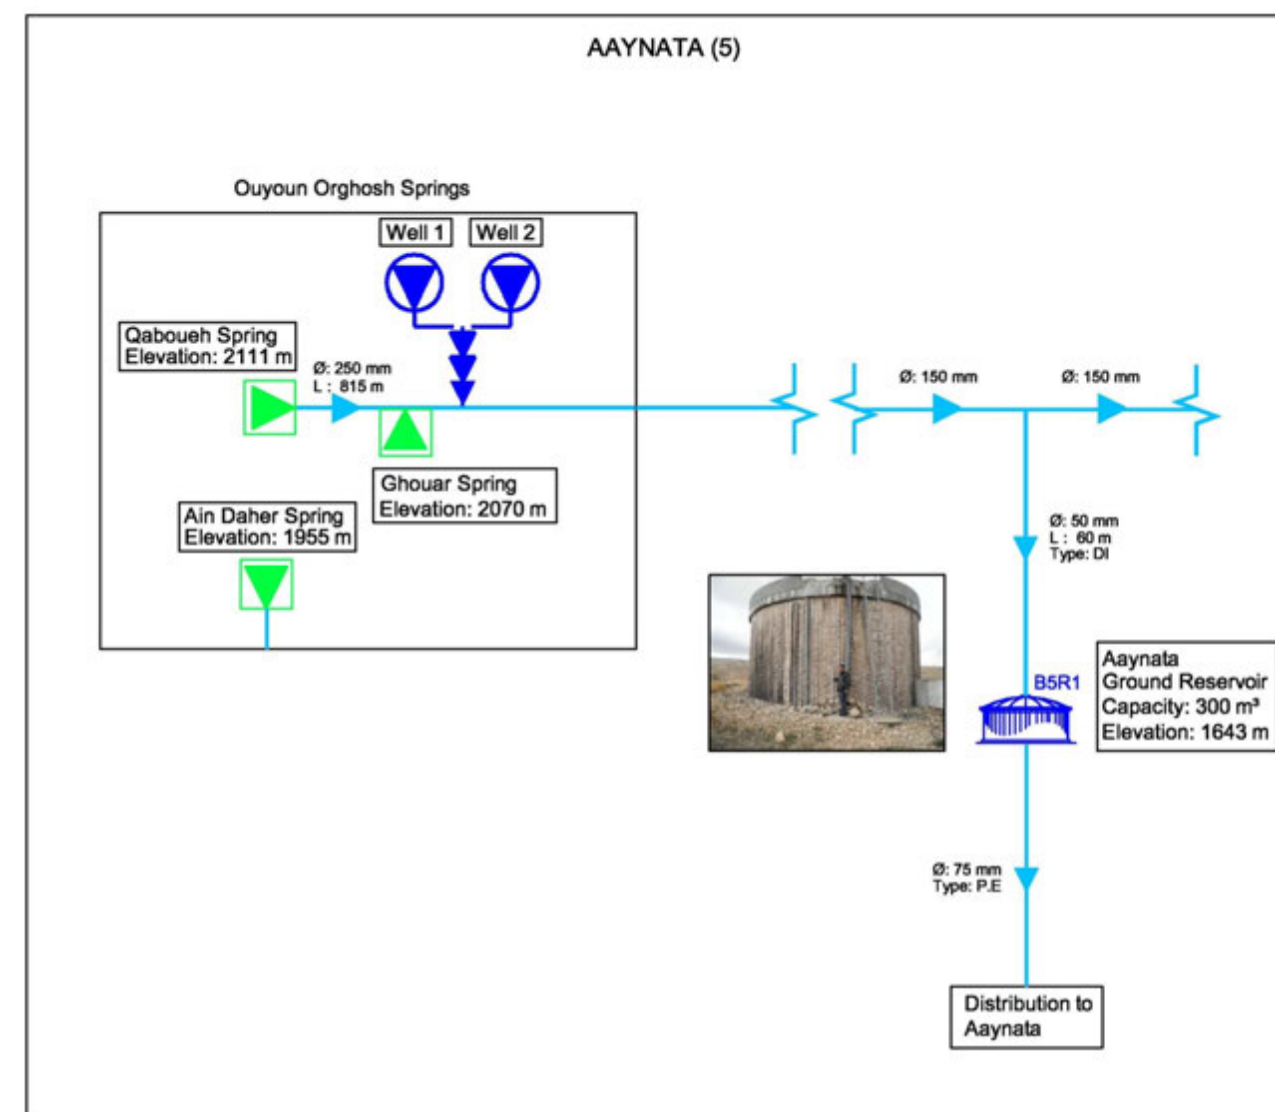
**Aynata (5)**

The existing water network is in bad condition and it has a length of around 14 km. It covers a large area of the town.

Ouyoun Orghosh Spring: It consists of al Qaboueh Spring, Ghouar Spring, and Ain Daher Spring. These springs are supplying water to many villages in the Baalbeck caza.

Reservoir B5R1 (300 m³): Reservoir is in bad condition. It needs esthetical and structural rehabilitation.

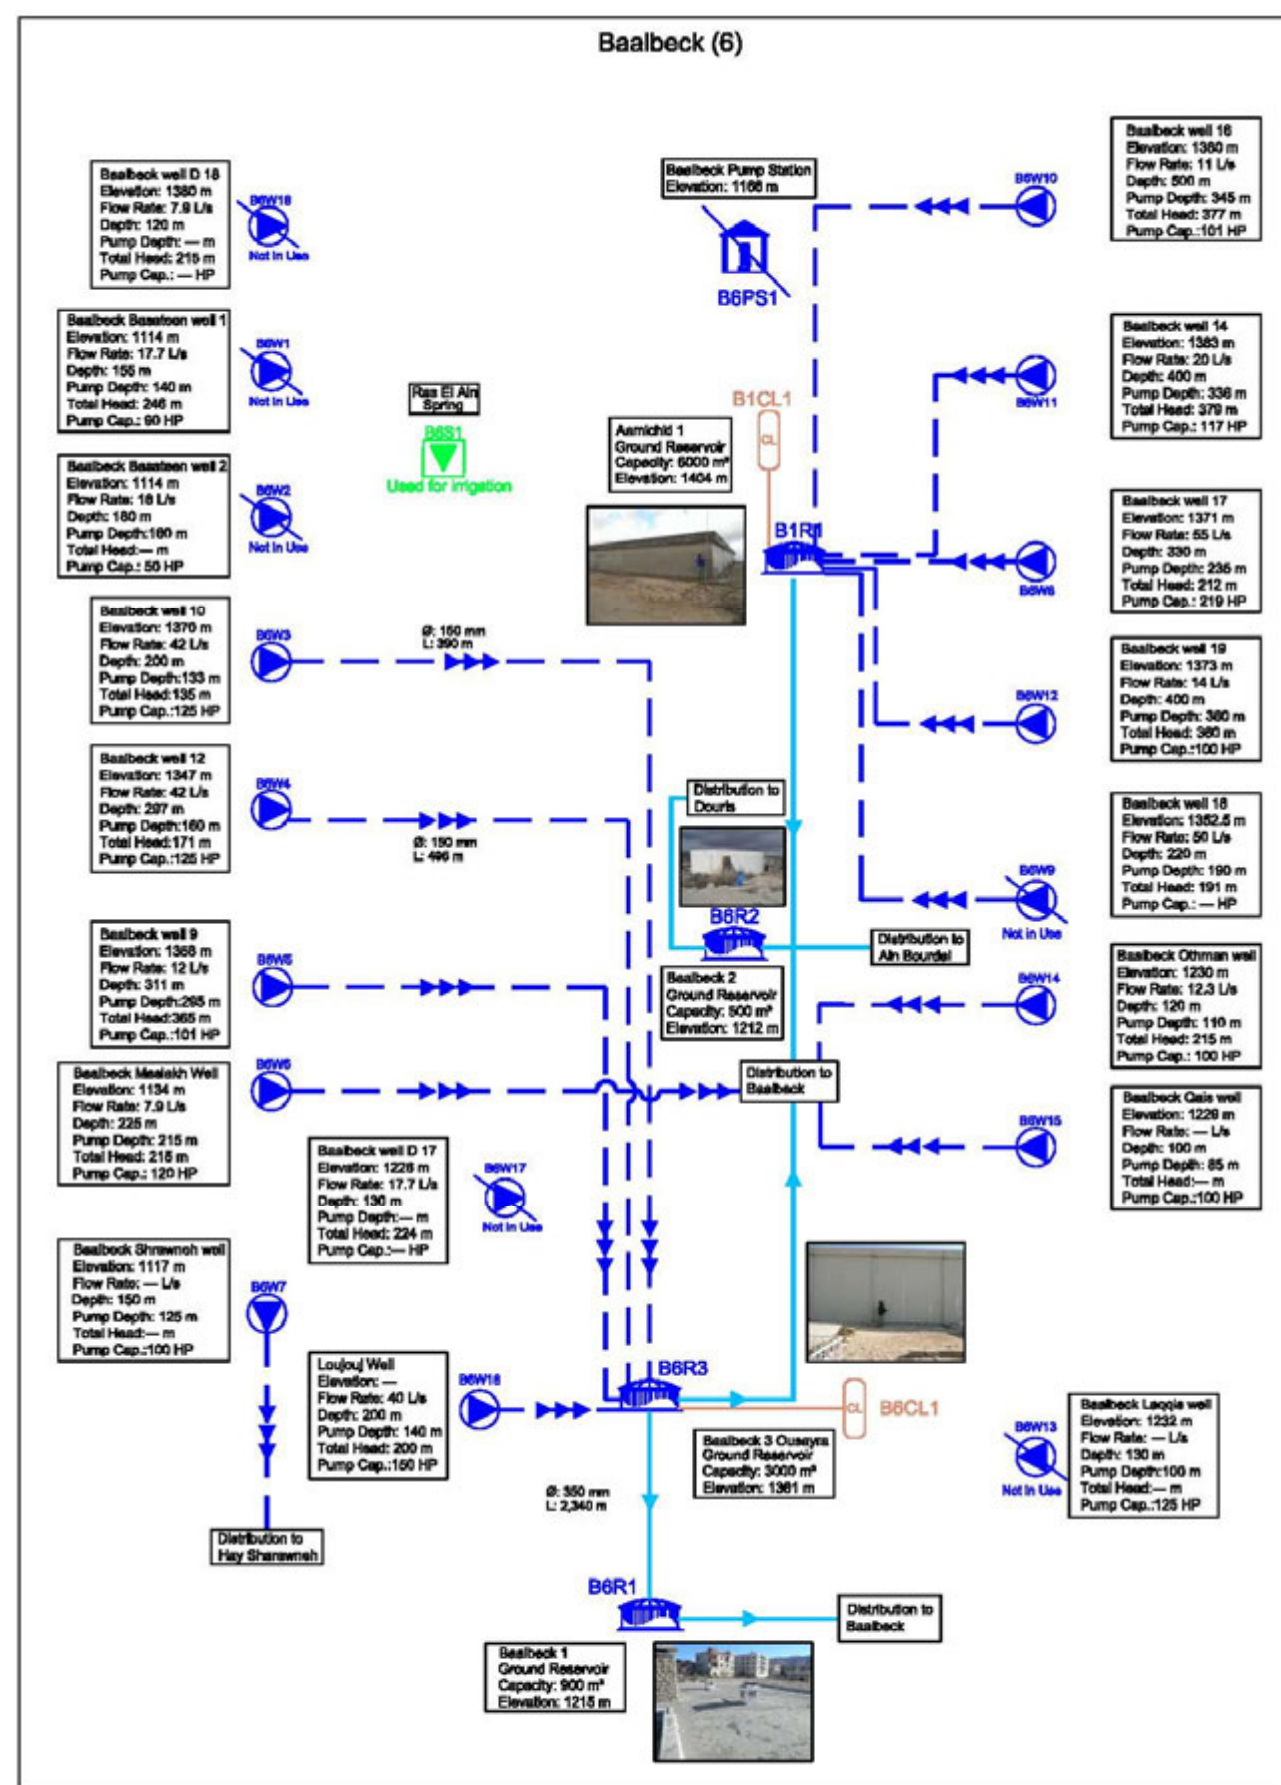
**Baalbeck (6)**

The existing water network is in very good condition and it has a length of around 268 km. It covers a large area of the town.

Well B6W1 (>15 years): Well is old and it is not in use anymore.

Well B6W3 (>15 years): Well is new. It supplies reservoir B6R3 and the distribution network of Baalbeck. Its valve chamber is subject to leakage and needs maintenance.

Well B6W5 (>15 years): Well is in good condition and it supplies reservoir B6R3.

Well B6W12 (>15 years): Well is in good condition.

Well B6W14: Well is in good condition and it directly supplies the distribution network of Baalbeck.

Well B6W15: Well is in good condition and it directly supplies the distribution network of Baalbeck.

Reservoir B6R1 (900m³): Reservoir is in good condition. The pipes and valves are rusted and they need maintenance.

Reservoir B6R2 (500m³): Reservoir is in bad condition. It needs esthetical and structural rehabilitation.

Reservoir B6R3 (<10 years; 3000m³): Reservoir is in good condition.

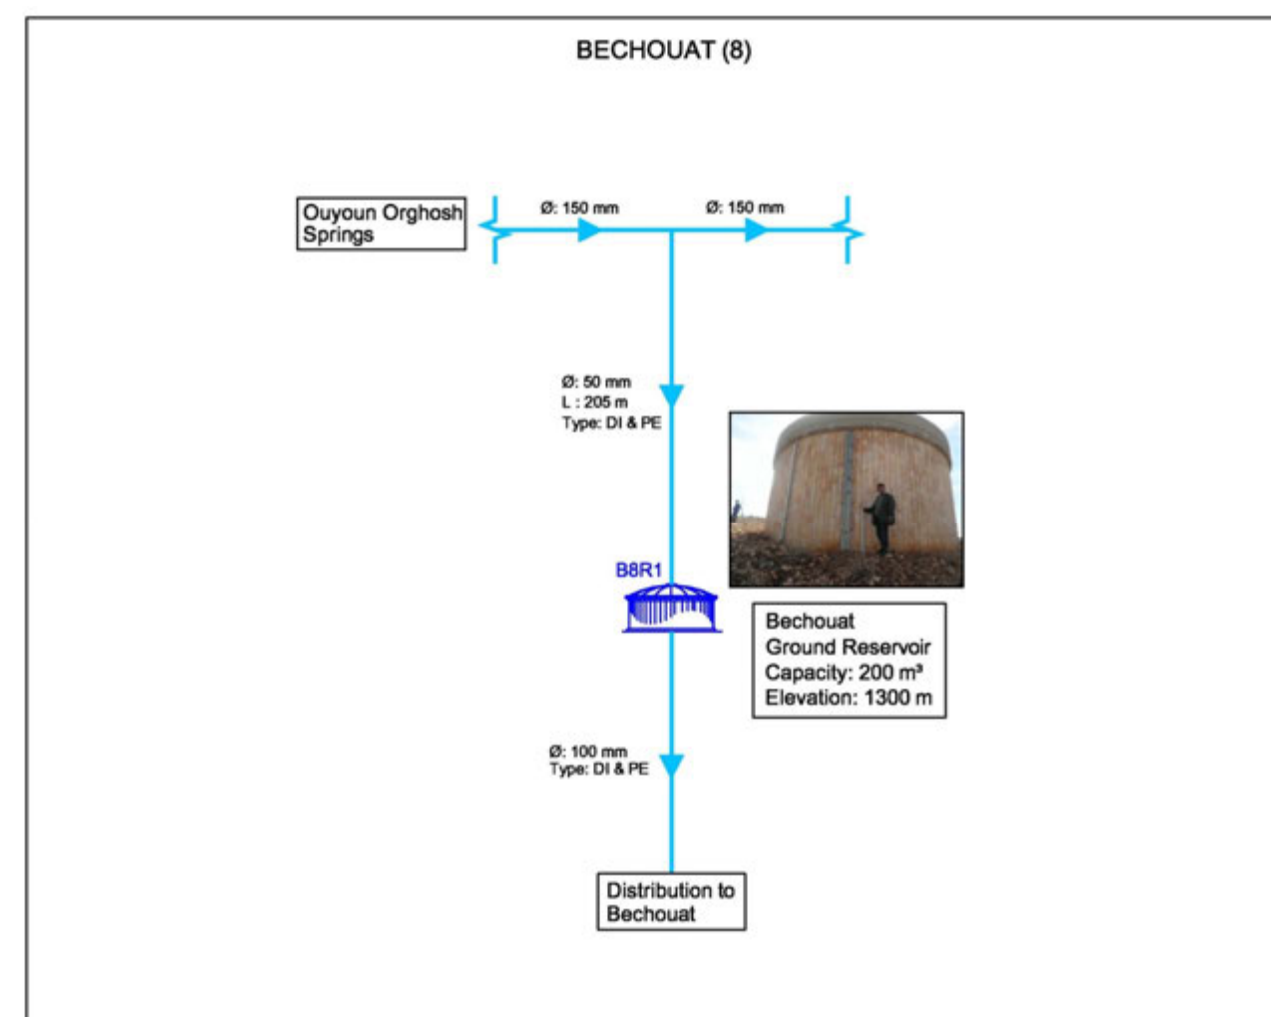
**Bechouat (8)**

The existing water network is in medium condition and it has a length of around 17 km. It covers a part of the town.

Reservoir B8R1 (>10 years; 200m³): Reservoir is in good condition. Its valve chamber is subject to leakage. This reservoir needs minor maintenance.

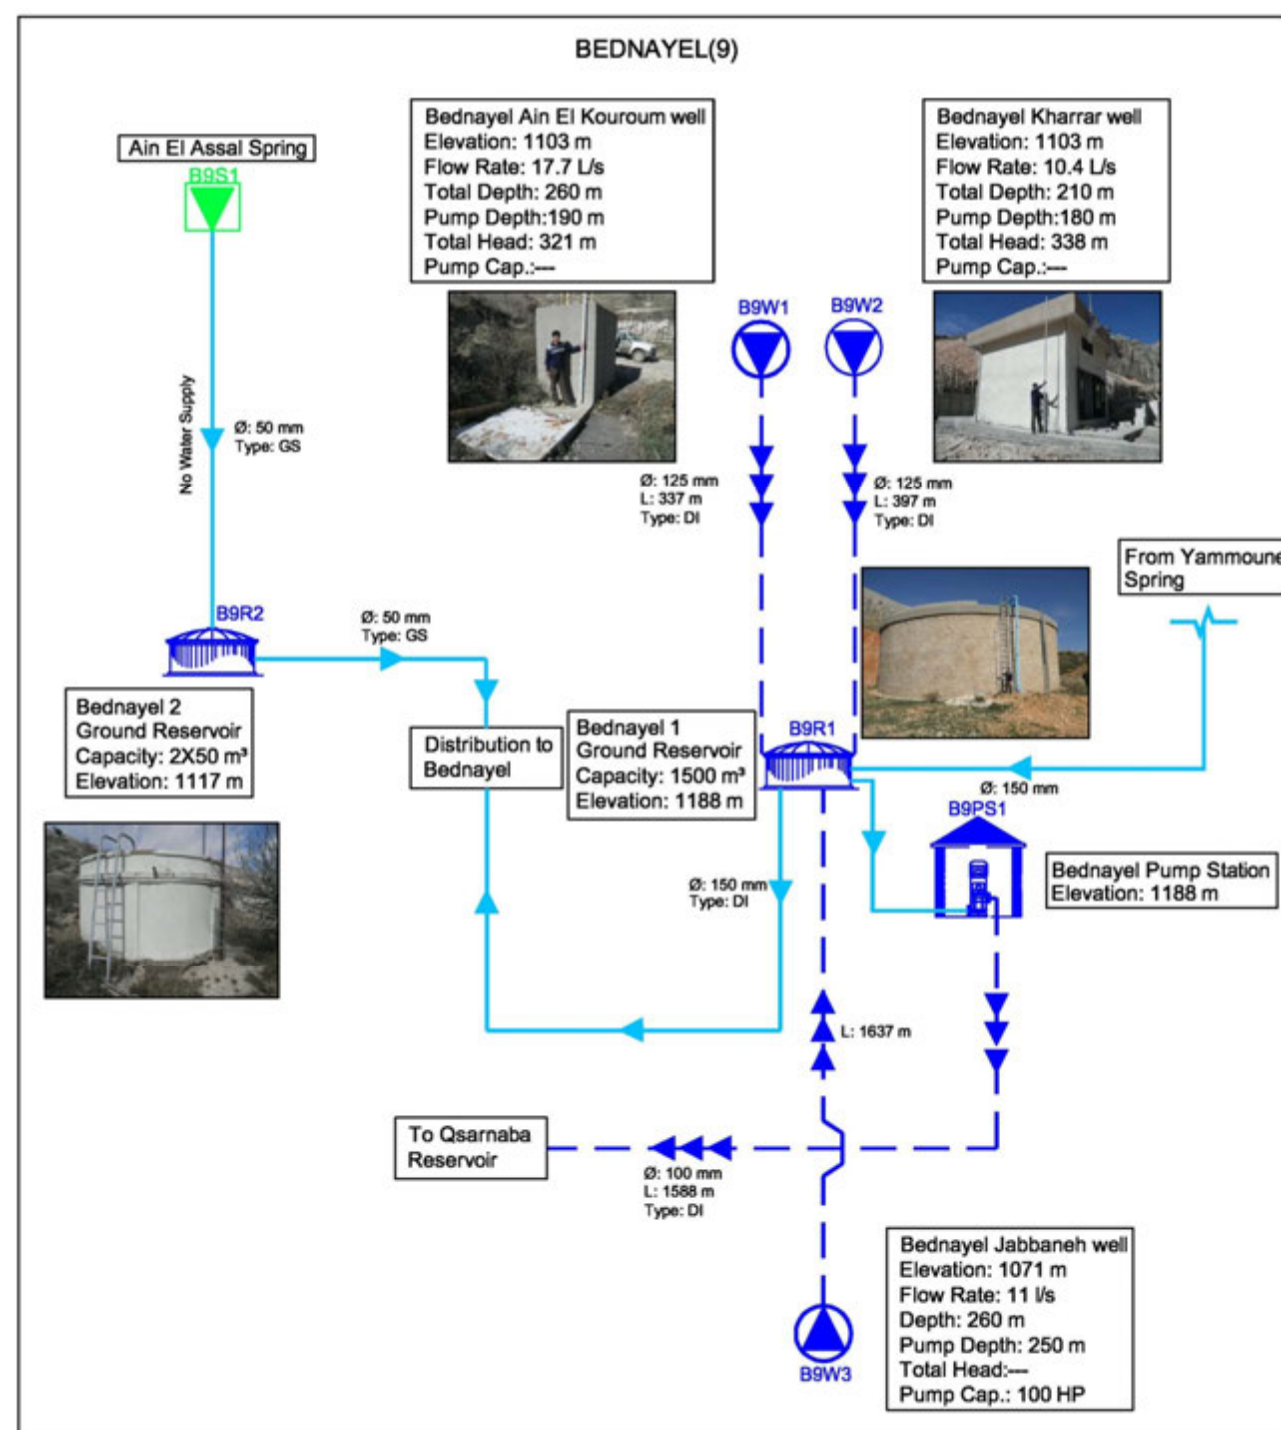
**Bednaye (9)**

The existing water network is in very good condition and it has a length of around 26.3 km. It covers a large area of the town.

Well B9W1 (>15 years): Well is in good condition but it suffers from a shortage of electric power. There is a chlorination unit for this well but it is still under construction.

Well B9W2 (>10 years): Well is in good condition but it suffers from pump ignition problems and needs maintenance.

Pump station B9PS1: Pump is within the reservoir control room. It is in good condition.

Reservoir B9R1 (>10 years; 1500m<sup>3</sup>): Reservoir is in good condition and it has a chlorinator unit.

Reservoir B9R2 (2x50 m<sup>3</sup>): Reservoir is in an acceptable condition and it needs esthetical rehabilitation.

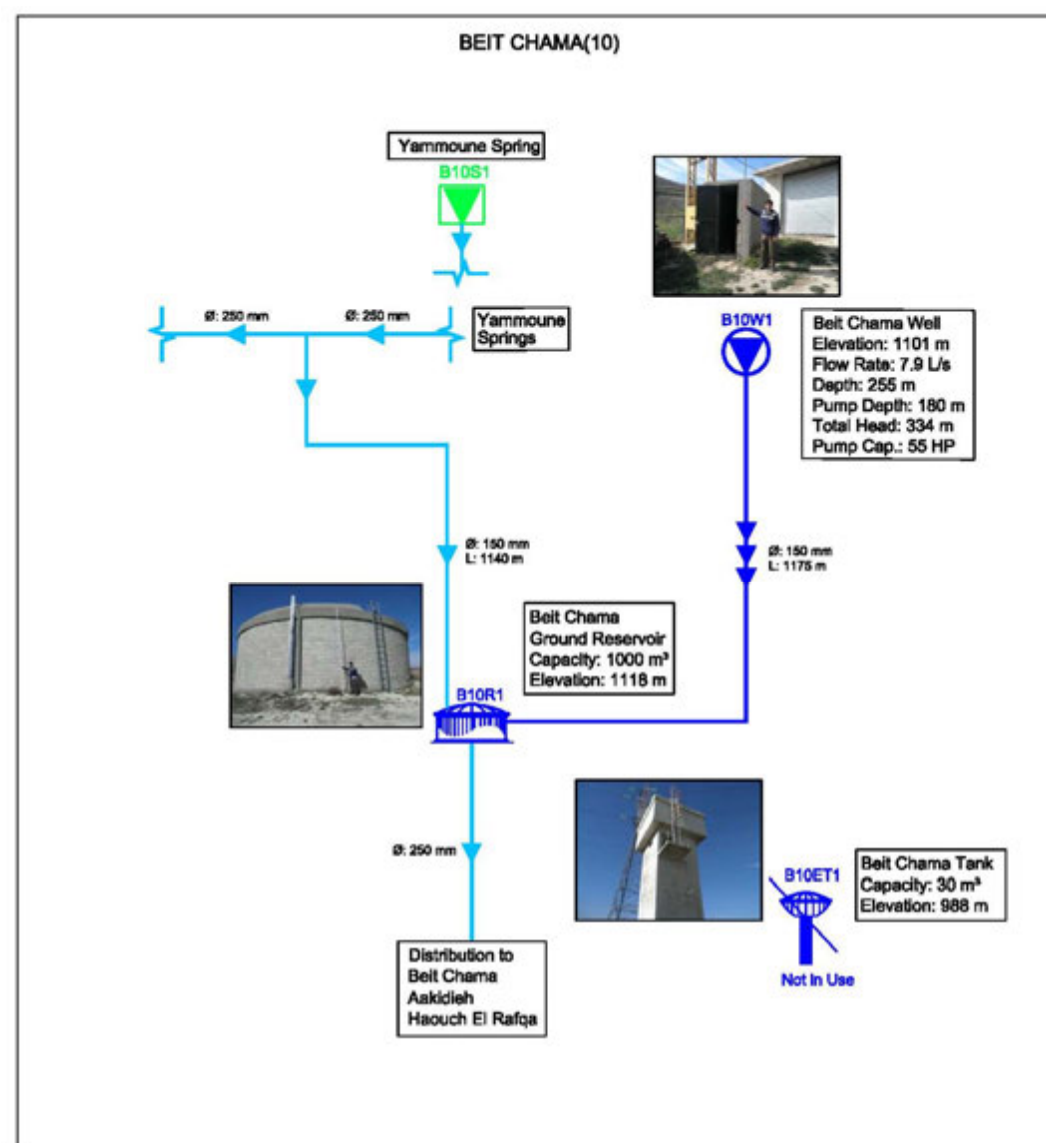
**Beit Chama (10)**

The existing water network is in very good condition and it has a length of around 15 km. It covers a large area of the town.

Well B10W1 (15 years old): Well is in good condition but it suffers from a shortage of electric power.

Reservoir B10R1 (>10 years; 1000 m³): Reservoir is in good condition and is equipped with a chlorination chamber, but its tanks are empty.

Elevated tank B10ET1 (30 m³): Tank is in an acceptable condition but it is not connected to the distribution network. It is not in use.

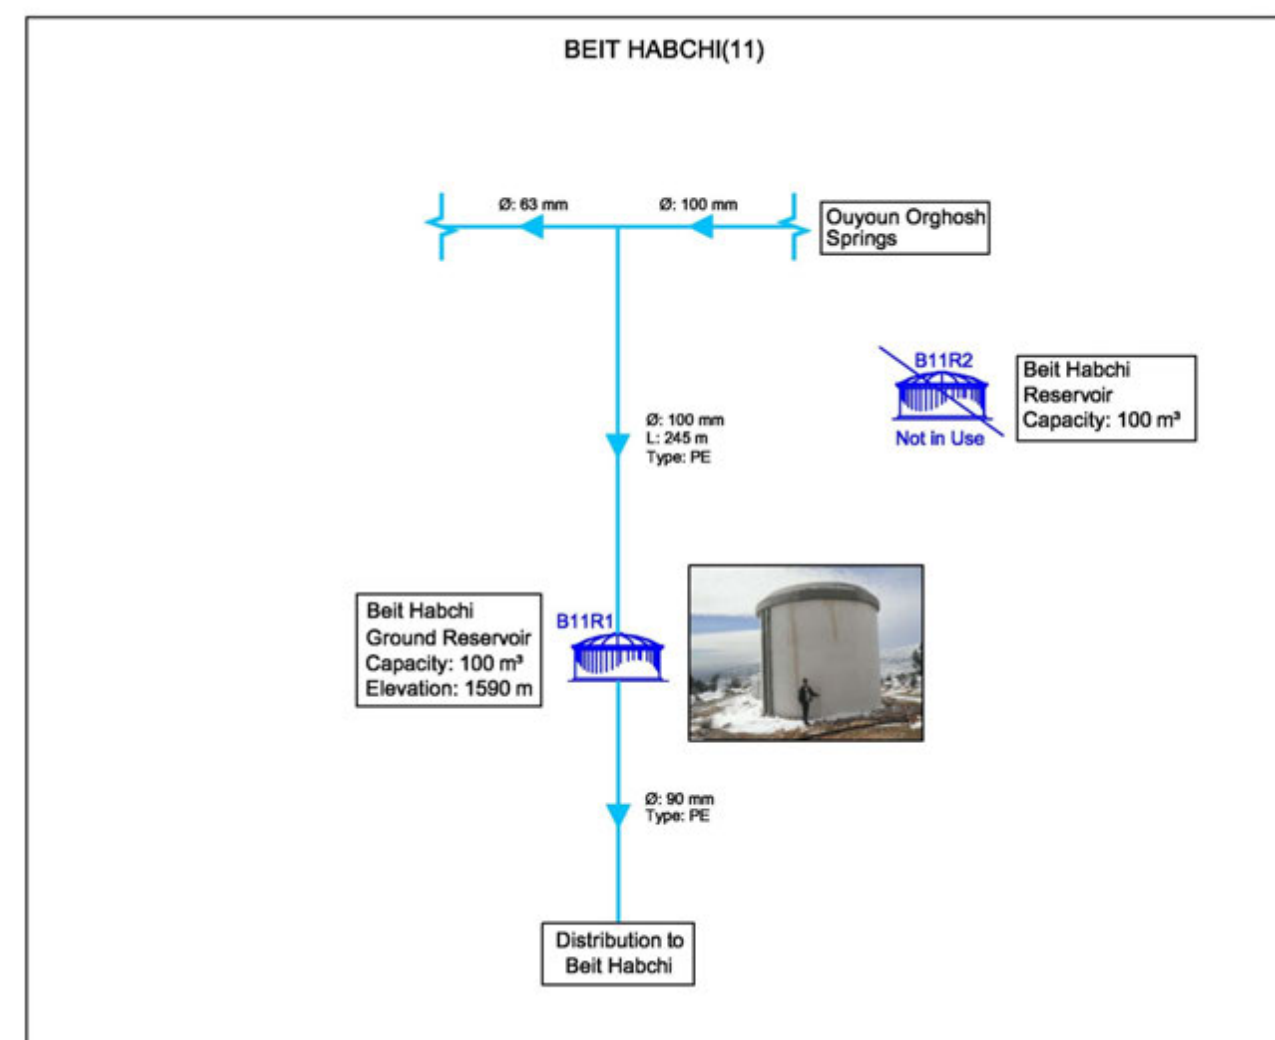
**Beit Habchi (11)**

There is no available information concerning the water network of the town.

Reservoir B11R1 (100m³): Reservoir is in good condition.

Reservoir B11R2 (100 m³): Reservoir is not in use.

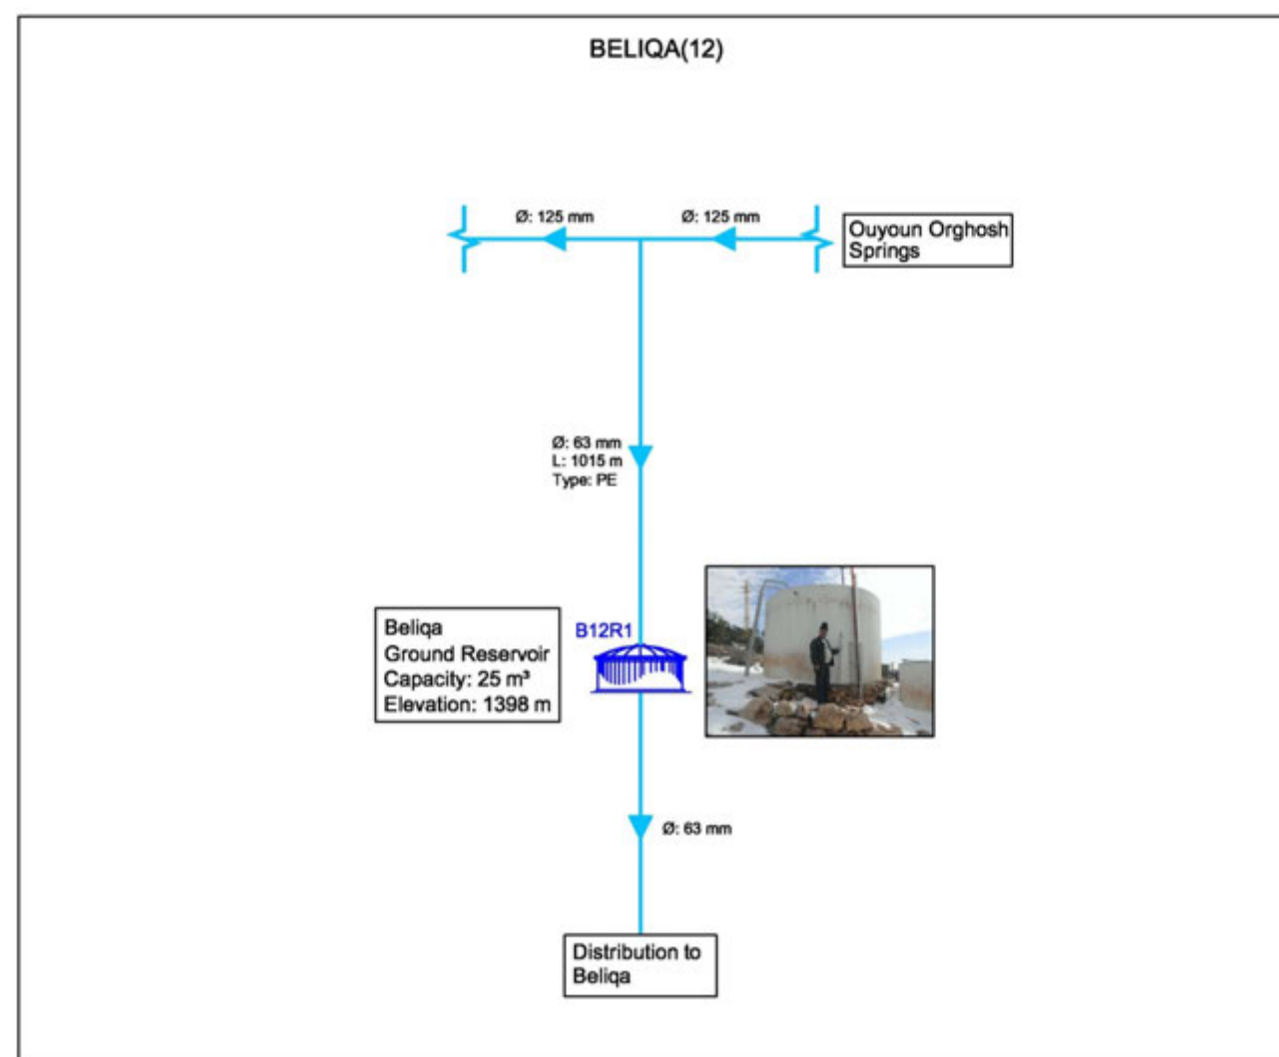
**Belqa (12)**

The existing water network is in very good condition and it has a length of around 1 km. It covers a large area of the town.

Reservoir B12R1 (25 m³): Reservoir is in bad condition and needs esthetical and structural rehabilitation or reconstruction. The pipes and valves are rusted and they need maintenance

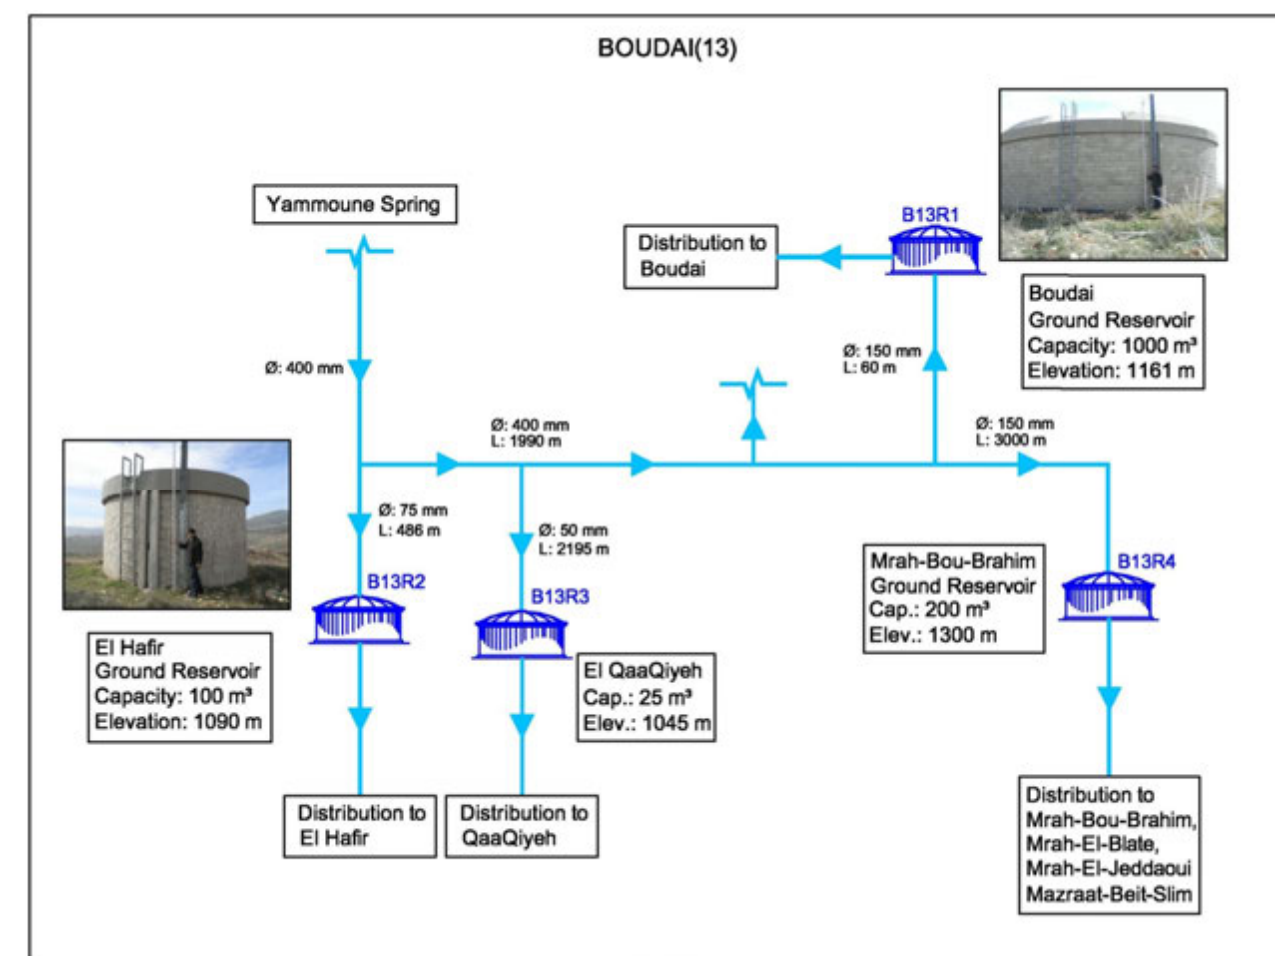
**Boudai (13)**

The existing water network is in good condition and it has a length of around 44 km. It covers a part of the town.

Reservoir B13R1 (>10 years; 1000 m³): Reservoir is in good condition.

Reservoir B13R2 (100 m³): Reservoir is in good condition.

Reservoir B13R4 (200m³): No information available.

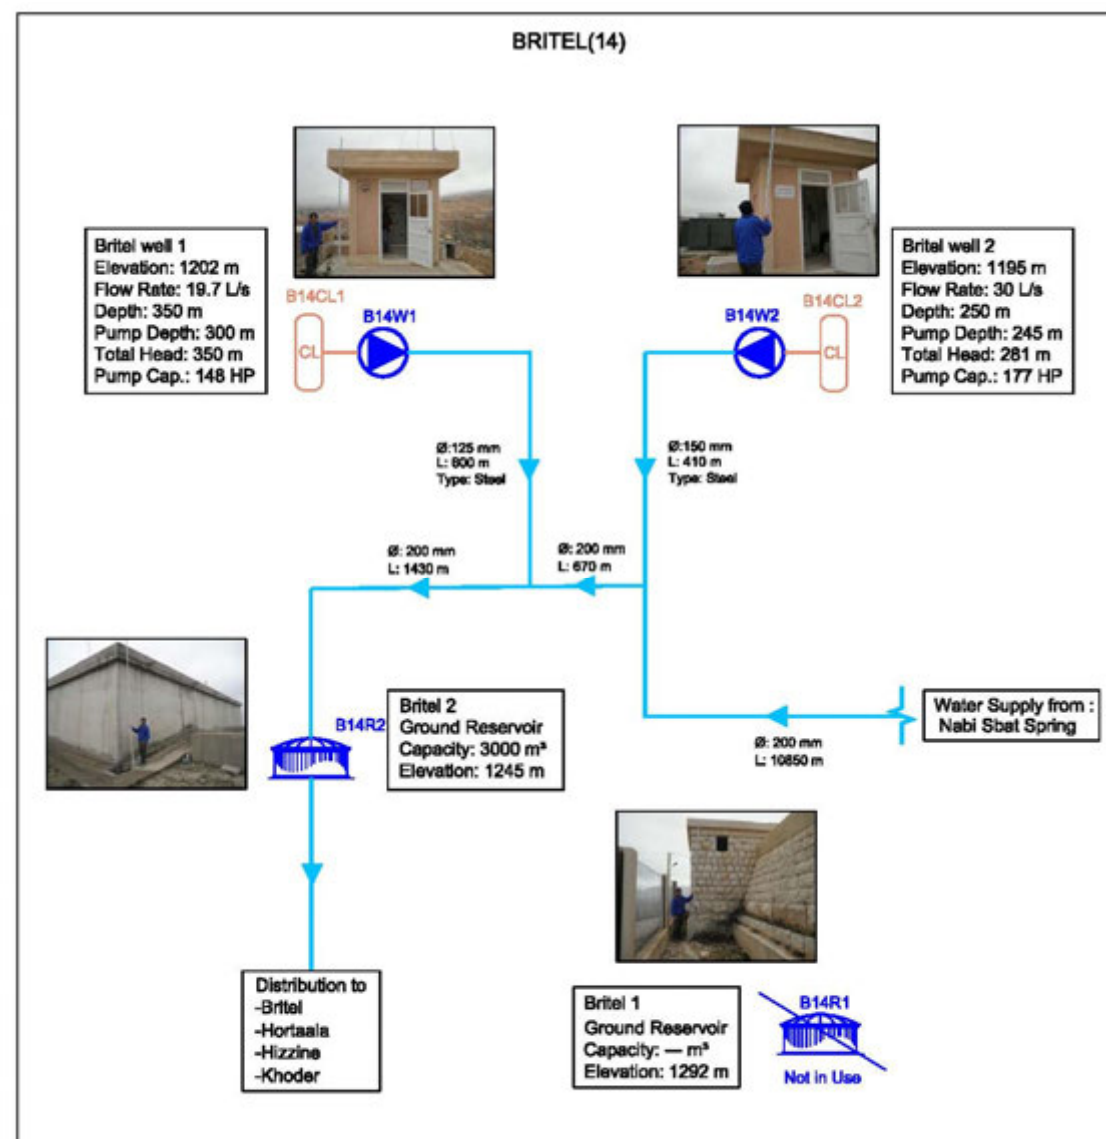
**Britel (14)**

The existing water network is in very good condition and it has a length of around 103 km. It covers a large area of the town.

Well B14W1 (>15 years): Well is in good condition and is equipped with a chlorination chamber. It suffers from a shortage of electric power.

Well B14W2 (>15 years): Well is in good condition and is equipped with a chlorination chamber.

Reservoir B14R2 (3000 m³): Reservoir is in good condition.

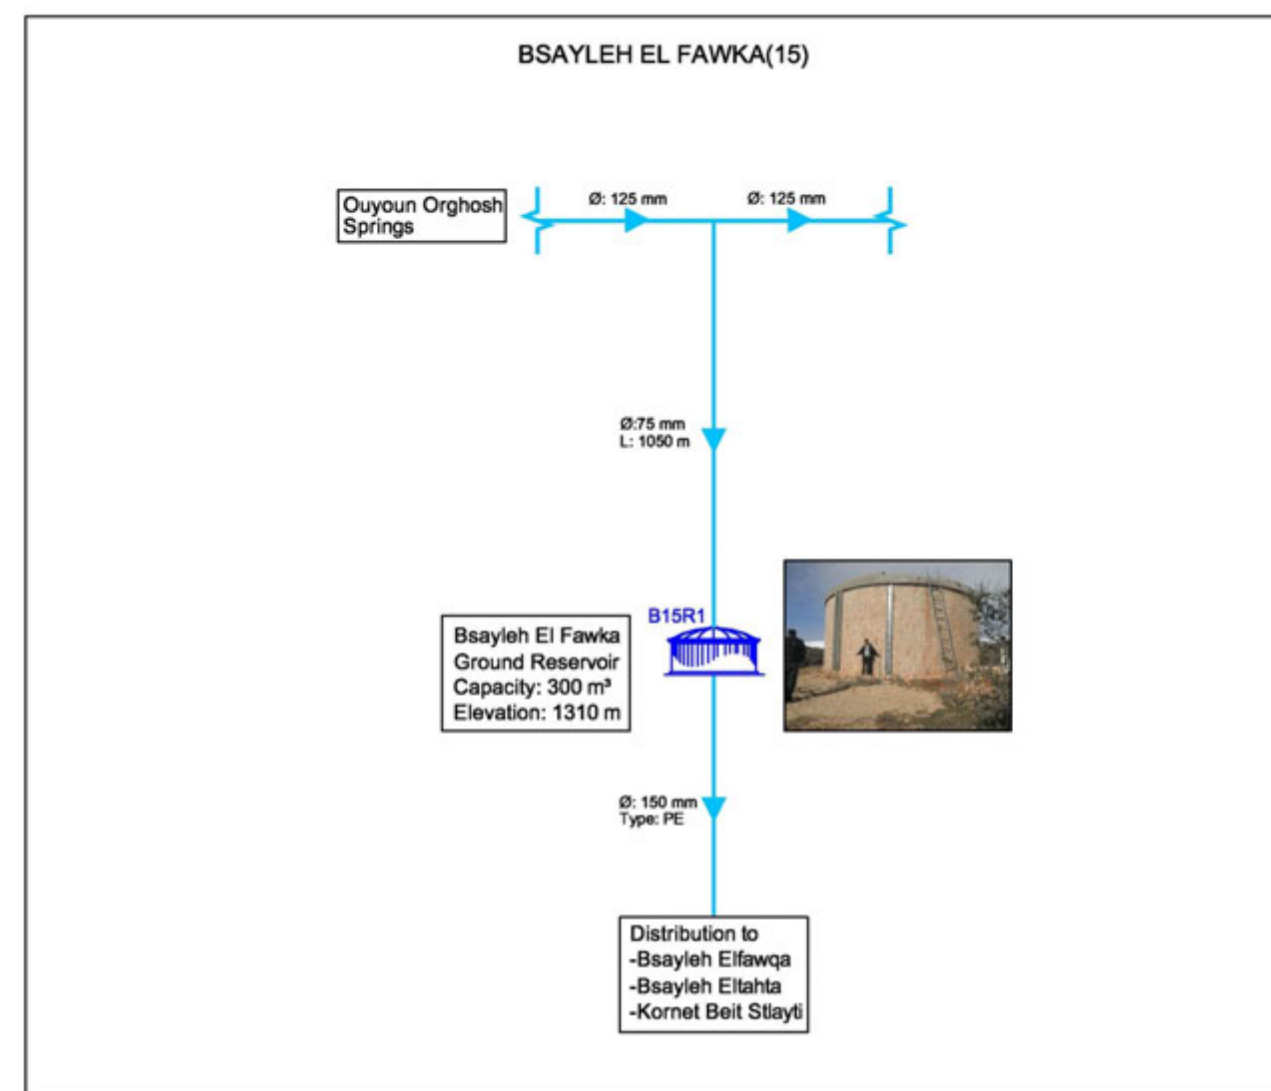
**Bsayleh el Fawka (15)**

There is no available information concerning the water network of the town.

Reservoir B15R1 (300m³): Reservoir is in good condition.

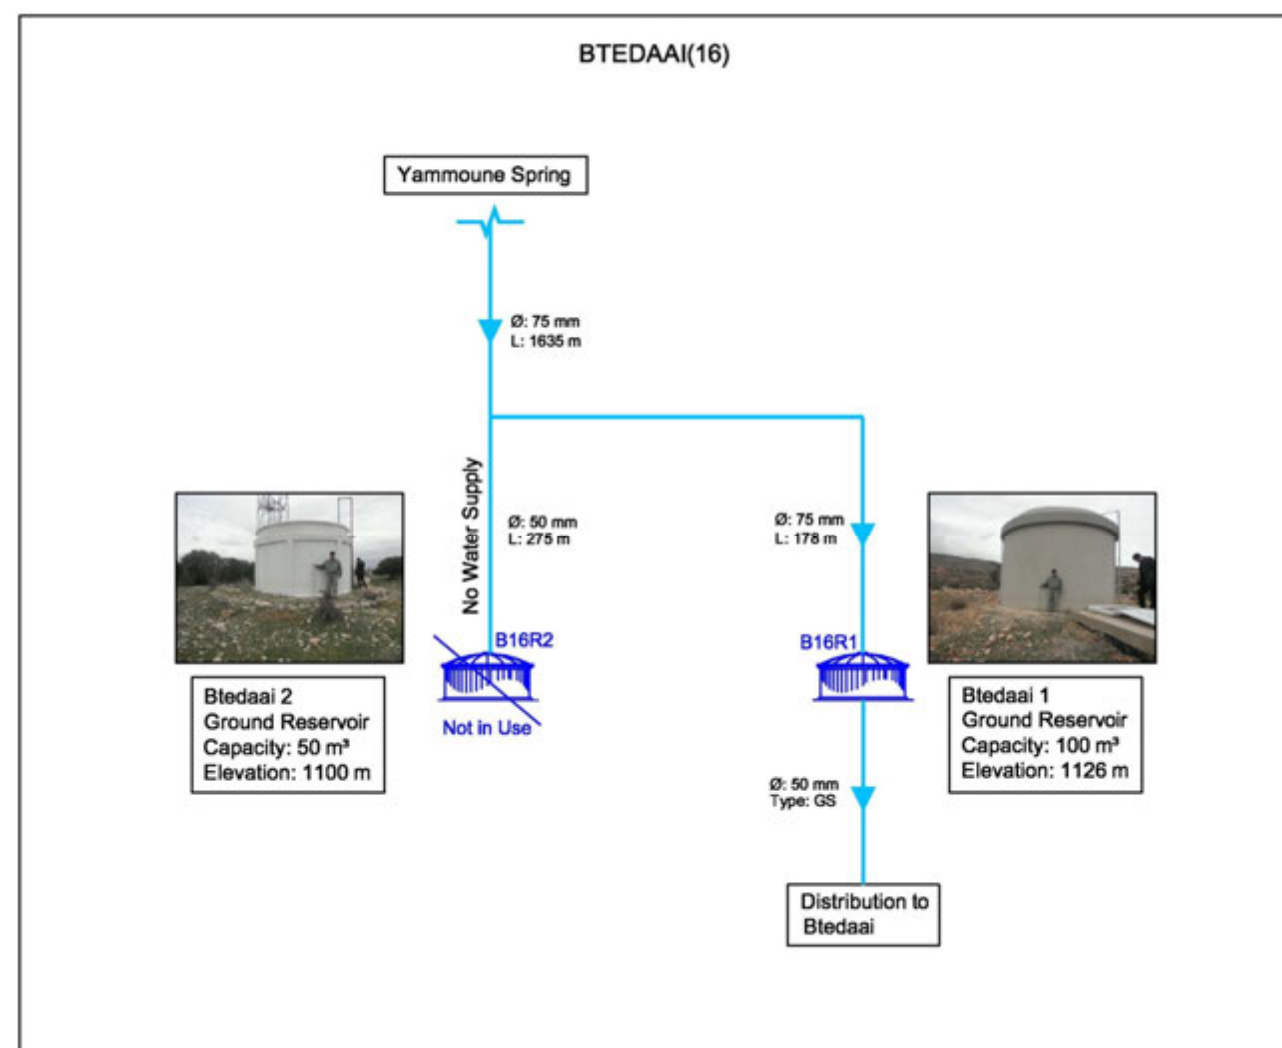
**Btedaai (16)**

The existing water network is in bad condition and it has a length of around 7.3 km. It covers a part of the town.

Reservoir B16R1 (>10 years; 100 m³): Reservoir is in good condition.

Reservoir B16R2 (50 m³): Reservoir is in good condition but it is not currently in use. The inlet and outlet pipes are unfilled with water but there is no available information concerning their conditions.

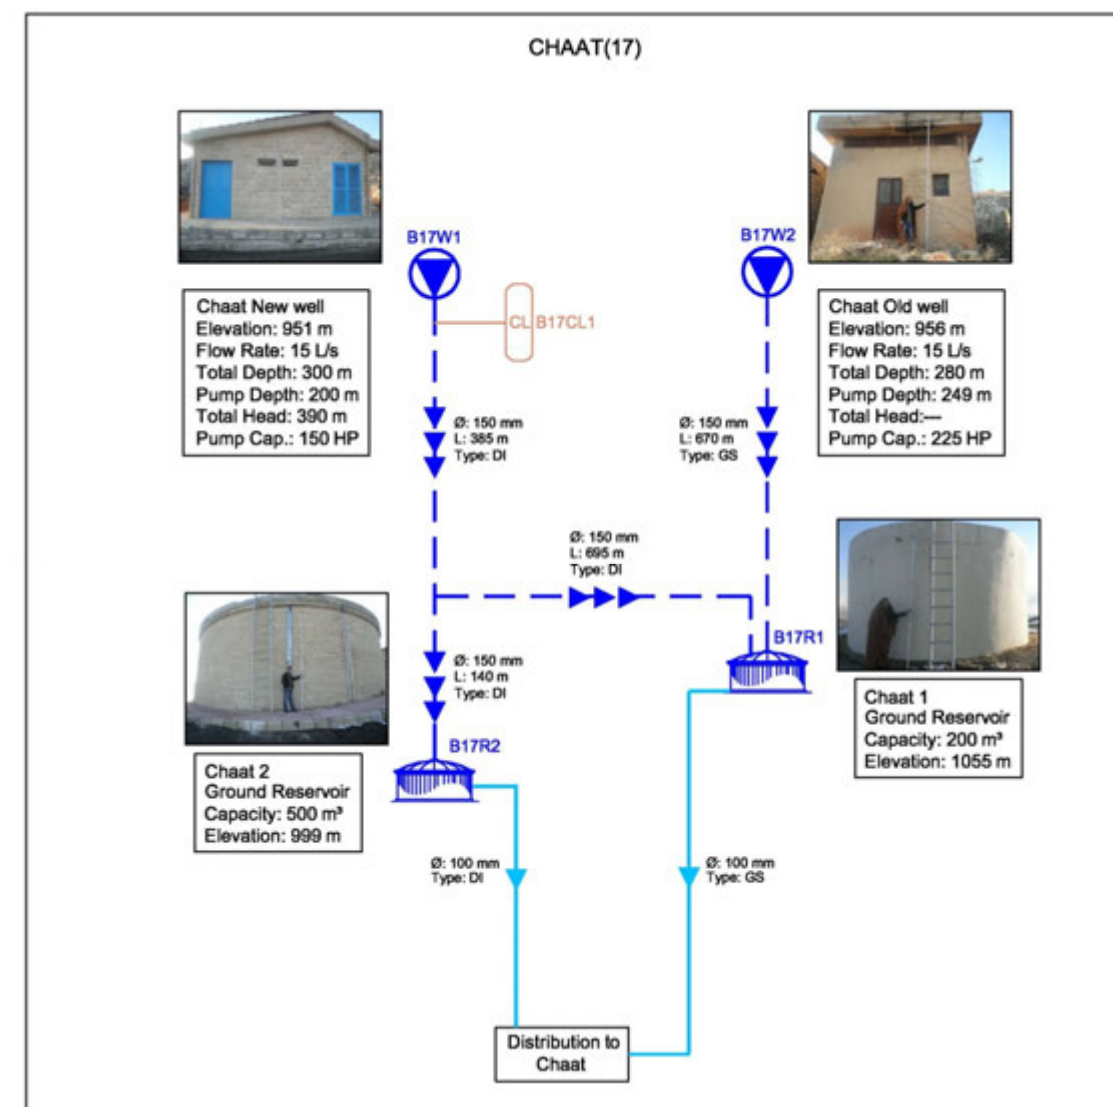
**Chaat (17)**

The existing water network is in bad condition and it has a length of around 19.6 km. It covers a part of the town. It is under maintenance by the municipality.

Well B17W1 (5 years old): Well is in good condition but it suffers from a shortage of electric power. It supplies reservoir b17r2 and is equipped with a chlorination chamber, though not operational.

Well B17W2 (>25 years): Well is in good condition and it supplies reservoir B17R1.

Reservoir B17R1 (>40 years; 200 m³): Reservoir is in bad condition and needs esthetical and structural rehabilitation or reconstruction. The pipes and valves are rusted and they need maintenance.

Reservoir B17R2 (5 years old; 500 m³): Reservoir is in good condition.

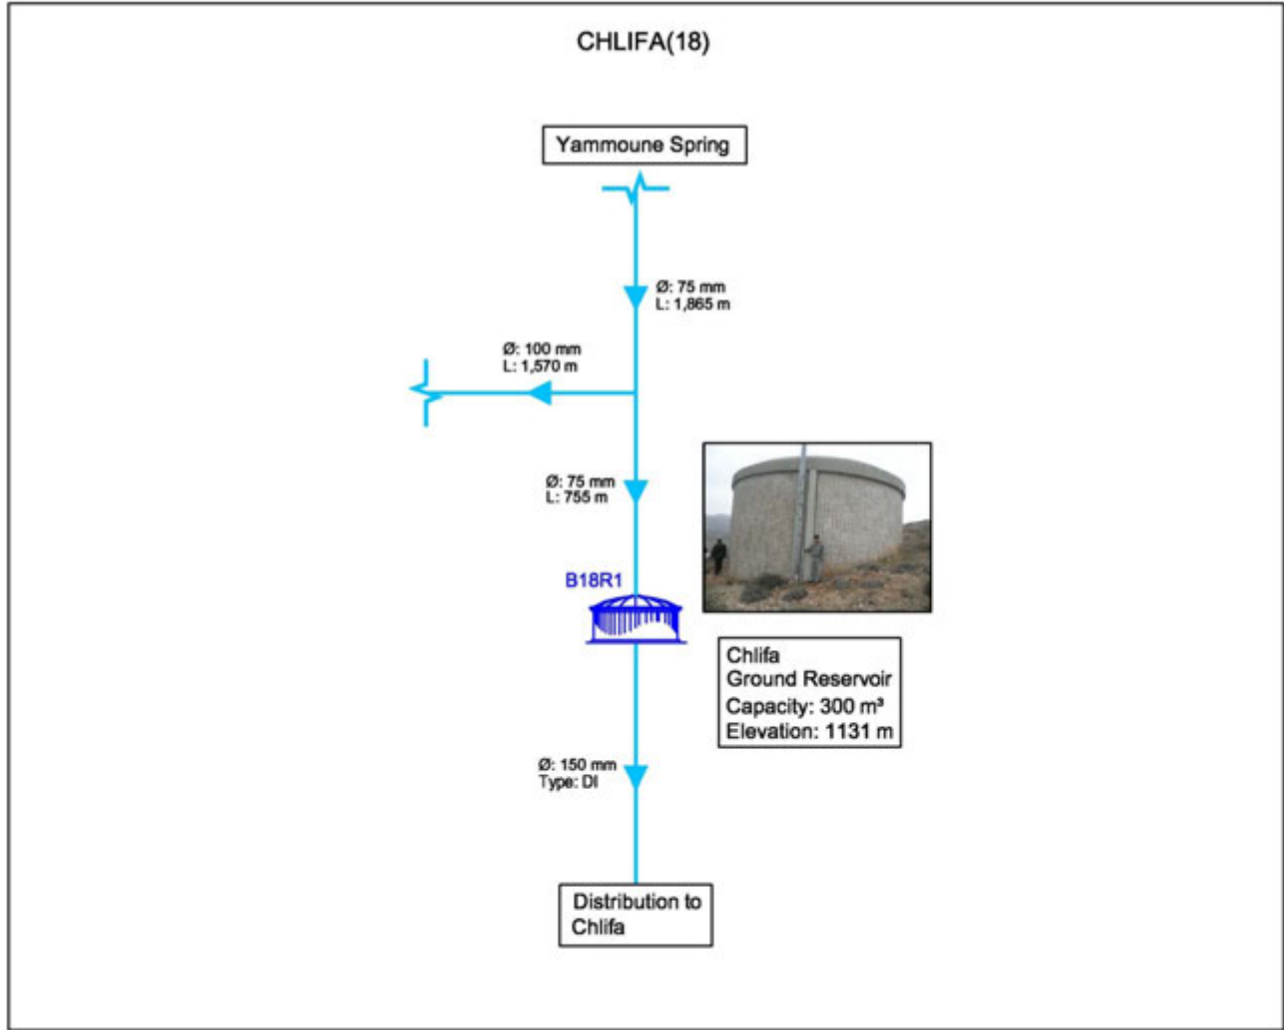
**Chlifa (18)**

The existing water network is in very good condition and it has a length of around 9.3 km. It covers a large area of the town.

Reservoir B18R1 (>10 years; 300 m³): Reservoir is in good condition.
