# WATER SUPPLY AND WASTEWATER SYSTEMS MASTER PLAN FOR THE BEKAA WATER ESTABLISHMENT

## WATER ASSESSMENT REPORT

January 2014  
Updated May 2015

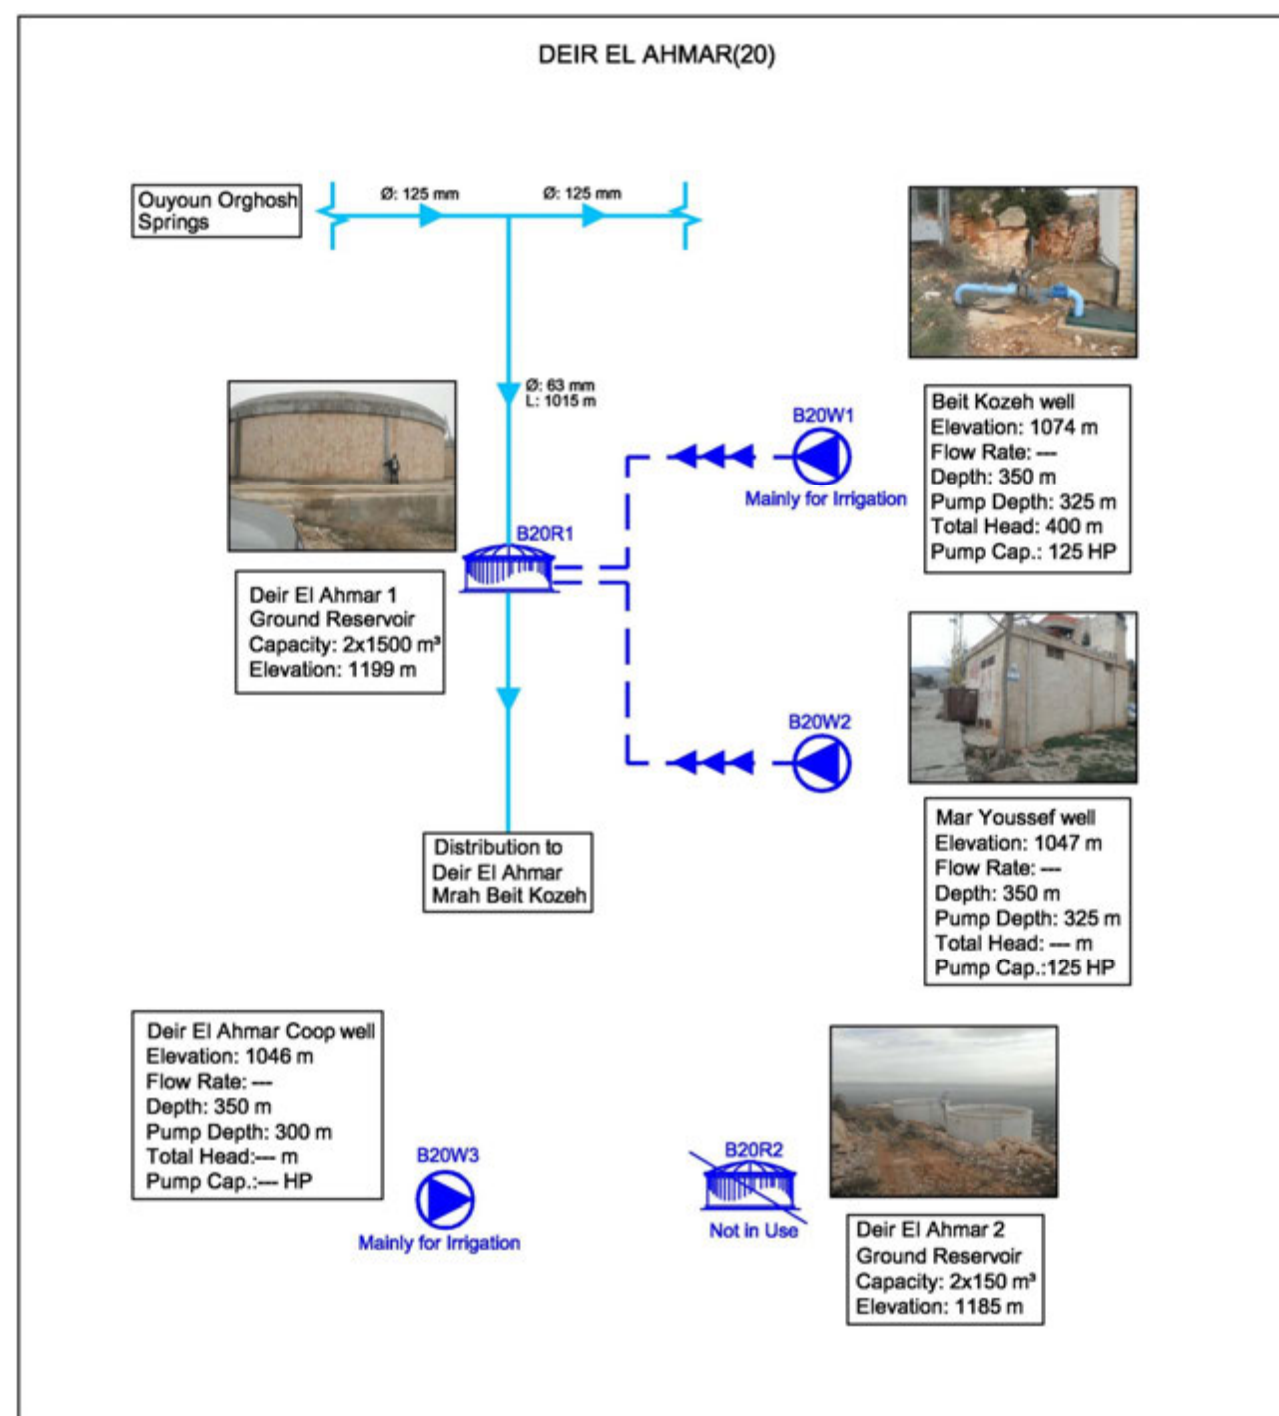
**Deir El Ahmar (20)**

The existing water network is in medium condition and it has a length of around 35 km. It covers a part of the town.

**Well B20W1 (>15 years):** Well is in good condition but it suffers from a shortage of electric power. It is used mainly for irrigation purposes only but the booster pump is currently damaged.

**Well B20W2 (>20 years):** Well has not been in use for 4 years and booster pump is damaged. A new pump shall be installed.

**Reservoir B20R1 (2x1500 m³):** Reservoirs are in good condition.

**Reservoir B20R2 (2x150 m³):** Reservoirs are in bad condition and not in use anymore. It needs esthetical and structural rehabilitation or reconstruction. The pipes and valves are rusted and they need maintenance.

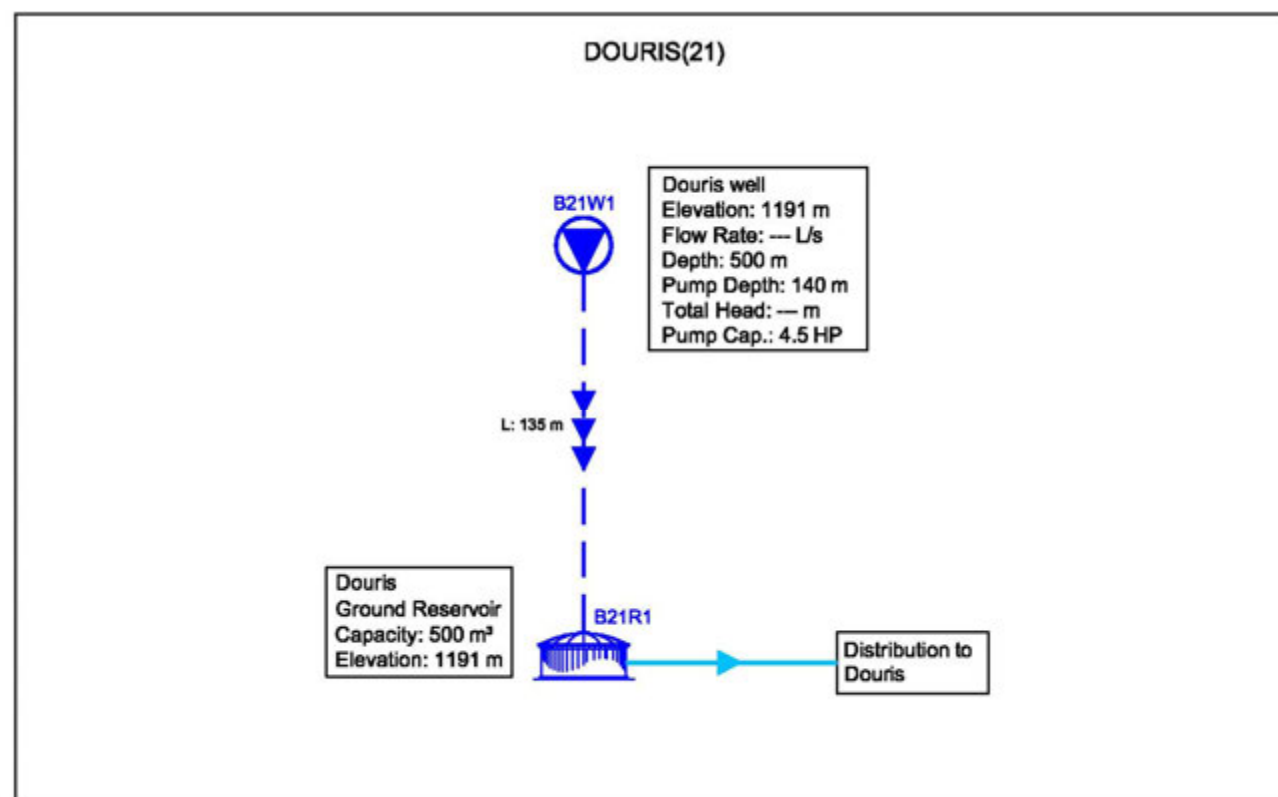
## Douris (21)

The existing water network is in good condition and it has a length of around 49 km. It covers a part of the town.

Well B21W1 (>10 years): Well is in good condition.

Reservoir B21R1 (500 m³): Reservoir is new and it is in good condition.

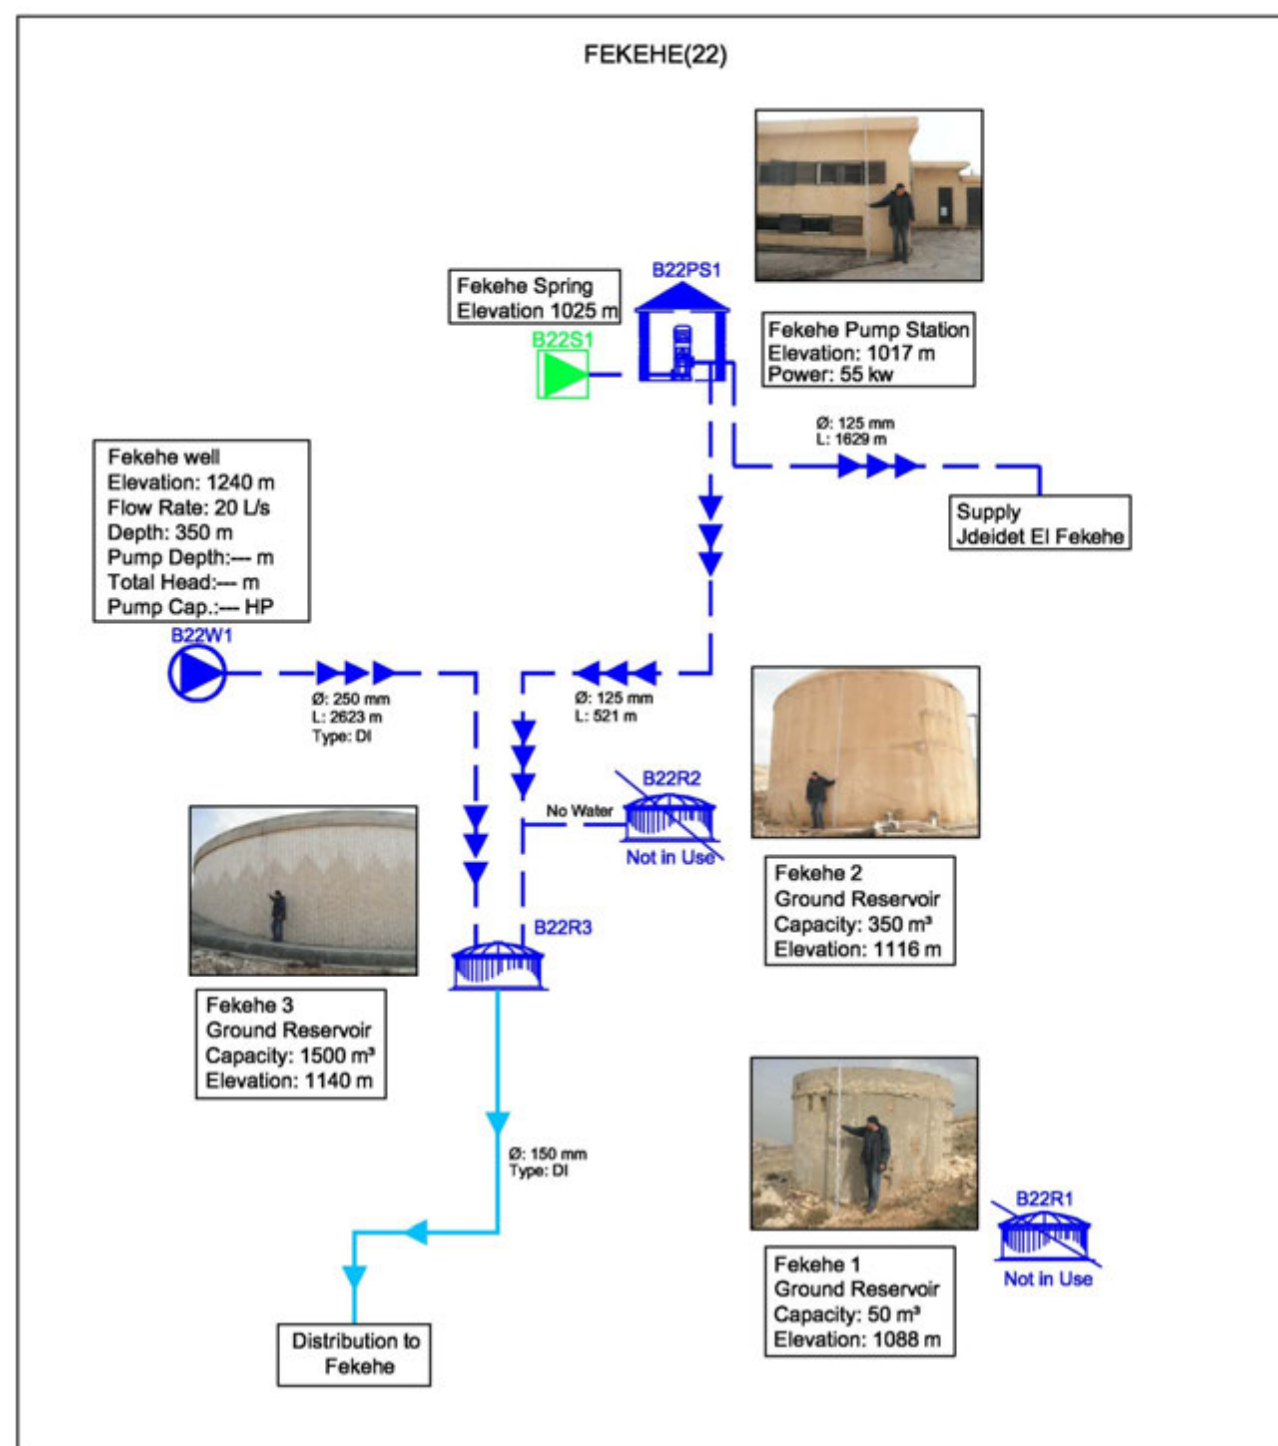
**Fekehe (22)**

The existing water network is in good condition and it has a length of around 49.3 km. It covers a large area of the town.

Well B22W1 (5 years old): Well is new and in good condition.

Pump station B22PS1: Station is in good condition.

Reservoir B22R1 (>60 years; 50 m<sup>3</sup>): Reservoir is very old and it is not in use. It needs esthetical and structural rehabilitation or reconstruction. The pipes and valves are rusted and they need maintenance.

Reservoir B22R3 (>5 years; 1500 m<sup>3</sup>): Reservoir is in good condition.

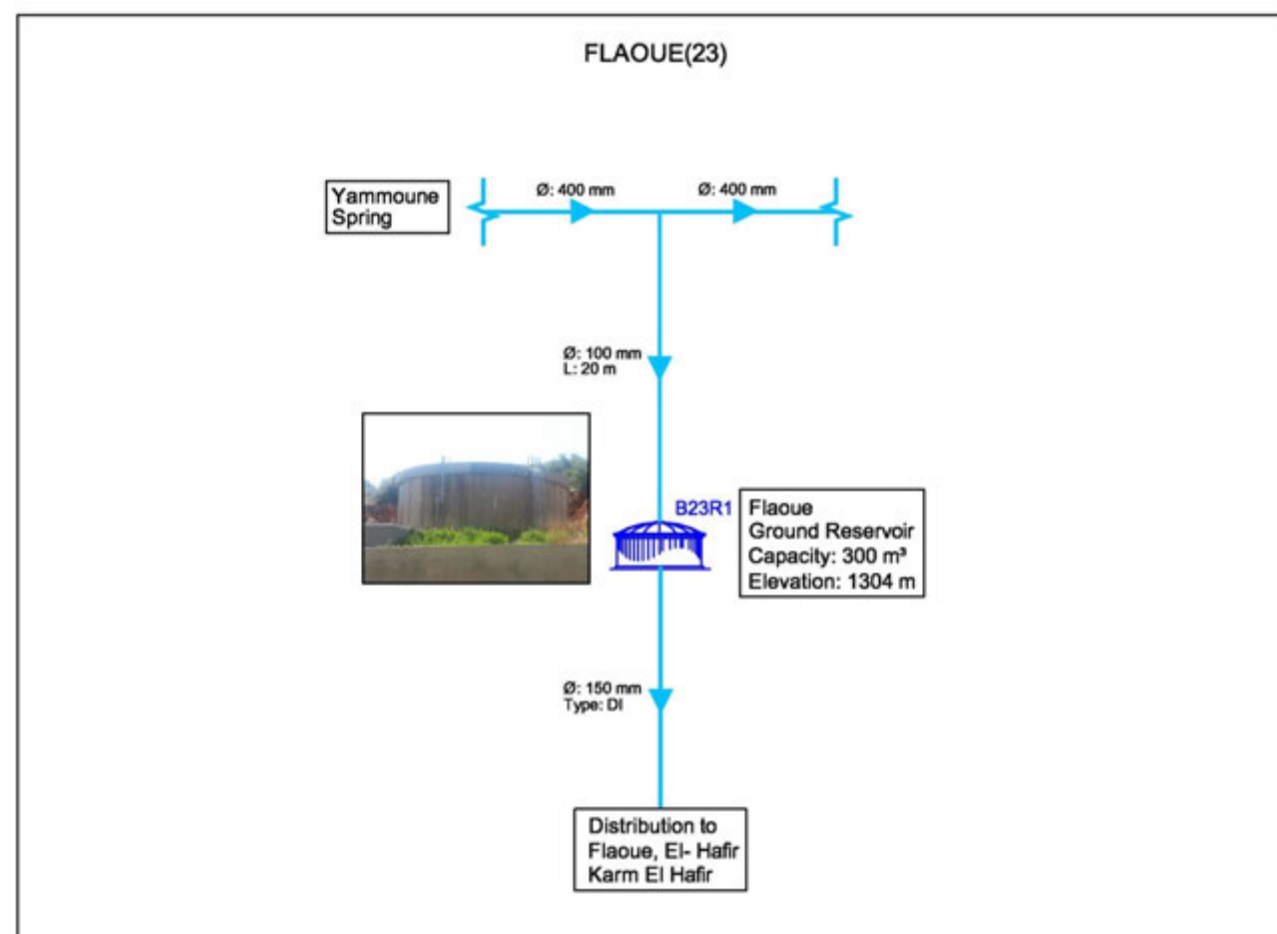
**Flaoue (23)**

The existing water network is in very good condition and it has a length of around 9 km. It covers a large area of the town.

Reservoir B23R1 (>10 years; 300 m³): Reservoir is in good condition. However, it overflows during low flow conditions in the networks.

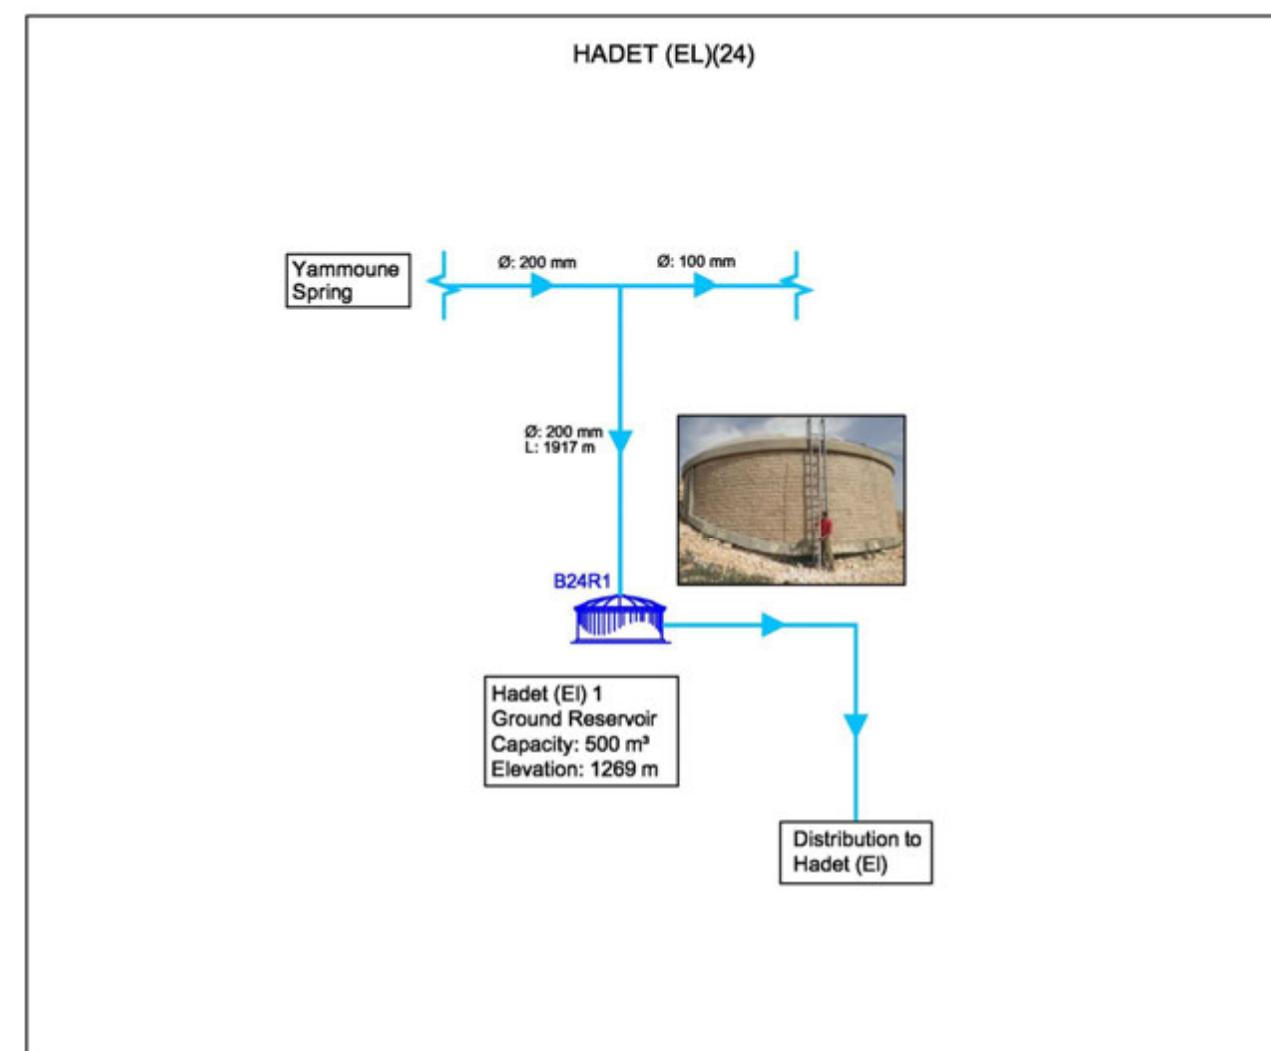
**Hadet (El) (24)**

The existing water network is in medium condition and it has a length of around 20 km. It covers a part of the town.

Reservoir B24R1 (>10 years; 500 m³): Reservoir is in good condition.

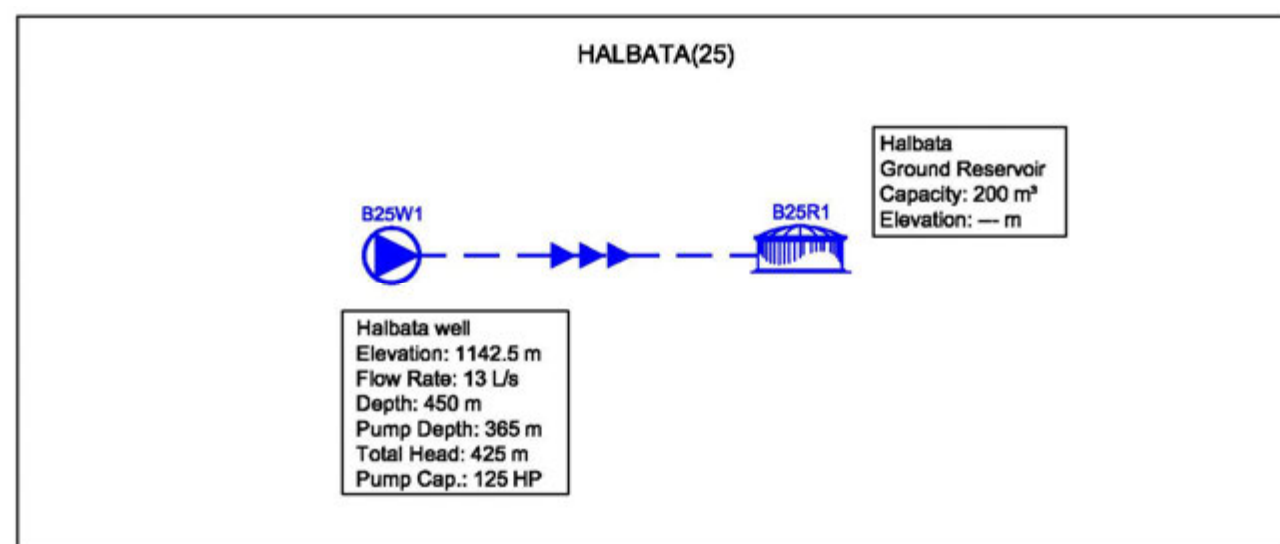
## Halbata (25)

There is no available information concerning the water network of the town.

Well B25W1 (20 years old): Well suffers from a shortage of electric power. No more available information.

Reservoir B25R1 (< 2 years; 200 m³): This reservoir is new and it is in very good condition.

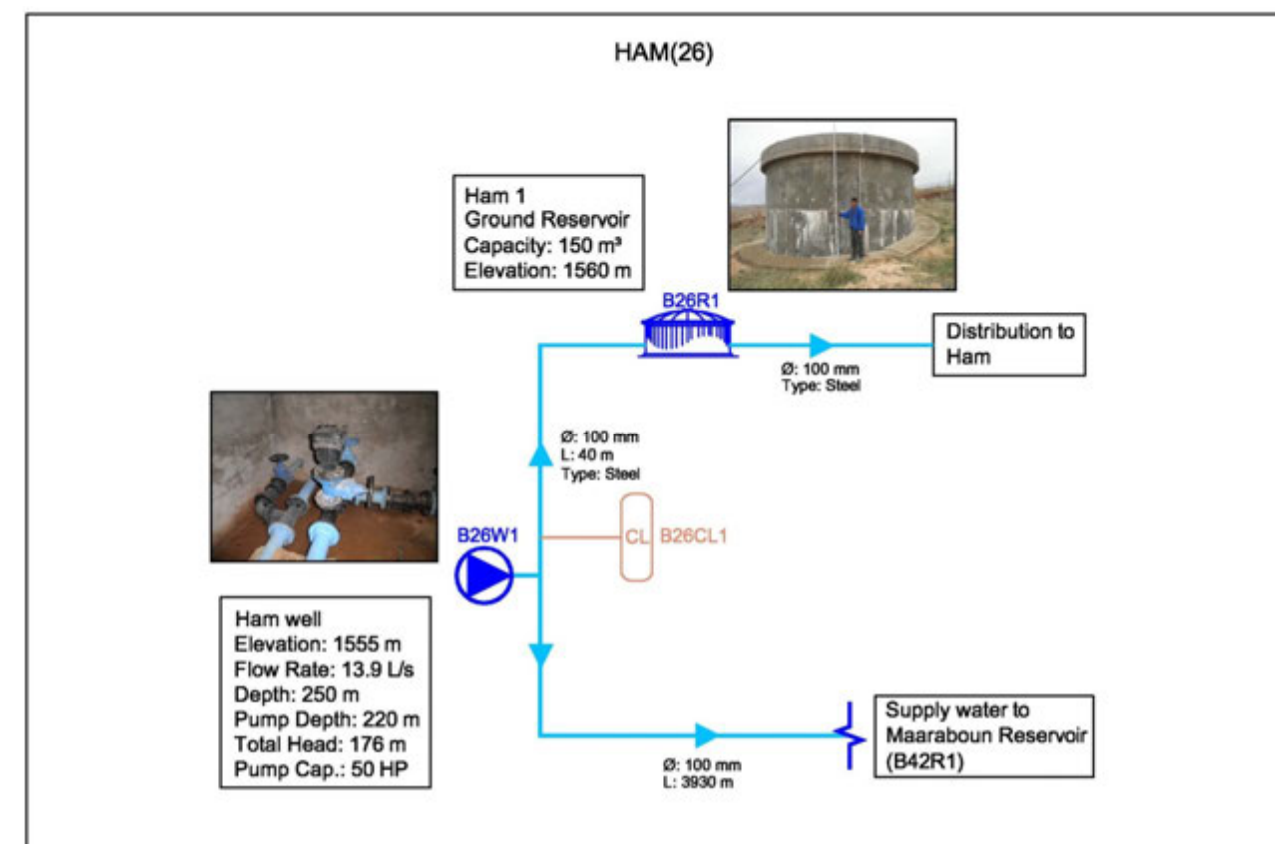
## Ham (26)

The existing water network is in very good condition and it has a length of around 7.3 km. It covers a large area of the town.

Well B26W1 (>15 years): Well is in good condition but it suffers from a shortage of electric power.

Reservoir B26R1 (150m³): Reservoir is in good condition. It needs esthetical rehabilitation.

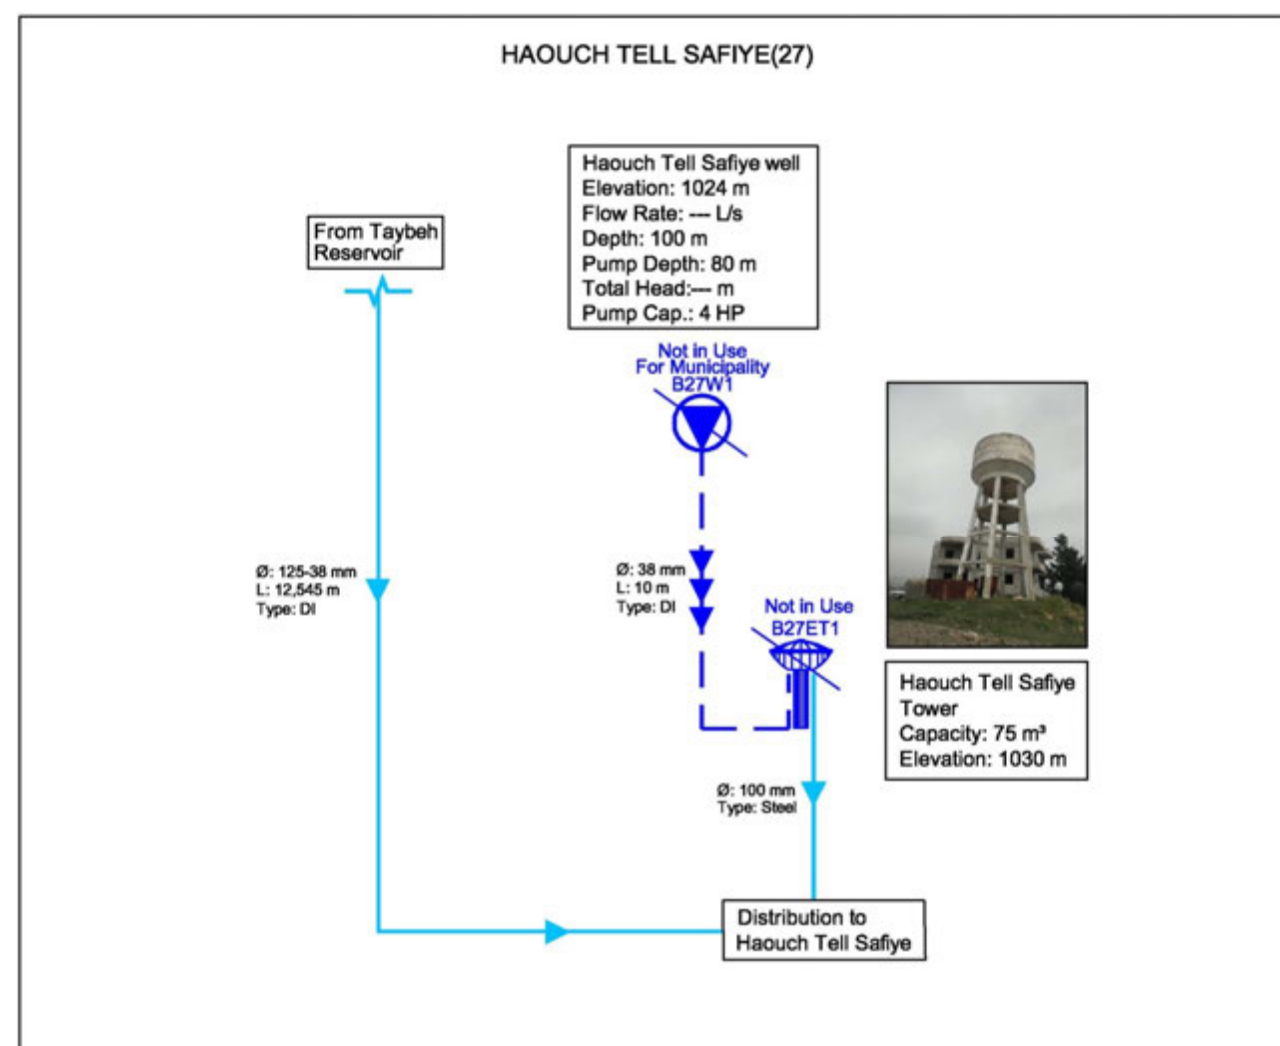
**Haouch tell safiye (27)**

The existing water network is in very good condition and it has a length of around 11.3 km. It covers a large area of the town.

Well B27W1 (10 years old): Well is not in use and it suffers from a shortage of electric power.

Elevated tank B27ET1 (75 m³): Elevated tank is in an acceptable condition but it is not in use. A new network exists and is supplied from Taybe reservoir.

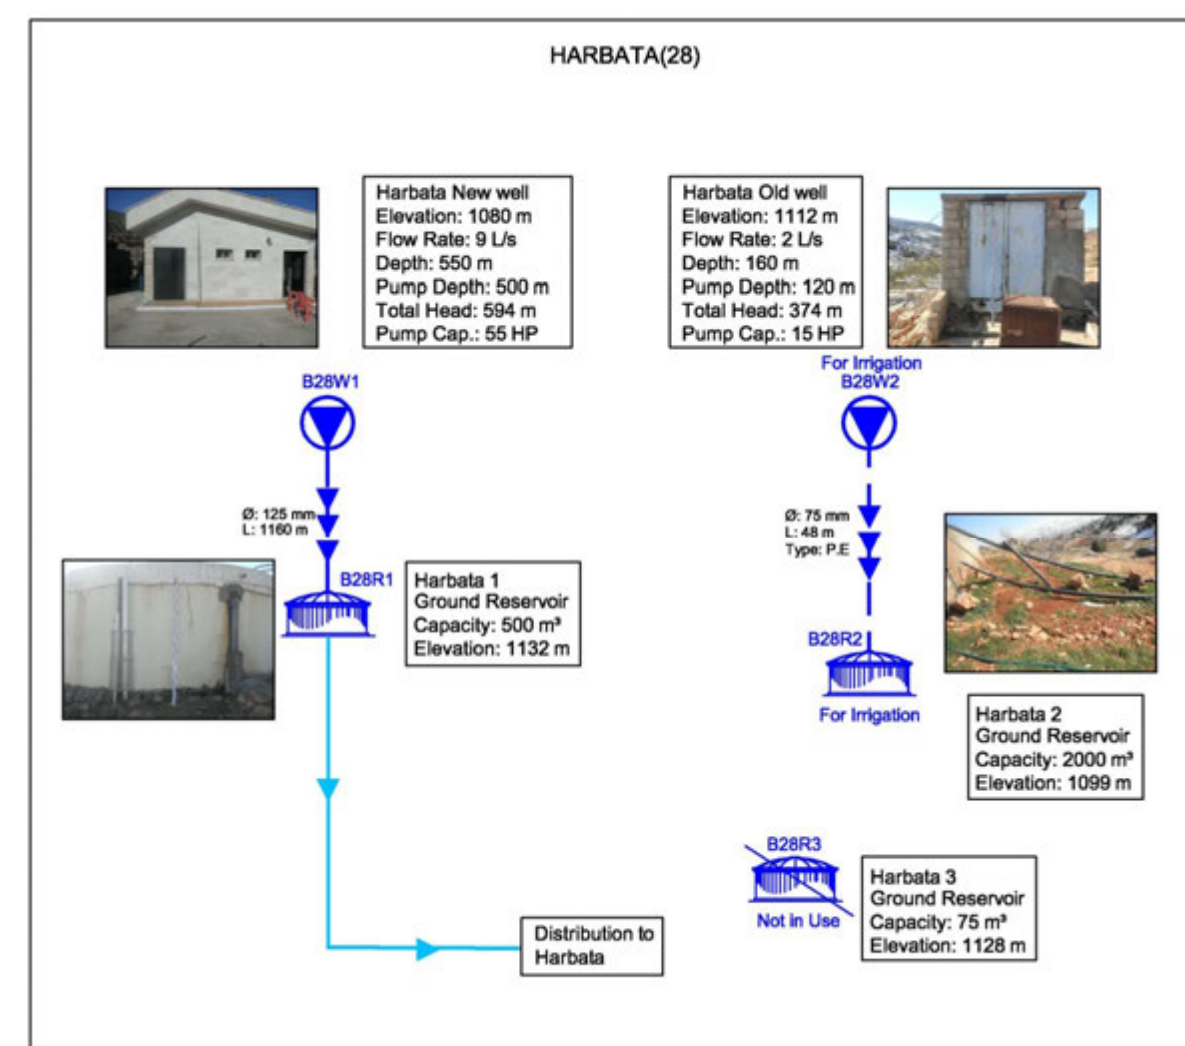
**Harbata (28)**

The existing water network is in very good condition and it has a length of around 15.7 km. It covers a large area of the town.

Well B28W1 (>10 years): Well is in good condition but it suffers from a shortage of electric power. There is a chlorination room with 2 cylinders but it is not working.

Reservoir B28R1 (>40 years; 500 m³): Reservoir is in bad condition. It needs esthetical and structural rehabilitation. The pipes and valves are rusted and they need maintenance.

Reservoir B28R2 (2000 m³): Reservoir is open-top and it is in an acceptable condition but the inlet and outlet pipes and valves are rusted. This reservoir needs some minor maintenance. This reservoir is used only for irrigation.

Reservoir B28R3 (old; 75 m³): Reservoir is old and it is not in use.

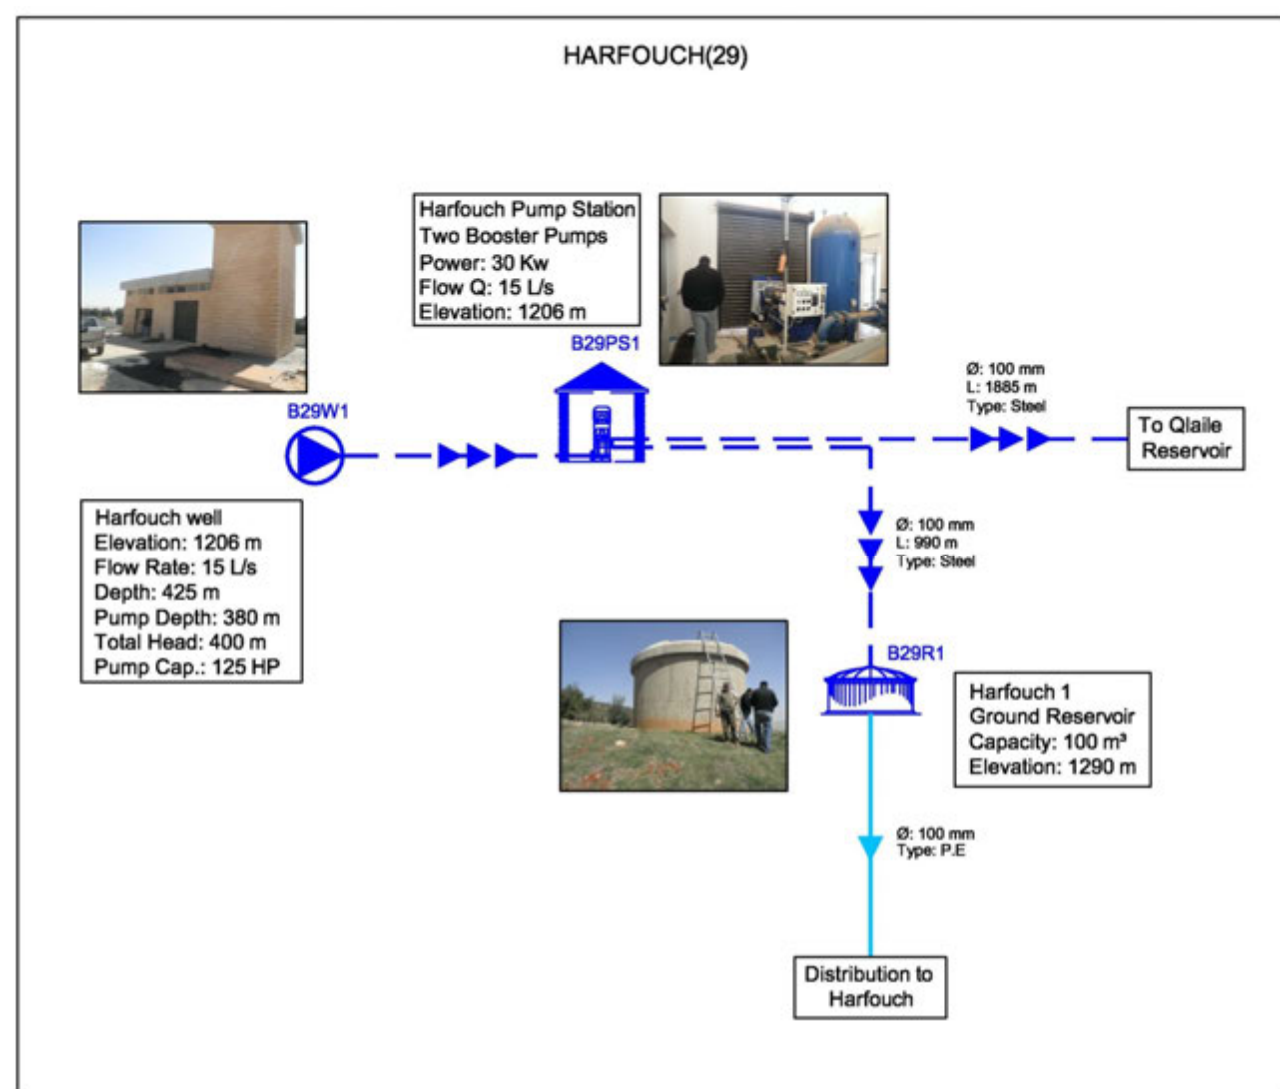
**Harfouch (29)**

There is no available information concerning the water network of the town.

Well B29W1 (20 years old): Well is in good condition.

Pump station B29PS1: Pump station is in good condition but it is not in use yet.

Reservoir B29R1 (>10 years; 100 m³): Reservoir is in good condition but it is not in use yet.

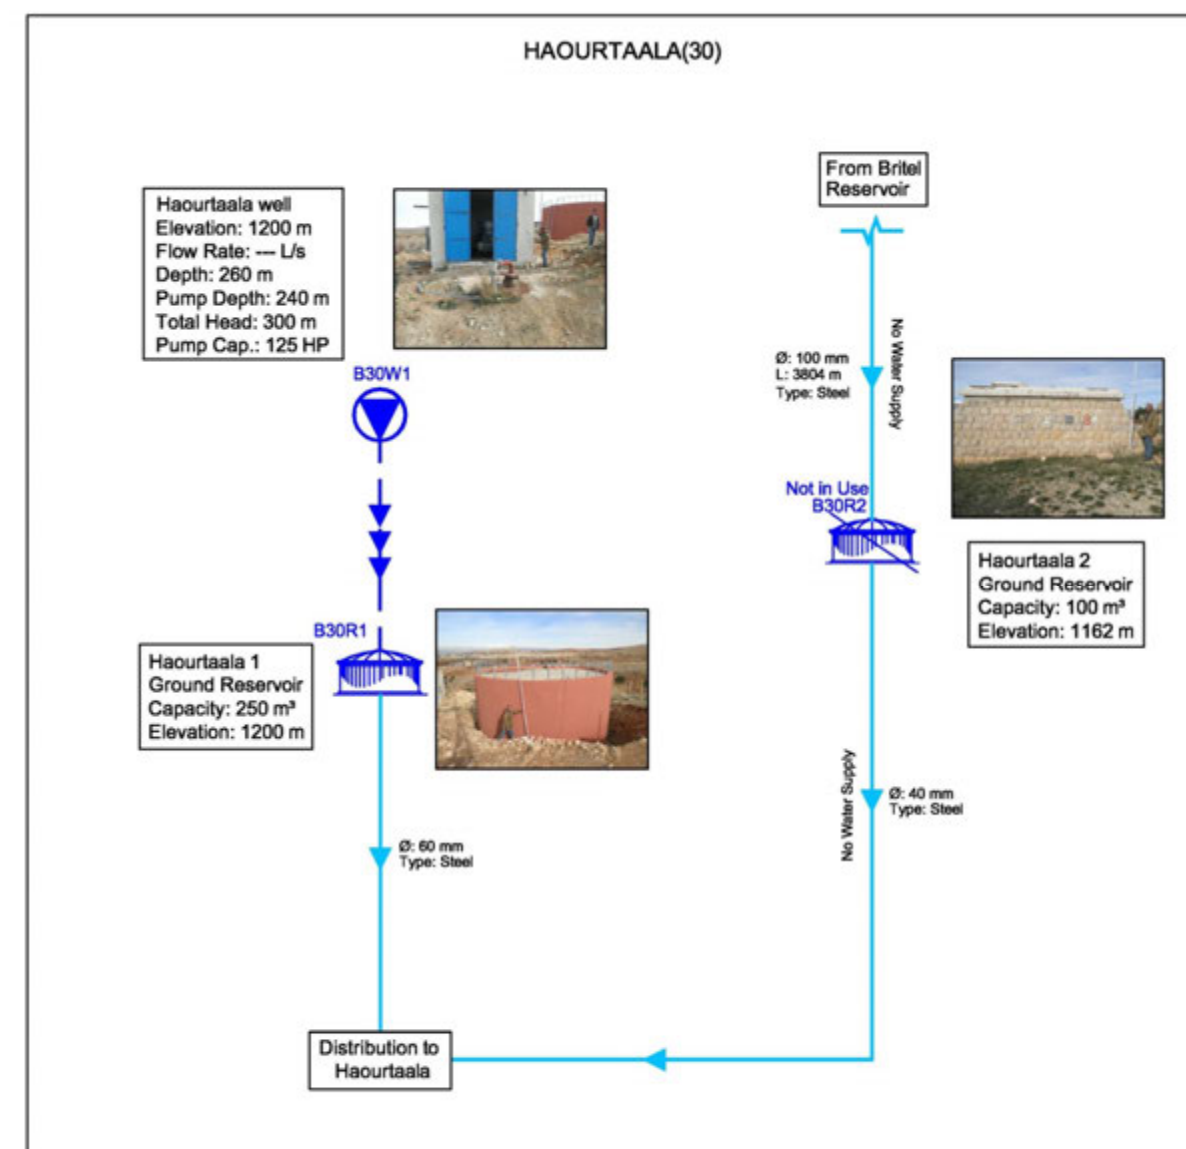
**Haourtaala (30)**

The existing water network is in very good condition and it has a length of around 43 km. It covers a large area of the town.

Well B30W1 (10 years old): Well is in good condition but it suffers from a shortage of electric power.

Reservoir B30R1 (250 m³): Reservoir is in good condition.

Reservoir B30R2 (100 m³): Reservoir is old but it is in an acceptable condition. It needs esthetical rehabilitation. The pipes and valves are rusted and they need maintenance. This reservoir is not in use anymore.

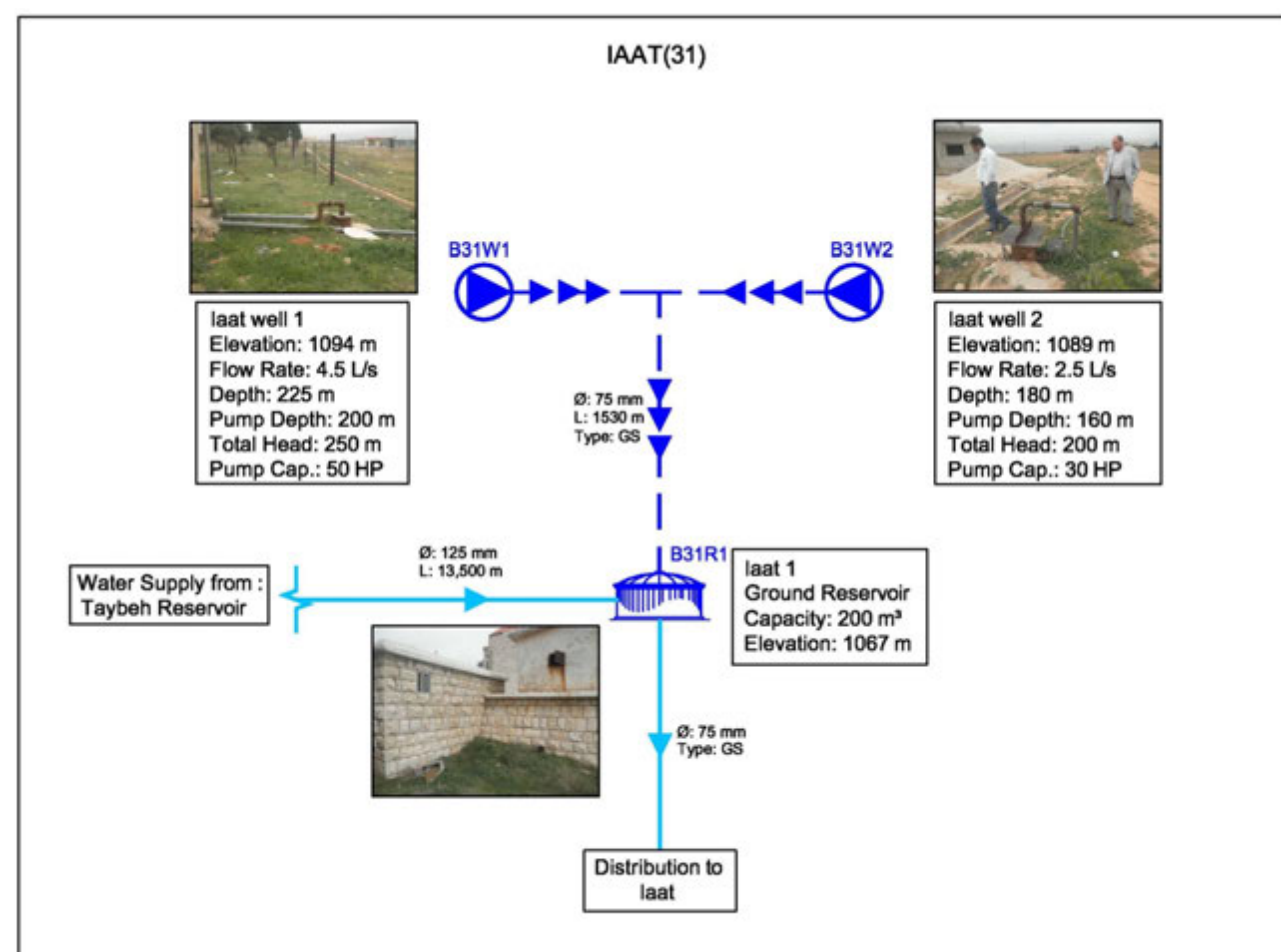
**laat (31)**

The existing water network is in very good condition and it has a length of around 32.5 km. It covers a large area of the town.

Well B31W1 (15 years old): Well is in good condition.

Well B31W2 (15 years old): Well is in good condition but it suffers from a shortage of electric power.

Reservoir B31R1 (200 m³): Reservoir is old but it is in acceptable condition.

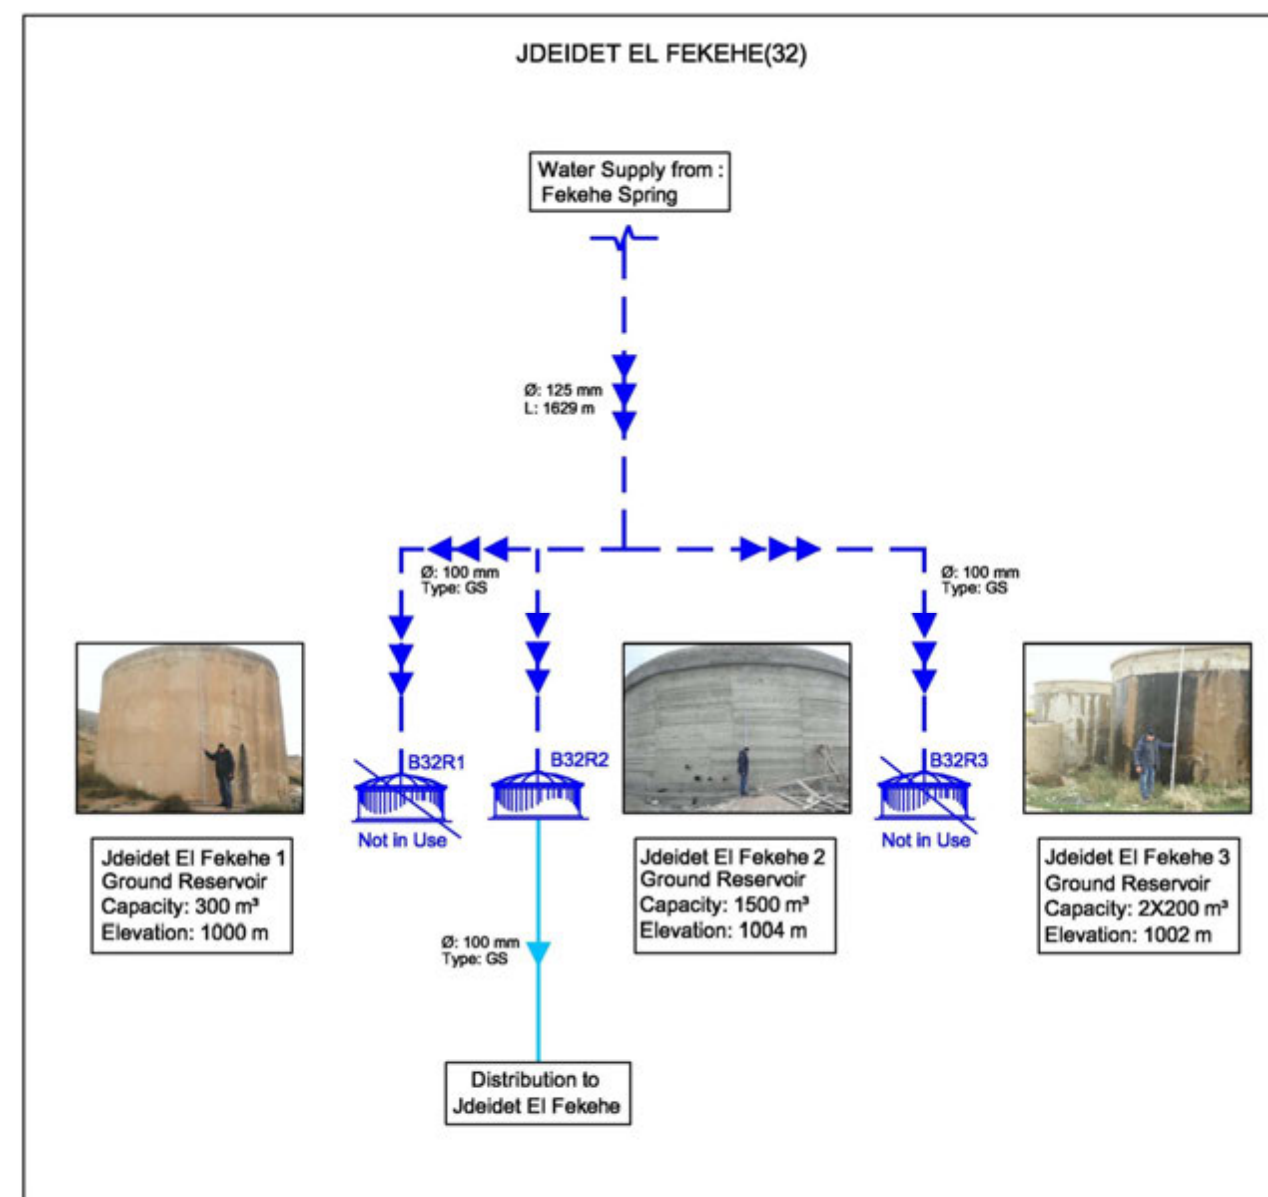
**Jdeidet El Fekehe (32)**

There is no available information concerning the water network of the town.

Reservoir B32R1 (>10 years; 300m³): Reservoir is in bad condition and it is not in use.

Reservoir B32R3 (>35 years; 2x200 m³): Reservoir is in bad condition. It needs esthetical and structural rehabilitation. The pipes and valves are rusted and they need maintenance. This reservoir is not in use.

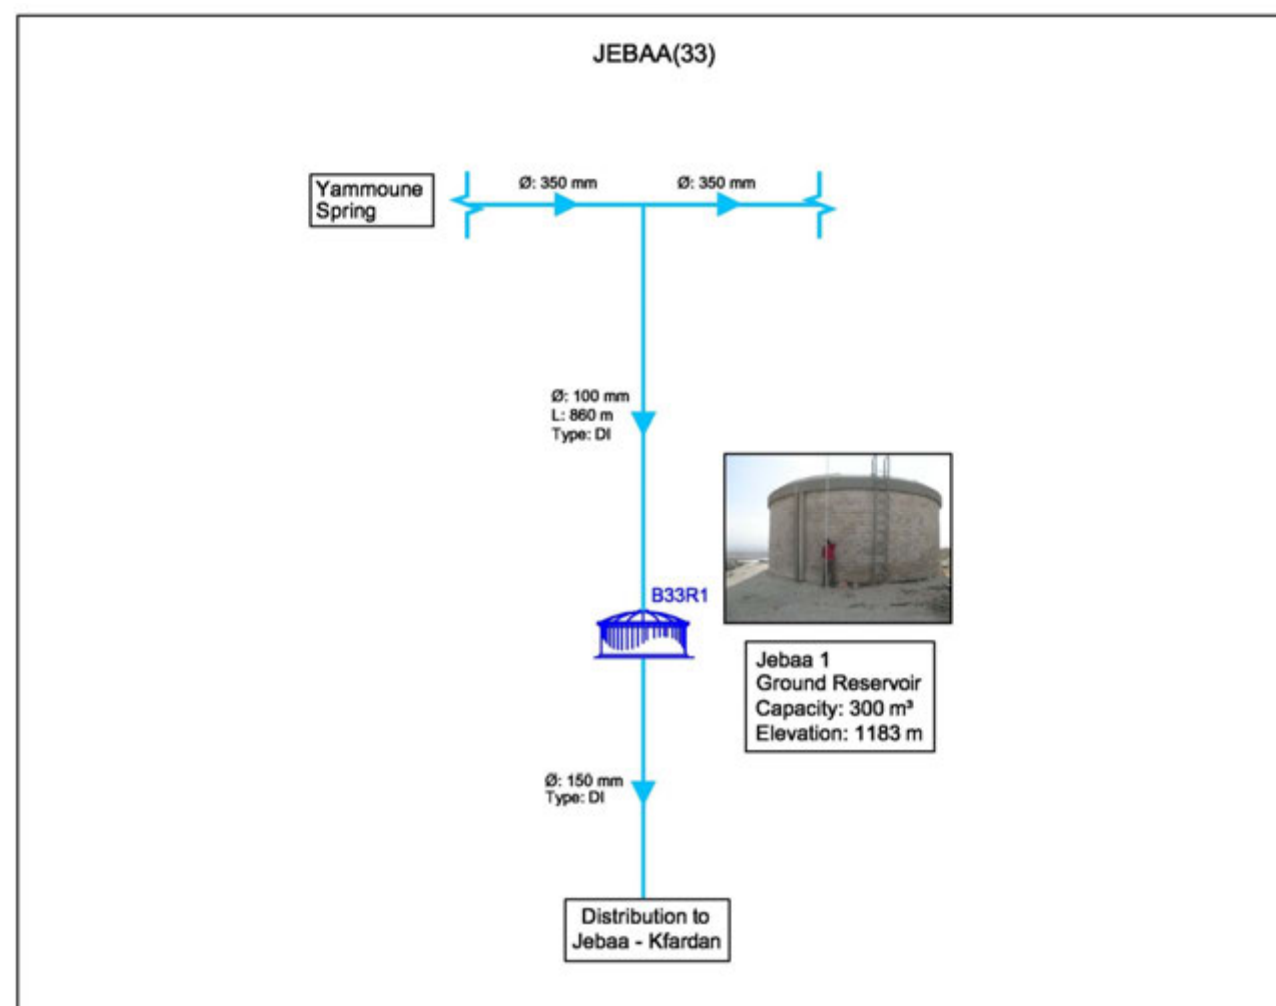
**Jebaa (33)**

The existing water network is in medium condition and it has a length of around 5.7 km. It covers a large area of the town.

Reservoir B33R1 (>10 years; 300 m³): Reservoir is in good condition.

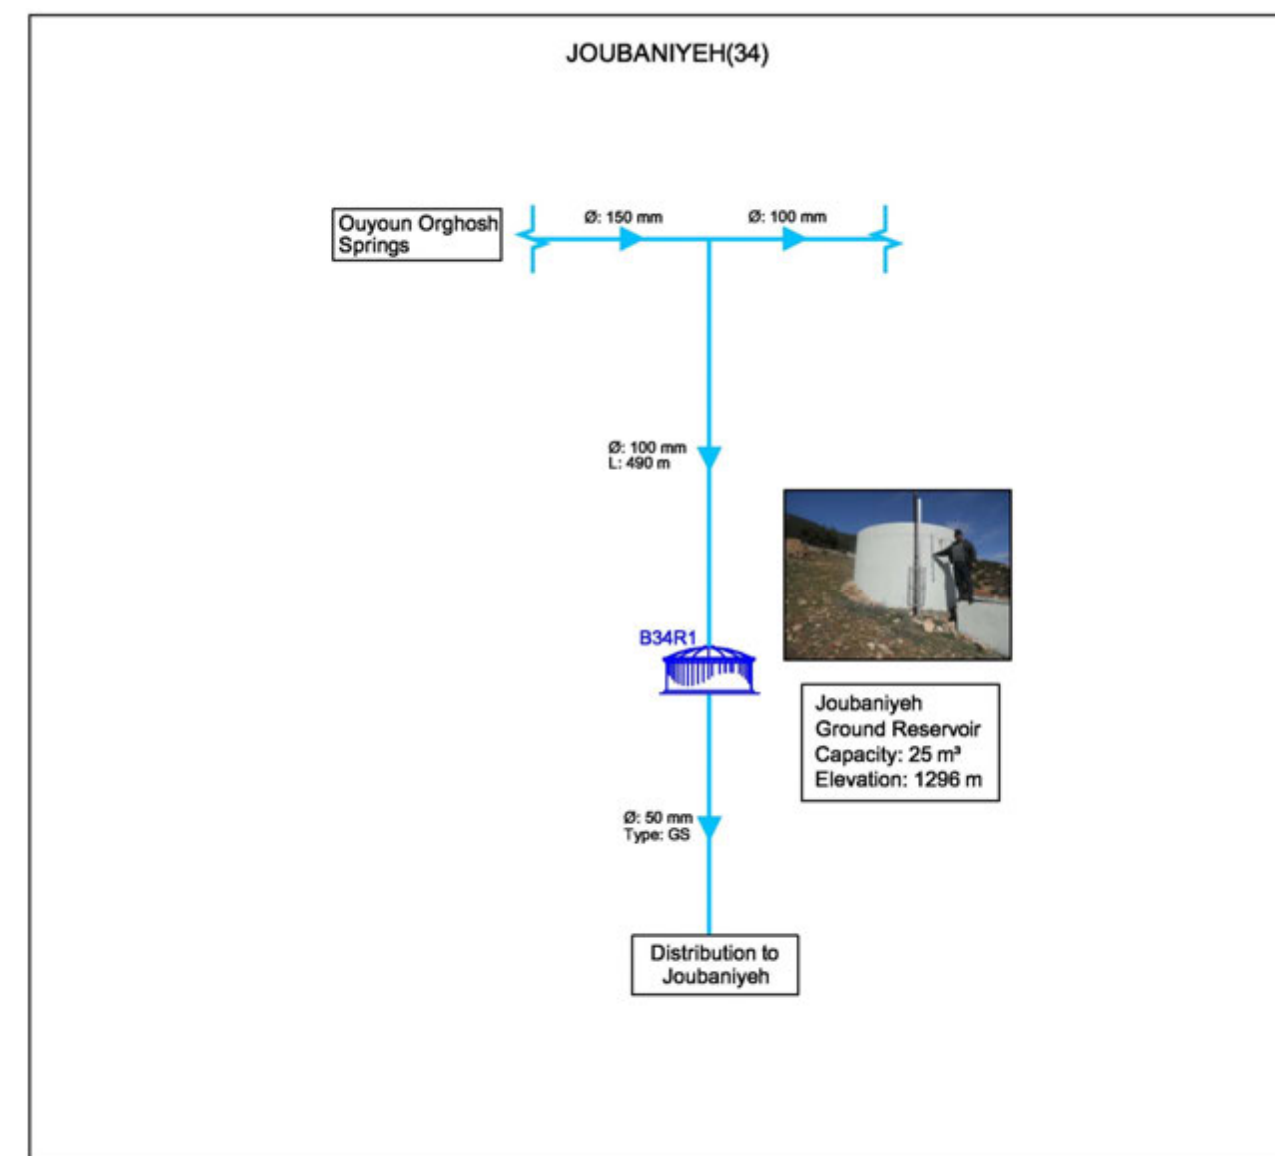
**Joubaniyeh (34)**

There is no available information concerning the water network of the town.

Reservoir B34R1 (>10 years; 25m³): Reservoir is in good condition.

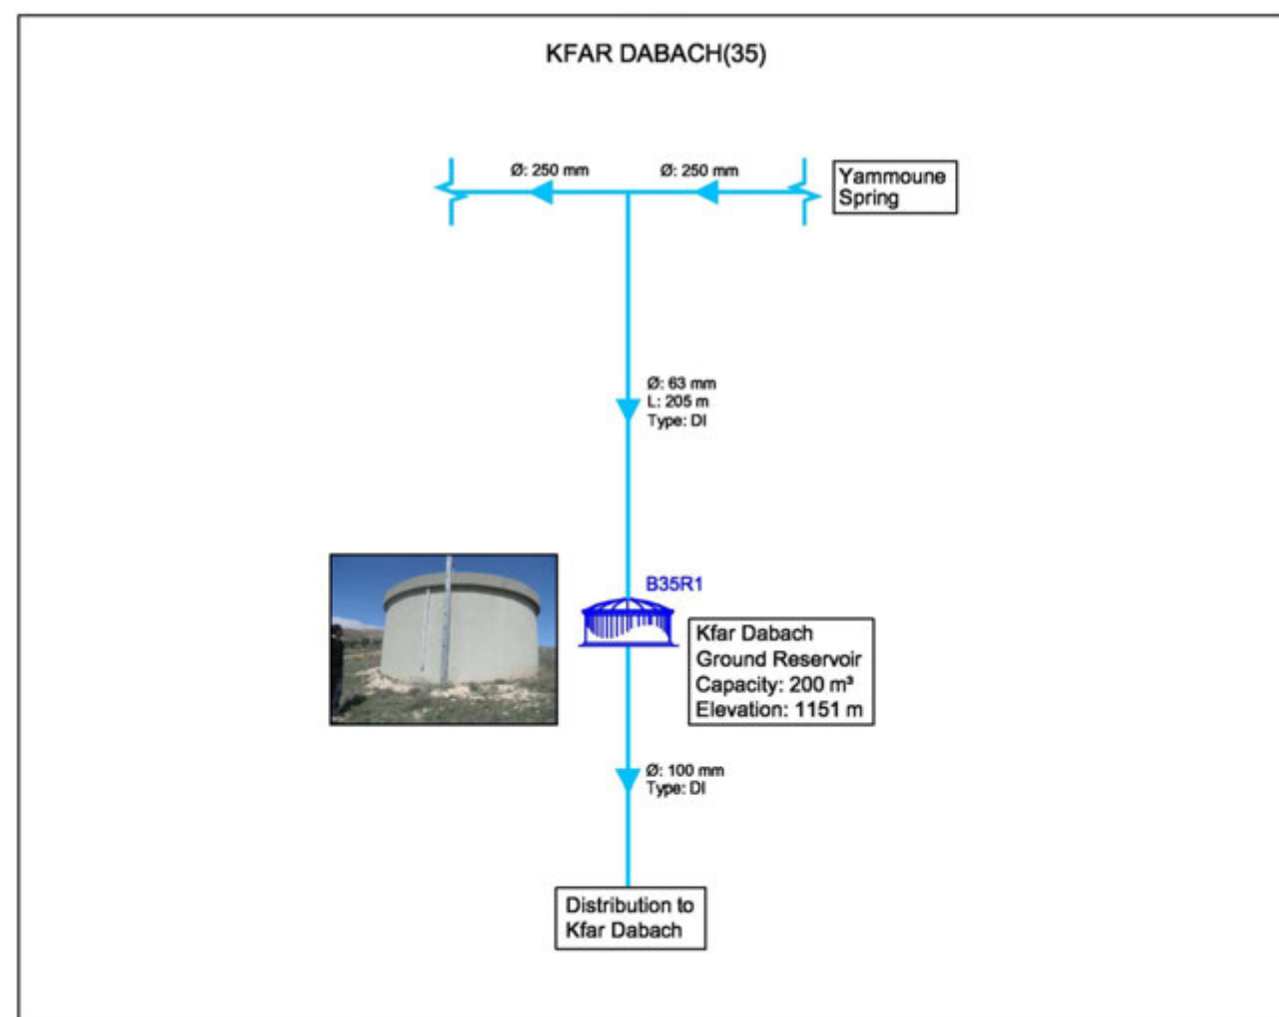
### Kfar Dabach (35)

The existing water network is in very good condition and it has a length of around 7.2 km. It covers a large area of the town.

Reservoir B35R1 (10 years old; 200 m³): Reservoir is new and it is in good condition.
