# WATER SUPPLY AND WASTEWATER SYSTEMS MASTER PLAN FOR THE BEKAA WATER ESTABLISHMENT

## WATER ASSESSMENT REPORT

January 2014  
Updated May 2015

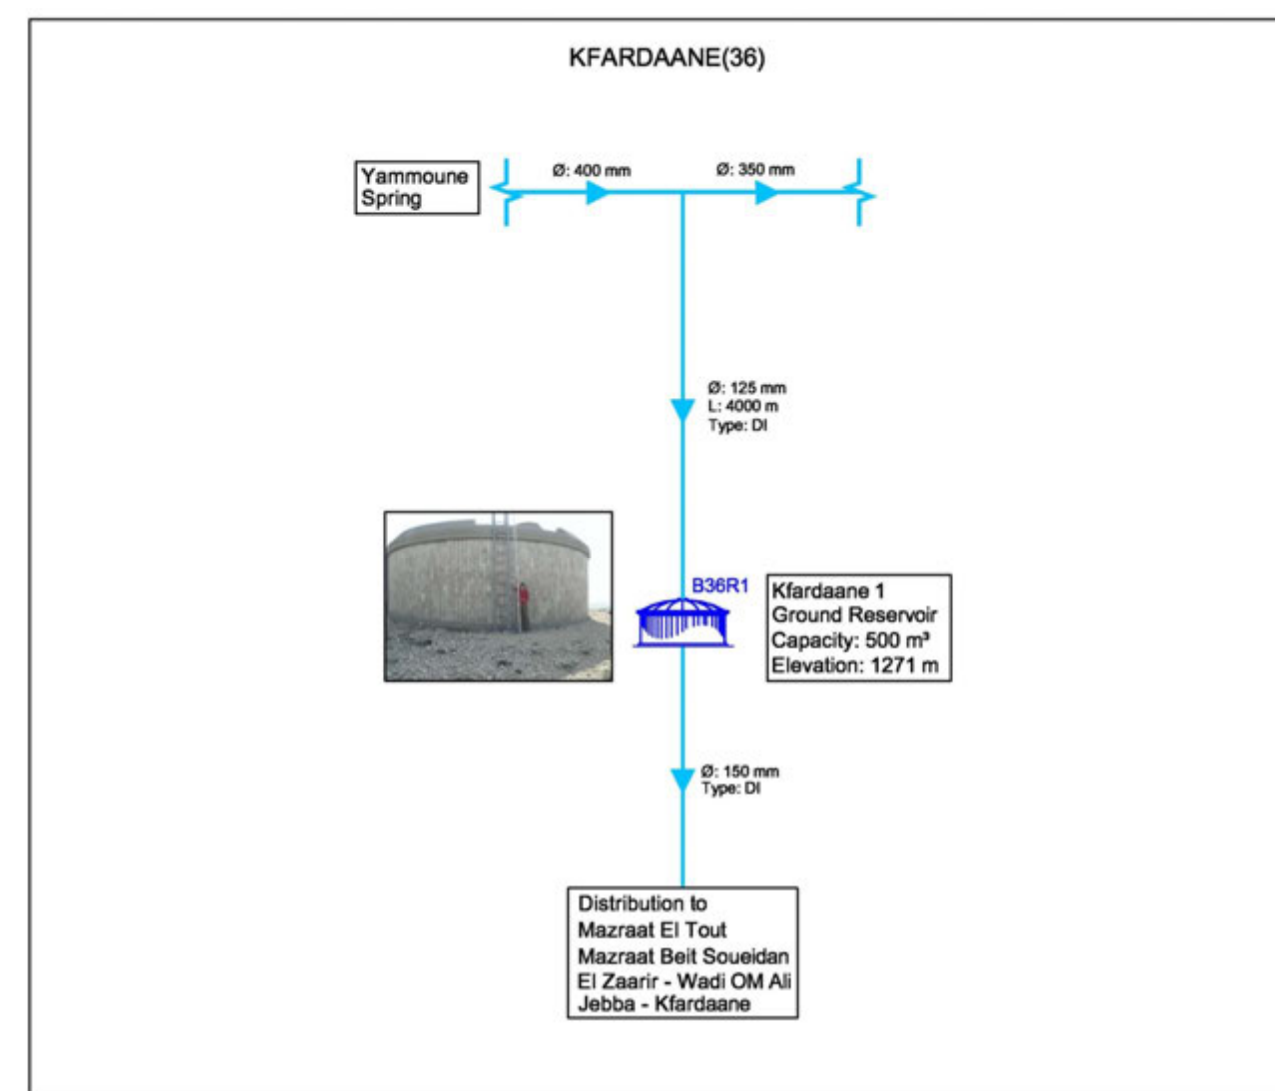
### Kfardaane (36)

The existing water network is in very good condition and it has a length of around 16.7 km. It covers a part of the town.

Reservoir B36R1 (>10 years; 500 m³): Reservoir is in good condition.

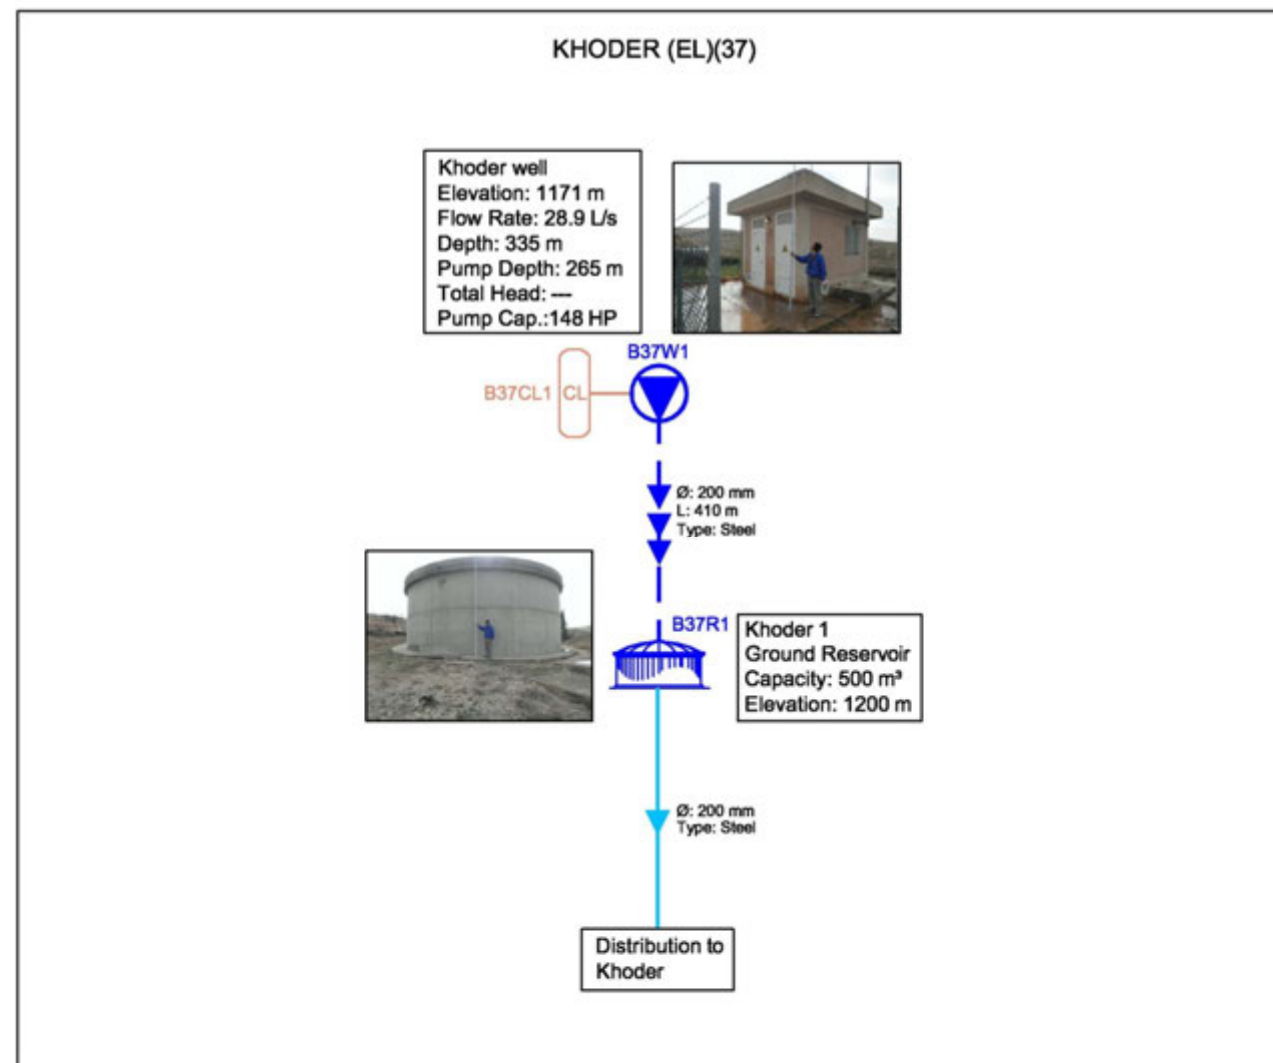
**Khoder (EI) (37)**

The existing water network is in good condition and it has a length of around 10.5 km. It covers a large area of the town.

Well B37W1 (>15 years): Well is in good condition but it suffers from a shortage of electric power.

Reservoir B37R1 (500 m³): Reservoir is in good condition.

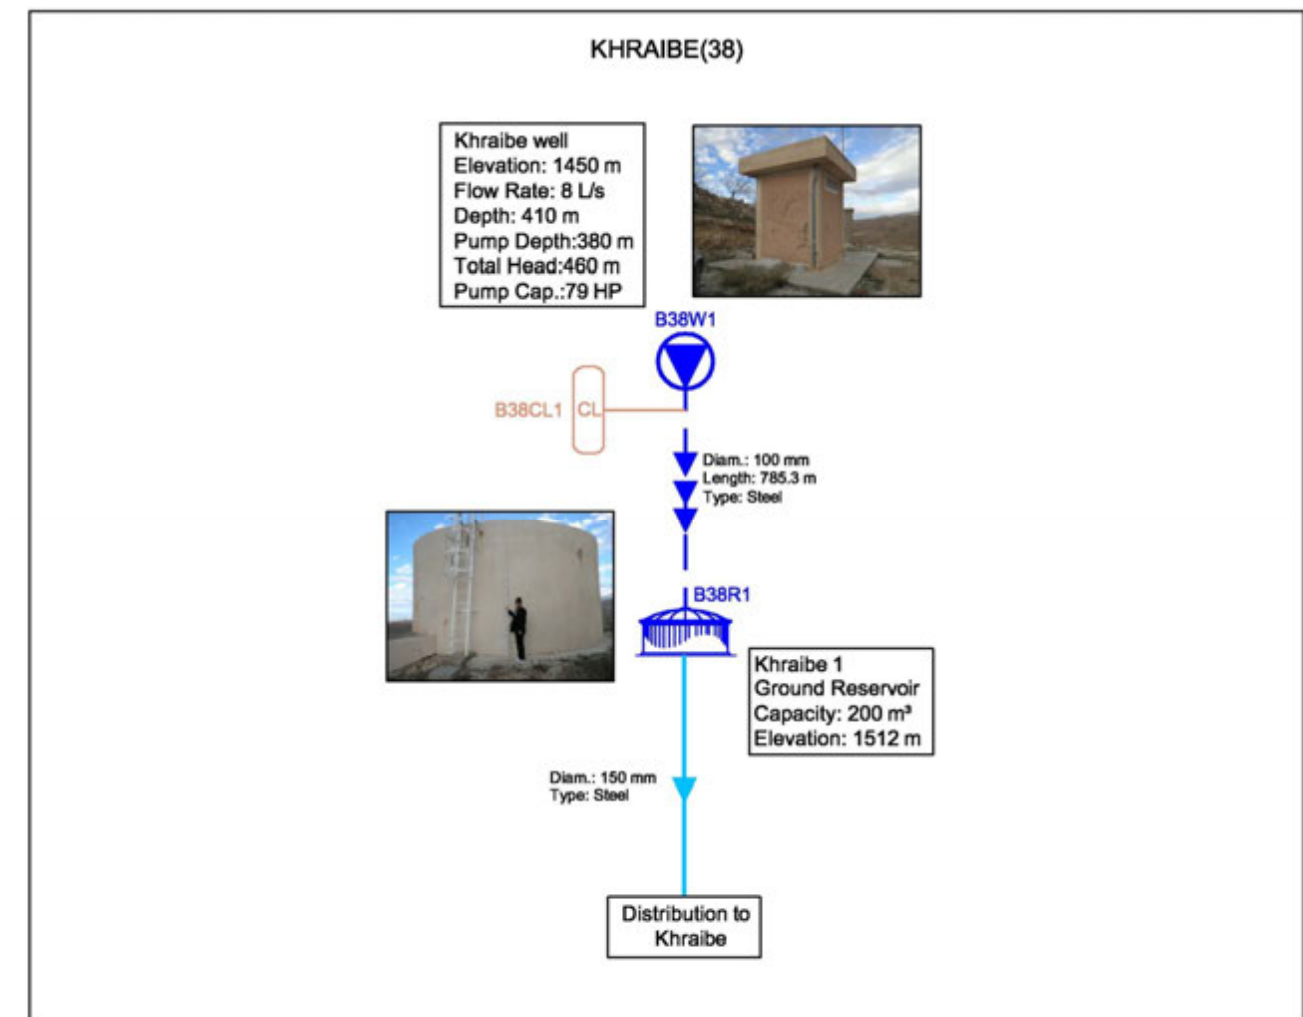
**Khraibe (38)**

The existing water network is in bad condition and it has a length of around 7.4 km. It covers a large area of the town.

Well B38W1 (>15 years): Well is in good condition but it suffers from a shortage of electric power. It has a chlorination unit.

Reservoir B38R1 (200 m³): Reservoir is in good condition.

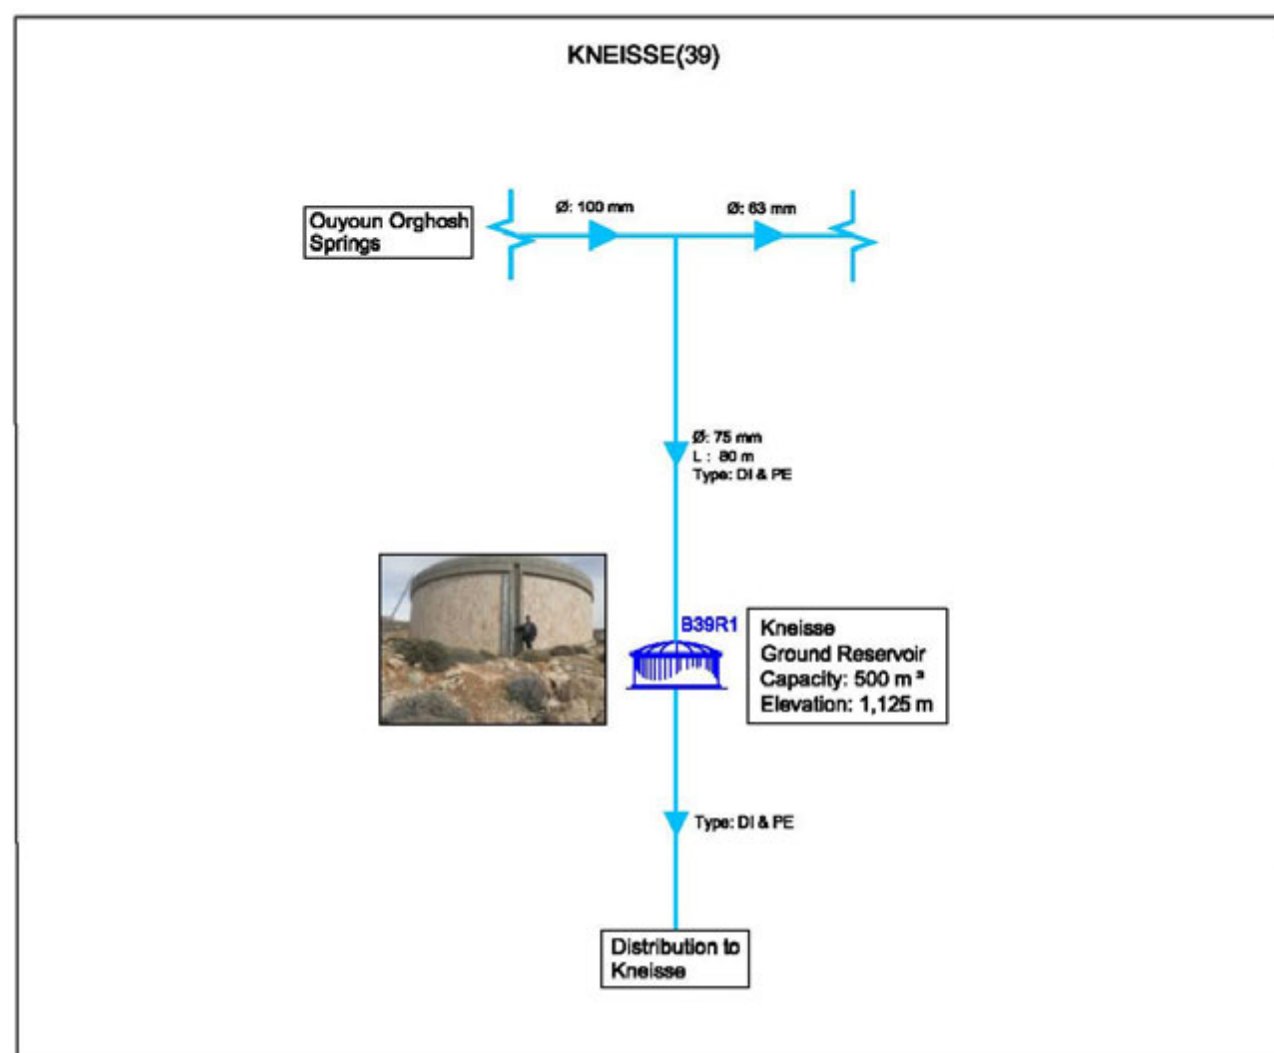
**Kneisse (39)**

The existing water network is in very good condition and it has a length of around 6.8 km. It covers a large area of the town.

Reservoir B39R1 (>10 years; 500 m<sup>3</sup>): Reservoir is in good condition.

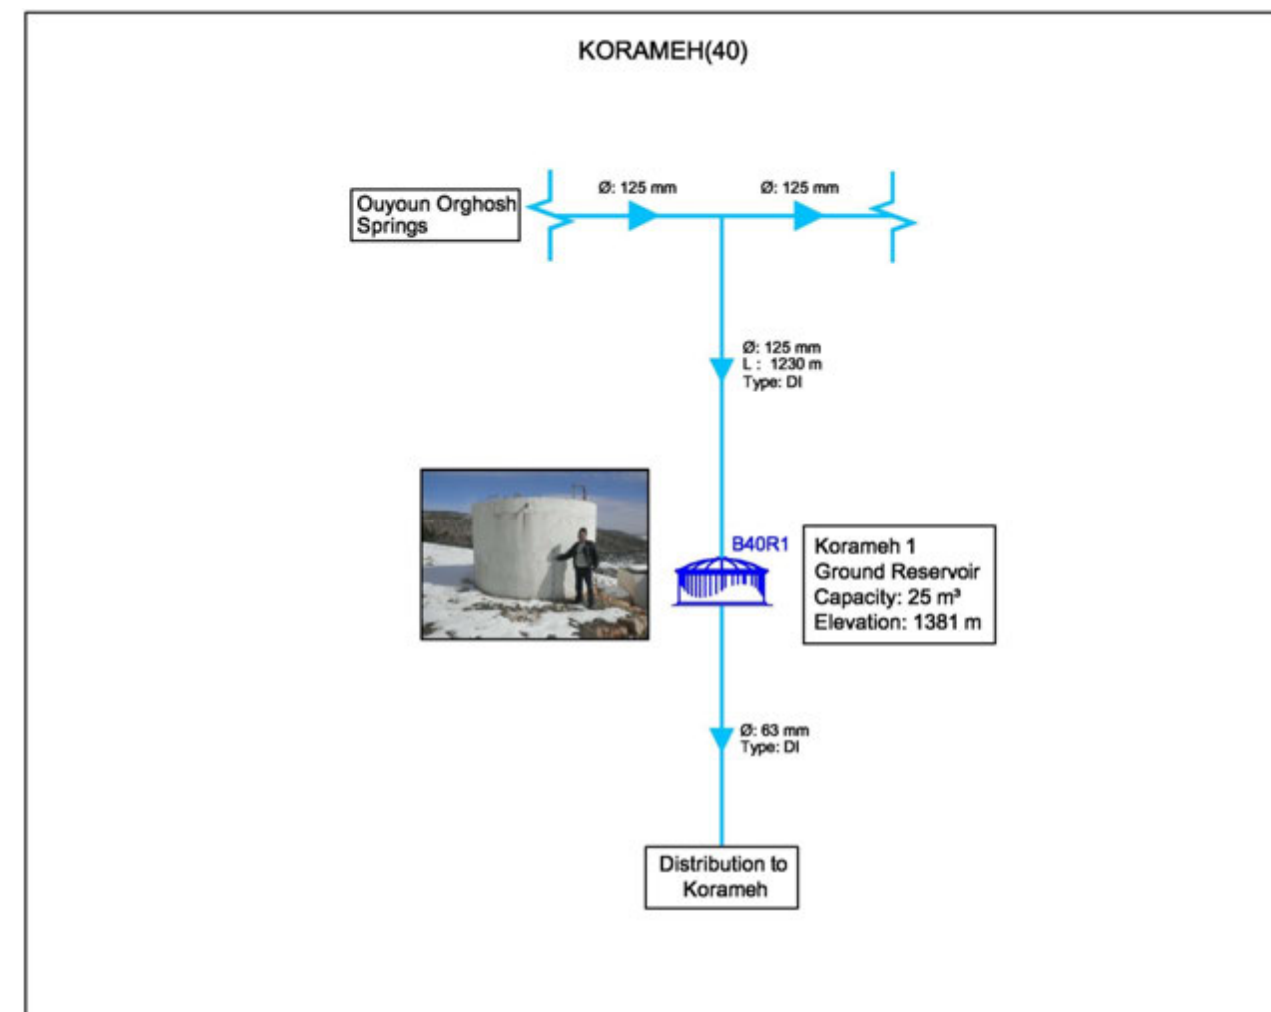
**Korameh (40)**

There is no available information concerning the water network of the town.

Reservoir B40R1 (25 m<sup>3</sup>): Reservoir is in an acceptable condition. Its pipes are rusted and subjected to leakage. It needs some minor maintenance.

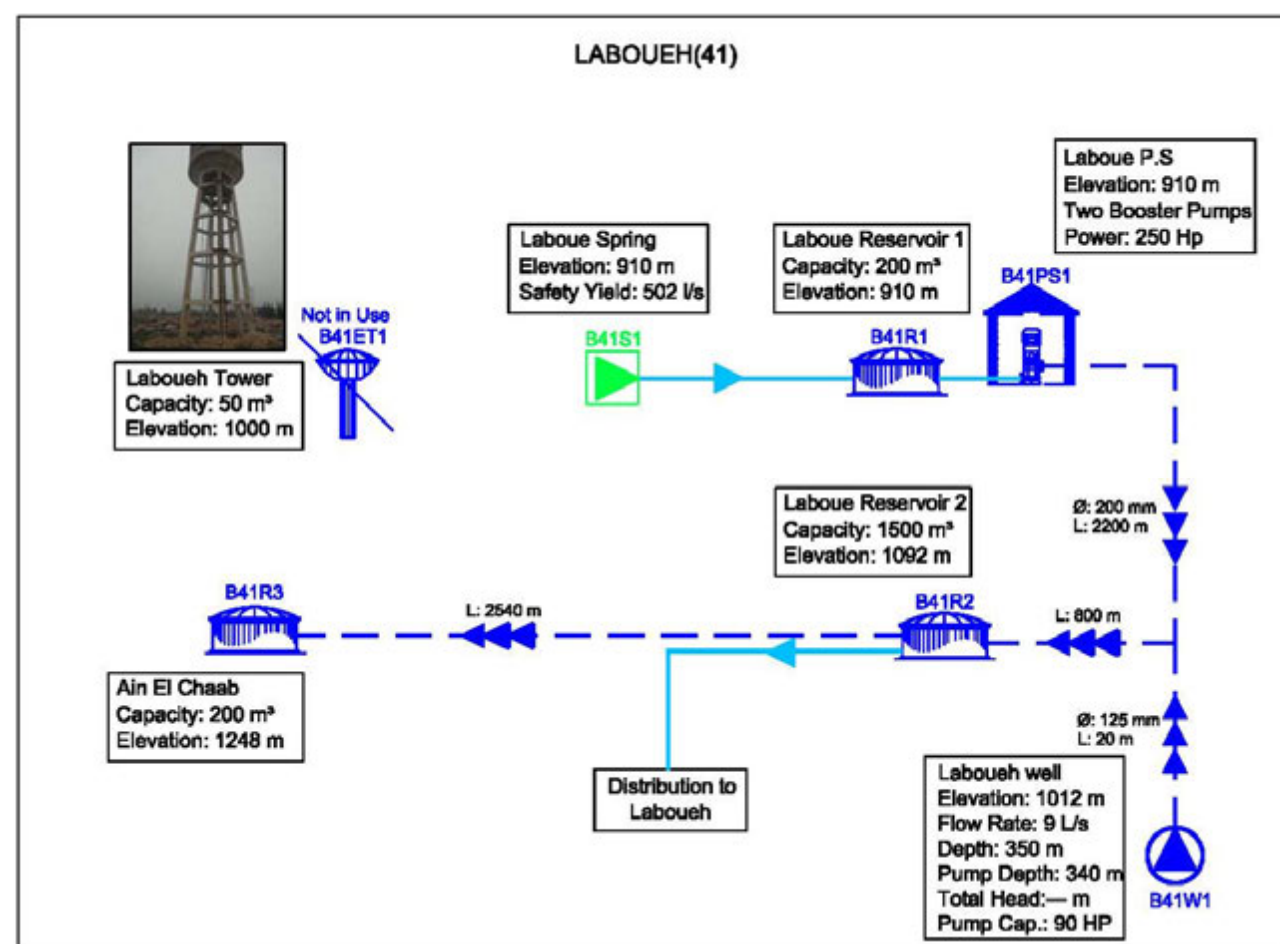
**Laboueh (41)**

The existing water network is in very good condition and it has a length of around 59 km. It covers a large area of the town.

Well B41W1 (<5 years): Well is new and it is in good condition.

Elevated tank B41ET1 (45 years old; 50 m³): Elevated tank is old but it is in an acceptable condition but it is not in use. This reservoir needs rehabilitation.

Reservoir B41R2 (< 2 years, 1500 m³), B41R3 (<2 years, 200 m³): Reservoirs are new and they are in a very good condition.

Pump station B41PS1: No available information.

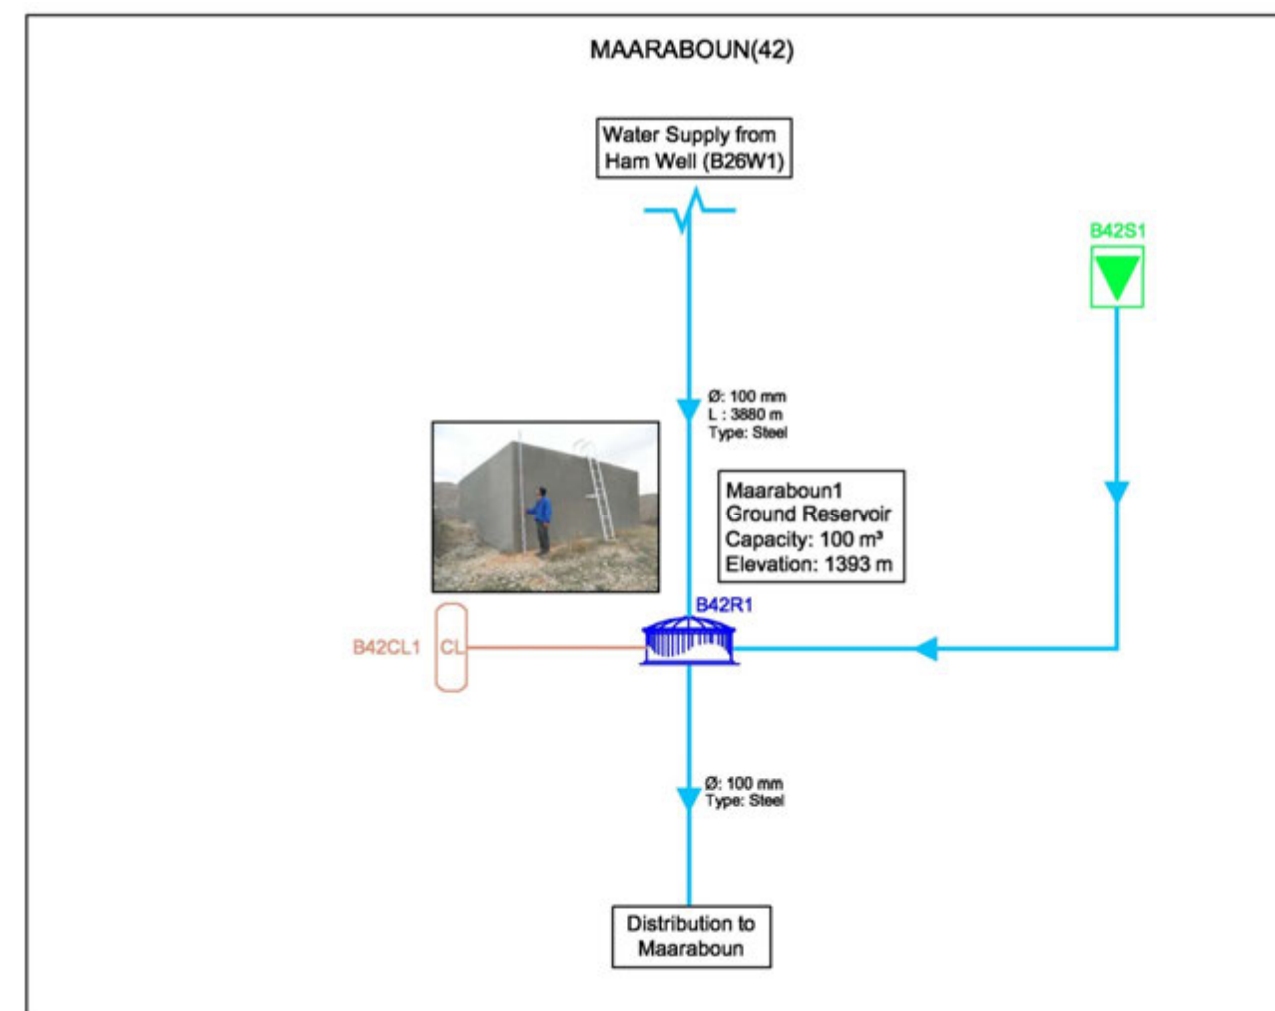
**Maaraboun (42)**

The existing water network is in bad condition and it has a length of around 4.6 km. It covers a large area of the town.

Reservoir B42R1 (100 m³): Reservoir is in good condition.

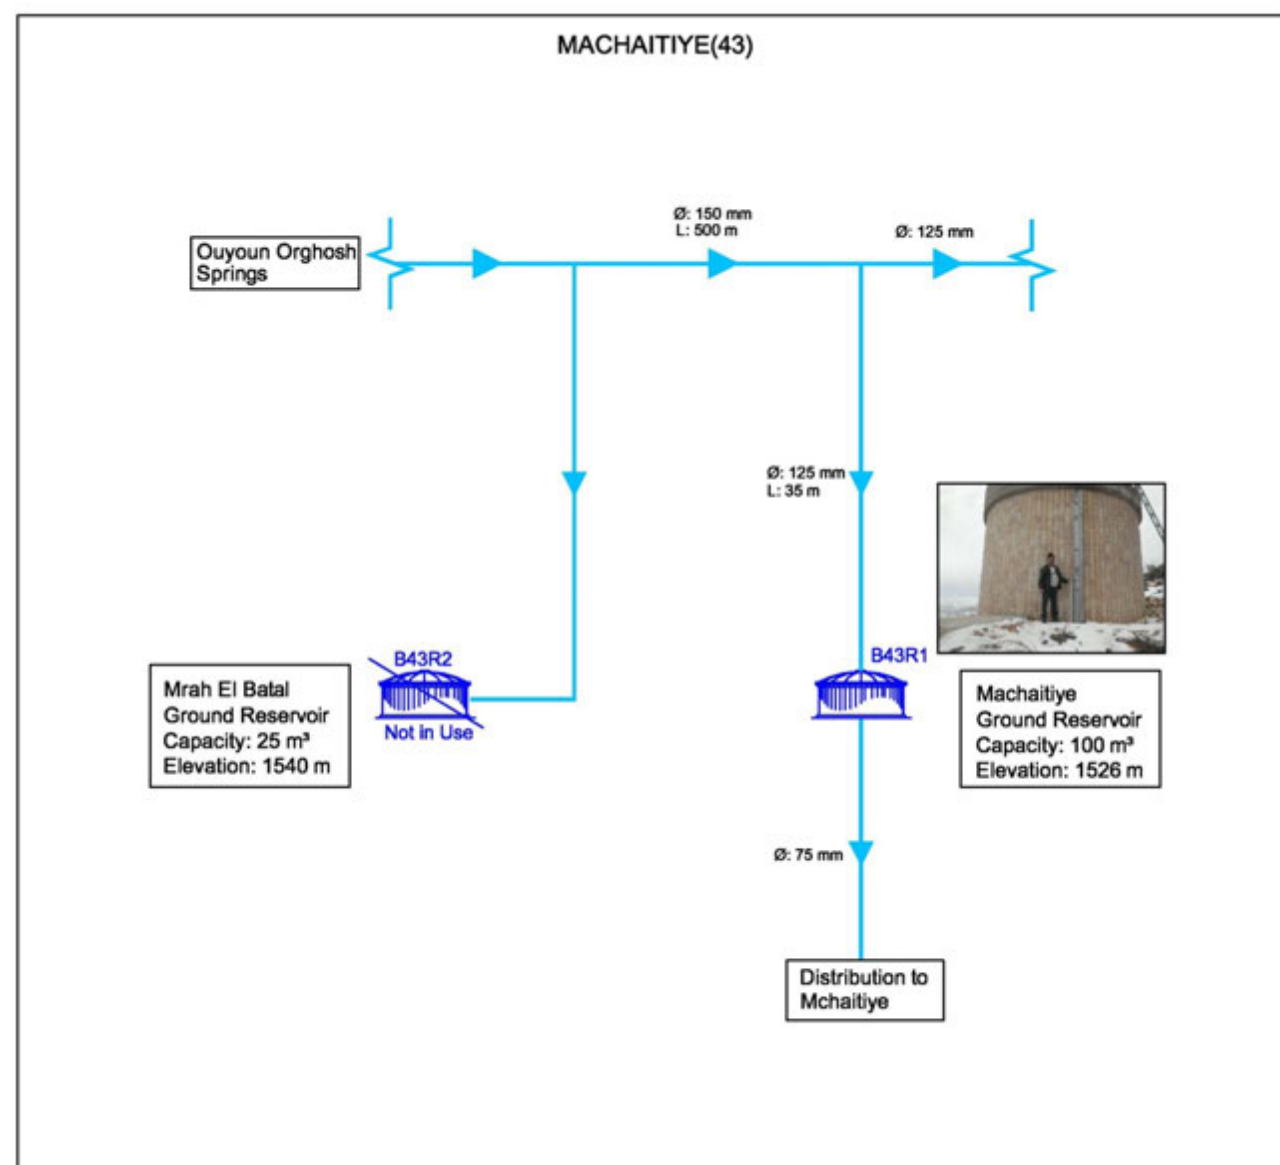
**Machaitiye (43)**

The existing water network is in very good condition and it has a length of around 6.2 km. It covers a large area of the town.

Reservoir B43R1 (100 m³): Reservoir is in good condition.

Reservoir B43R2 (25 m³): Reservoir is not in use.

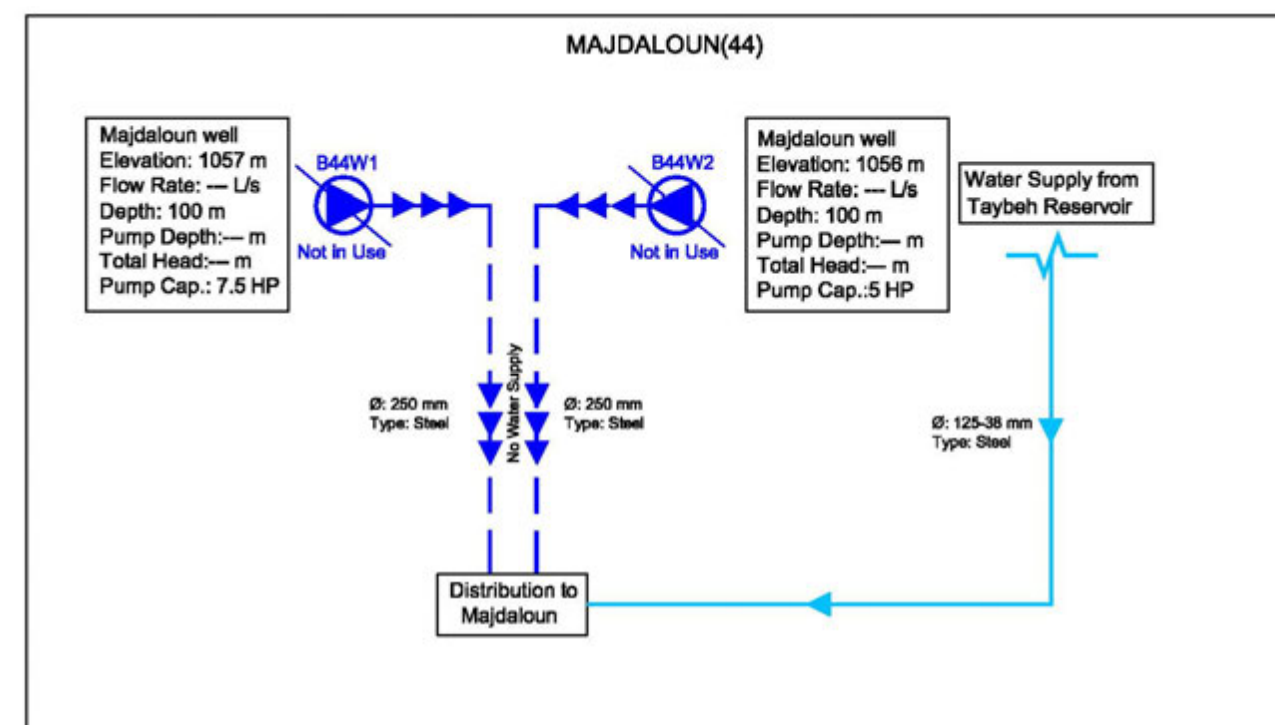
**Majdaloun (44)**

The existing water network is in good condition and it has a length of around 4.3 km. It covers a large area of the town.

Well B44W1 (15 years old): Well is not in use.

Well B44W2 (15 years old): Well is not in use.

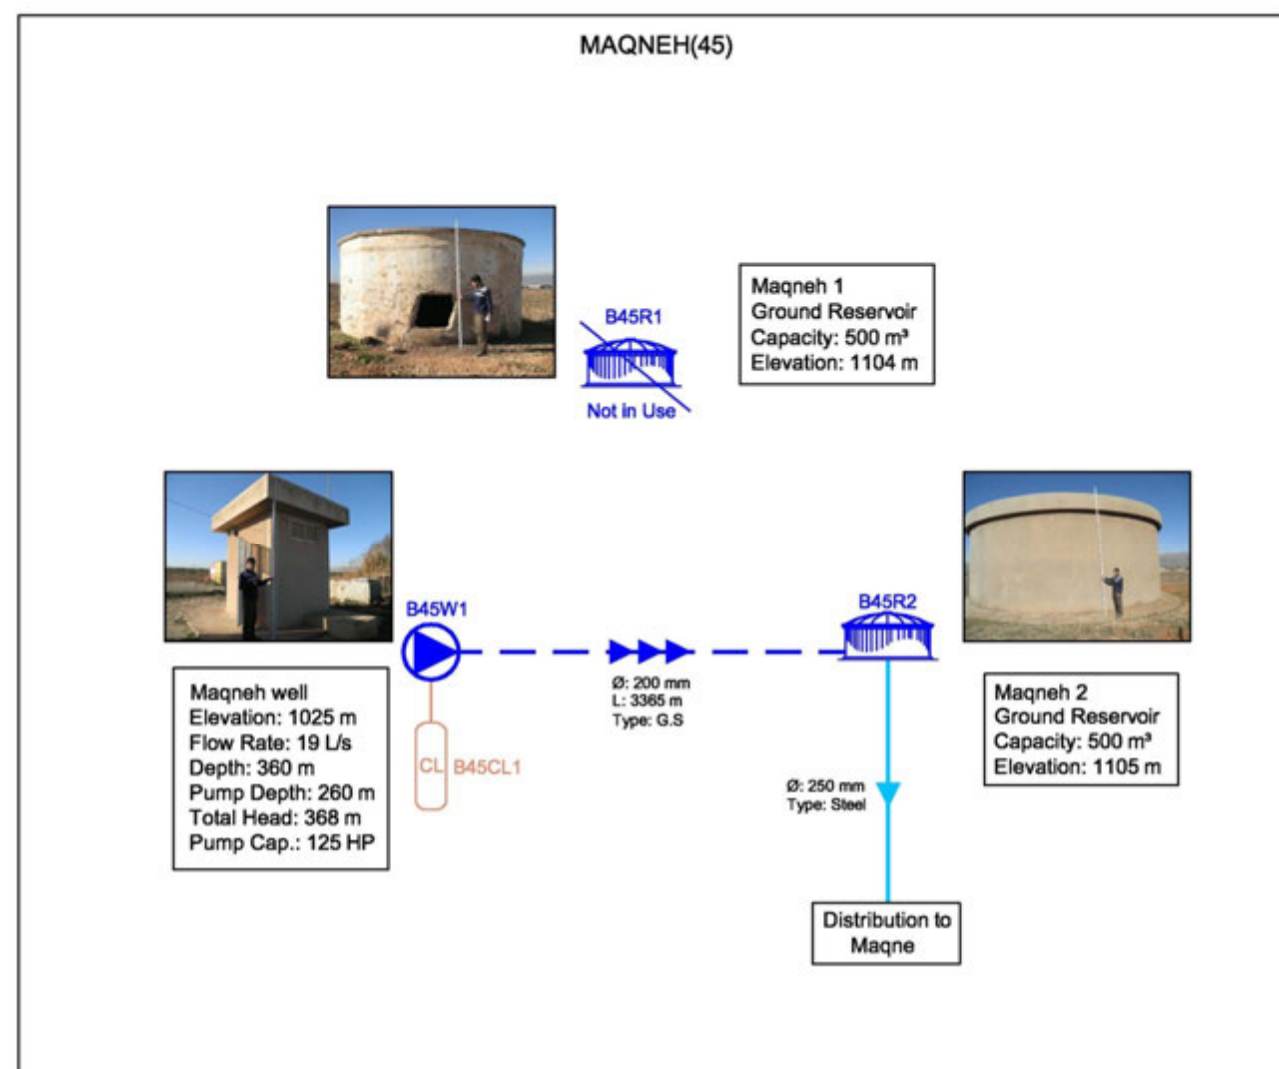
**Maqneh (45)**

The existing water network is 13 years old and it is in good condition.

Well B45W1 (>10 years): Well is in good condition.

Reservoir B45R1 (500 m<sup>3</sup>): Reservoir is in bad condition and it is not in use. This reservoir is structurally damaged. It needs rehabilitation or reconstruction. The pipes and valves are rusted and they need maintenance.

Reservoir B45R2 (>10 years; 500 m<sup>3</sup>): Reservoir is in good condition.

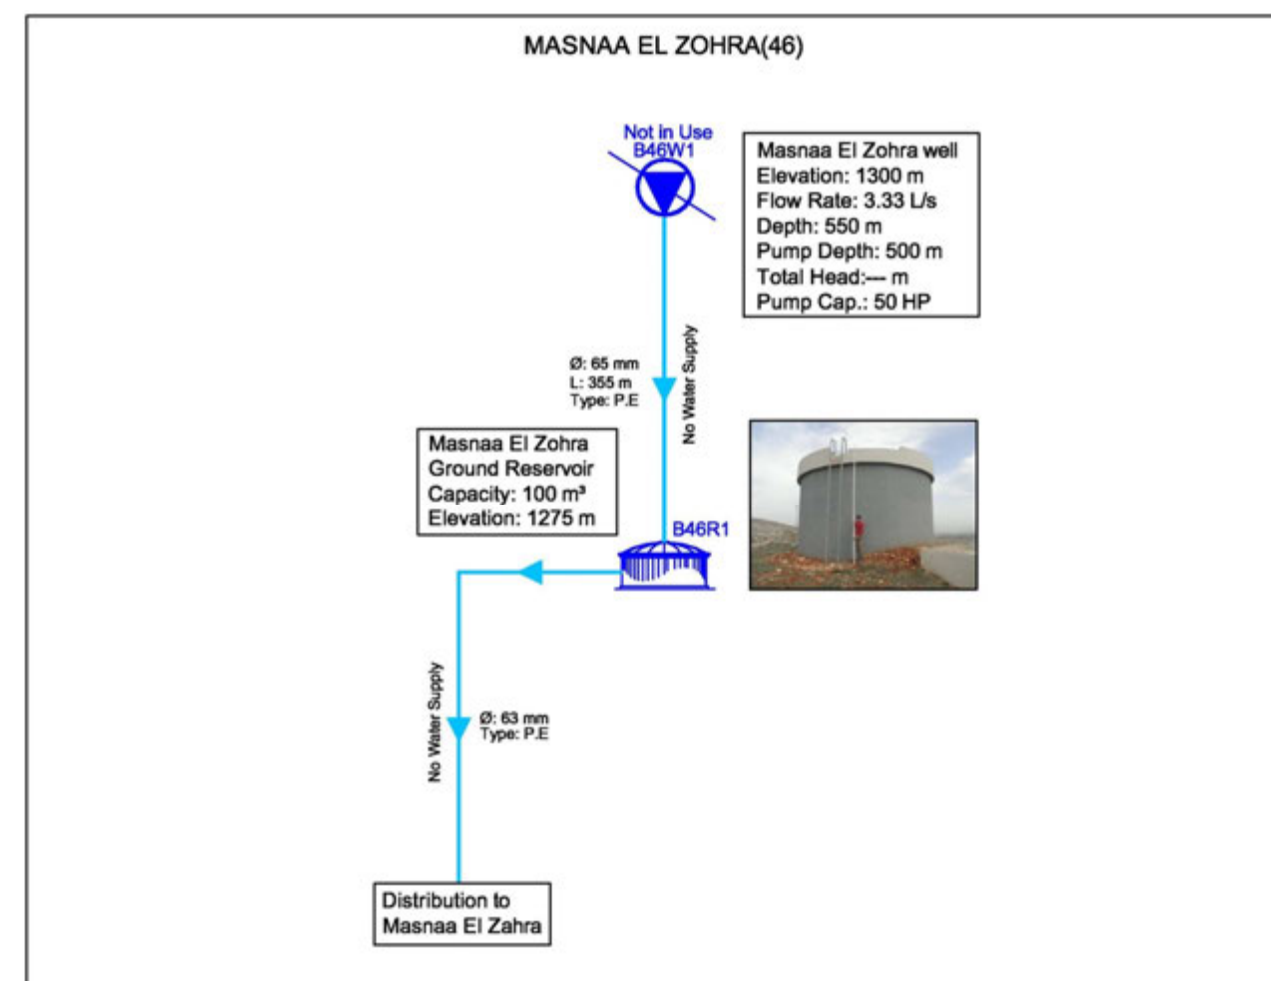
**Masnaa El Zohra (46)**

There is no available information concerning the water network of the town.

Well B46W1: Well is not in use.

Reservoir B46R1 (>10 years; 100 m<sup>3</sup>): Reservoir is in good condition.

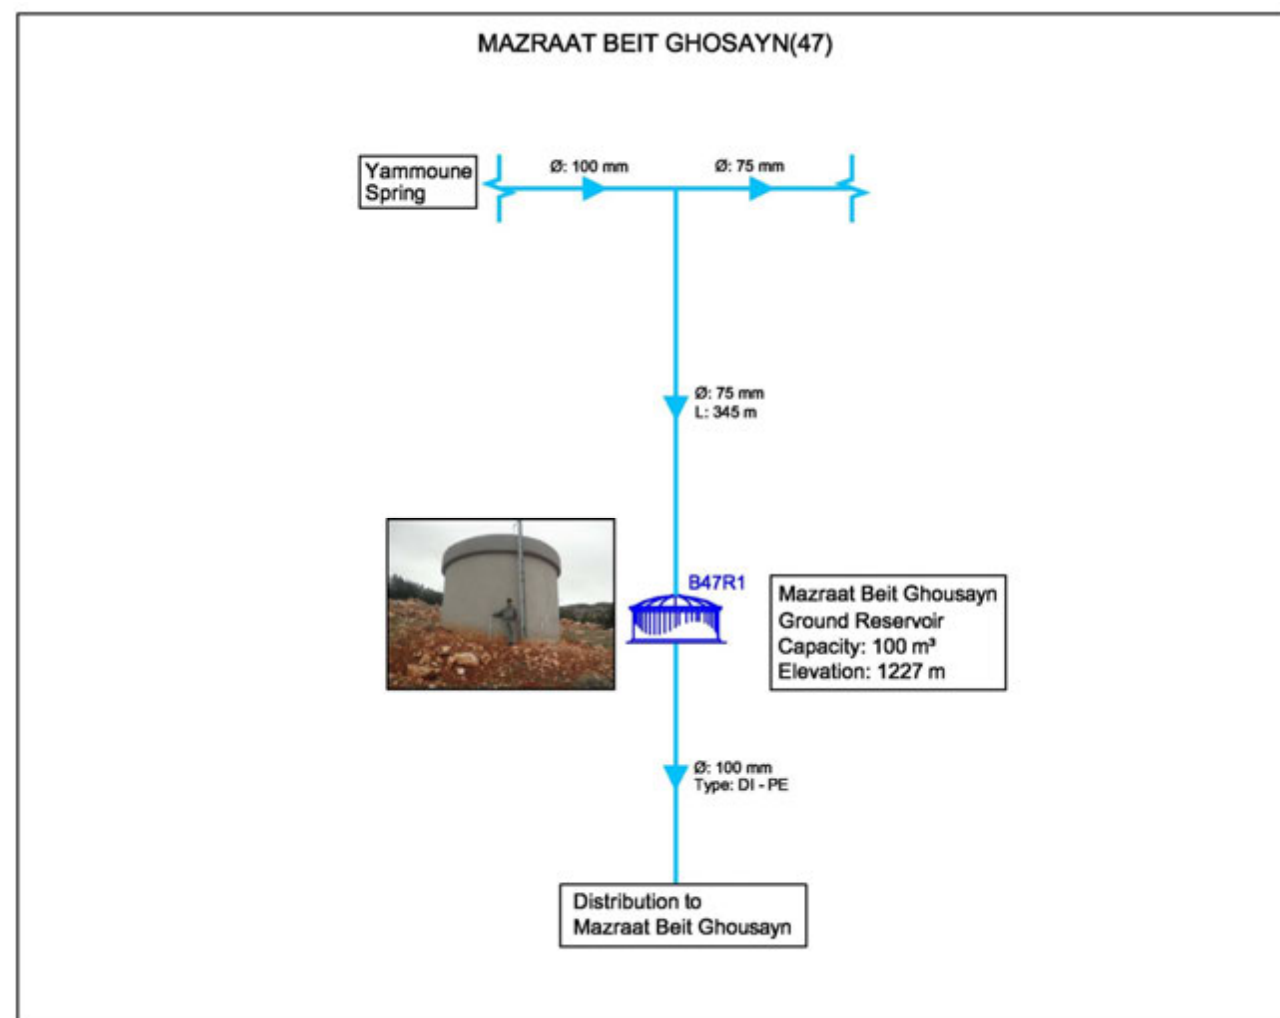
### Mazraat Beit Ghosayn (47)

There is no available information concerning the water network of the town.

Reservoir B47R1 (>10 years; 100 m³): Reservoir is in good condition.

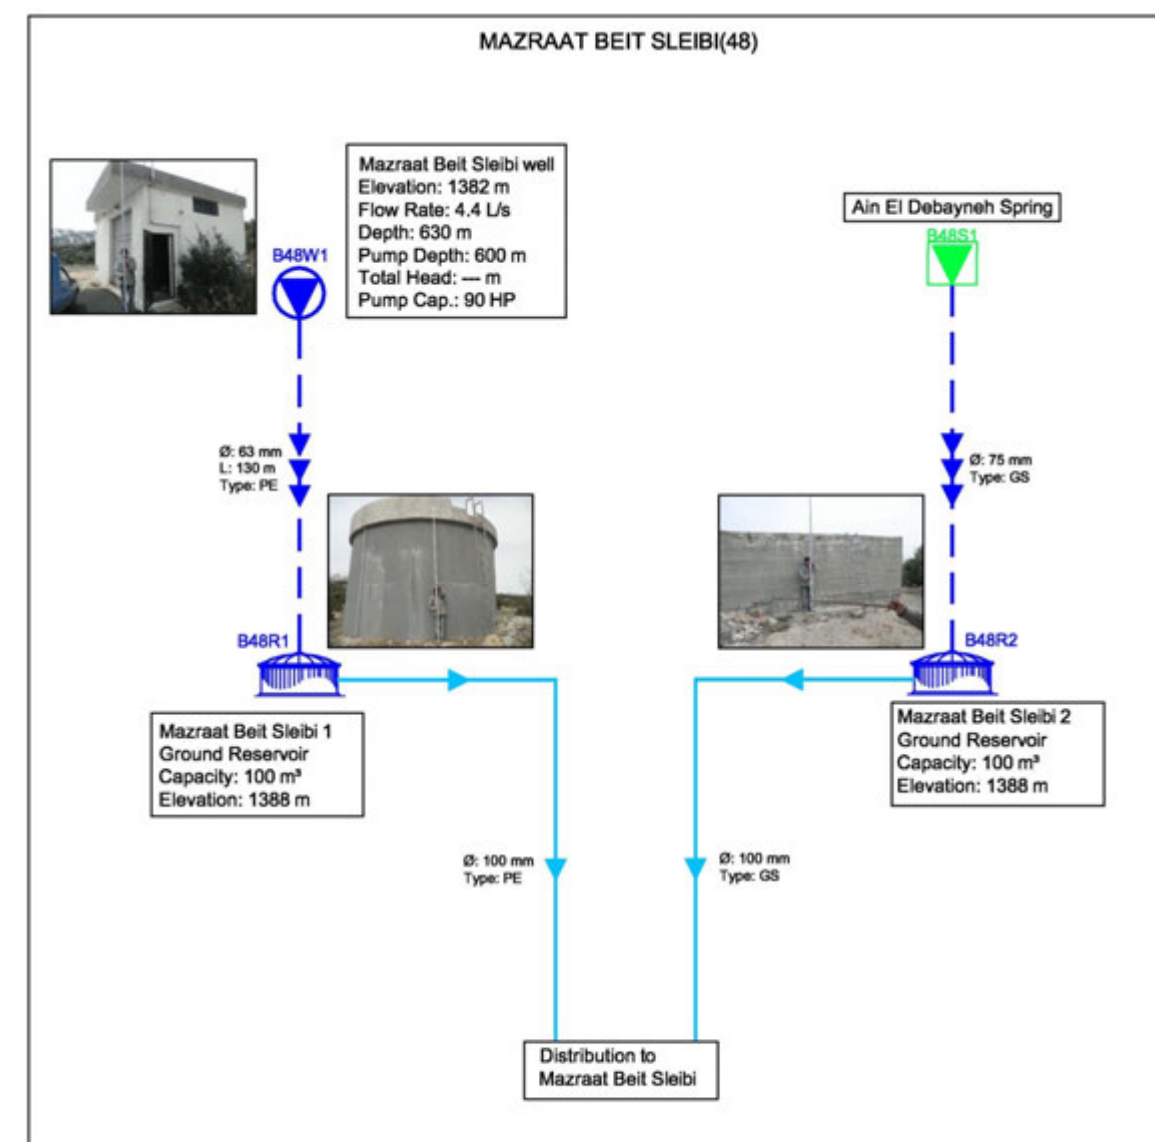
### Mazraat Beit Sleibi (48)

The existing water network is in very good condition and it has a length of around 9.3 km. It covers a large area of the town.

Well B48W1 (20 years old): Well is in good condition and directly supplies the water distribution network. It has a power generator.

Reservoir B48R1 (<10 years; 100 m³): Reservoir is in good condition but it is not in use.

Reservoir B48R2 (100 m³): Reservoir is in an acceptable condition. It is subject to leakage and the valve chamber is damaged and filled with vegetation and water.

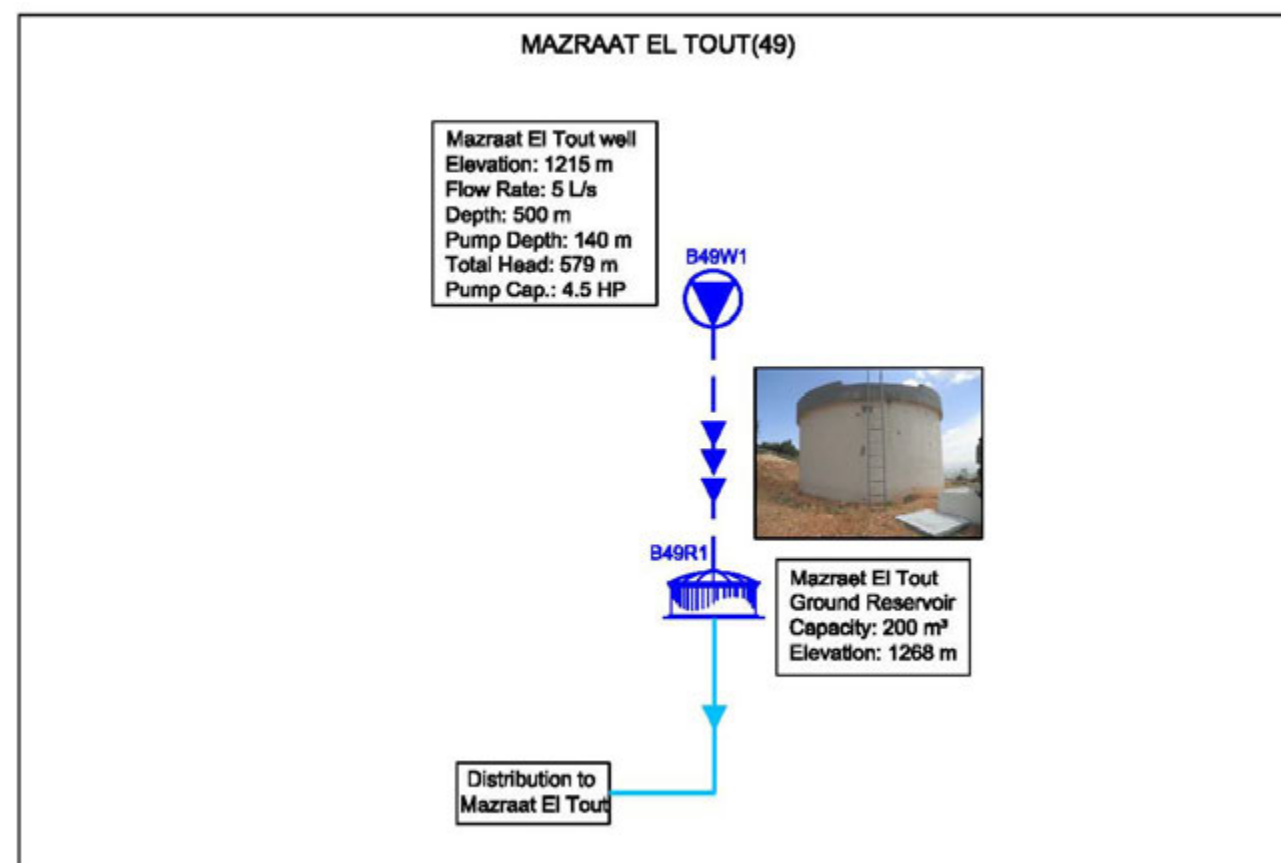
### Mazraat El Tout (49)

There is no available information concerning the water network of the town.

Well B49W1 (5 years old): It is a newly drilled well. This well suffers from a shortage of electric power.

Reservoir B49R1 (5 years old; 200 m³): Reservoir is in good condition.

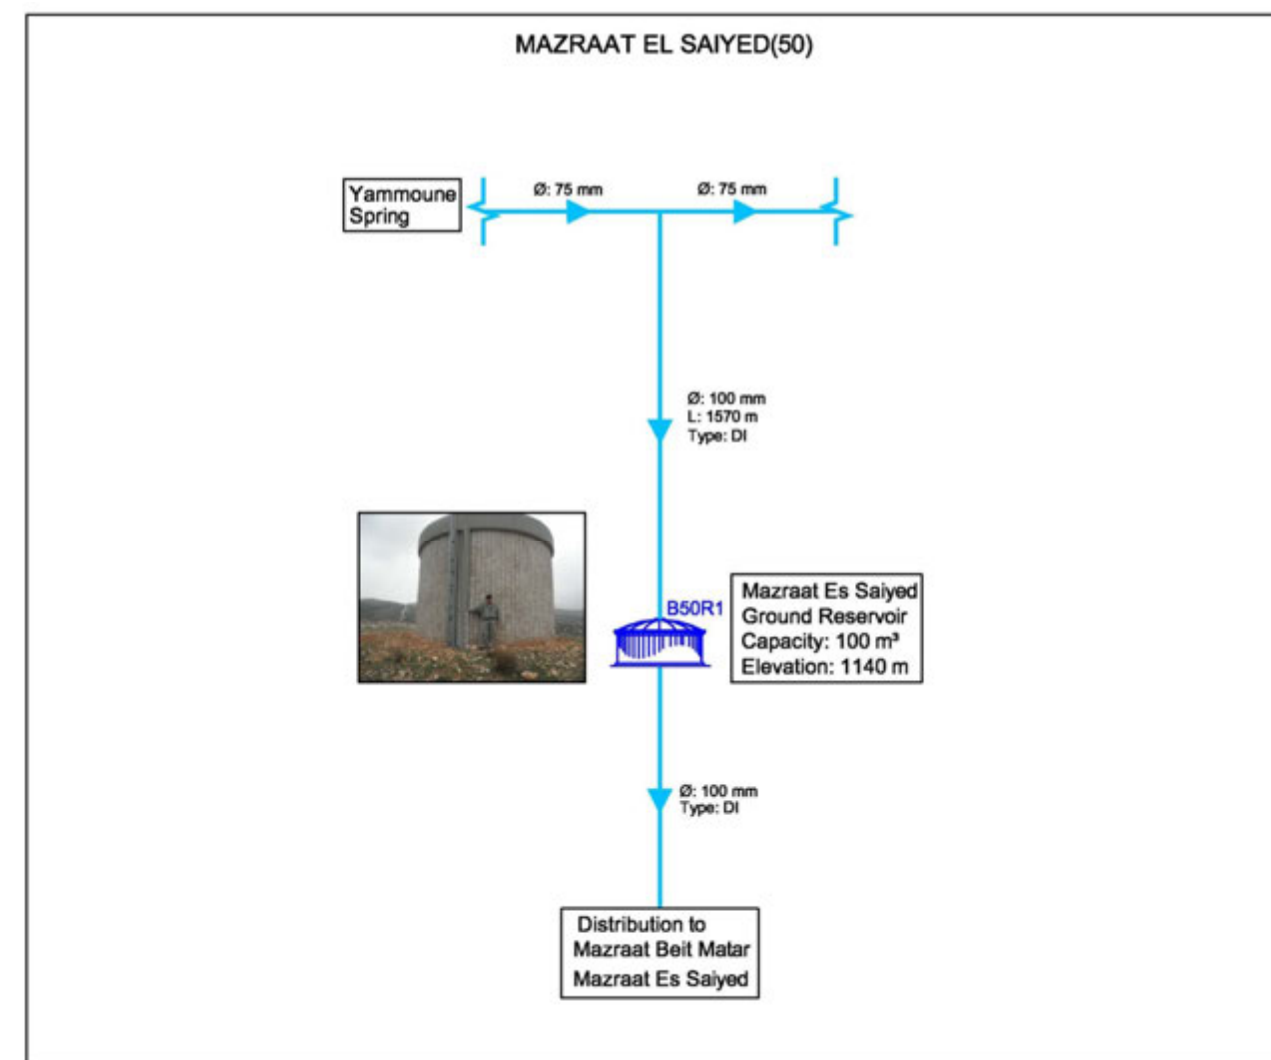
### Mazraat El Saiyed (50)

The existing water network is in very good condition and it has a length of around 10 km. It covers a large area of the town.

Reservoir B50R1 (>10 years; 100 m³): Reservoir is in good condition.

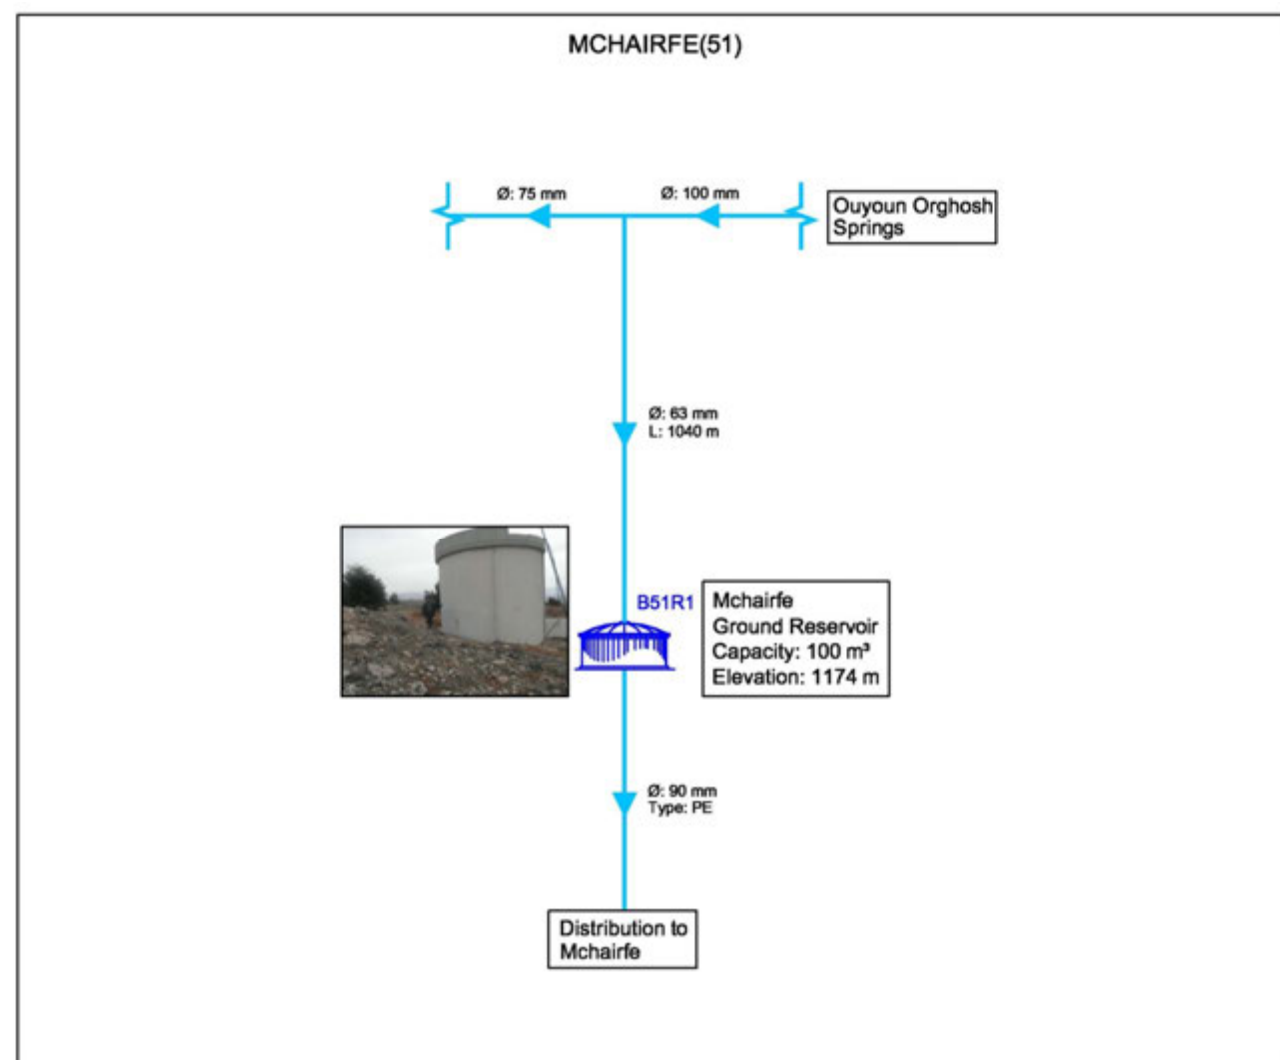
**Mchairfe (51)**

There is no available information concerning the water network of the town.

Reservoir B51R1 (>10 years; 100 m³): Reservoir is in good condition.
