# WATER SUPPLY AND WASTEWATER SYSTEMS MASTER PLAN FOR THE BEKAA WATER ESTABLISHMENT

## WATER ASSESSMENT REPORT

January 2014  
Updated May 2015

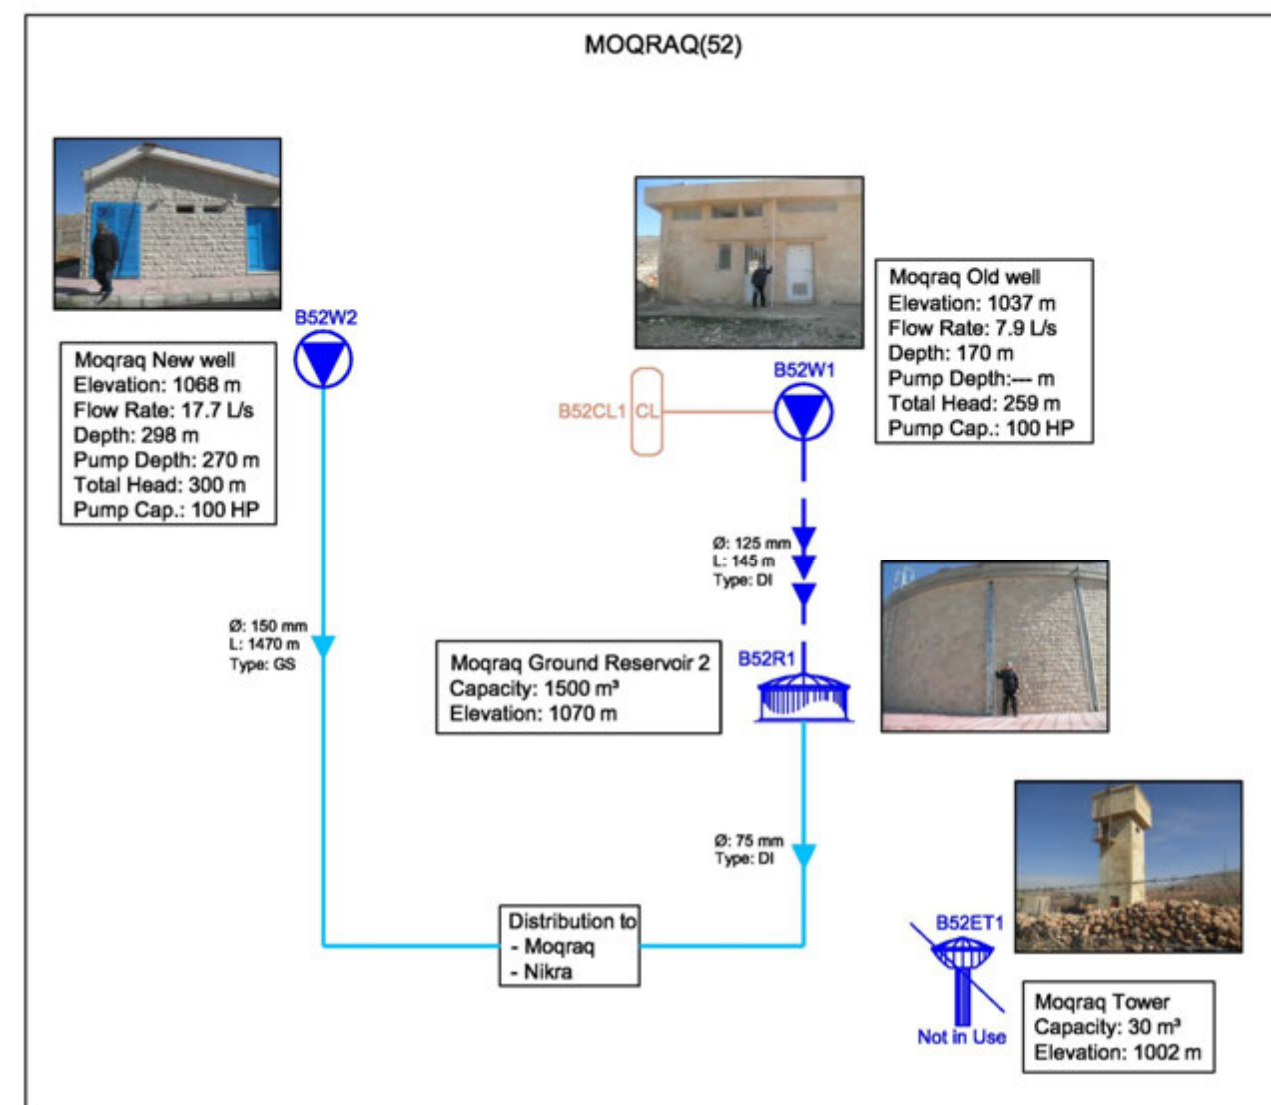
**Moqraq (52)**

The existing water network is in very good condition and it has a length of around 31.3 km. It covers a large area of the town.

Well B52W1 (35 years old): Well is old and it is in bad condition. Its building needs rehabilitation and its electric power needs to be changed.

Well B52W2 (5 years old): Well is new and it is in good condition but it suffers from a shortage of electric power. It is equipped with a chlorination room but it is not functioning. This well has a power generator.

Reservoir B52R1 (5 years old; 1500 m³): Reservoir is in good condition.

Elevated tank B52ET1 (45 years old; 30 m³): Elevated tank is very old and it is in bad condition. This elevated tank is not in use.

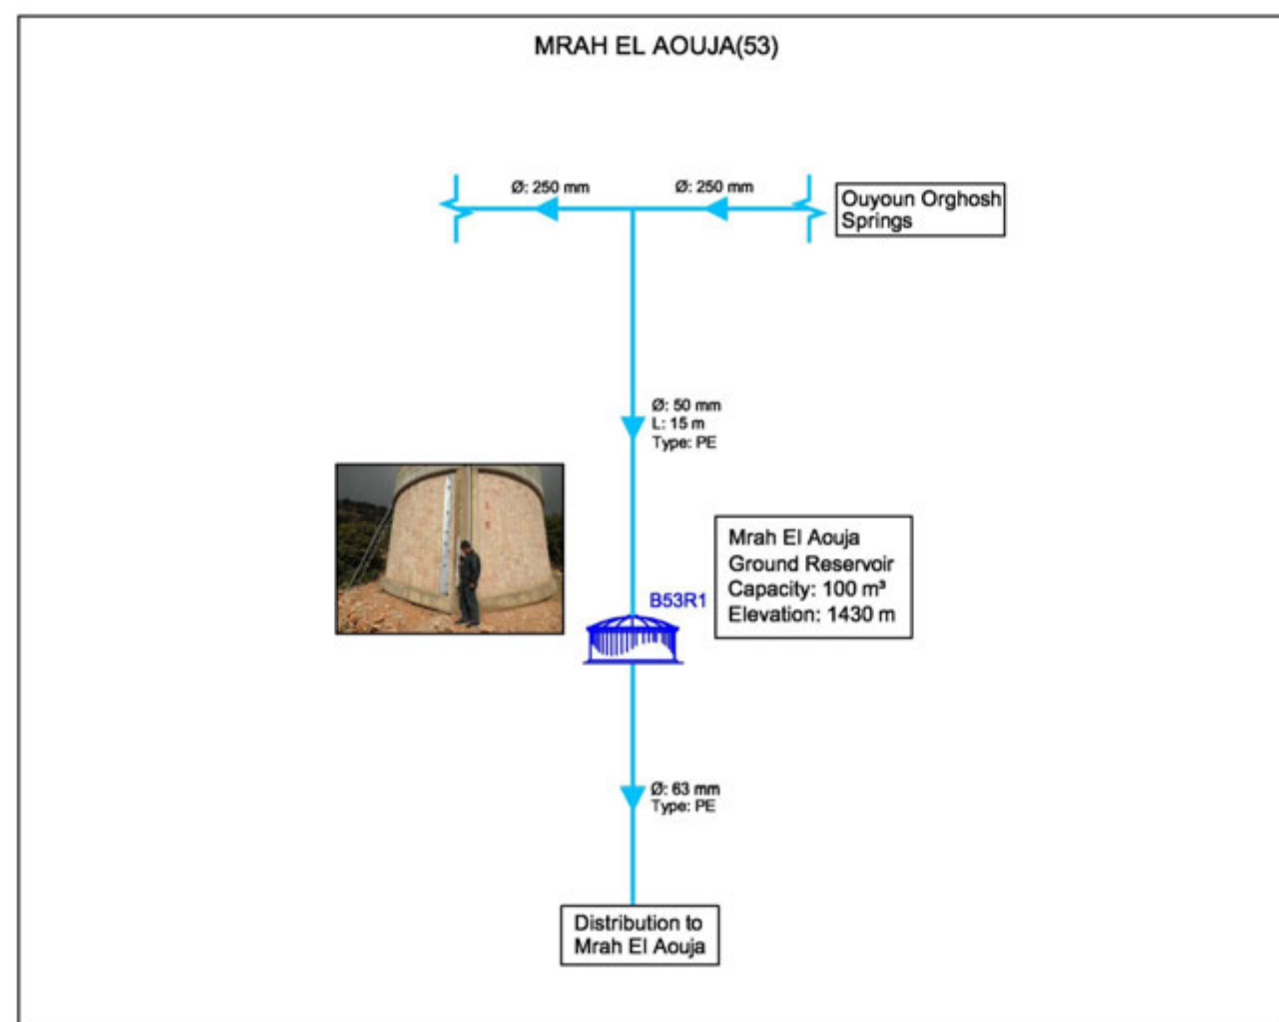
### Mrah El Aouja (53)

There is no available information concerning the water network of the town.

Reservoir B53R1 (>10 years; 100 m³): Reservoir is in good condition.

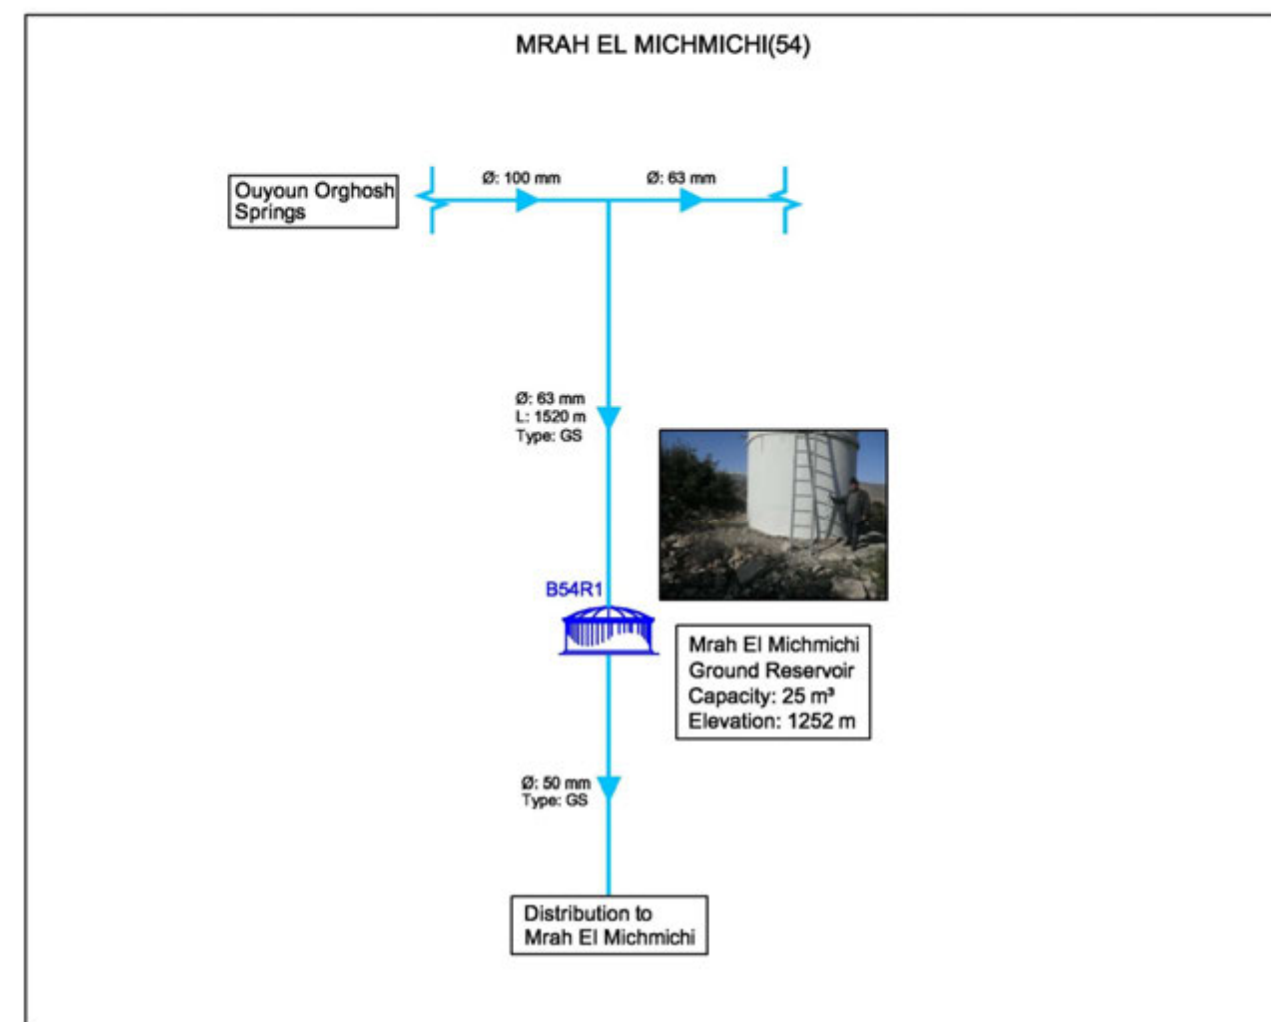
### Mrah El Michmichi (54)

There is no available information concerning the water network of the town.

Reservoir B54R1 (25 m³): Reservoir is in good condition.

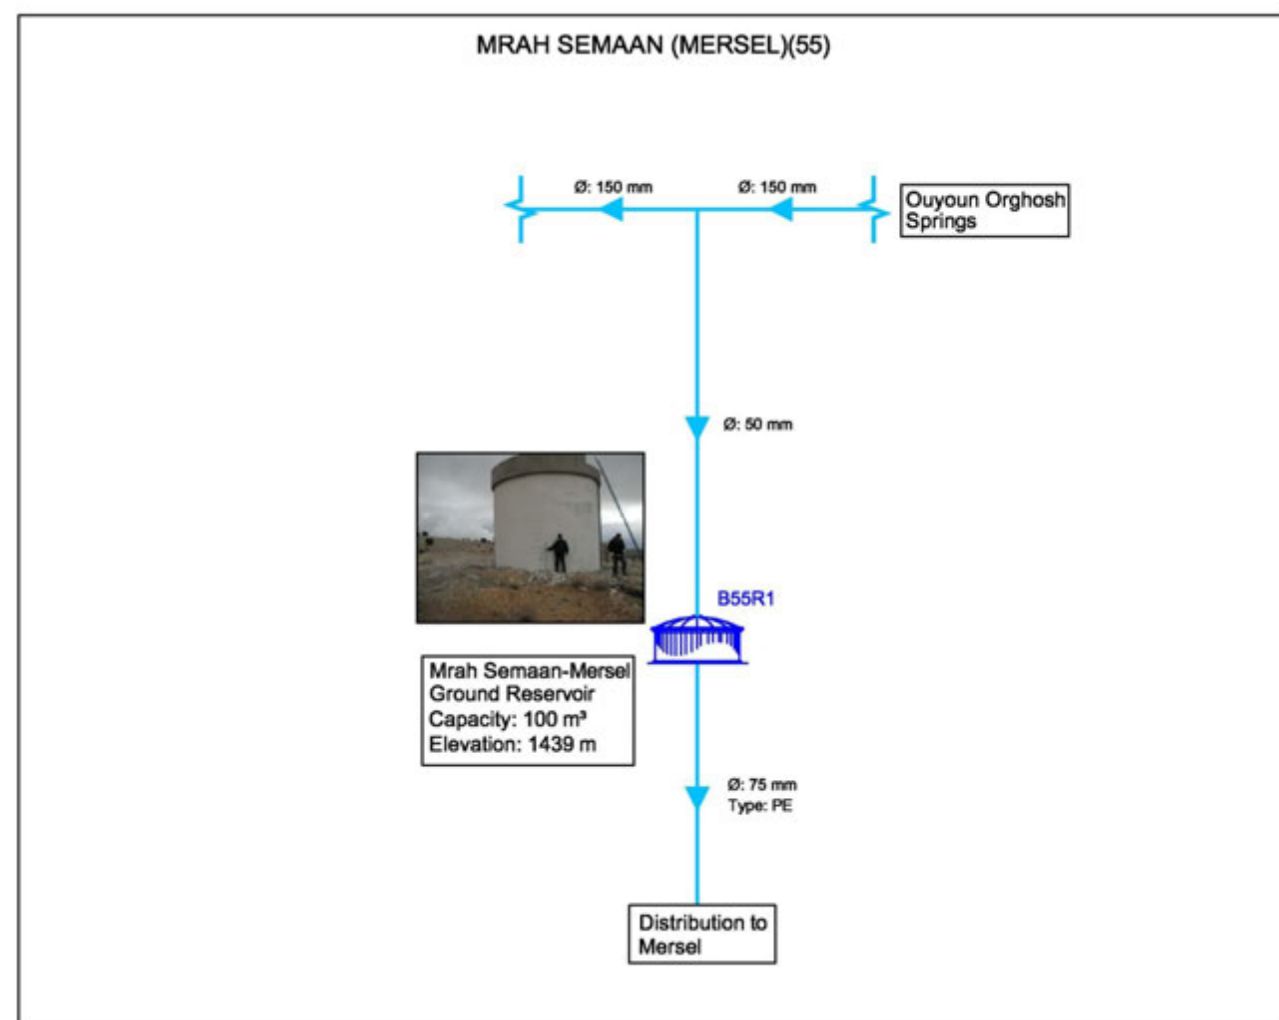
### Mrah Semaan (55)

There is no available information concerning the water network of the town.

Reservoir B55R1 (100 m³): Reservoir is new and it is in good condition.

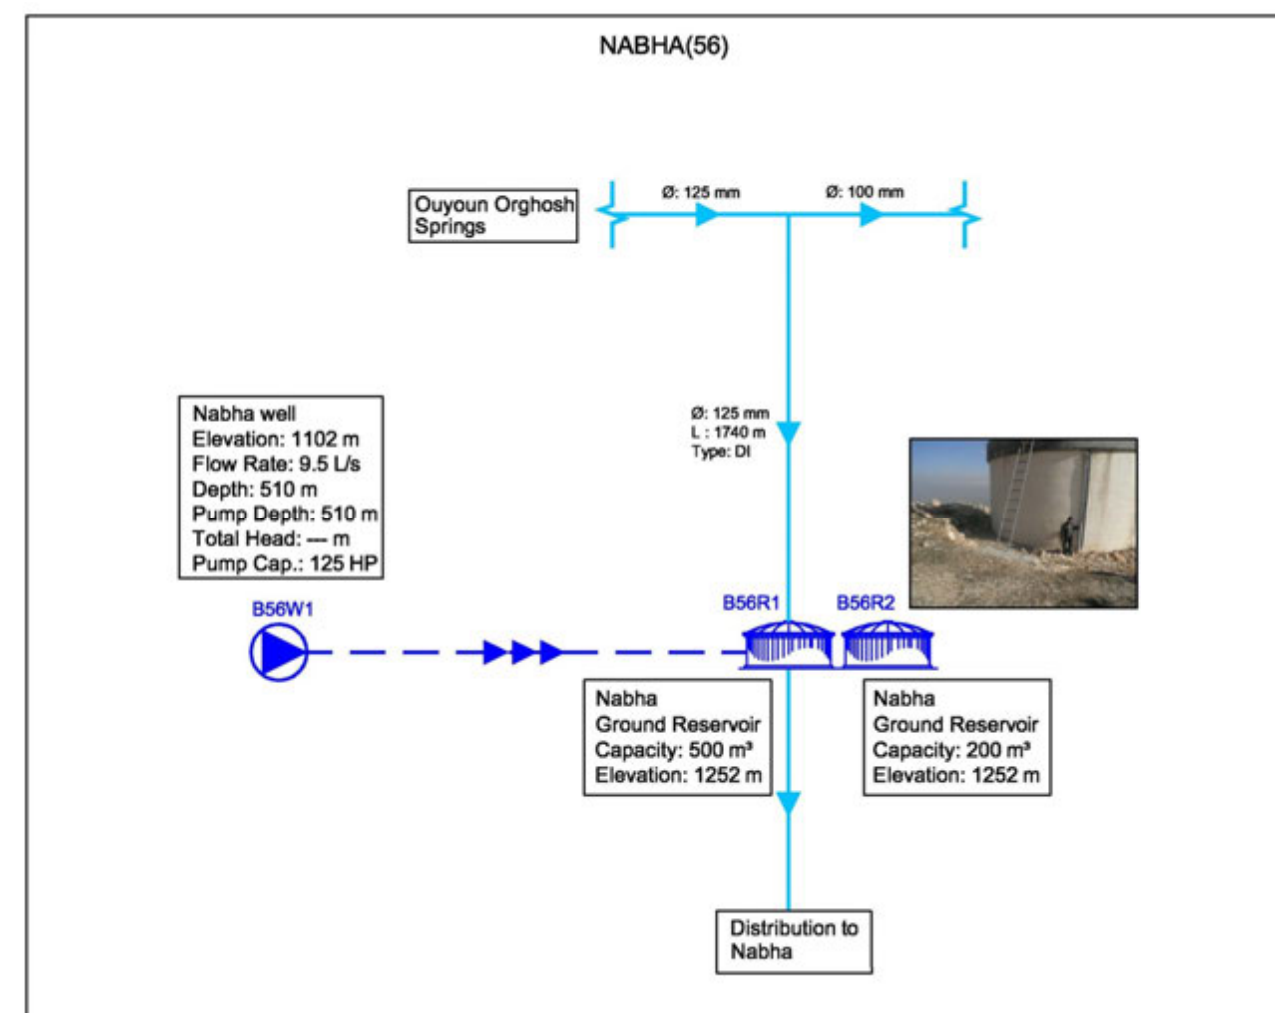
### Nabha (56)

The existing water network is in medium condition and it has a length of around 41 km. It covers a large area of the town.

Well B56W1 (5 years old): Well is in good condition. No more available information.

Reservoir B56R1 (>10 years; 500 m³): Reservoir is in good condition.

Reservoir B56R2 (200 m³): Reservoir is in good condition.

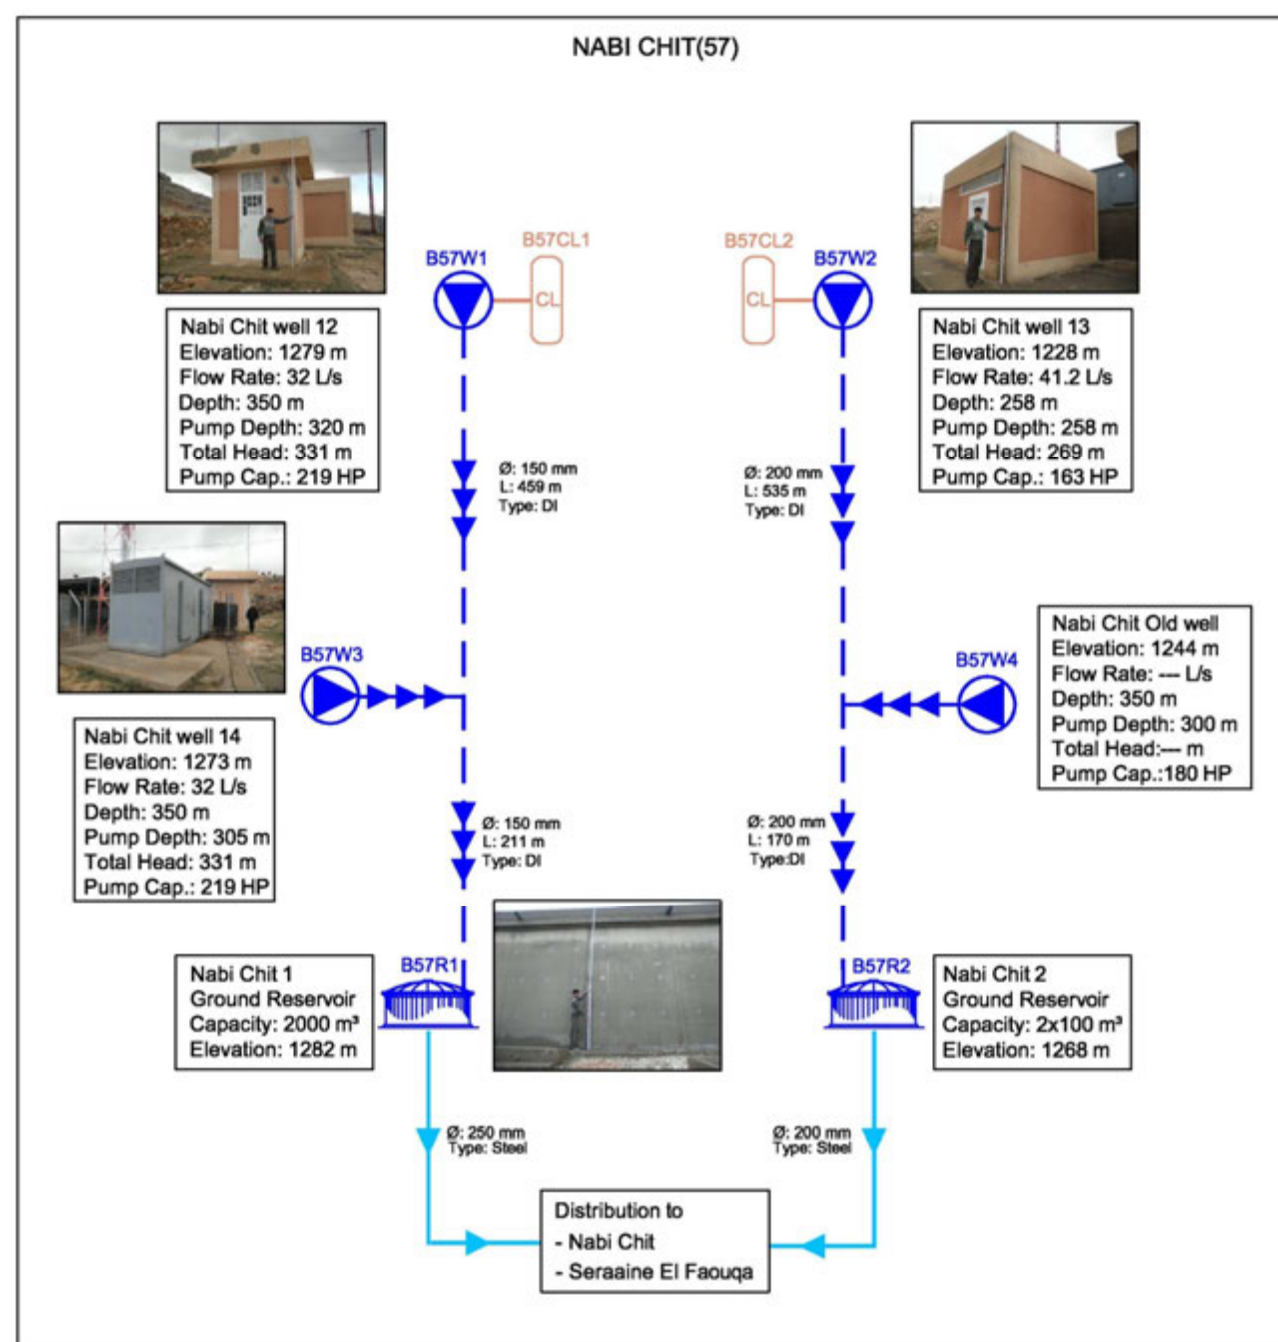
**Nabi Chit (57)**

The existing water network is in good condition and it has a length of around 34 km. It covers a large area of the town.

Well B57W1 (>15 years): Well is in good condition but it suffers from a shortage of electric power. It has a power generator but it is not always operational.

Well B57W2 (>15 years): Well is in good condition but it suffers from a shortage of electric power.

Well B57W3 (>15 years): Well is in good condition but it suffers from a shortage of electric power.

Well B57W4 (20 years old): Well is old and in bad condition. It is not in use anymore.

Reservoir B57R1 (2000 m³): Reservoir is new and it is in good condition. It has a chlorination unit.

Reservoir B57R2 (2x100 m³): Reservoir is very old but it is in an acceptable condition. This reservoir is not in use anymore. It needs rehabilitation.

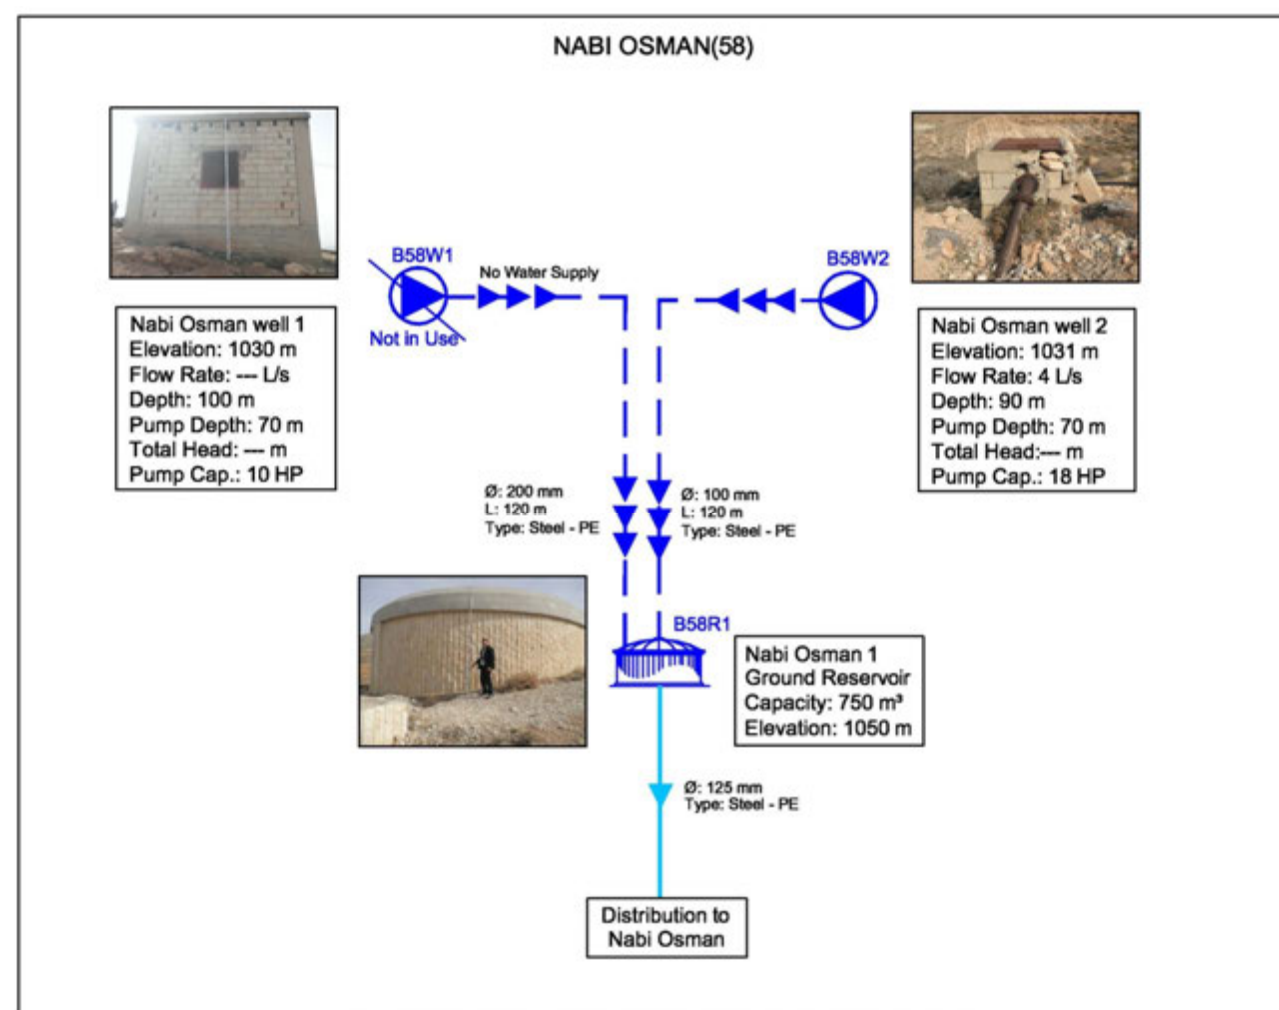
**Nabi Osman (58)**

The existing water network is in very good condition and it has a length of around 23.5 km. It covers a large area of the town.

Well B58W1 (>10 years): Well is new but it is not in use.

Well B58W2: Well is in good condition but it suffers from water shortage depending on season. Its outlet pipe is rusted and needs to be changed.

Reservoir B58R1 (>10 years; 750 m³): Reservoir is in good condition.

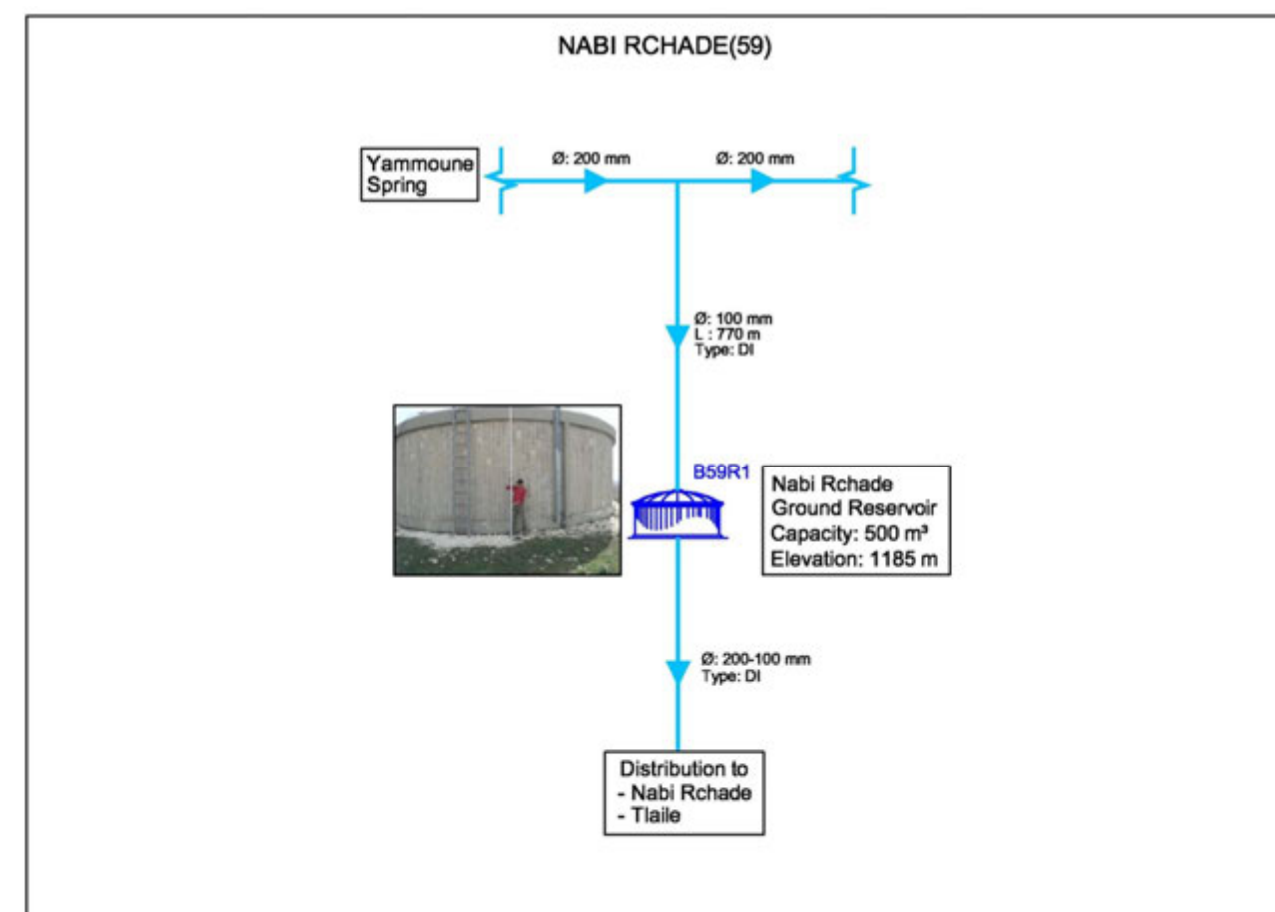
**Nabi Rchade (59)**

The existing water network is in good condition and it has a length of around 8 km. It covers a part of the town.

Reservoir B59R1 (>10 years; 500 m³): Reservoir is in good condition.

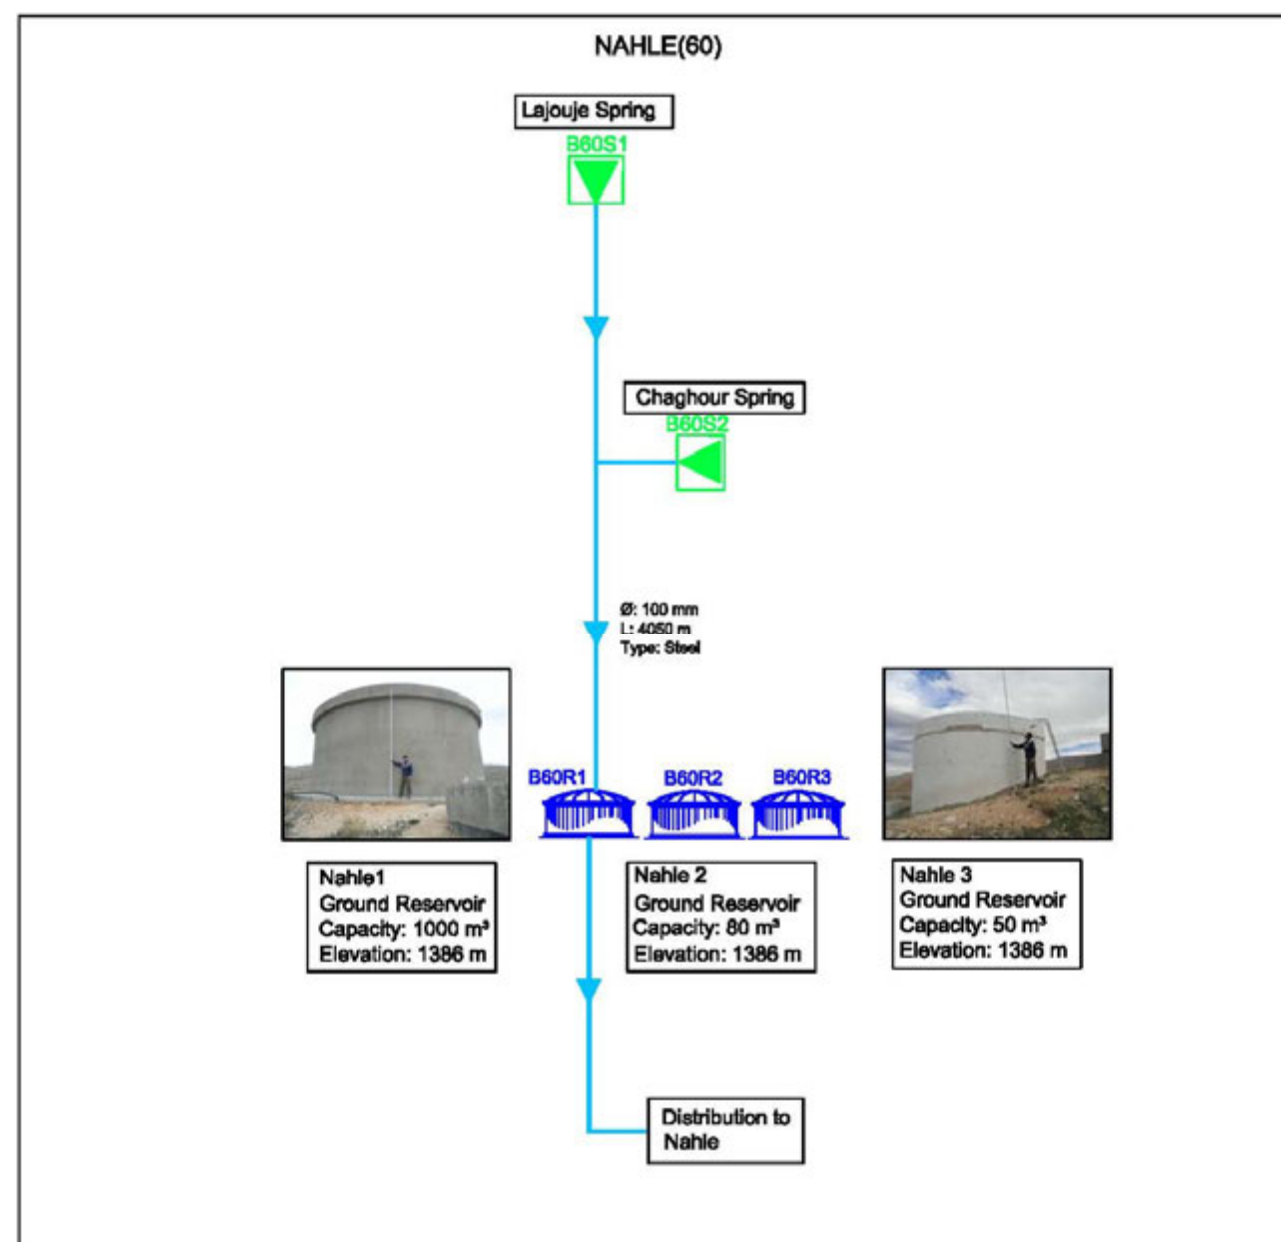
**Nahle (60)**

The existing water network is in good condition and it has a length of around 17 km. It covers a large area of the town.

Spring B60S1: No available information.

Reservoir B60R1 (1000 m³): Reservoir is new and it is in good condition.

Reservoir B60R2 (80 m³): Reservoir is old but it is in an acceptable condition.

Reservoir B60R3 (50 m³): Reservoir is in good condition.

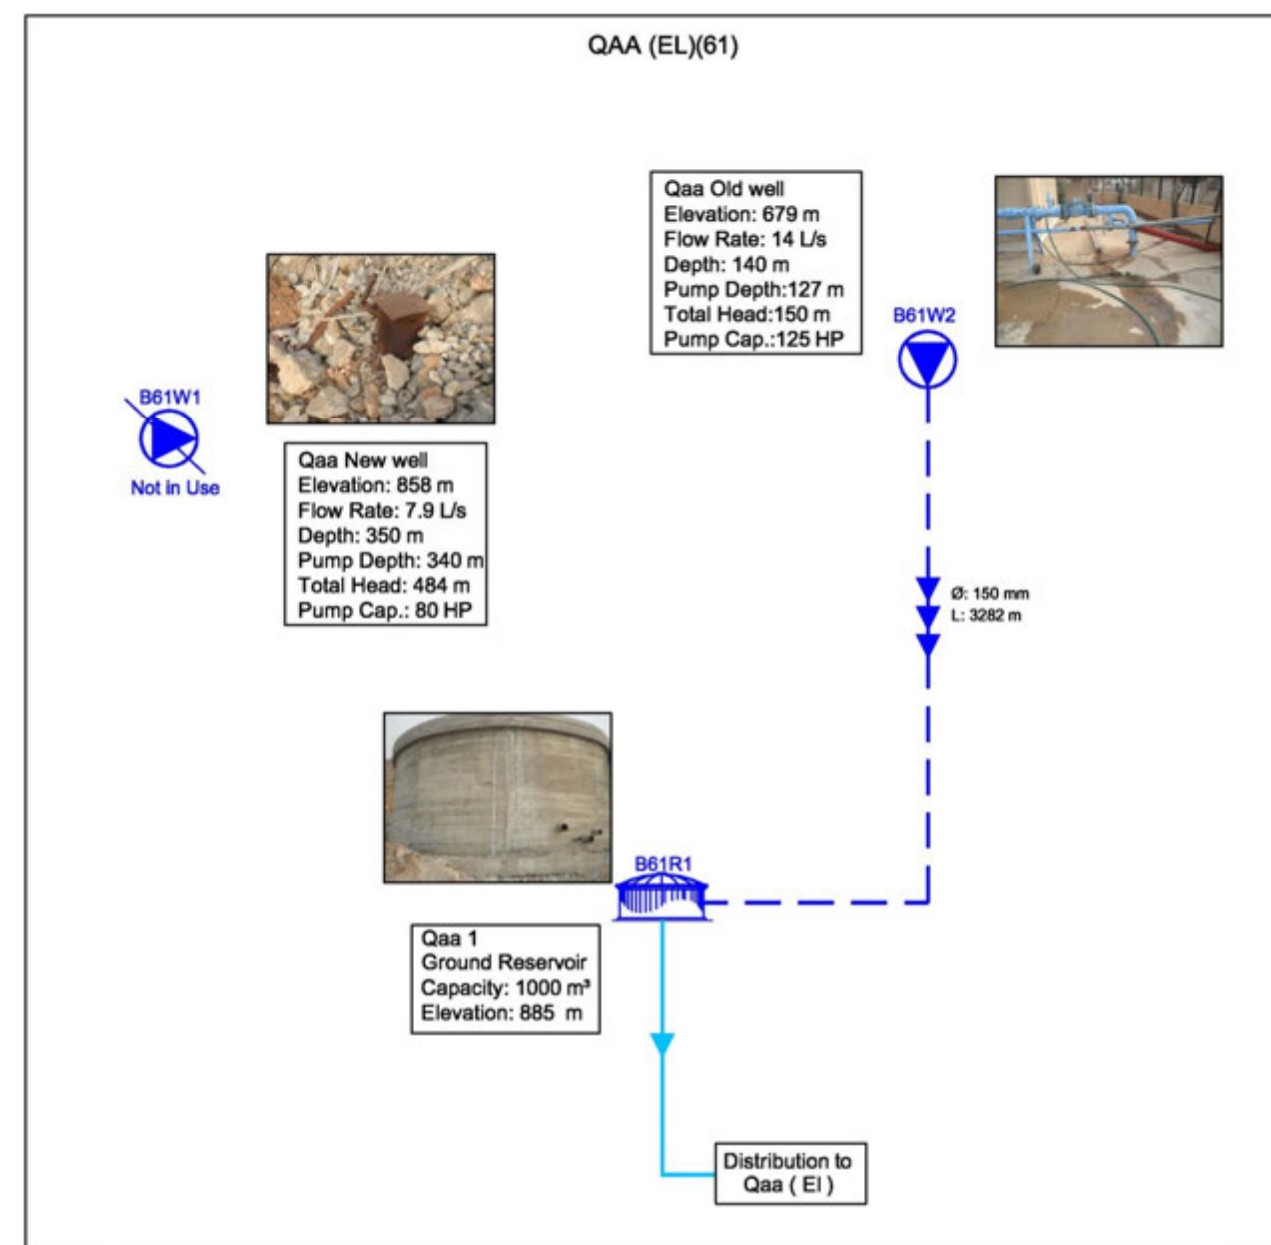
**Qaa (EI) (61)**

The existing water network is in good condition and it has a length of around 33.4 km. It covers a large area of the town.

Well B61W1 (<25 years): Well was still under construction during visit time. It is not in use.

Well B61W2 (35 years old): Well is old but it is in an acceptable condition. It suffers from a shortage of electric power.

Reservoir B61R1 (1000 m³): Reservoir is under construction during time visit. It will be supplied with water from B61W2 well in the near future.

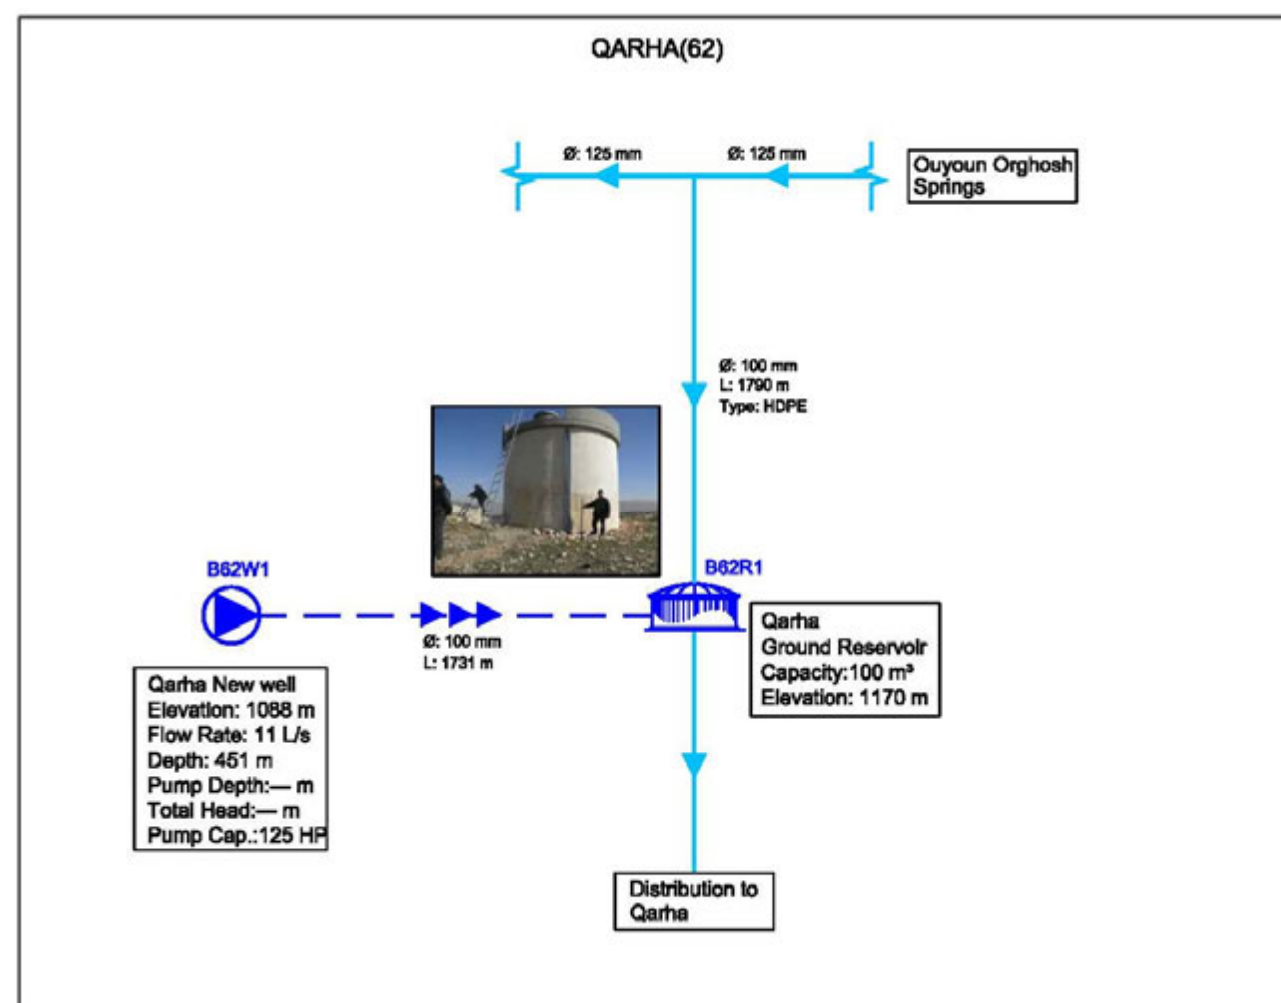
**Qarha (62)**

The existing water network is in medium condition and it has a length of around 3.6 km. It covers a part of the town.

Reservoir B62R1 (>10 years; 100 m³): Reservoir is in good condition.

Well B62W1 (<2 years): Well is new and it is in very good condition.

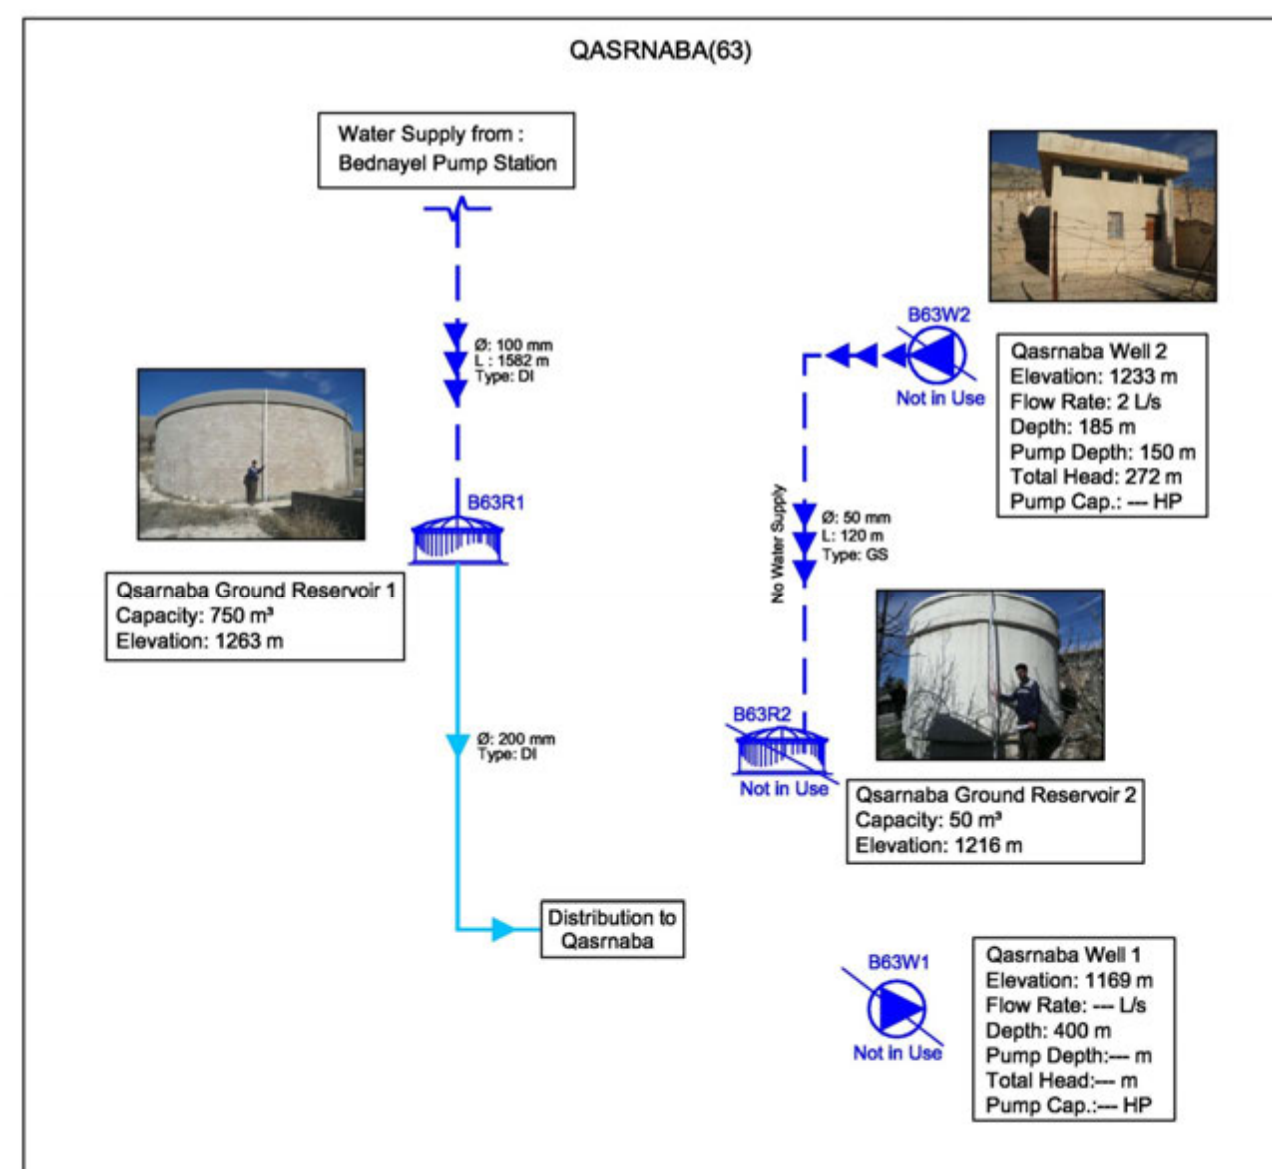
**Qasrnaba (63)**

The existing water network is in medium condition and it has a length of around 16.4 km. It covers a large area of the town

Well B63W1 (<5 years): Well is new but it is not in use.

Reservoir B63R1 (>10 years; 750 m³): Reservoir is in good condition.

Reservoir B63R2 (20 years old; 50 m³): Reservoir is in good condition but it is not in use.

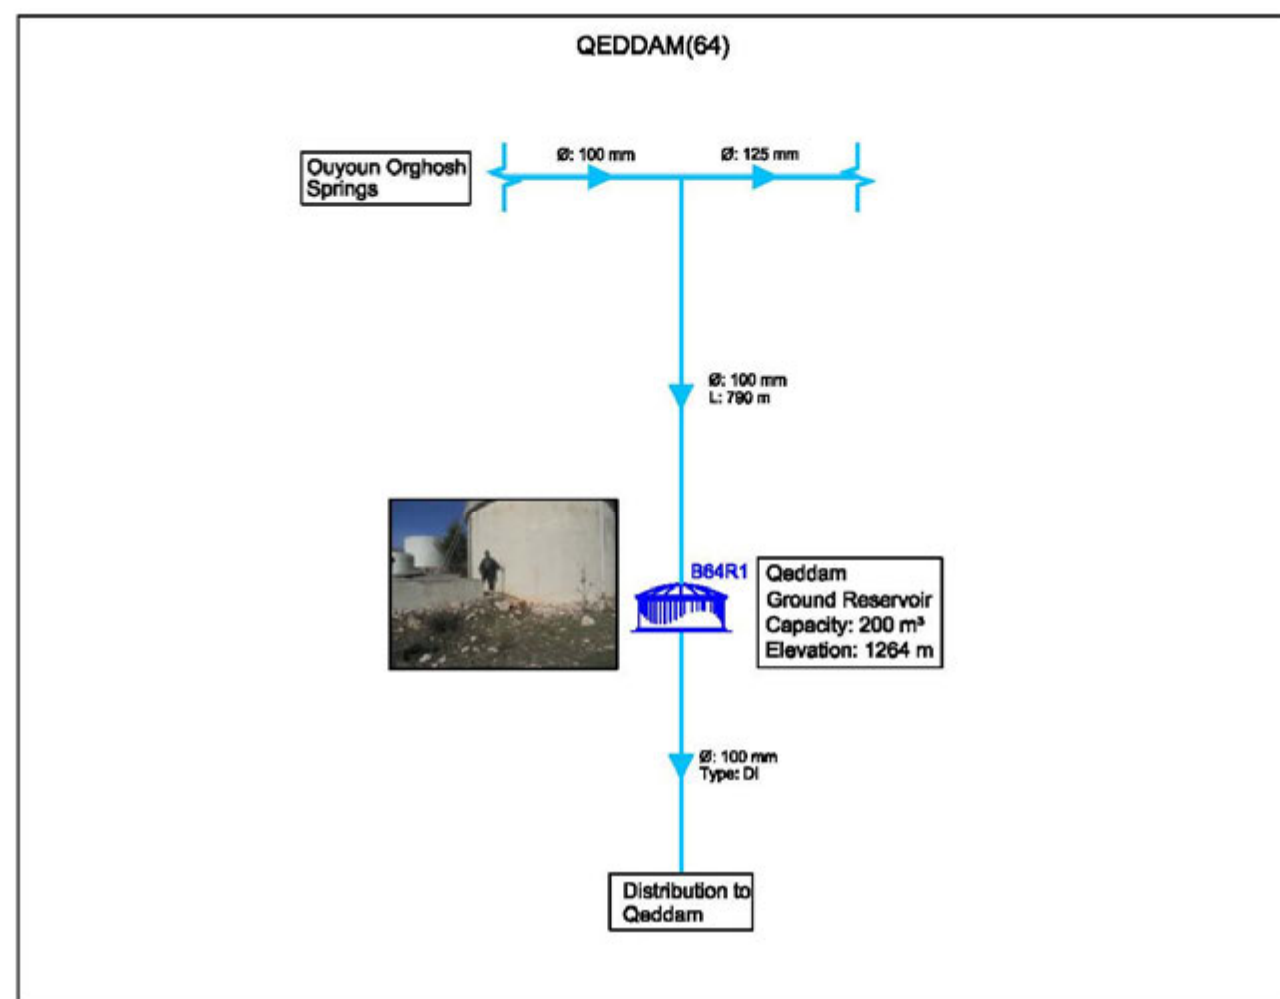
**Qeddam (64)**

The existing water network is in good condition and it has a length of around 5.3 km. It covers a large area of the town.

Reservoir B64R1 (>10 years; 200 m³): Reservoir is in good condition.

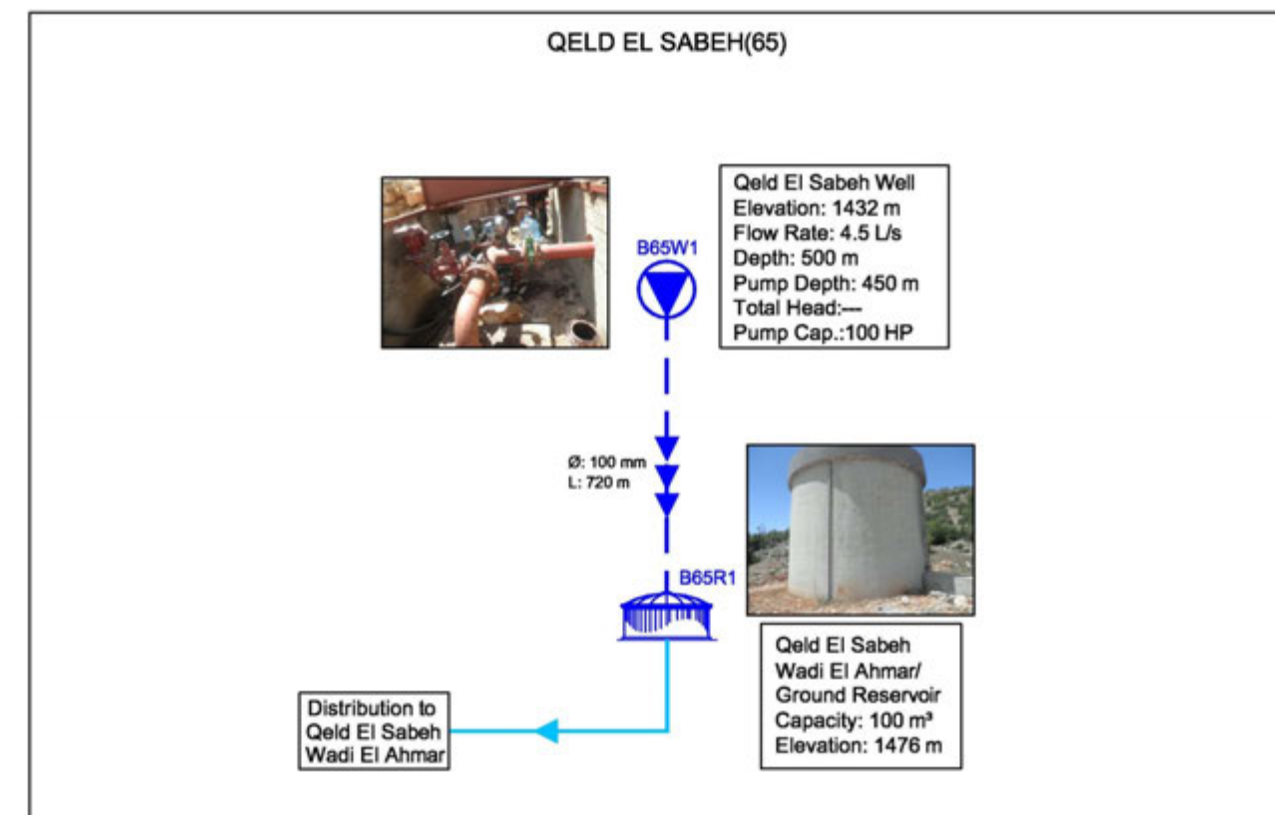
**Qeld El Sabeh (65)**

The existing water network of Qeld El Sabeh, Ramassa and Beit Mcheik is in bad condition and it has a length of around 4.6 km. It covers a large area of the three towns.

Well B65W1 (15 years old): Well is in good condition but it suffers from a shortage of electric power. This well is not under the supervision and operation of BWE; rather the municipality operates it.

Reservoir B65R1 (100 m³): Reservoir is in good condition.

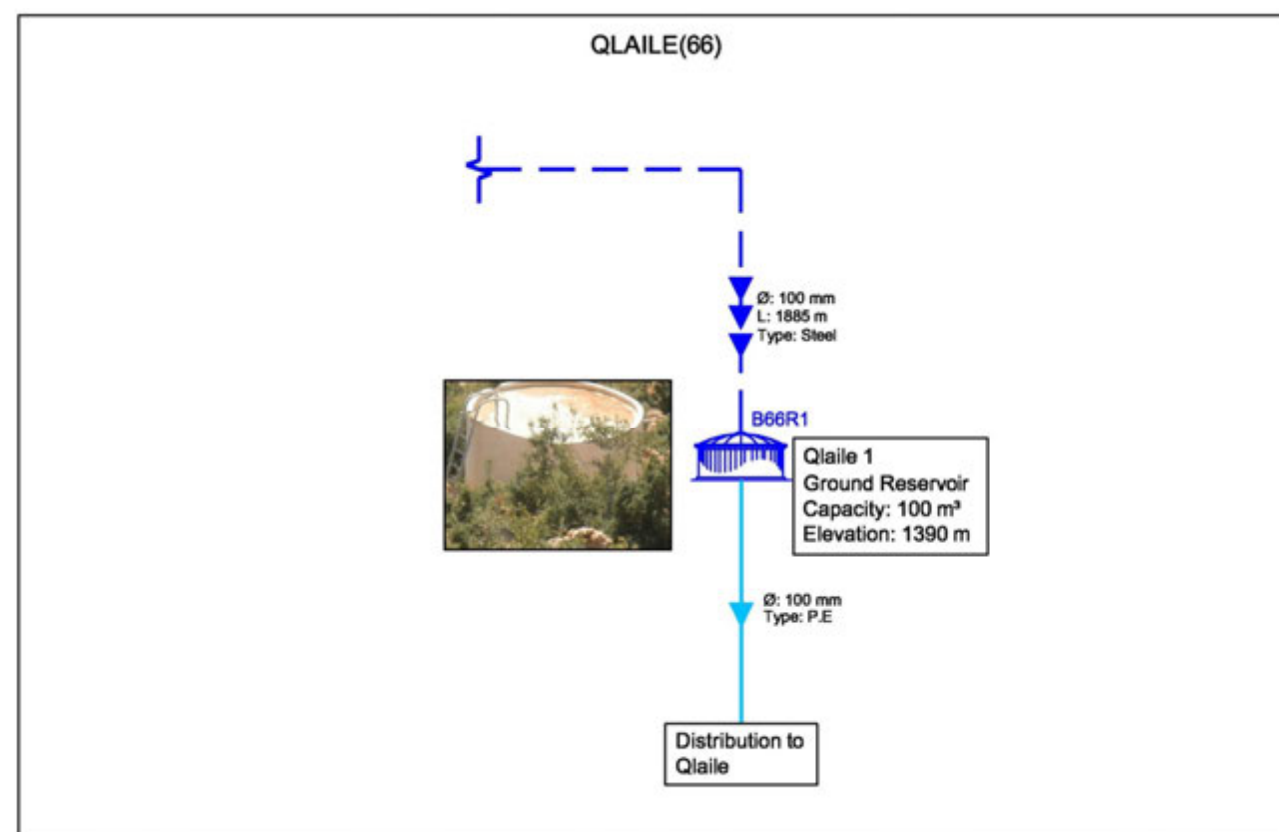
**Qlaile (66)**

There is no available information concerning the water network of the town.

Reservoir B66R1 (15 years old; 100 m³): No available information concerning this reservoir. However, there is a non-used old small reservoir next to b66r1.

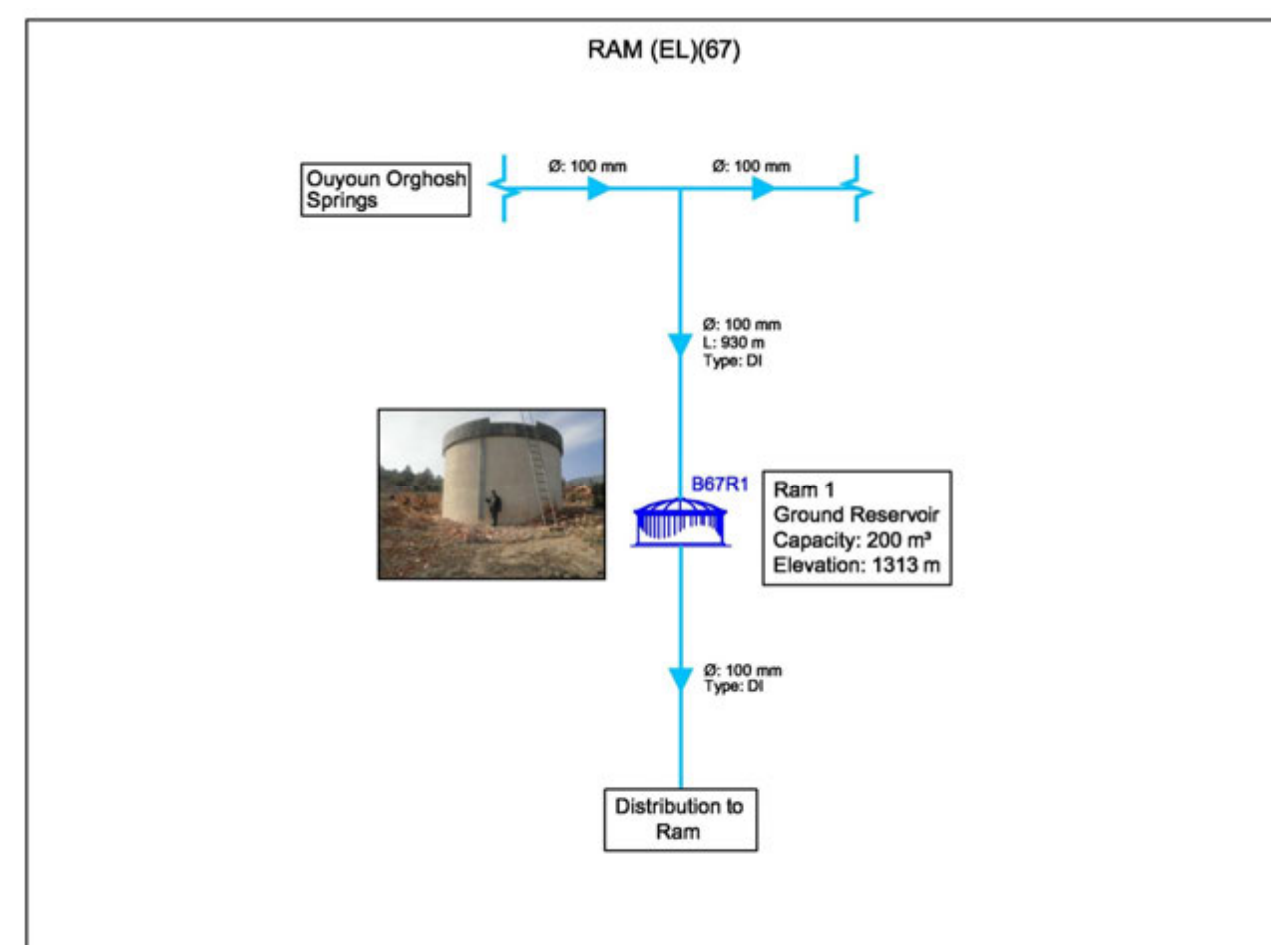
**Ram (el) (67)**

The existing water network is in good condition and it has a length of around 5.5 km. It covers a part of the town.

Reservoir B67R1 (>10 years; 200 m³): Reservoir is in good condition.
