# WATER SUPPLY AND WASTEWATER SYSTEMS MASTER PLAN FOR THE BEKAA WATER ESTABLISHMENT

## WATER ASSESSMENT REPORT

January 2014  
Updated May 2015

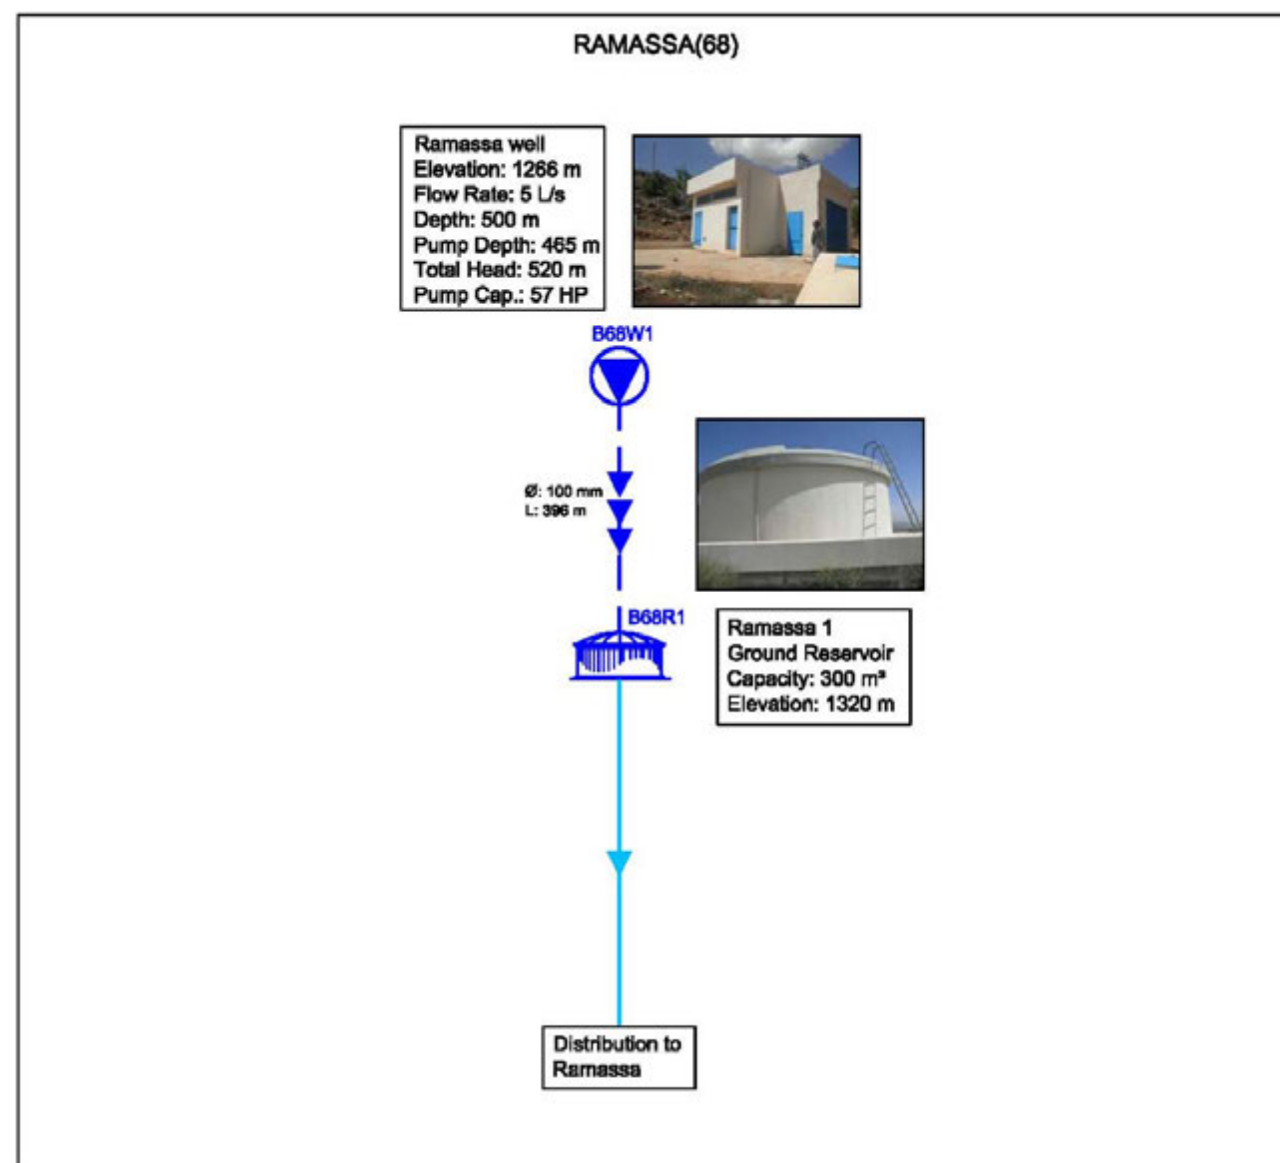
**Ramassa (68)**

The existing water network of ramassa is in bad condition. It covers a large area of the three towns.

Well B68W1 (<5 years): Well is in good condition but it suffers from lack of water.

Reservoir B68R1 (5 years old; 300 m³): Reservoir is in good condition.

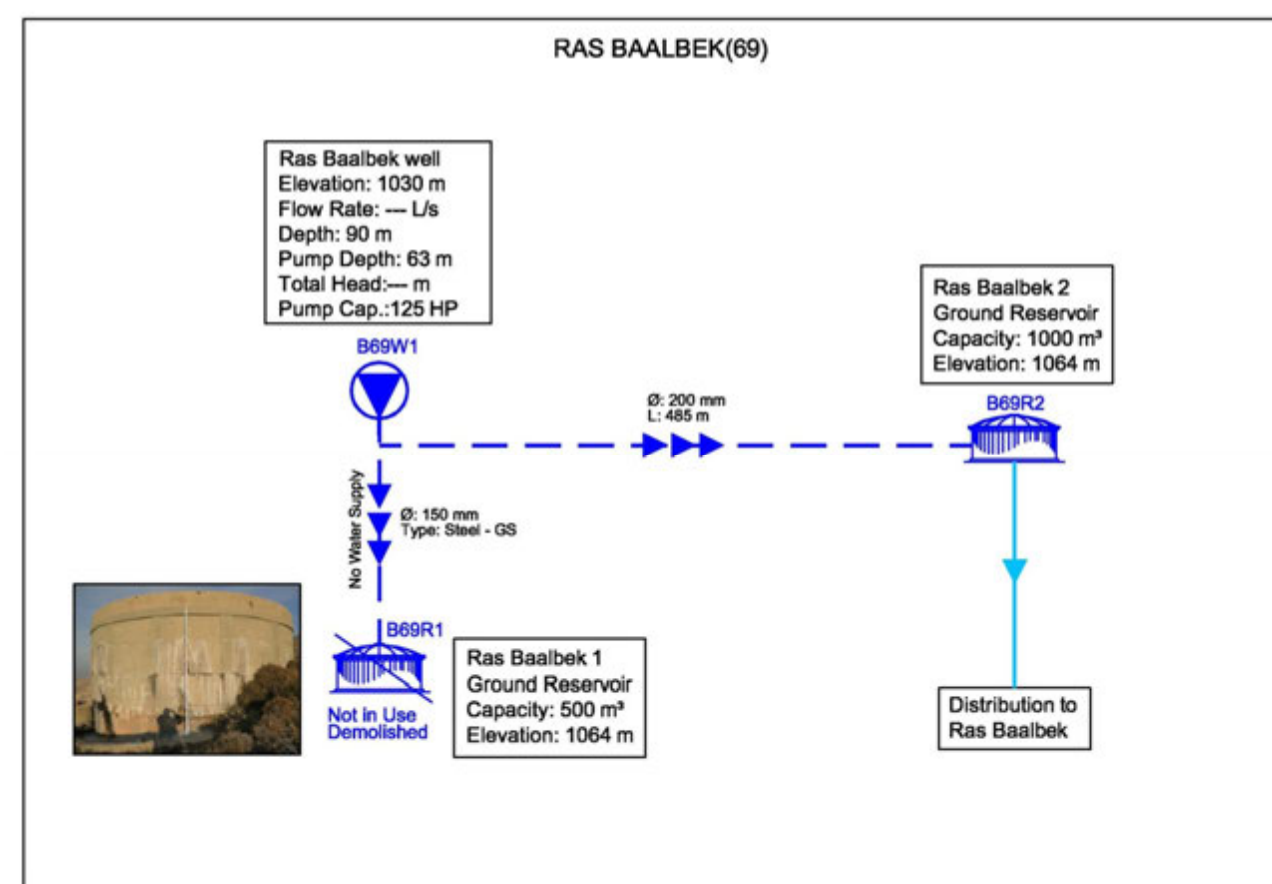
**Ras Baalbek (69)**

The existing water network is in bad condition and it has a length of around 20.3km. It covers a large area of the town.

Well B69W1 (25 years old): No available information.

Reservoir B69R1 (55 years old; 500 m³): Reservoir is in bad condition. It needs esthetical and structural rehabilitation or reconstruction. The pipes and valves are rusted they needs maintenance. This reservoir is not in use and it may be destroyed.

Reservoir B69R2 (< 2 years old; 1000 m³): This reservoir is new and it is in very good condition.

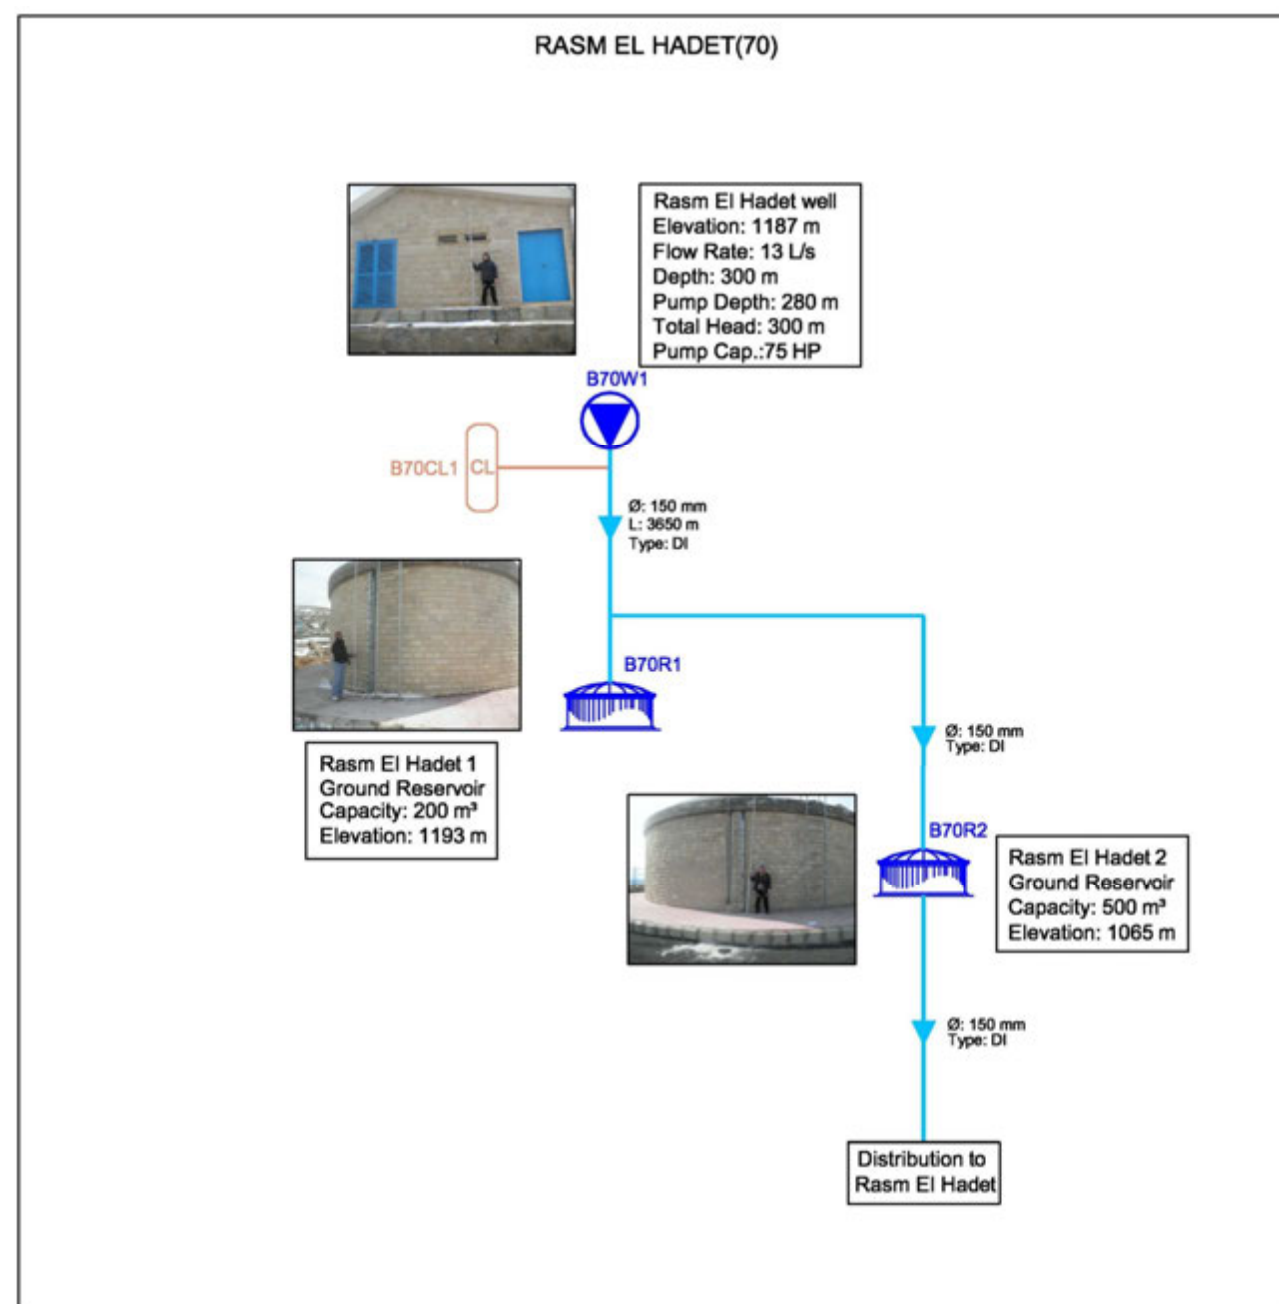
**Rasm El Hadet (70)**

There is no available information concerning the water network of the town.

Well B70W1 (5 years old): Well is new and it is in good condition. This well has a power generator.

Reservoir B70R1 (5 years old; 200 m³): Reservoir is in good condition.

Reservoir B70R2 (5 years old; 500 m³): Reservoir is in good condition.

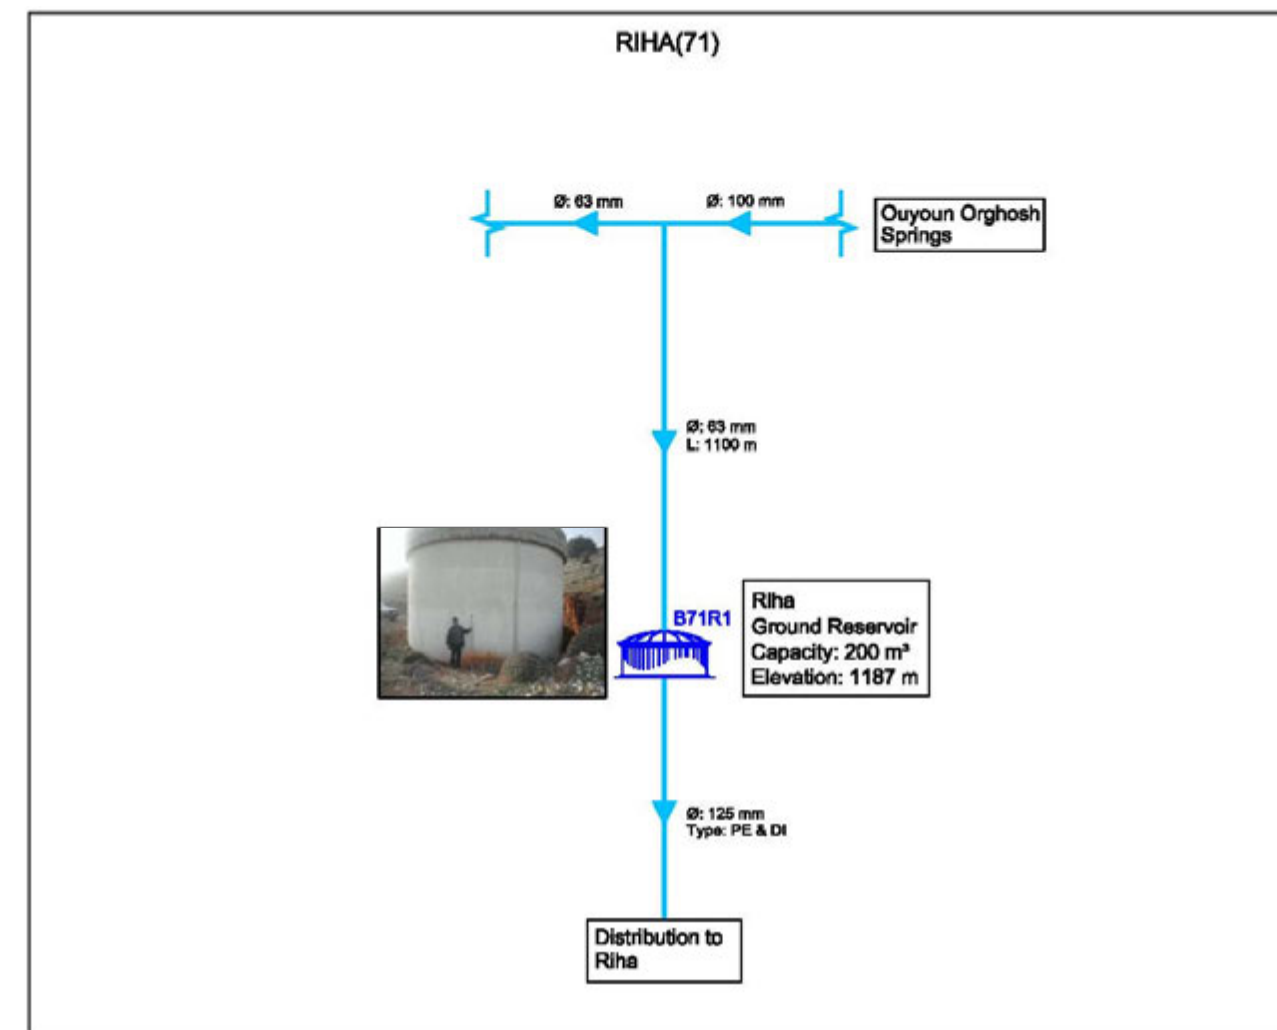
**Riha (71)**

The existing water network is in good condition and it has a length of around 3.8 km. It covers a large area of the town.

Reservoir B71R1 (>10 years; 200 m³): Reservoir is in good condition.

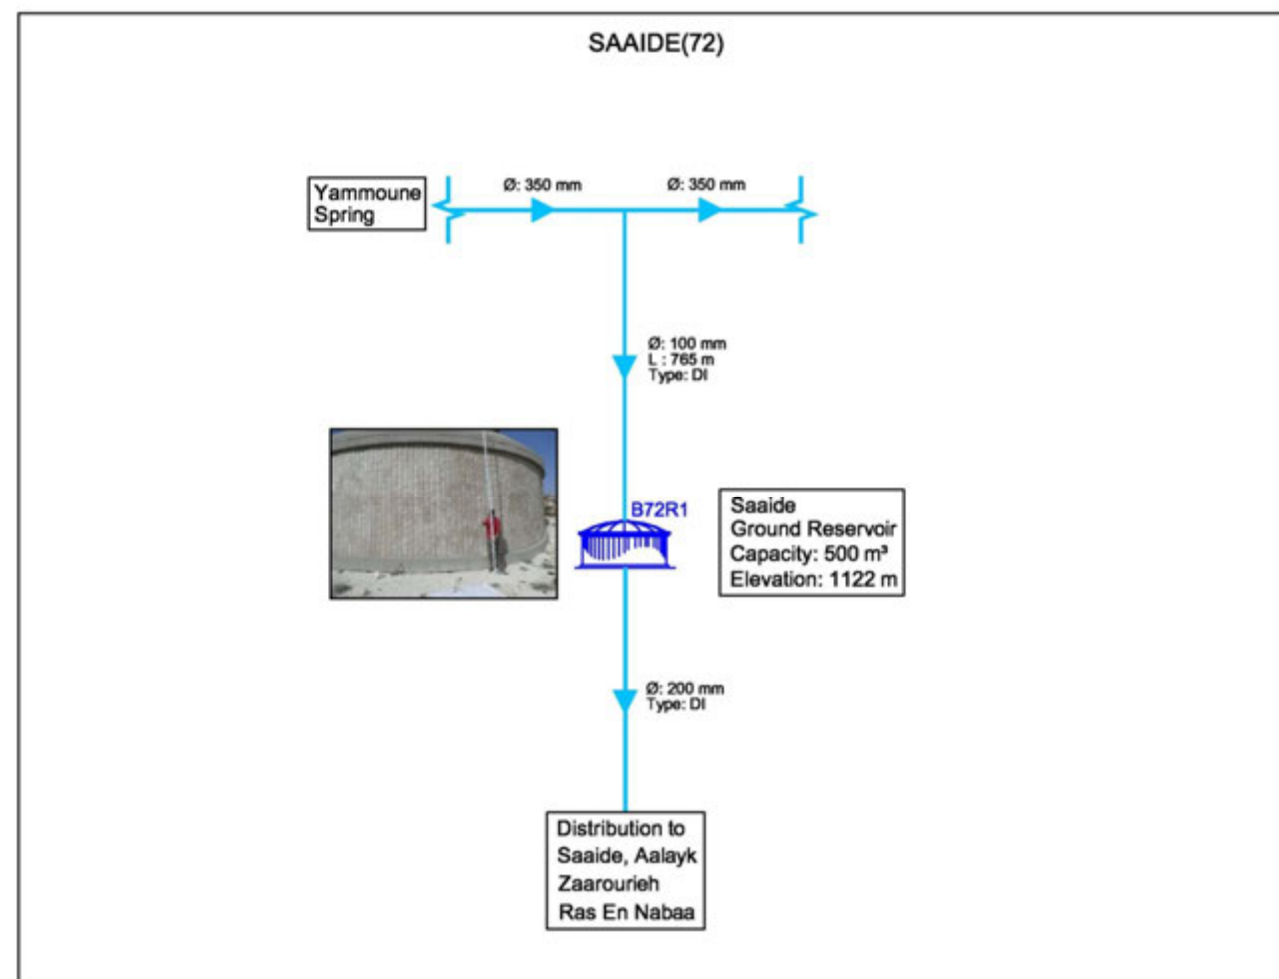
**Saaide (72)**

The existing water network is in good condition and it has a length of around 15.2 km. It covers a large area of the town.

Reservoir B72R1 (>10 years; 500 m³): Reservoir is in good condition.

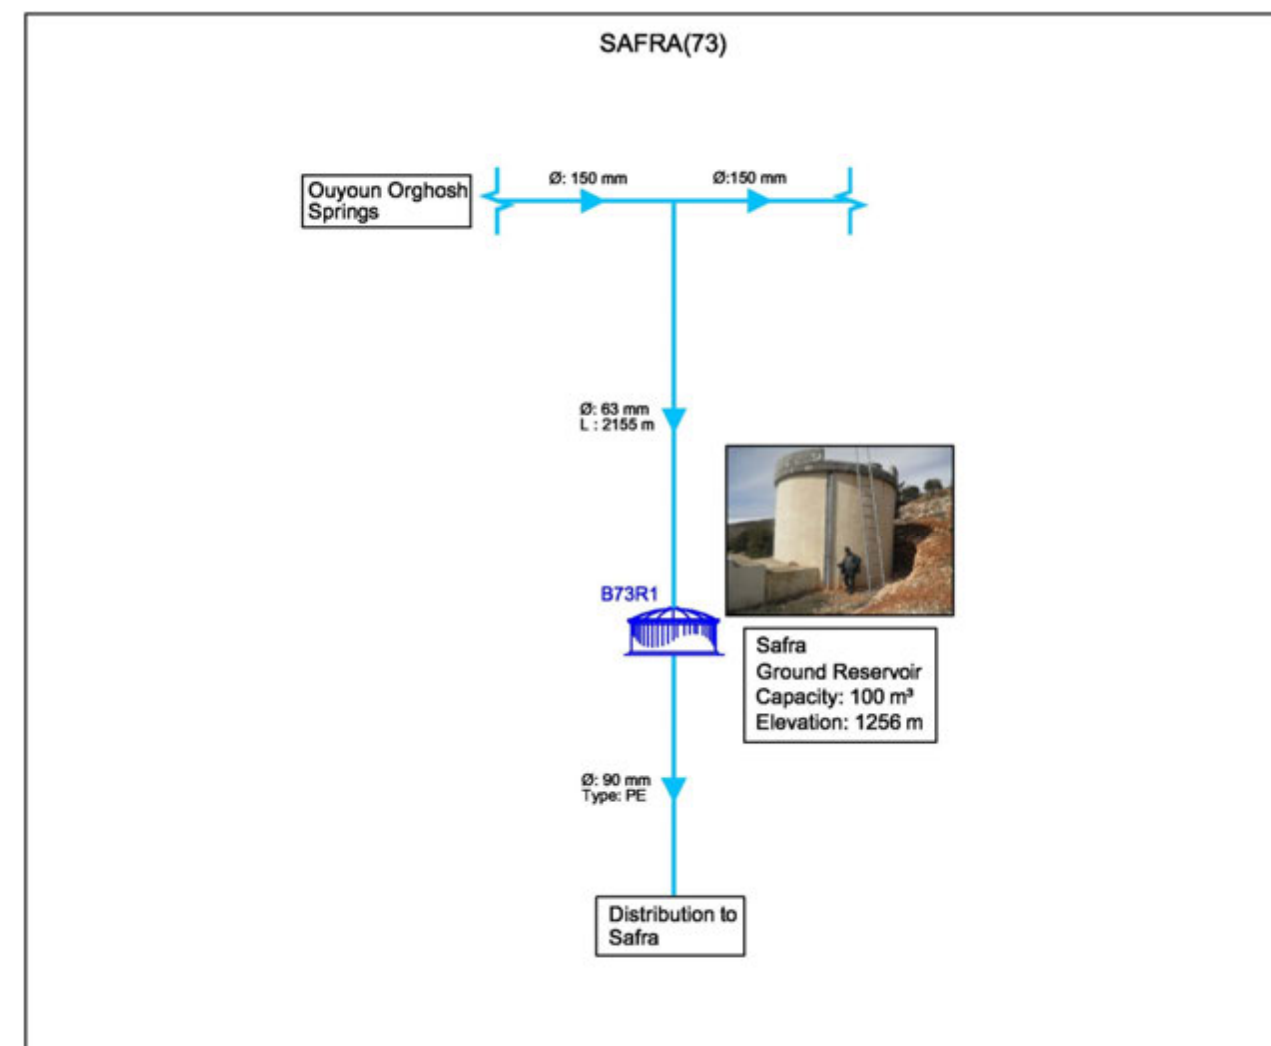
**Safra (73)**

The existing water network is in good condition and it has a length of around 3.5 km. It covers a large area of the town.

Reservoir B73R1 (>10 years; 100 m³): Reservoir is in good condition.

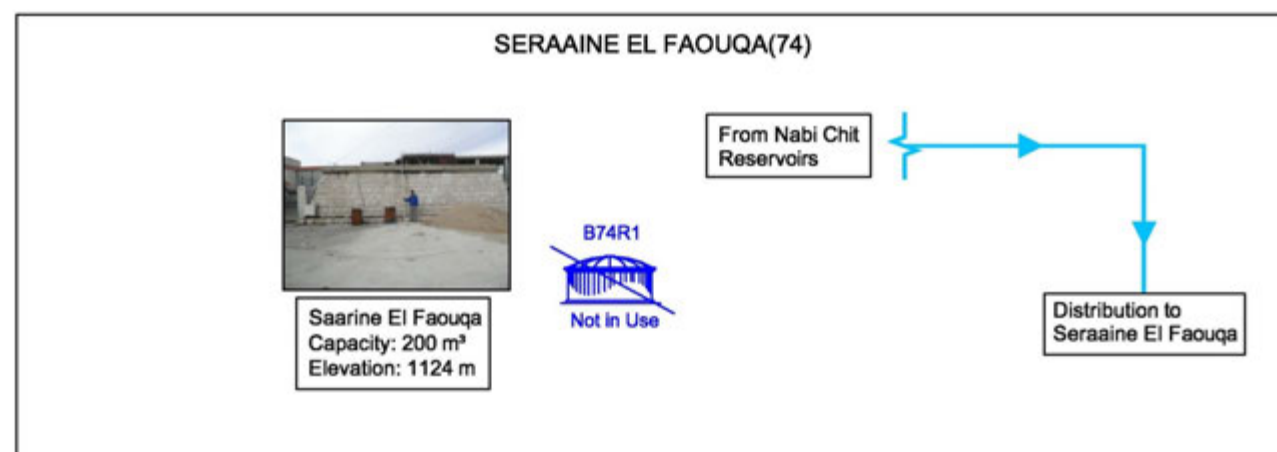
**Seraaine El Faouqa (74)**

There is no available information concerning the water network of the town.

Reservoir B74R1 (>10 years; 200 m³): Reservoir is very old but it is in an acceptable condition. This reservoir is not in use.

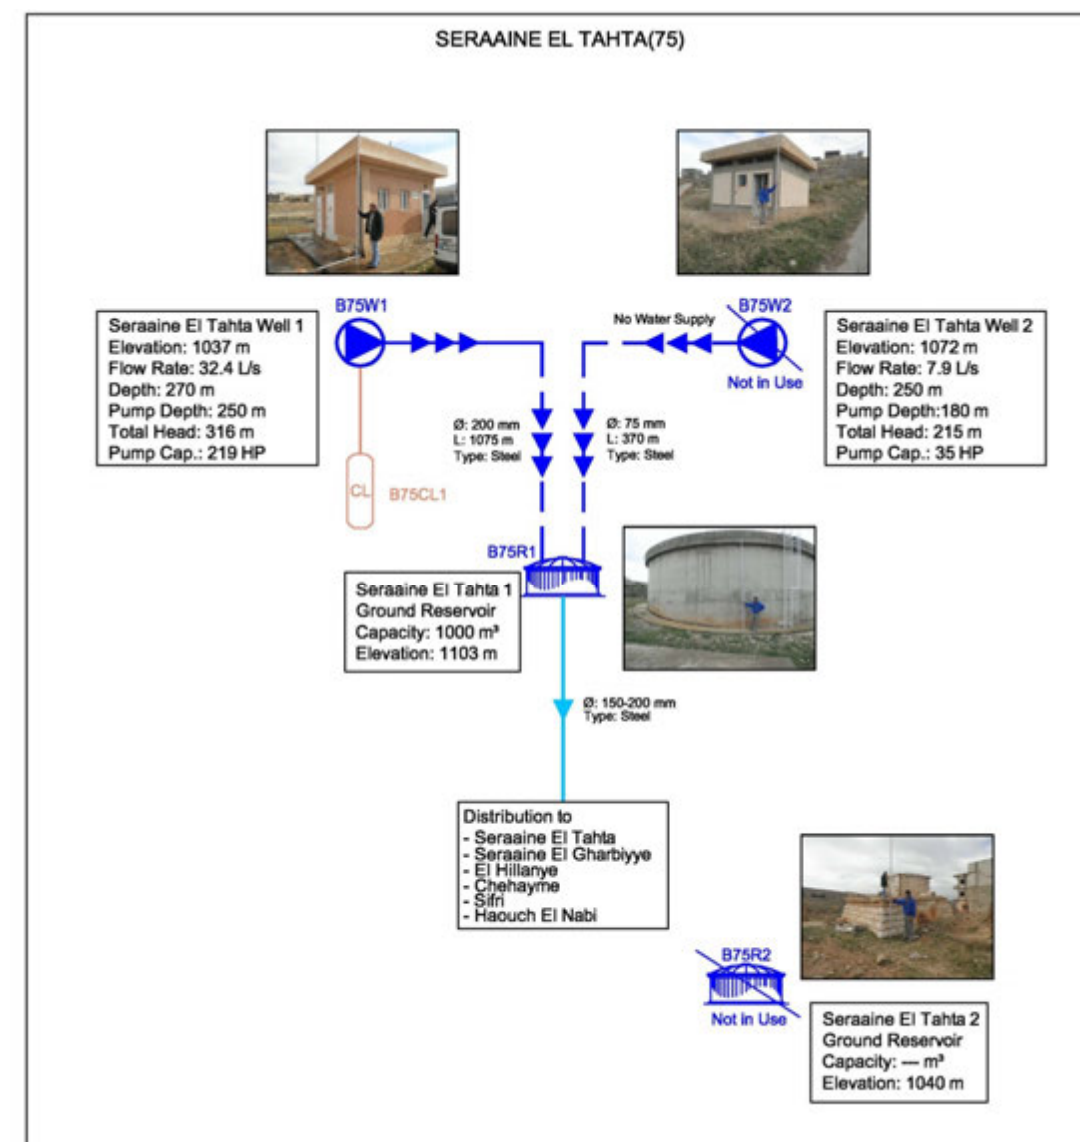
**Seraaine El Tahta (75)**

The existing water network is in good condition and it has a length of around 83 km. It covers a large area of the town.

Well B75W1: Well is in good condition but it suffers from a shortage of electric power. It has a chlorination unit and a power generator.

Well B75W2: Well is in bad condition and is not in use. Its outlet pipe is rusted.

Reservoir B75R1 (1000 m³): Reservoir is in good condition.

Reservoir B75R2: Reservoir is very old and it is in bad condition. It needs esthetical and structural rehabilitation. The pipes and valves are rusted and they need maintenance. It is not in use.

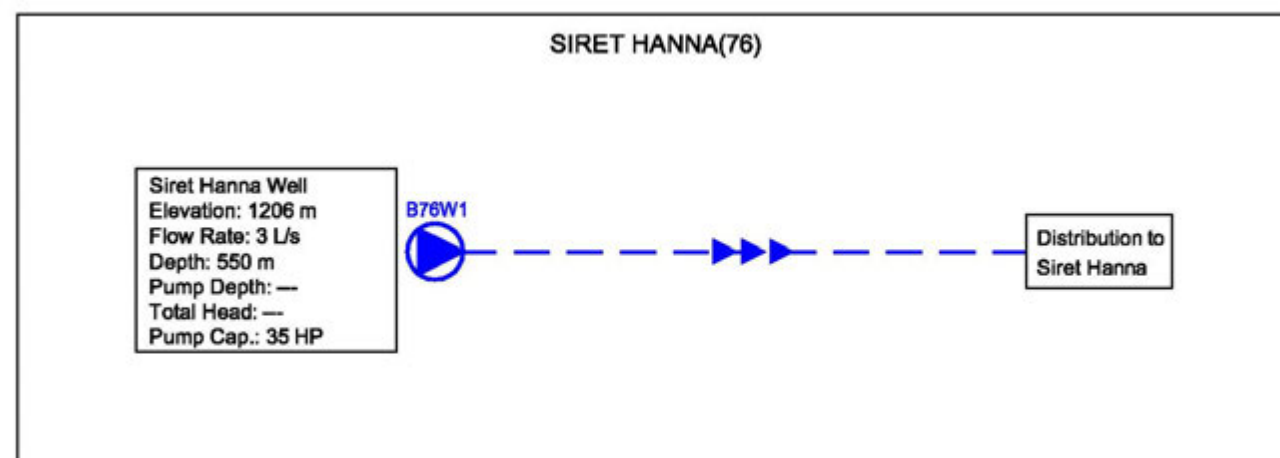
## Siret Hanna (76)

There is no available information concerning the water network of the town.

Well B76W1 (< 2years): Well is new and it is in good condition.

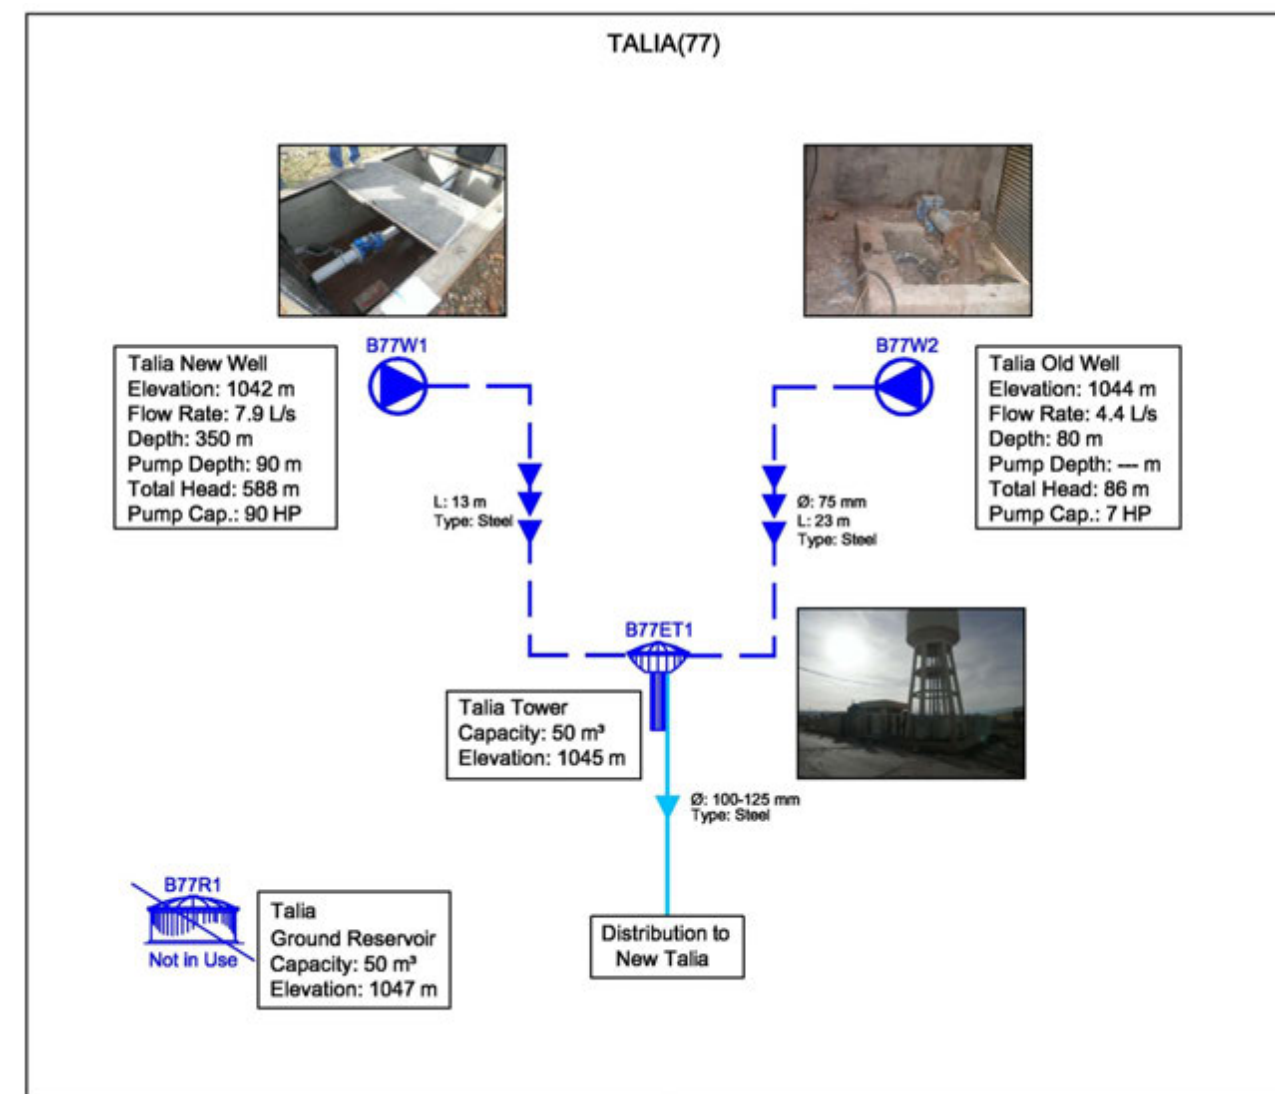
## Talia (77)

The existing water network is in very good condition and it has a length of around 19 km. It covers a large area of the town.

Well B77W1 (15 years old): Well is in good condition but it suffers from a shortage of electric power.

Well B77W2: Well is old and it is in bad condition. It suffers from a shortage of electric power. This well needs rehabilitation.

Reservoir B77R1 (50 m³): Reservoir is very old and it is in bad condition. It is not in use. This reservoir needs rehabilitation or reconstruction.

Elevated tank B77ET1 (50 m³): Elevated tank is in good condition.

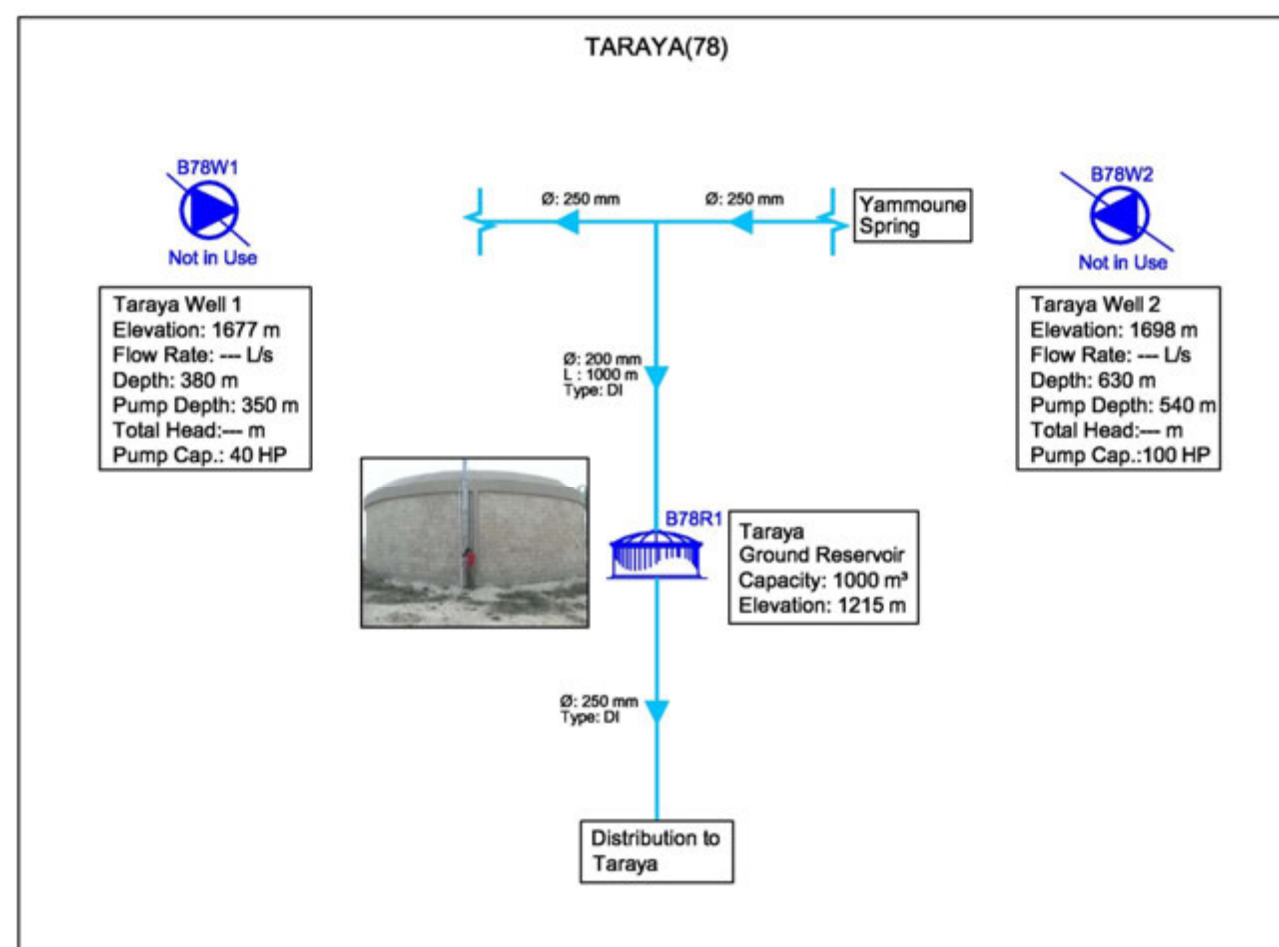
**Taraya (78)**

The existing water network is in good condition and it has a length of around 28 km. It covers a large area of the town.

Well B78W1 (>5 years): Well is not in use.

Reservoir B78R1 (>10 years; 1000 m<sup>3</sup>): Reservoir is in good condition.

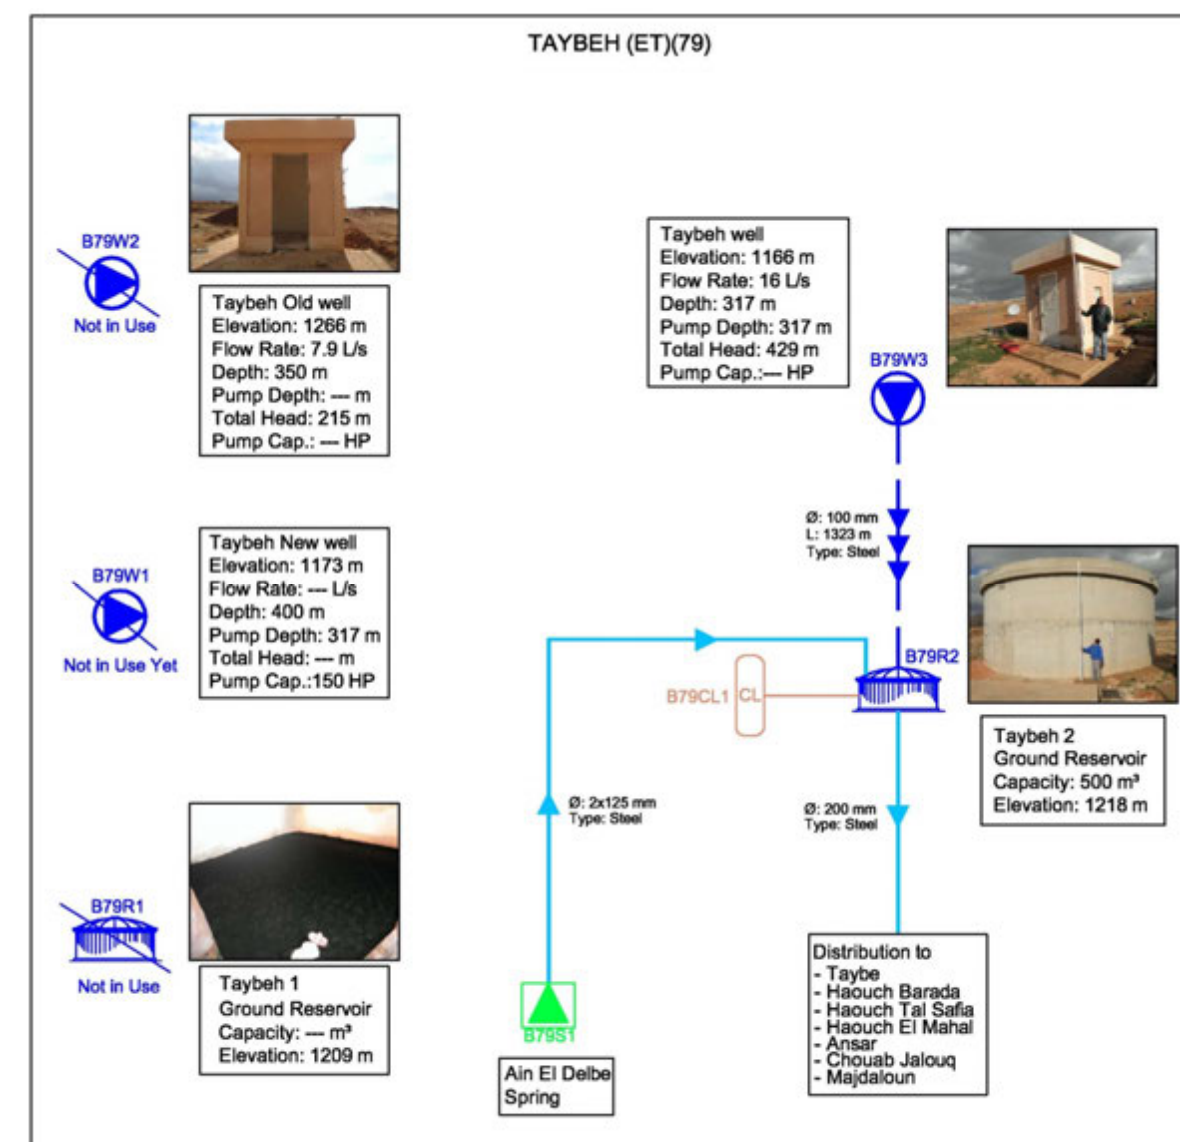
**Taybeh (EI) (79)**

The existing water network is in good condition and it has a length of around 20 km. It covers a large area of the town.

Well B79W1 (15 years old): Well is new and it is in good condition but it is not in use yet.

Well B79W2 (>15 years): Well is in bad condition and it is not in use.

Well B79W3: Well is in good condition. It has a power generator.

Reservoir B79R1: Reservoir is very old and it is in bad condition. It needs esthetical and structural rehabilitation or reconstruction. The pipes and valves are rusted and they need maintenance. It is not in use.

Reservoir B79R2 (500 m<sup>3</sup>): Reservoir is in good condition but its indoor panel of water level indicator is missing.

Spring B79S1: Spring is coming from mountains. No more available information.

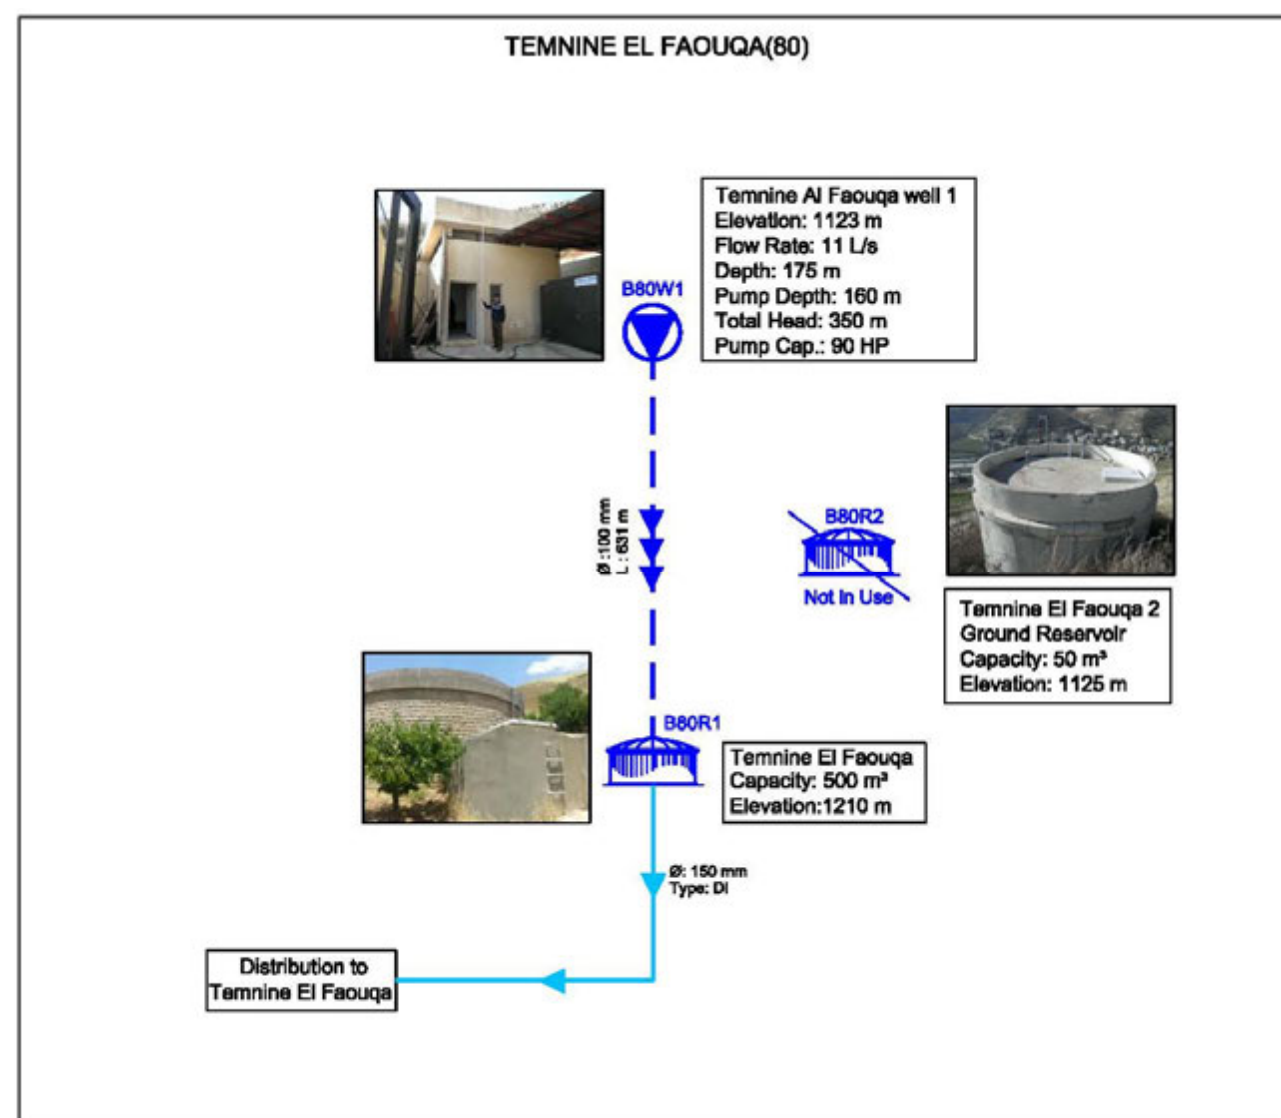
**Temnine El Faouqa (80)**

The existing water network is in good condition and it has a length of around 17 km. It covers a large area of the town.

Well B80W1 (>25 years): Well is in good condition. However, the chlorinator is not working due to leakage in the water pipe connection and the water is delivered without filtration or treatment so the water needs filtration especially in winter times due to turbulence. Also, the building needs rehabilitation especially for the control room but it is operational. The generator set is supplied with fuel from the municipality only during electrical blackouts.

Reservoir B80R1 (500 m³): Reservoir is in good condition.

Reservoir B80R2 (>10 years; 50 m³): Reservoir is in bad condition and it is not in use. It needs rehabilitation.

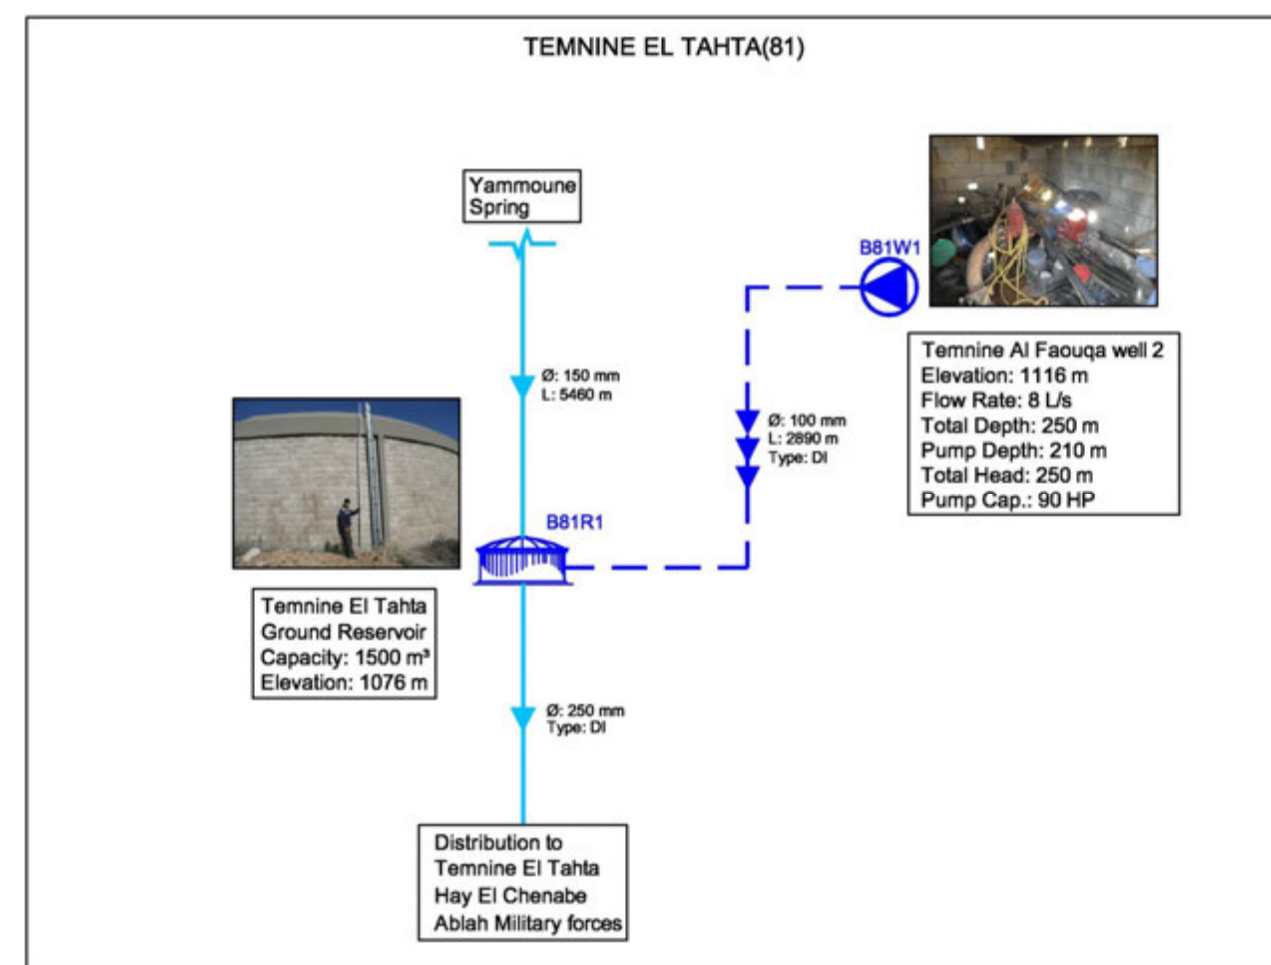
**Temnine El Tahta (81)**

The existing water network is in good condition and it has a length of around 17.3 km. It covers a large area of the town.

Well B81W1 (15 years old): Well is in bad condition. Pipes and valves shall be changed.

Reservoir B81R1 (>10 years; 1500 m³): Reservoir is in good condition.

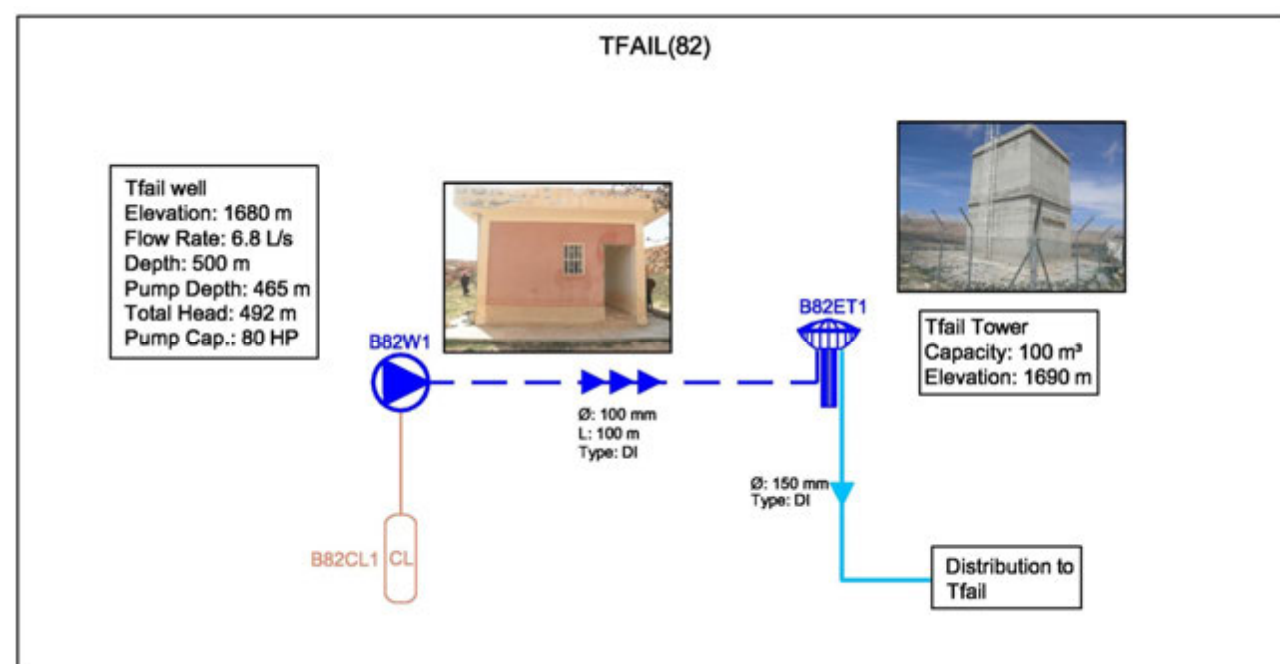
**Tfail (82)**

The existing water network is in good condition and it has a length of around 6 km. It covers a large area of the town.

Well B82W1 (>10 years): Well is not accessible but it is in use. This village cannot be reached from Lebanon.

Elevated tank B82ET1 (>10 years; 100 m<sup>3</sup>): Elevated tank is new and it is in good condition.

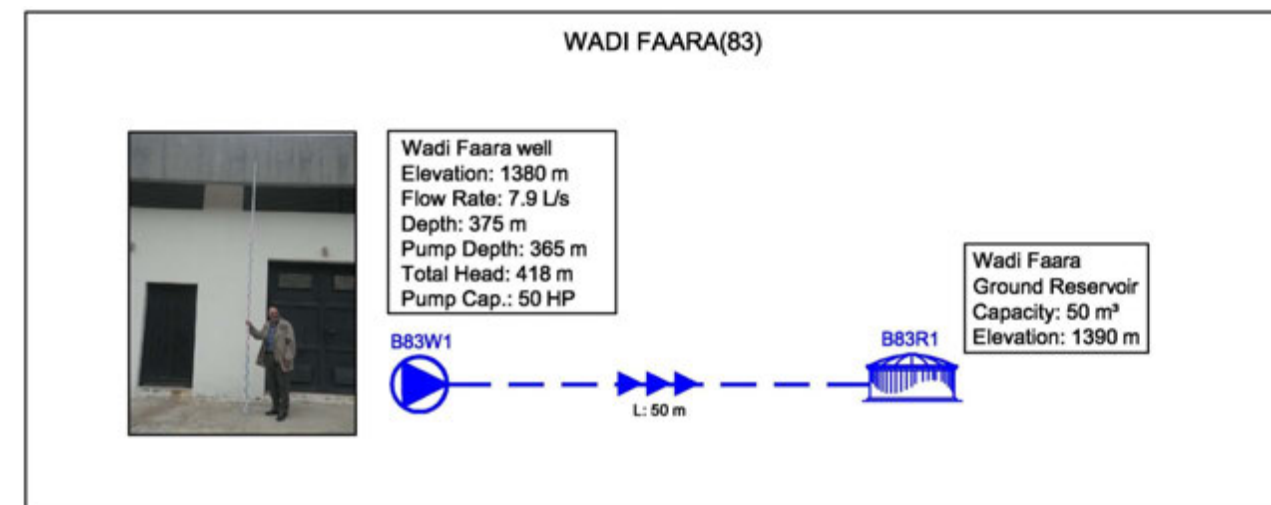
**Wadi Faara (83)**

There is no available information concerning the water network of the town.

Well B83W1 (20 years old): Well is in an acceptable condition. No available information.

Reservoir B83R1 (50 m<sup>3</sup>): No available information.

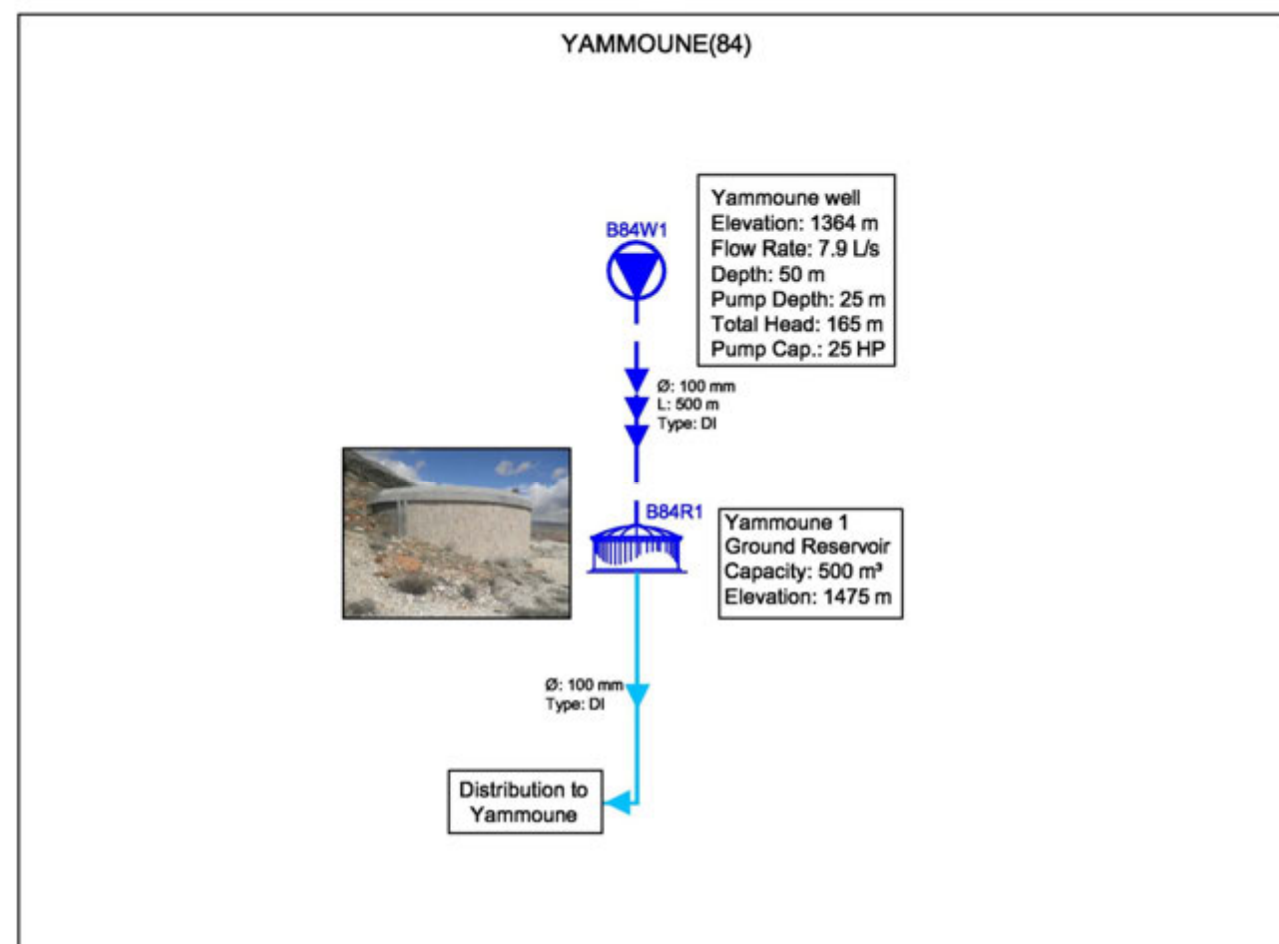
**Yammoune (84)**

The existing water network is in good condition and it has a length of around 7.6 km. It covers a large area of the town.

Well B84W1 (20 years old): Well is in good condition.

Reservoir B84R1 (10 years old; 500 m³): Reservoir is in good condition but it is not in use because there is no water source.

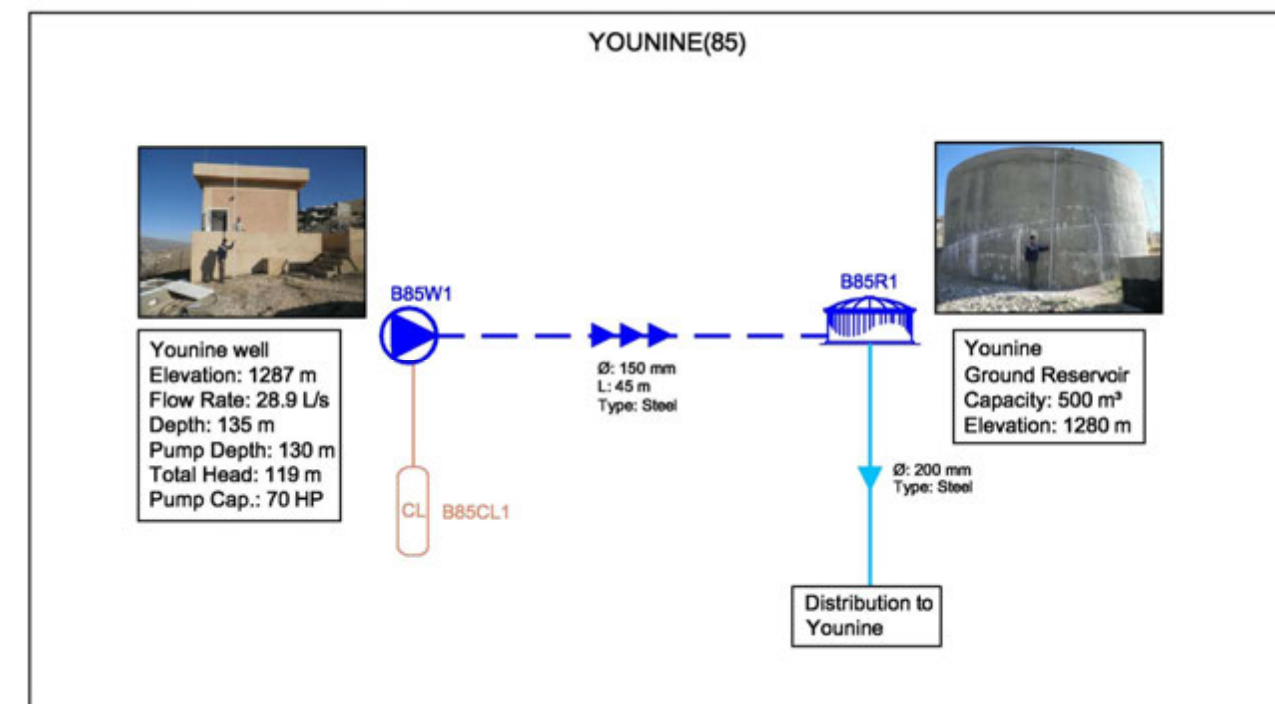
**Younine (85)**

The existing water network is in good condition and it has a length of around 38 km. It covers a large area of the town.

Well B85W1 (20 years old): Well is in good condition. It has new power generator.

Reservoir B85R1 (>10 years; 500 m³): Reservoir is in good condition.
