# WATER SUPPLY AND WASTEWATER SYSTEMS MASTER PLAN FOR THE BEKAA WATER ESTABLISHMENT

## WATER ASSESSMENT REPORT

January 2014  
Updated May 2015

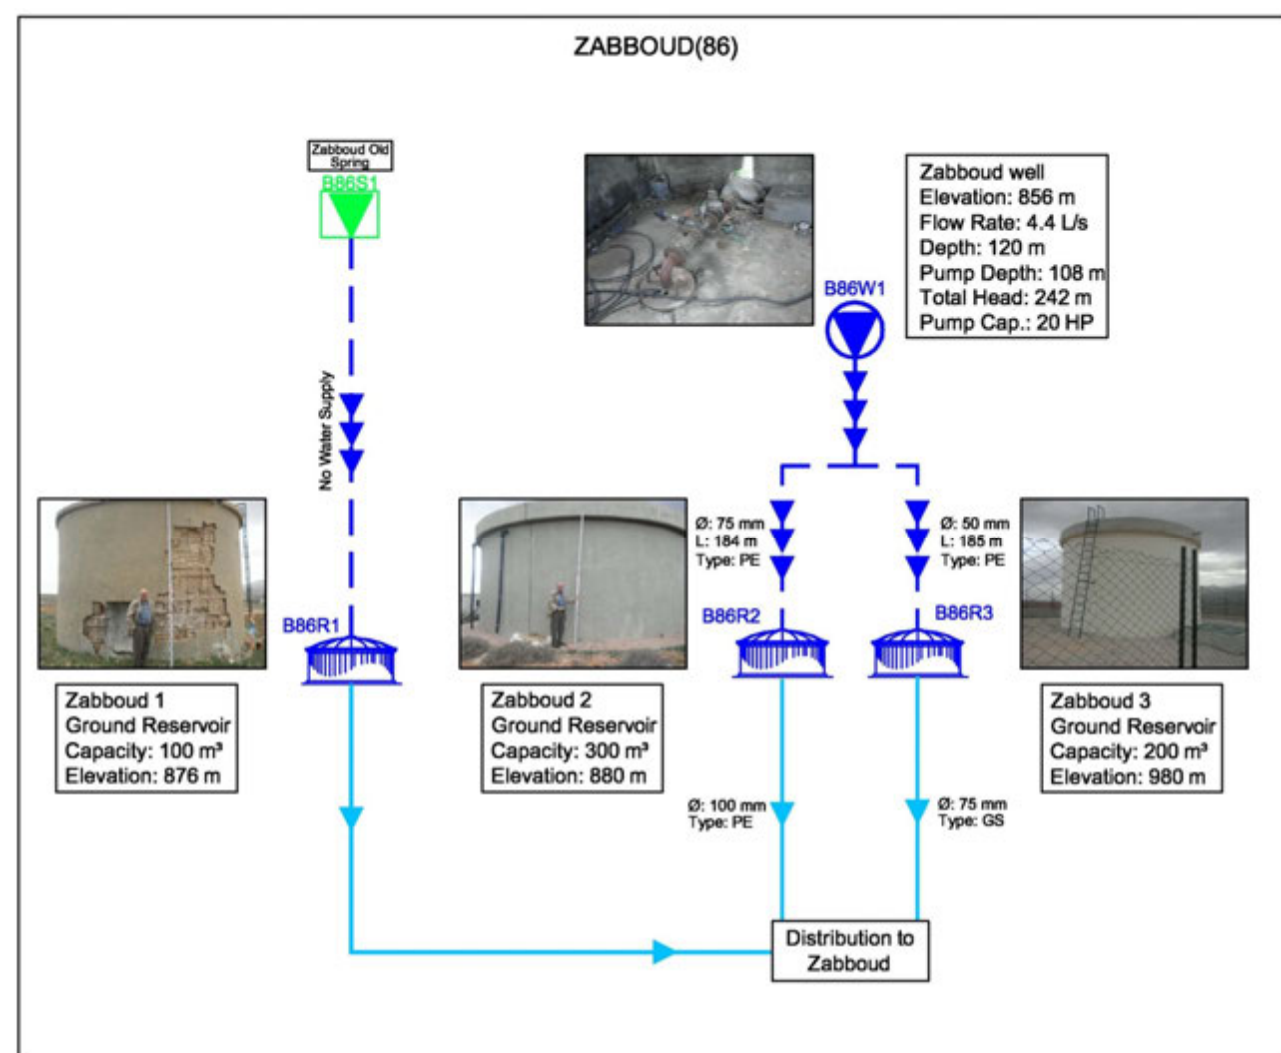
**Zabboud (86)**

The existing water network is 40 years old and it is in bad condition.

Well B86W1 (45 years old): Well is in bad condition but it suffers from a shortage of electric power. Its building needs rehabilitation. Pipes and valves are rusted and they need to be changed. This well needs rehabilitation.

Reservoir B86R1 (50 years old; 100 m³): Reservoir is in bad condition. It needs esthetical and structural rehabilitation or reconstruction. The pipes and valves are rusted and they need maintenance.

Reservoir B86R2 (>10 years; 300 m³): Reservoir is in good condition.

Reservoir B86R3 (10 years old; 200 m³): Reservoir is in good condition.

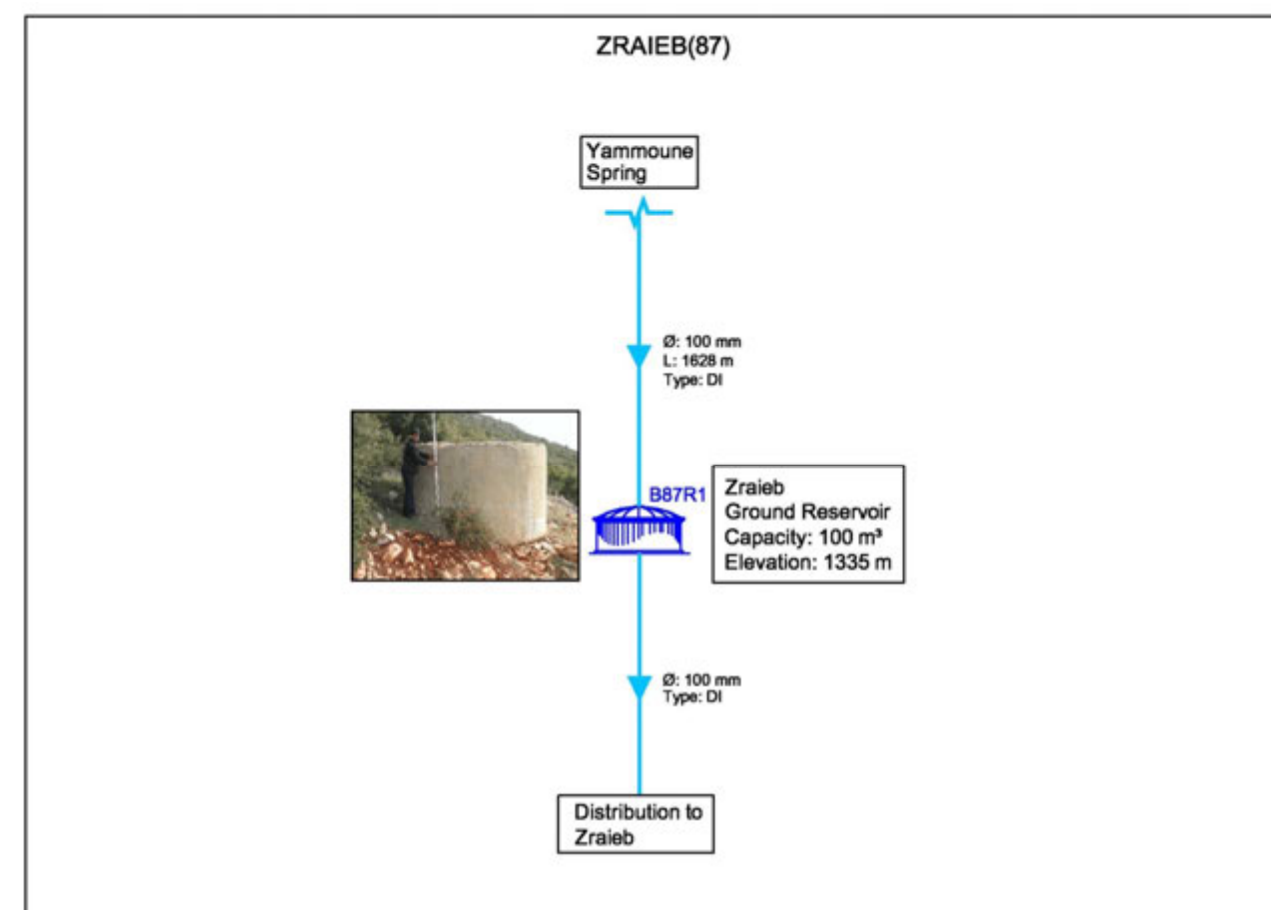
**Zraieb (87)**

The existing water network is in good condition and it has a length of around 4.2 km. It covers a large area of the town.

Reservoir B87R1 (>10 years; 100 m³): Reservoir is in bad condition. Yammoune water is not reaching the town. This reservoir needs rehabilitation.

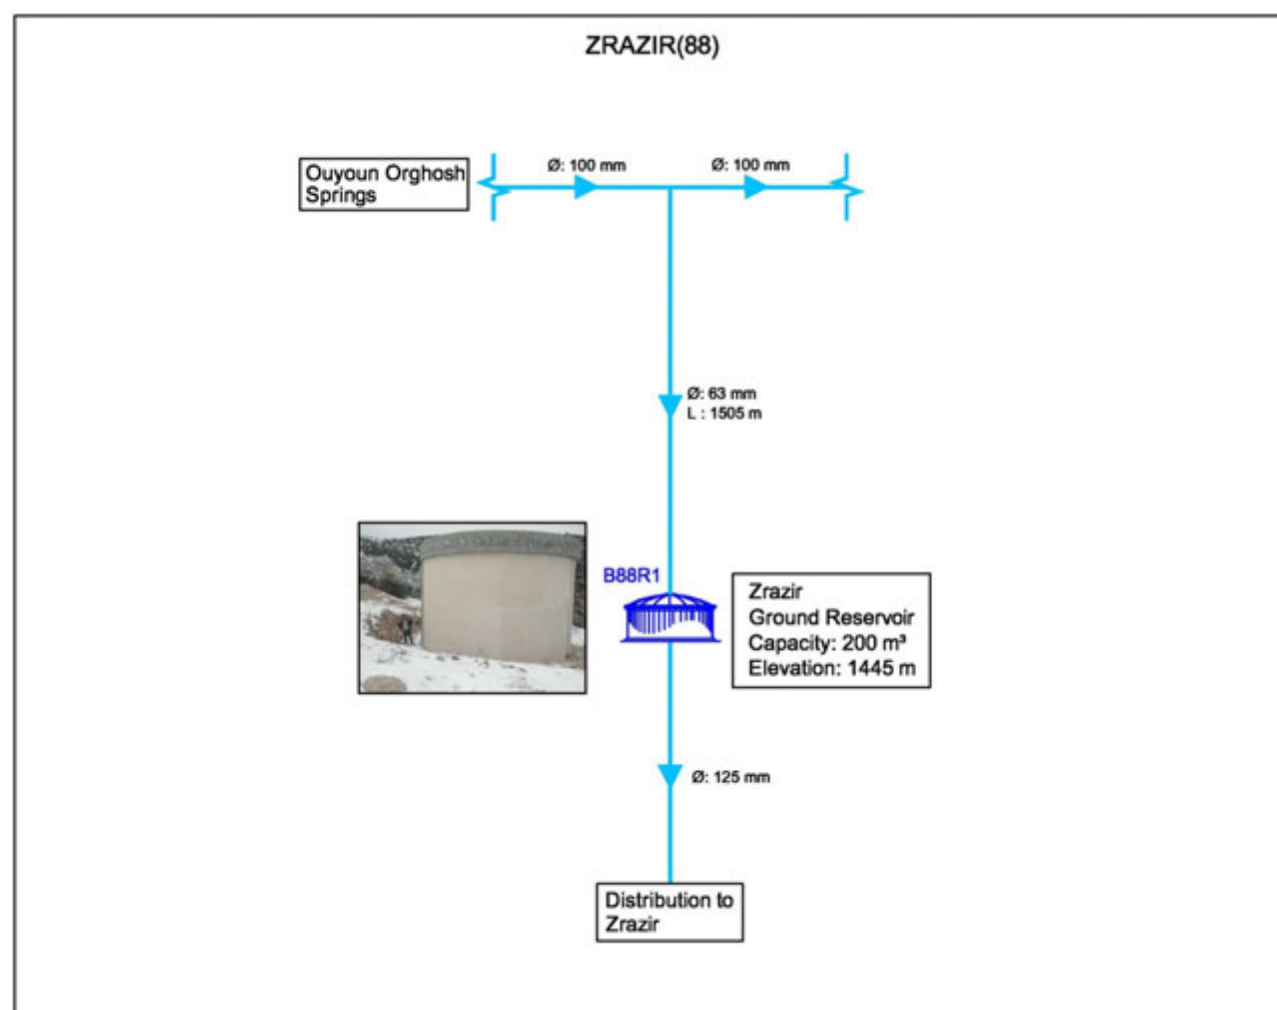
## Zrazir (88)

There is no available information concerning the water network of the town.

Reservoir B88R1 (200 m³): Reservoir is in good condition.

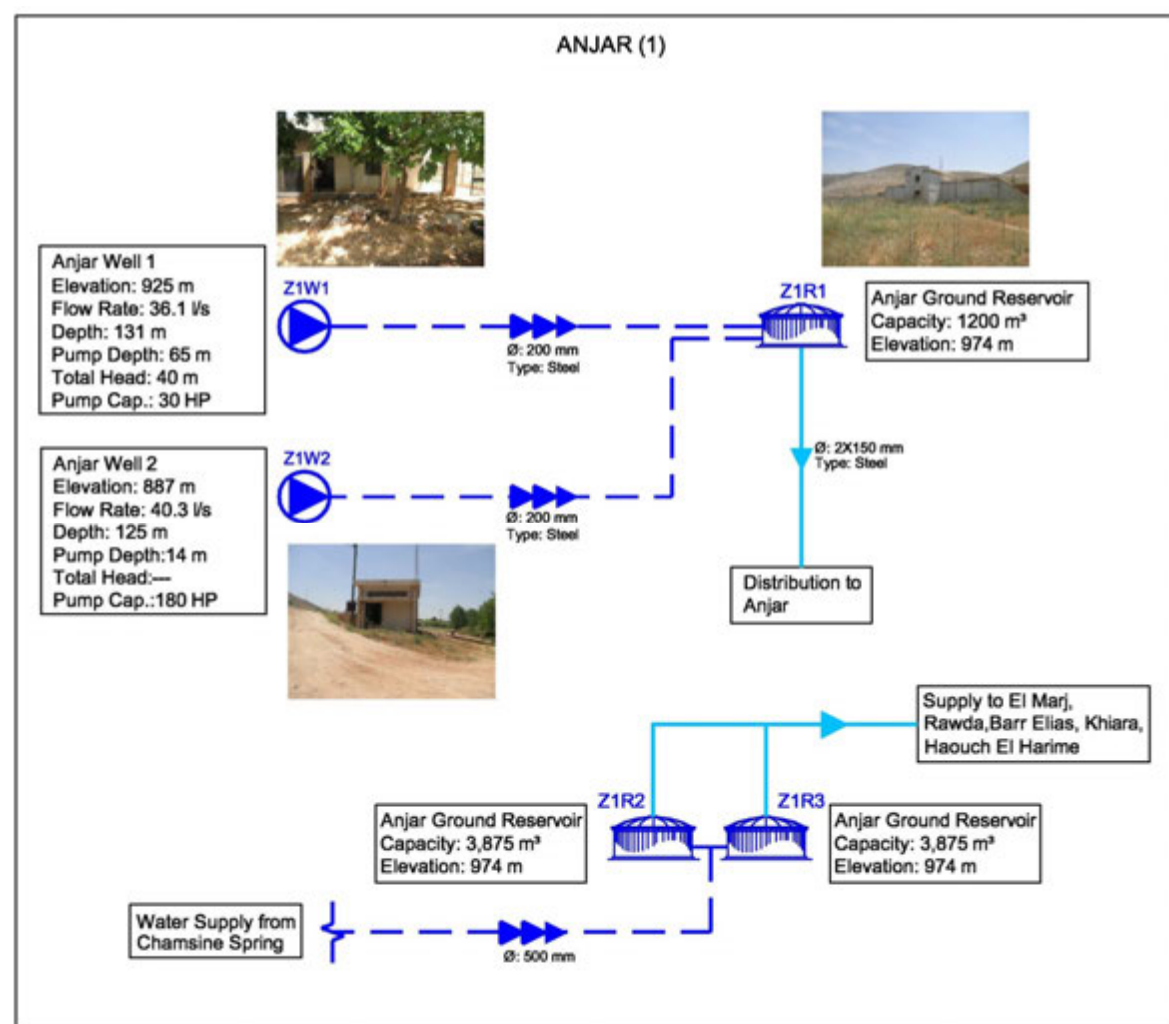
**Anjar (1)**

The existing water network is in very good condition and it has a length of around 27 km. It covers a large area of the town.

Well Z1W1 (15 years old): No information available.

Reservoir Z1R1 (>65 years; 1200 m³): Reservoir is old. Its pipes are rusted. This reservoir needs structural and architectural rehabilitations.

Reservoir Z1R2 (3875 m³): Reservoir is new and it is in good condition.

Reservoir z1R3 (3875 m³): Reservoir is new and it is in good condition.

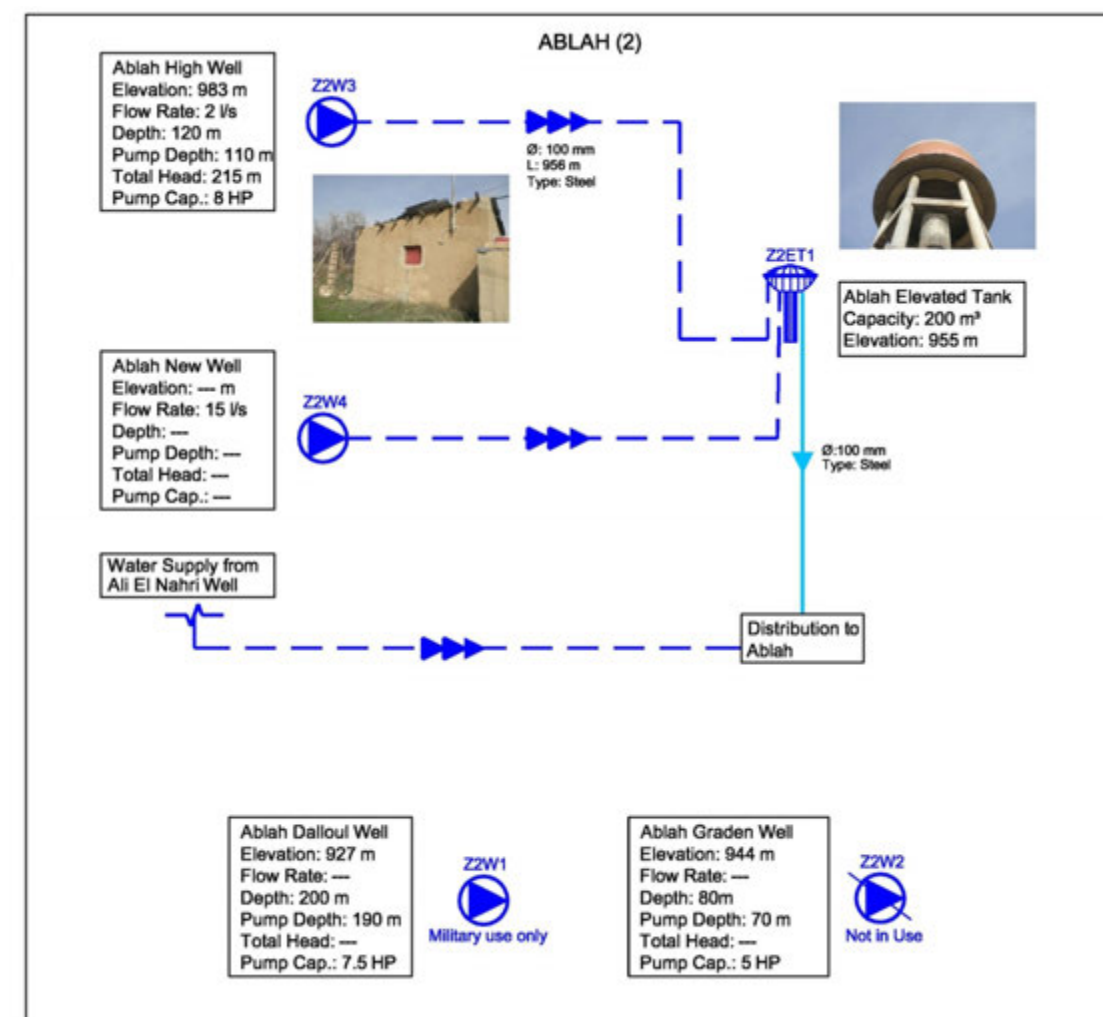
**Ablah (2)**

The existing water network is in medium condition and it has a length of around 9 km. It covers a part of the town.

Well Z2W1: Well is used only for military purposes. There is no direct water outlet.

Well Z2W3 (20 years old): Well is in bad condition and it suffers from a shortage of electric power. It was constructed 10 years ago.

Well Z2W4: Well is new and it is in good condition.

Elevated tank Z2ET1 (>15 years; 200 m³): It was constructed in year 1998. It is not in bad condition but it needs structural rehabilitation.

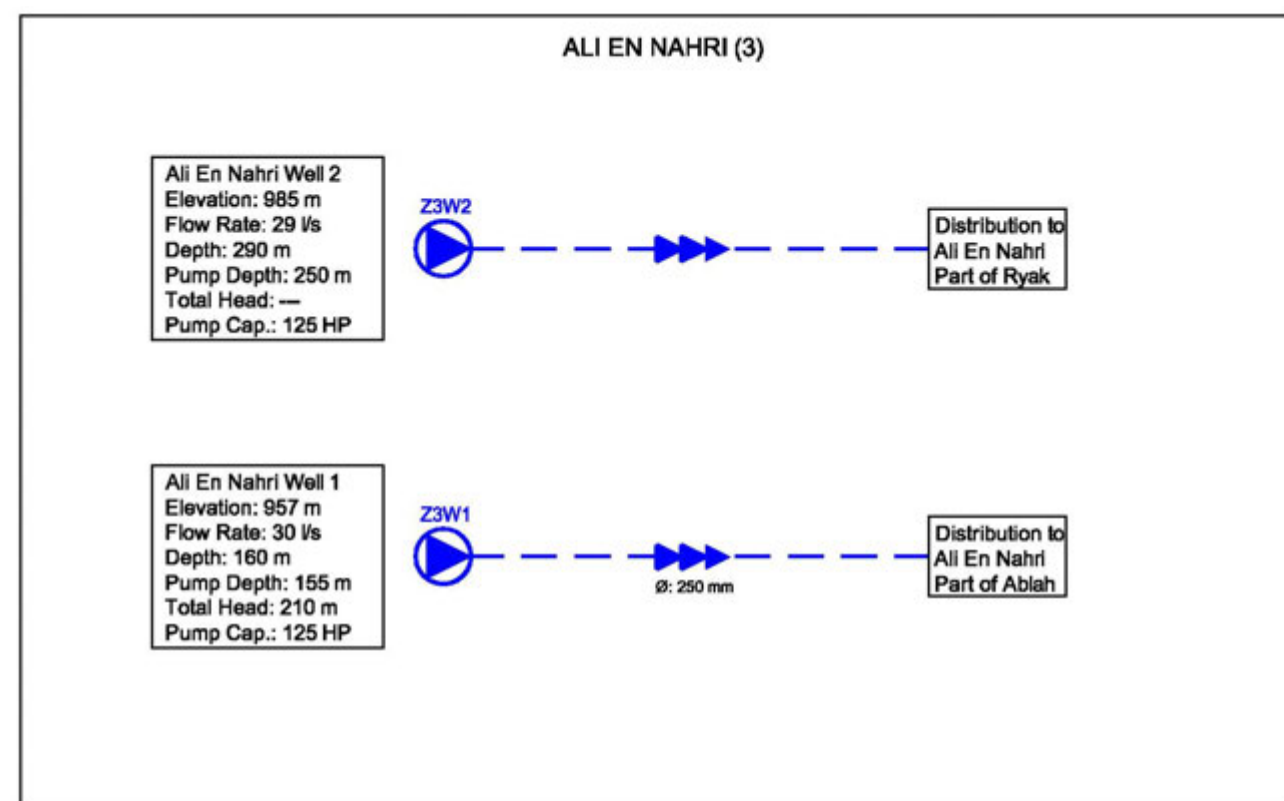
**Ali En Nahri (3)**

The existing water network is in medium condition and it has a length of around 16 km. It covers a large area of the town.

Well Z3W1 (>15 years): Well is very old but lately it was rehabilitated. It is not equipped to take electricity from the power point. Power will be supplied to the well by a private generator.

Well Z3W2 (10 years old): Well is in good condition. It was constructed in year 2007. A room contains two reservoirs 2 m<sup>3</sup> each. Also there is a very old reservoir with a volume of 10 m<sup>3</sup> but it is not used.

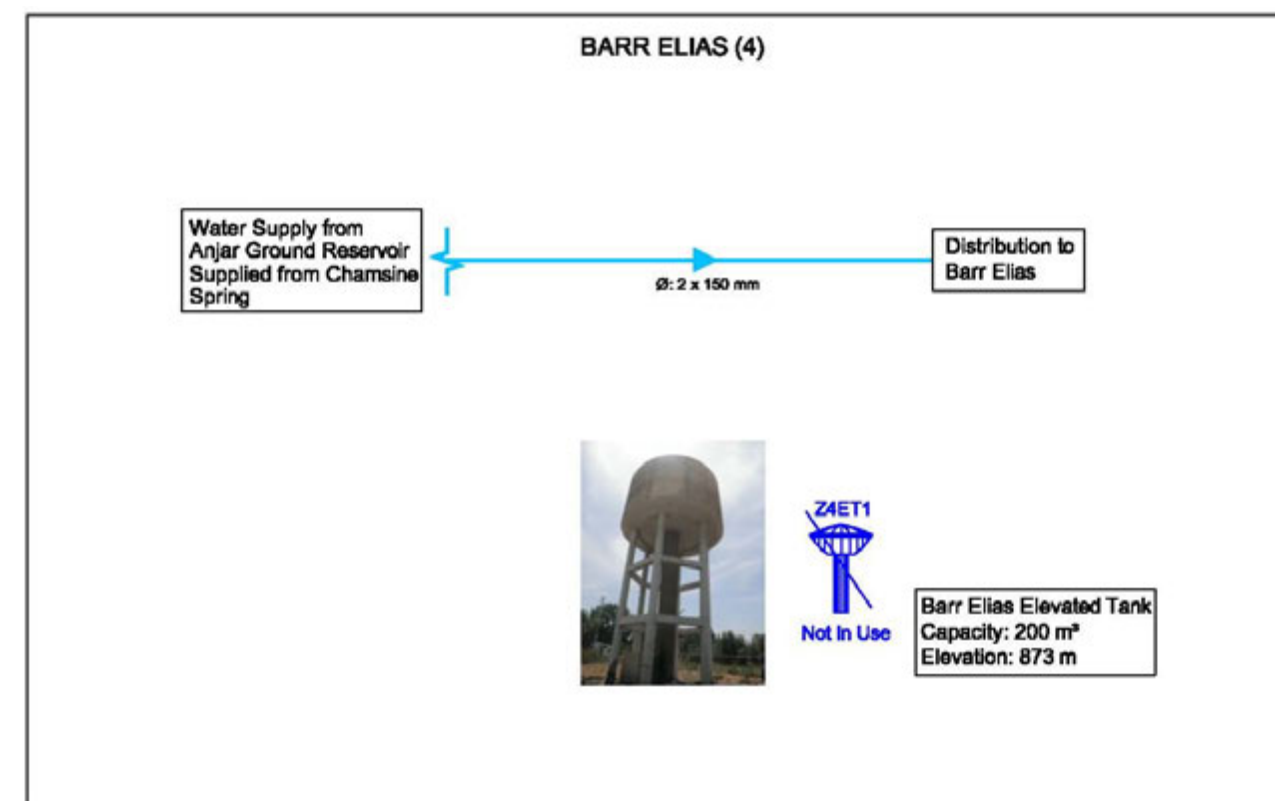
**Barr Elias (4)**

The existing water network is in very good condition and it has a length of around 82 km. It covers a large area of the town

Elevated tank Z4ET1 (200 m<sup>3</sup>): Elevated tank is not in use.

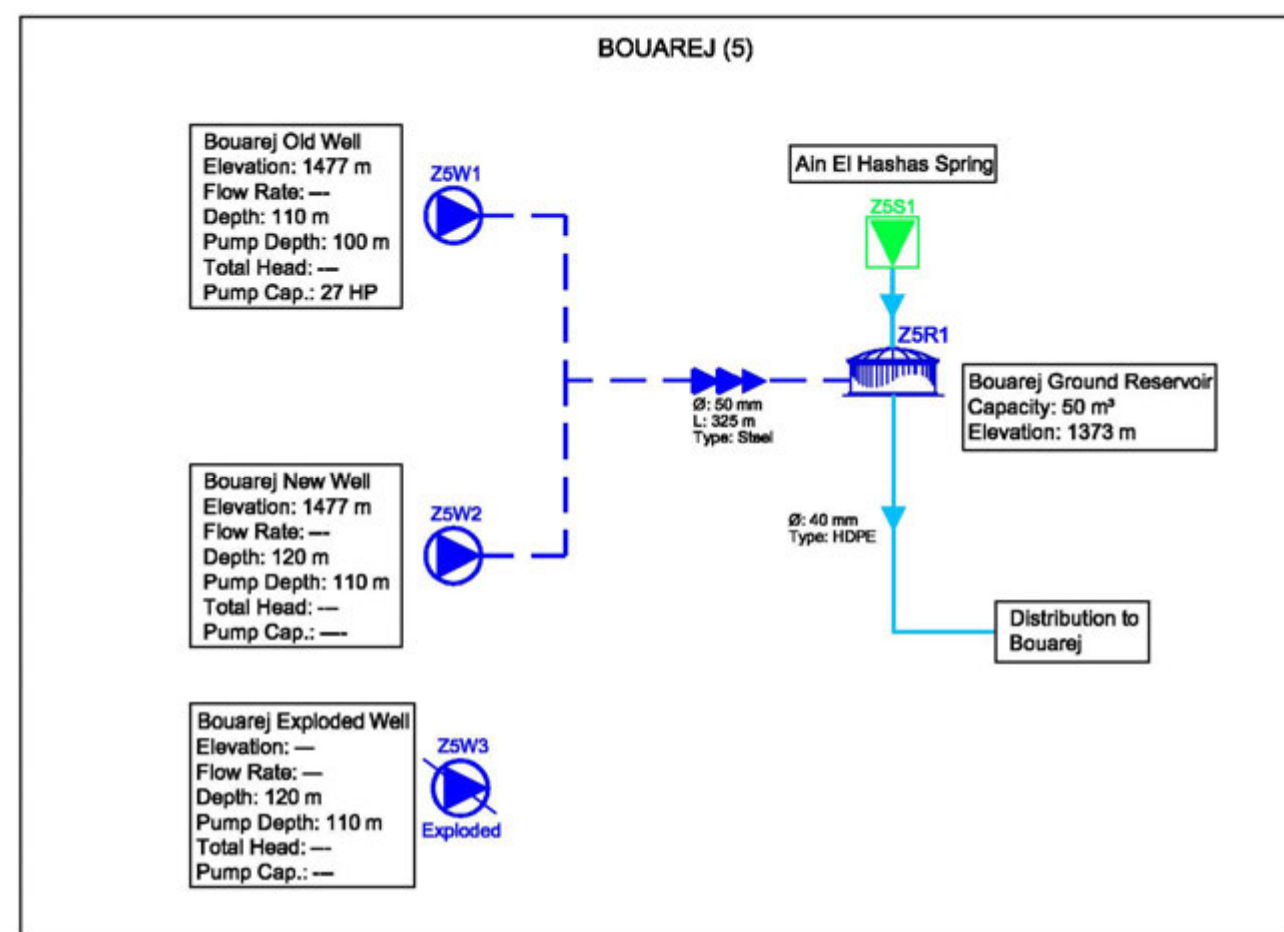
**Bouarej (5)**

The existing water network is in bad condition and it has a length of around 8 km. It covers a large area of the town.

Well Z5W1 (20 years old): No information available.

Reservoir Z5R1 (50 m³): No information available.

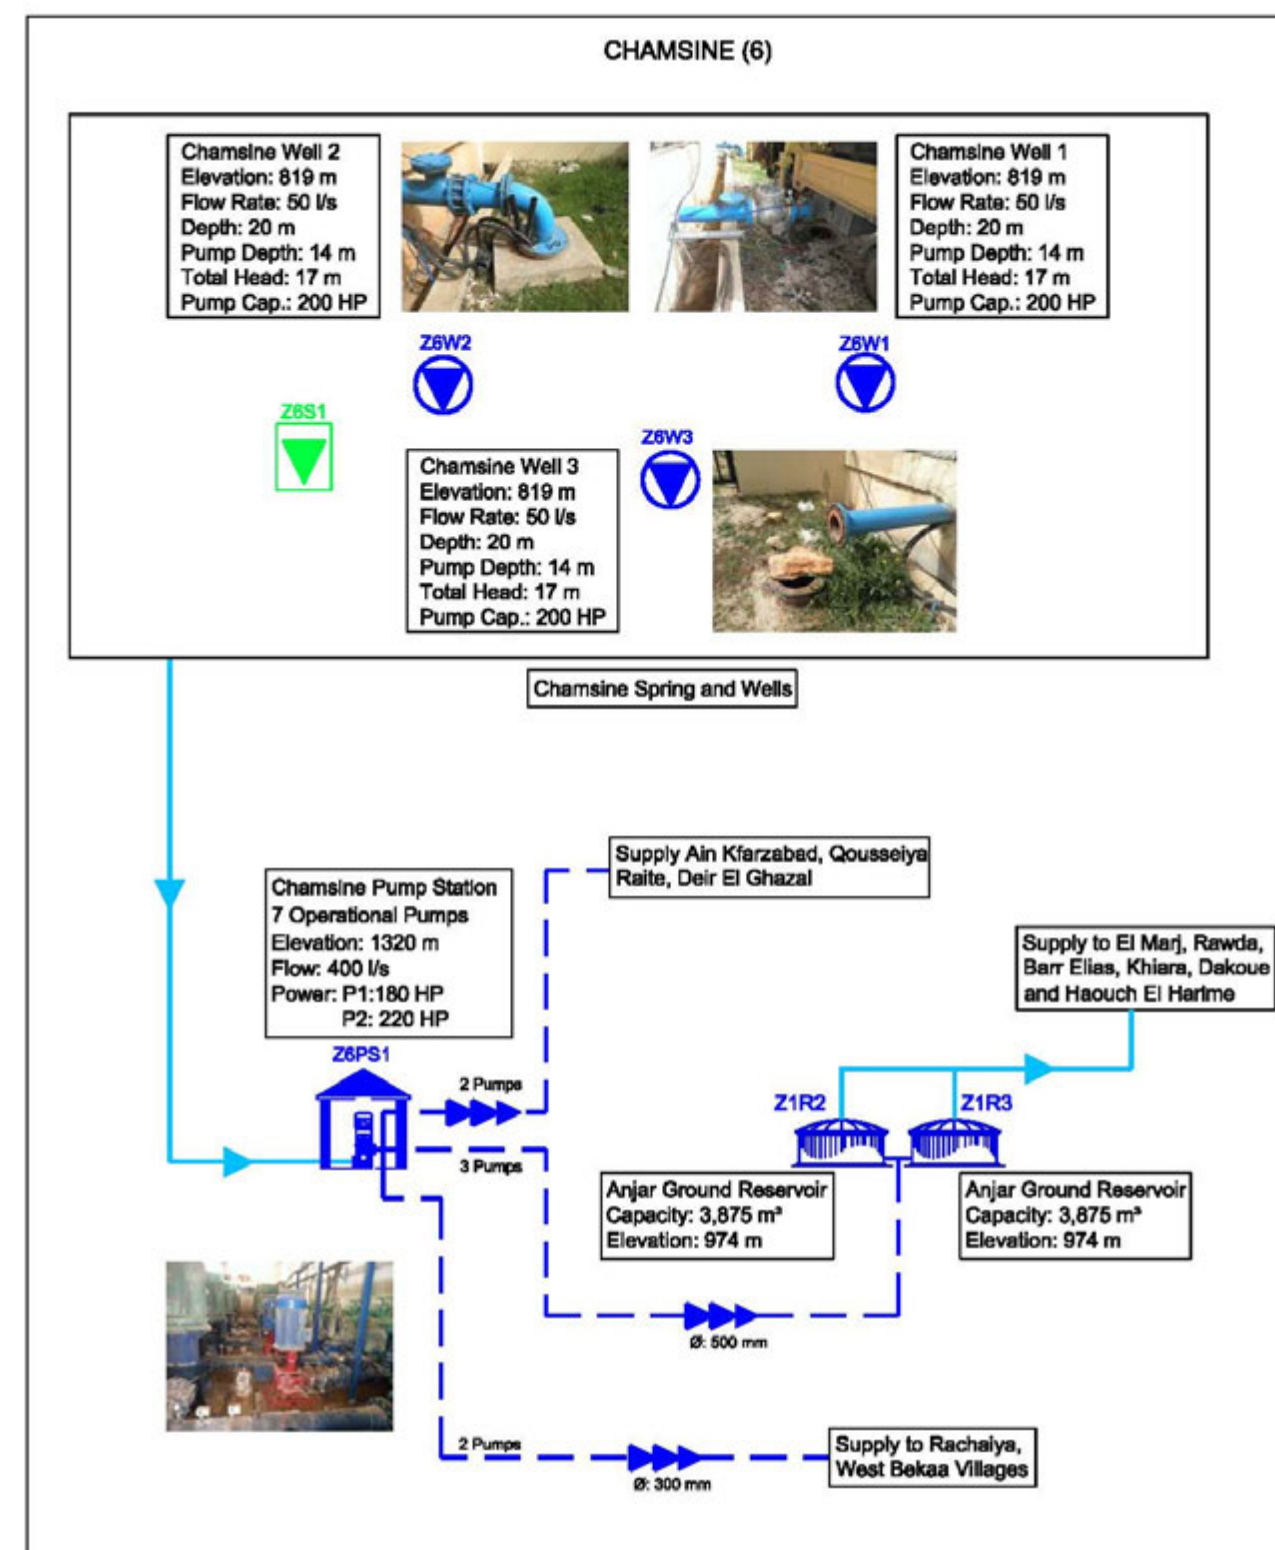
**Chamsine (6)**

Wells Z6W1 (<5 years) & Z6W2 (<5 years) & Z6W3 (<5 years): Wells are in good condition.

Spring Z6S1: The estimated safety yield for this spring is about 214 l/s.

Pump station Z6PS1: Pump station is old but it is in good condition.

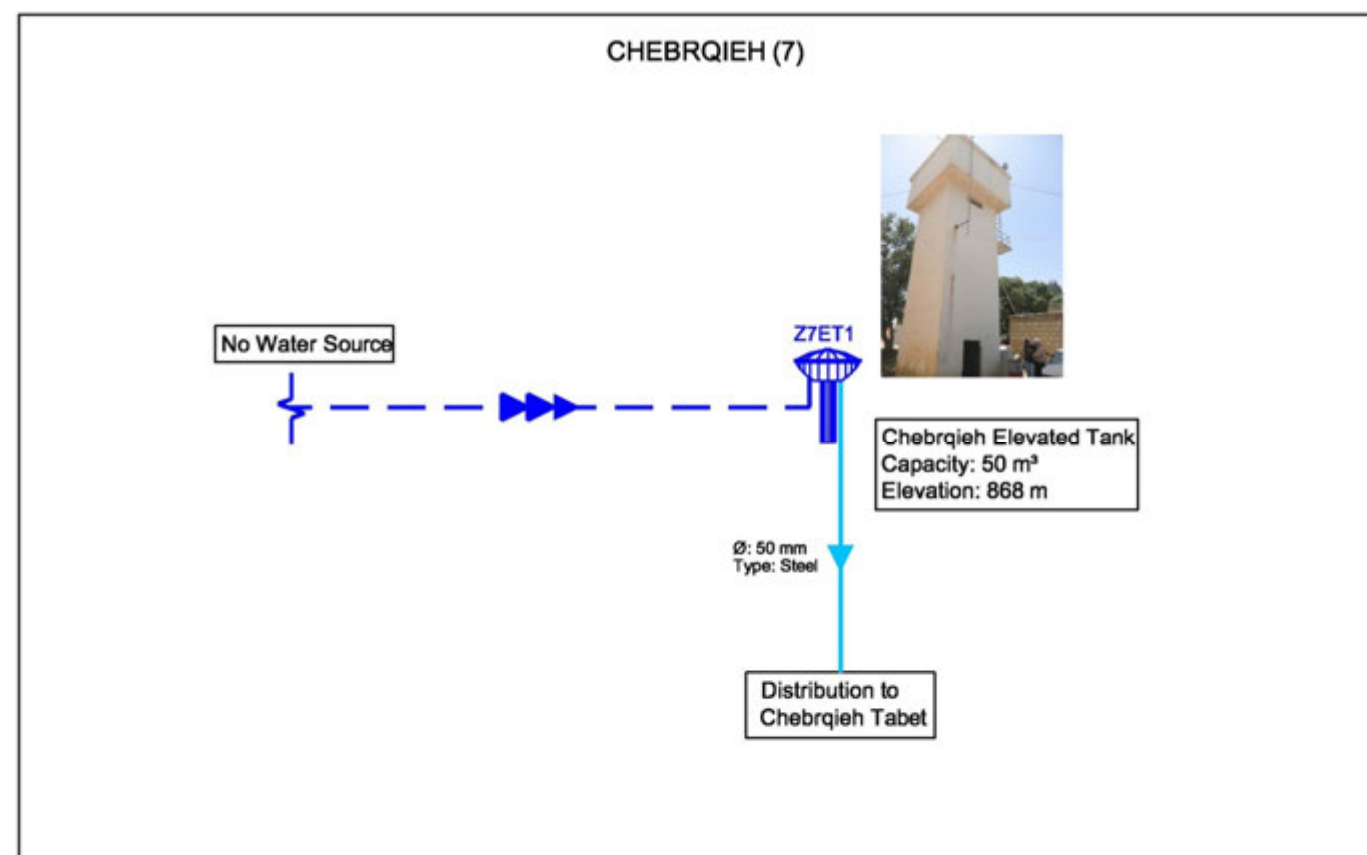
**Chebrqieh (7)**

The existing water network is very old (more than 30 years) and it is in bad condition. Most areas of this village are industrial. There is a problem regarding water supply between Chebrqieh and surrounding villages.

Elevated tank Z7ET1 (>60 years; 50 m³): Elevated tank is very old and it is not in use because no water source exists.

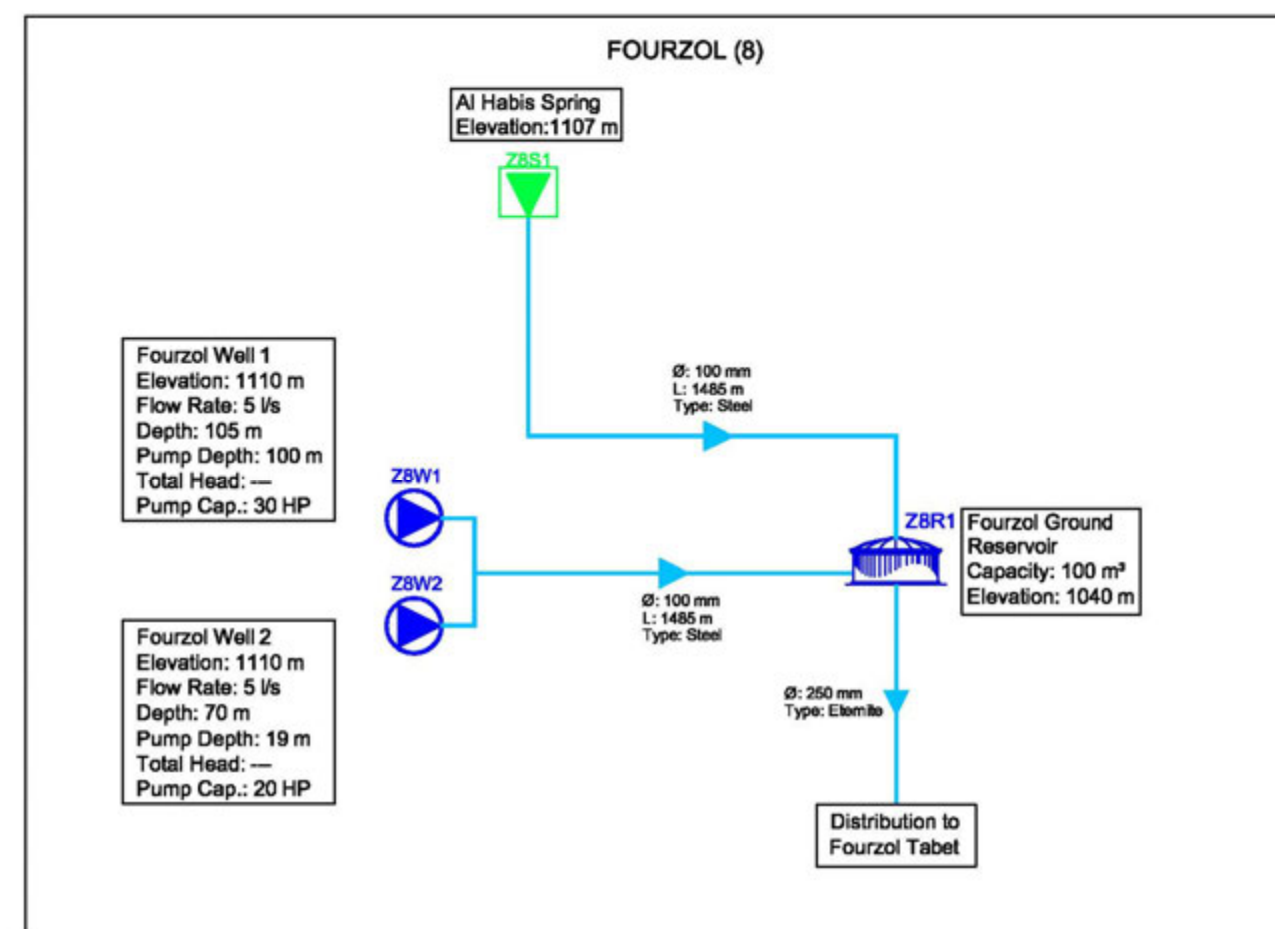
**Fourzol (8)**

The existing water network is in bad condition and it has a length of around 21 km. It covers a large area of the town.

Well Z8W1 (>45 years), Well Z8W2 (>45 years), Spring Z8S1, Reservoir Z8R1: no information available.

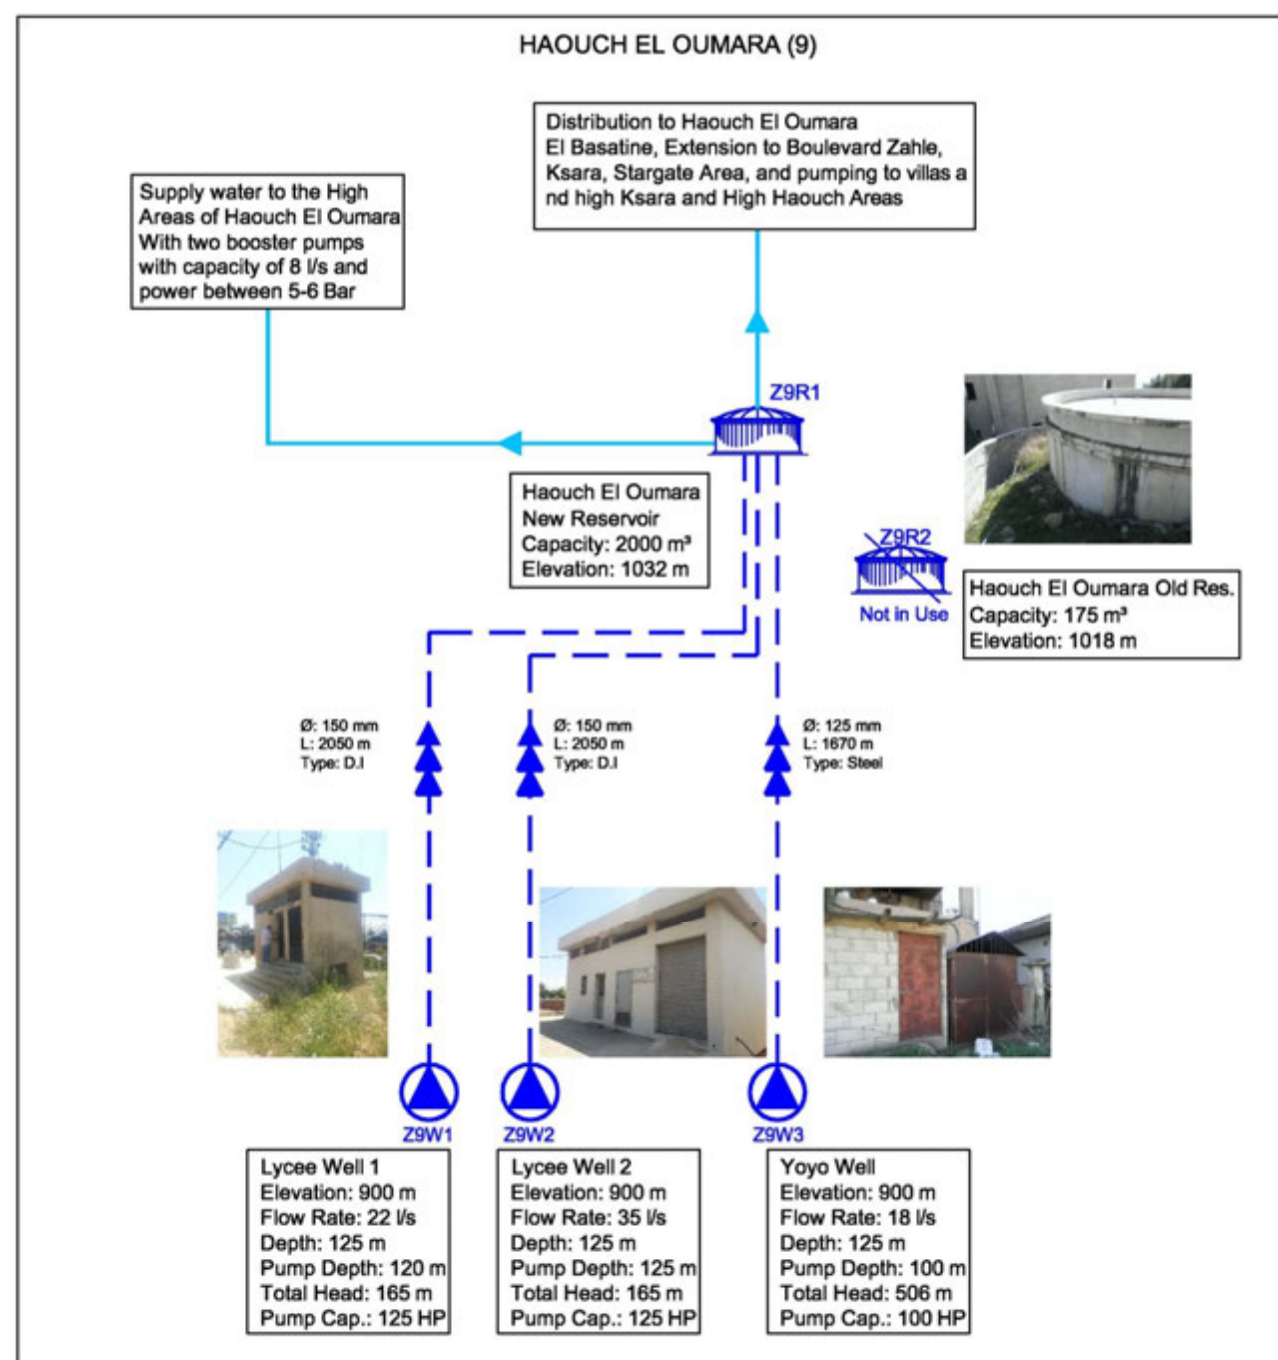
**Haouch El Oumara (9)**

A new network was installed and it is in excellent condition. It covers a large area of Haouch el Oumara

Well Z9W1 (15 years old): Well is not in bad condition but it suffers from a shortage of electric power. It was constructed 30 years ago.

Well Z9W2: Well is not in bad condition but it suffers from a shortage of electric power. It was constructed 10 years ago.

Reservoir Z9R1 (>10 years; 2000 m<sup>3</sup>): Reservoir is not in very bad condition, but it needs rehabilitation. A fence must be constructed to protect the facility.

Reservoir Z9R2 (175 m<sup>3</sup>): It is in very good condition; however it needs some minor maintenance (changing some valves, pipes...). This reservoir is not in use anymore.

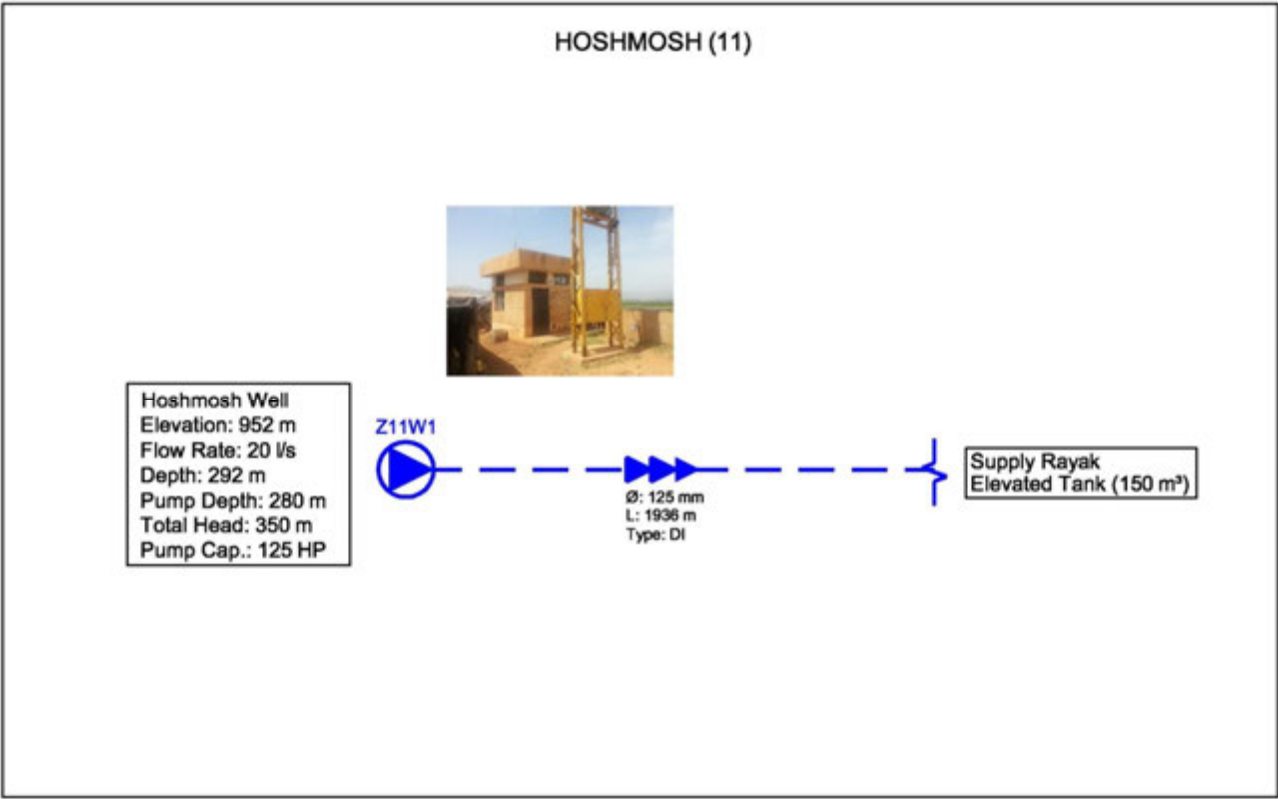
**Hoshmosh (11)**

There is no water existing network in this town. Water is transmitted from Hoshmosh well to Rayak elevated tank.

Well Z11W1: This well was constructed in year 2003. It is in good condition but it suffers from a shortage of electric power; however, its chamber needs some minor maintenance.

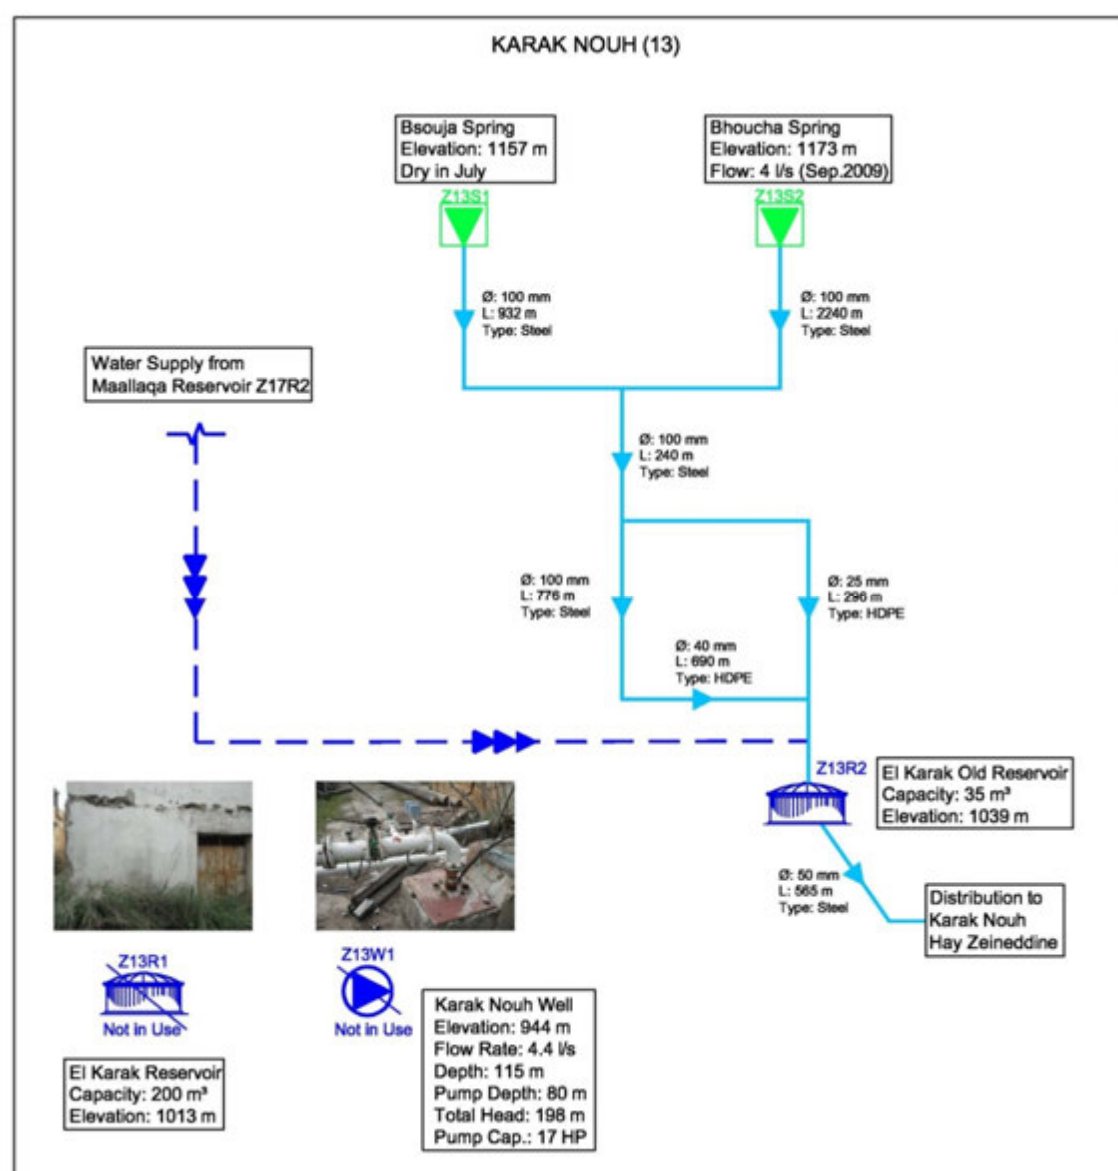
**Karak Nouh (13)**

The existing water network is very old (more than 30 years) and it is in bad condition. This network includes only two main pipe lines.

Well Z13W1 (50 years old): Well is not in use because it is muddy. It needs cleaning and rehabilitation or new boring. A chlorination room exists but it is not equipped.

Reservoir Z13R1 (200 m³): Reservoir is very old but it is in bad condition. Its pipes are rusted and need to be changed. This reservoir needs structural and architectural rehabilitations or reconstruction. This reservoir is not in use anymore.

Reservoir Z13R2 (35 m³): Reservoir is very old. No more available information.

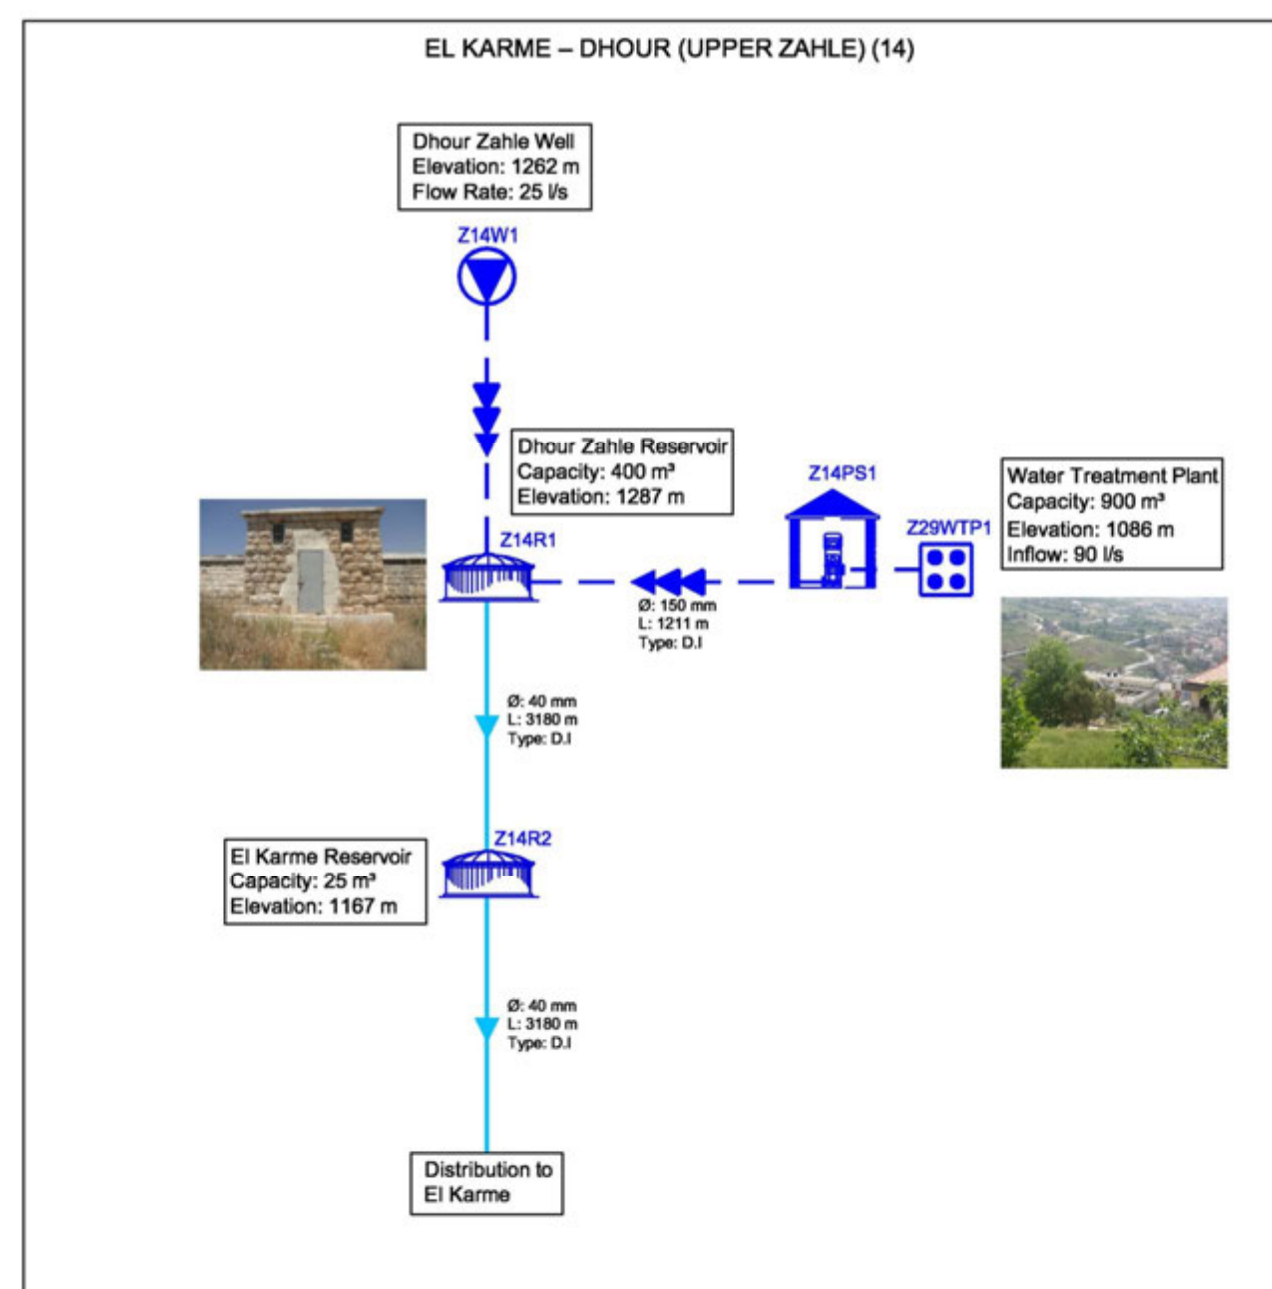
**El Karame – Dhour (Upper Zahle) (14)**

There is an old network in El Karame but it is in acceptable condition.

Well Z14W1: No available information.

Pump station Z14PS1: Pump station is old. Some pipes are rusted and they need to be changed. This pump station needs rehabilitation.

Reservoir Z14R2 (25 m³): No available information.

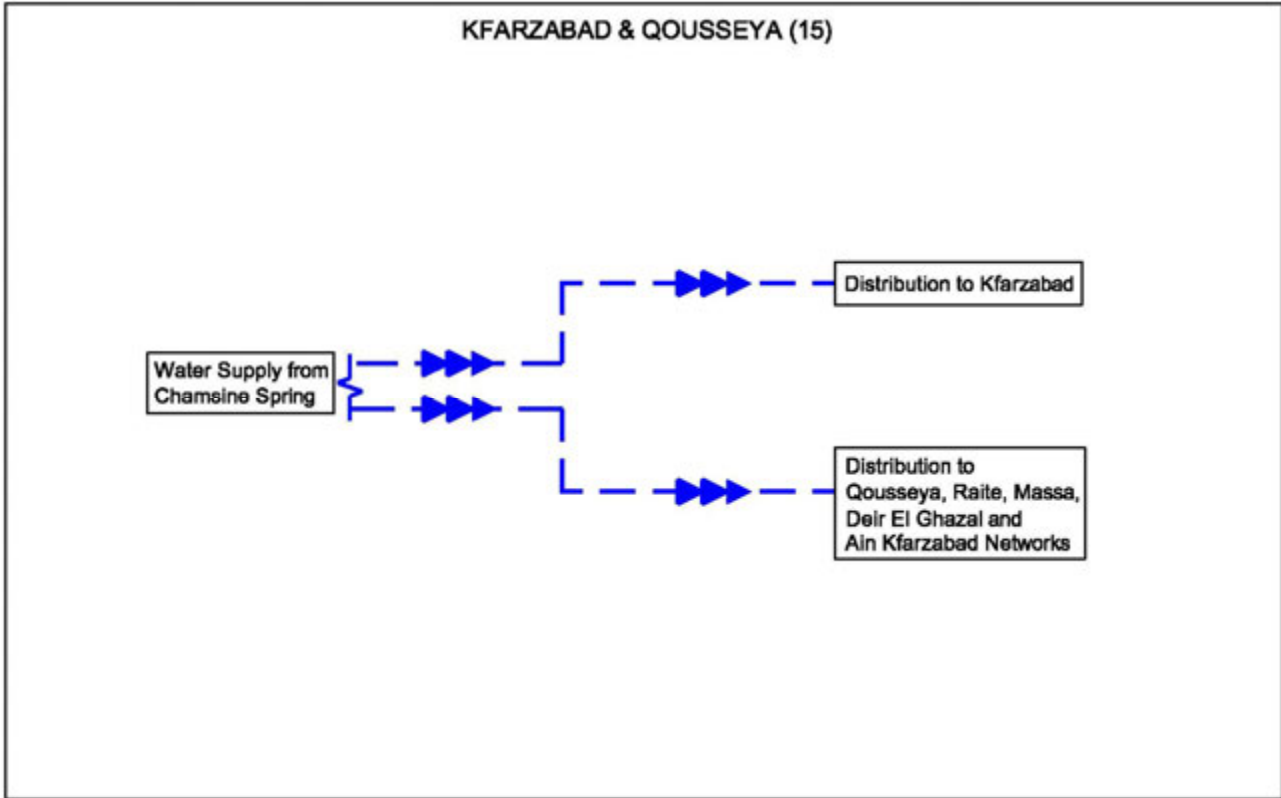
**Kfarzabad & Qousseya (15)**

The existing water network is in very good condition and it has a length of around 48 km. It covers a large area of the town.

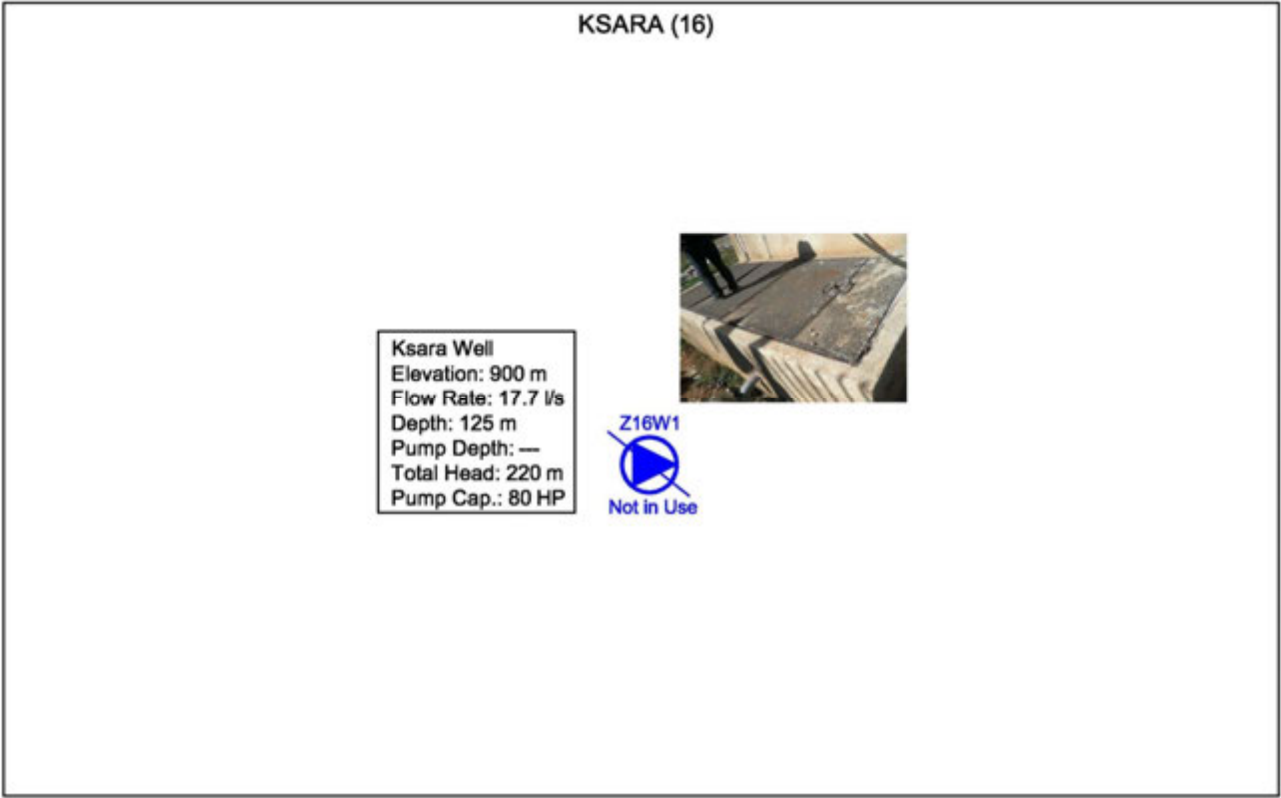
**Ksara (16)**

Water is supplied from Haouch El Oumara new network.

Well Z16W1: well is not in use. It has a chlorination system.
