# WATER SUPPLY AND WASTEWATER SYSTEMS MASTER PLAN FOR THE BEKAA WATER ESTABLISHMENT

## WATER ASSESSMENT REPORT

January 2014  
Updated May 2015

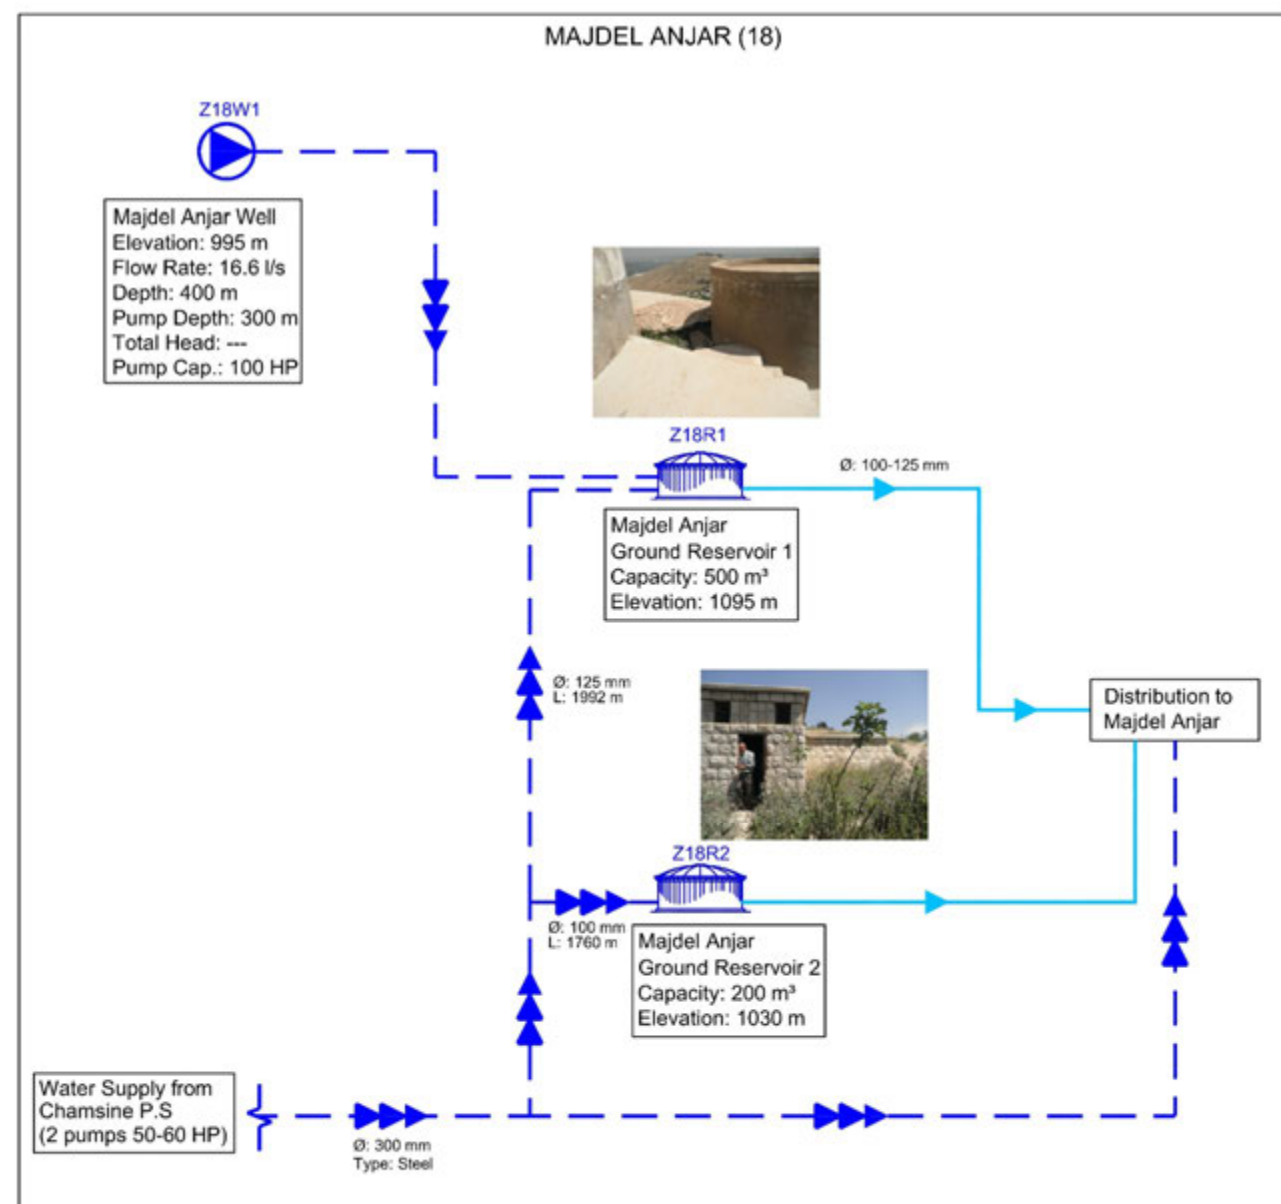
**Majdel Anjar (18)**

The existing water network is in very good condition and it has a length of around 77 km. It covers a large area of the town.

Well Z18W1 (>5 years): This well was constructed 7 years ago. It is not in bad condition but it suffers from a shortage of electric power.

Reservoir Z18R1 (55 years old; 500 m³): Reservoir is old and it is in bad condition. It needs esthetical and structural rehabilitations.

Reservoir Z18R2 (>25 years; 200 m³): Reservoir is very old and in bad condition. It needs reconstruction.

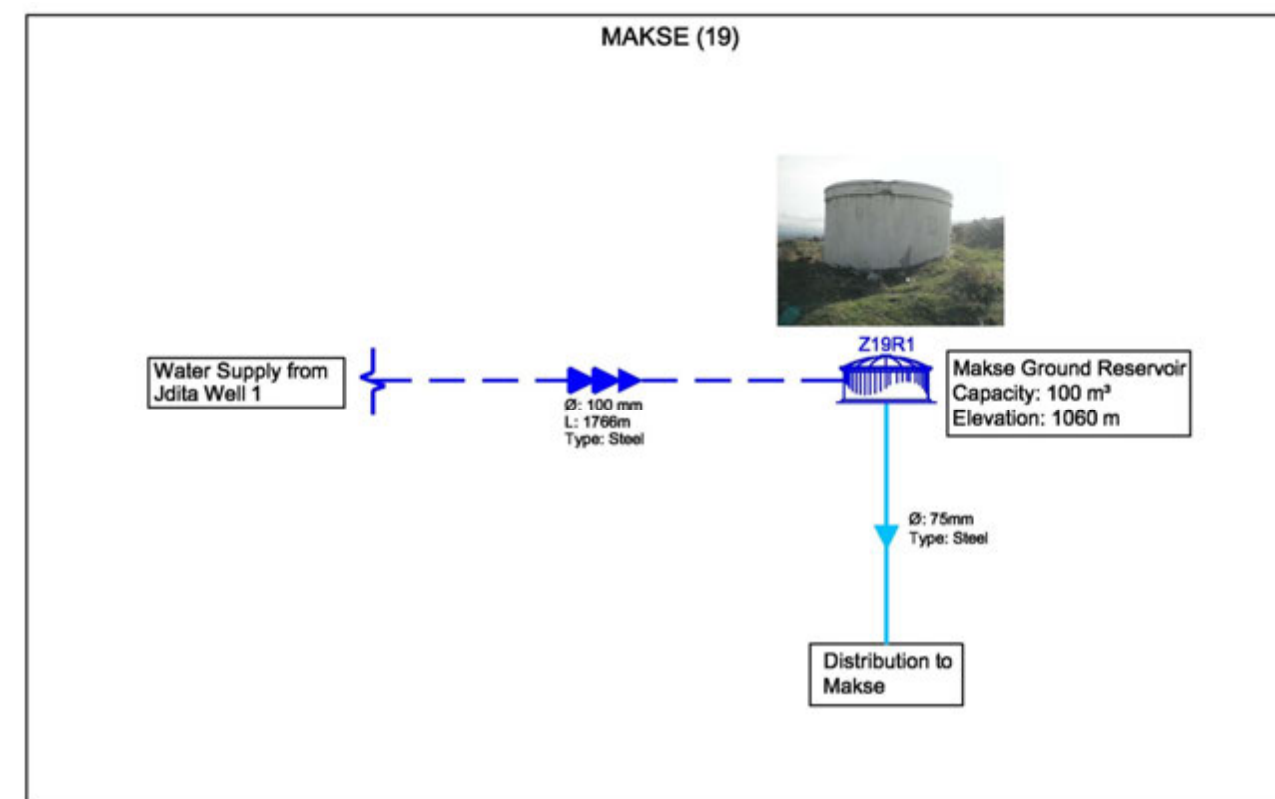
**Makse (19)**

The existing water network is in good condition and it has a length of around 4 km. It covers a large area of the town.

Reservoir Z19R1 (>45 years; 100 m³): Reservoir is old. It needs some maintenance and esthetical rehabilitation.

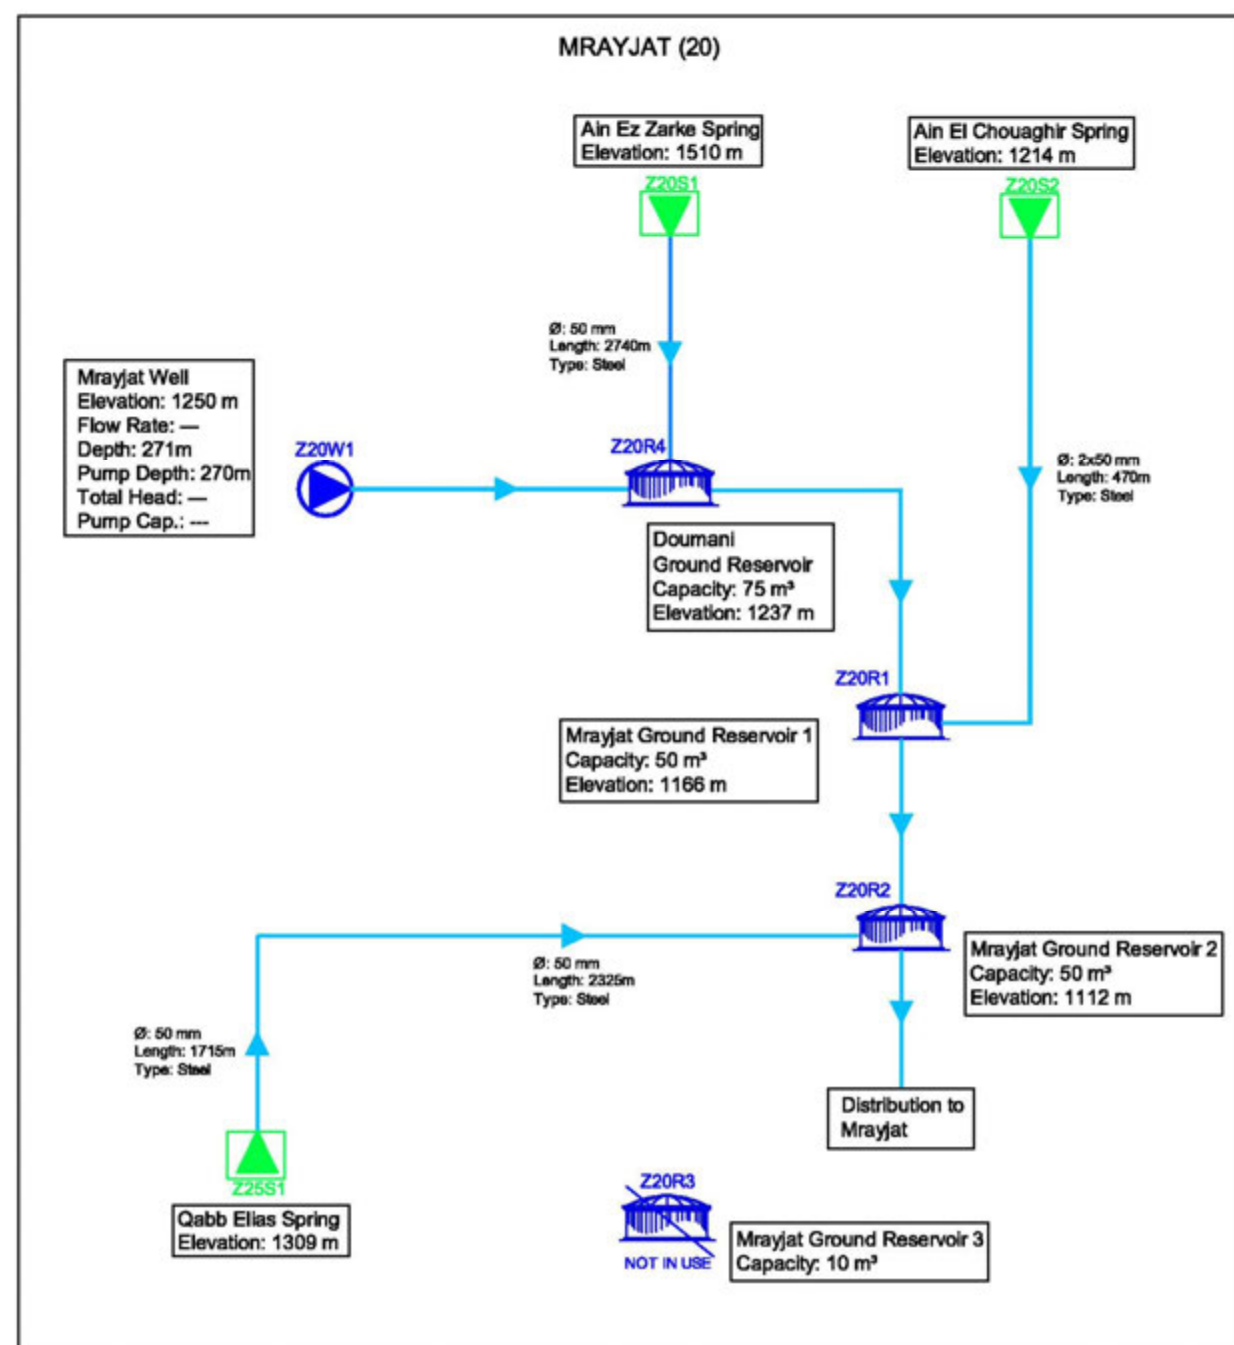
## Mrayjat (20)

No available information.

Well Z20W1 (>10 years), Springs Z20S1, Z20S2, Reservoirs Z20R1, Z20R2, Z20R3 & Z20R4:  
No available information.

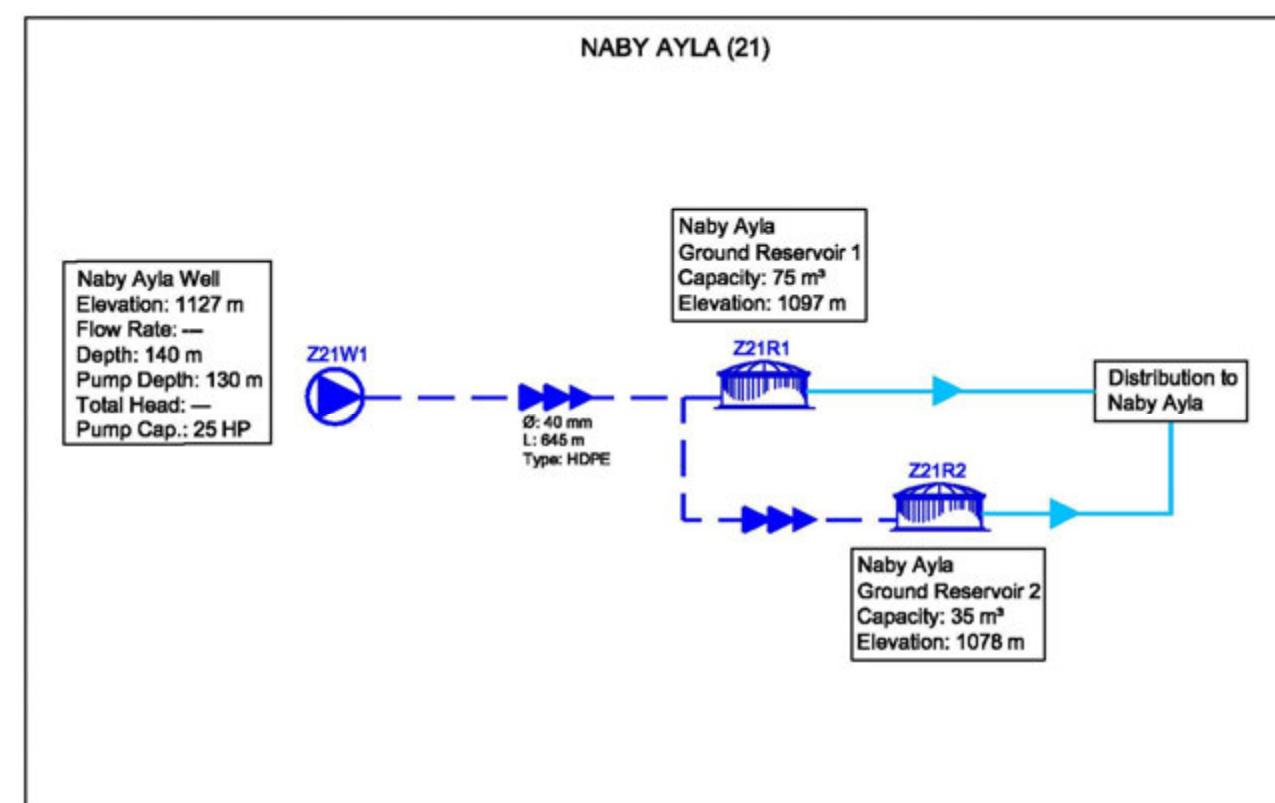
## Naby Ayla (21)

The existing water network is in good condition and it has a length of around 1.5 km. It covers a small part of the town.

Well Z21W1 (55 years old): Well is not accessible.

Reservoir Z21R2 (35 m³): No available information.

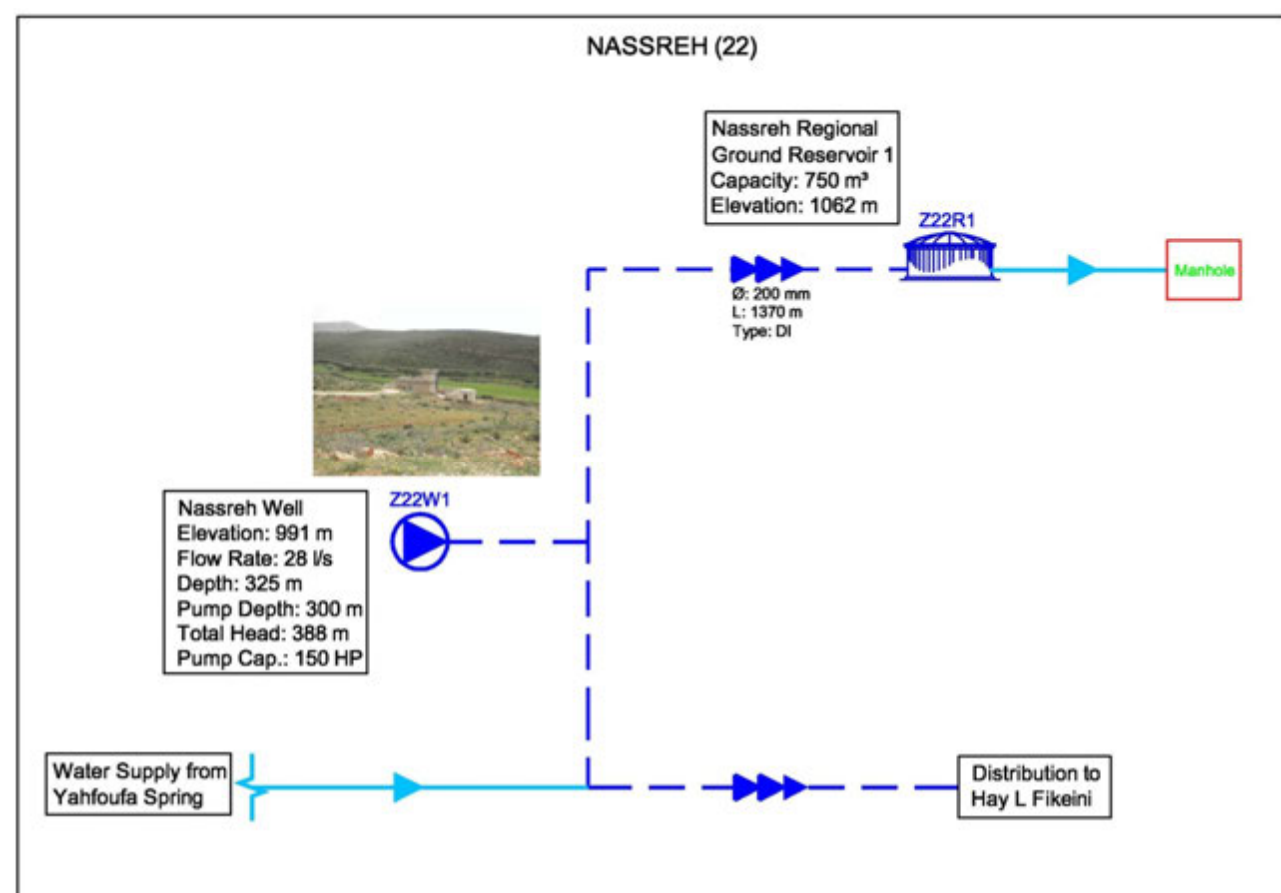
## Nassreh (22)

The existing water network is in bad condition and it has a length of around 12 km.

Well Z22W1 (20 years old): Well is in good condition after it was rehabilitated lately this year. It is suffer from a shortage of electric power and there is no chlorination unit.

Reservoir Z22R1 (750 m³): No available information.

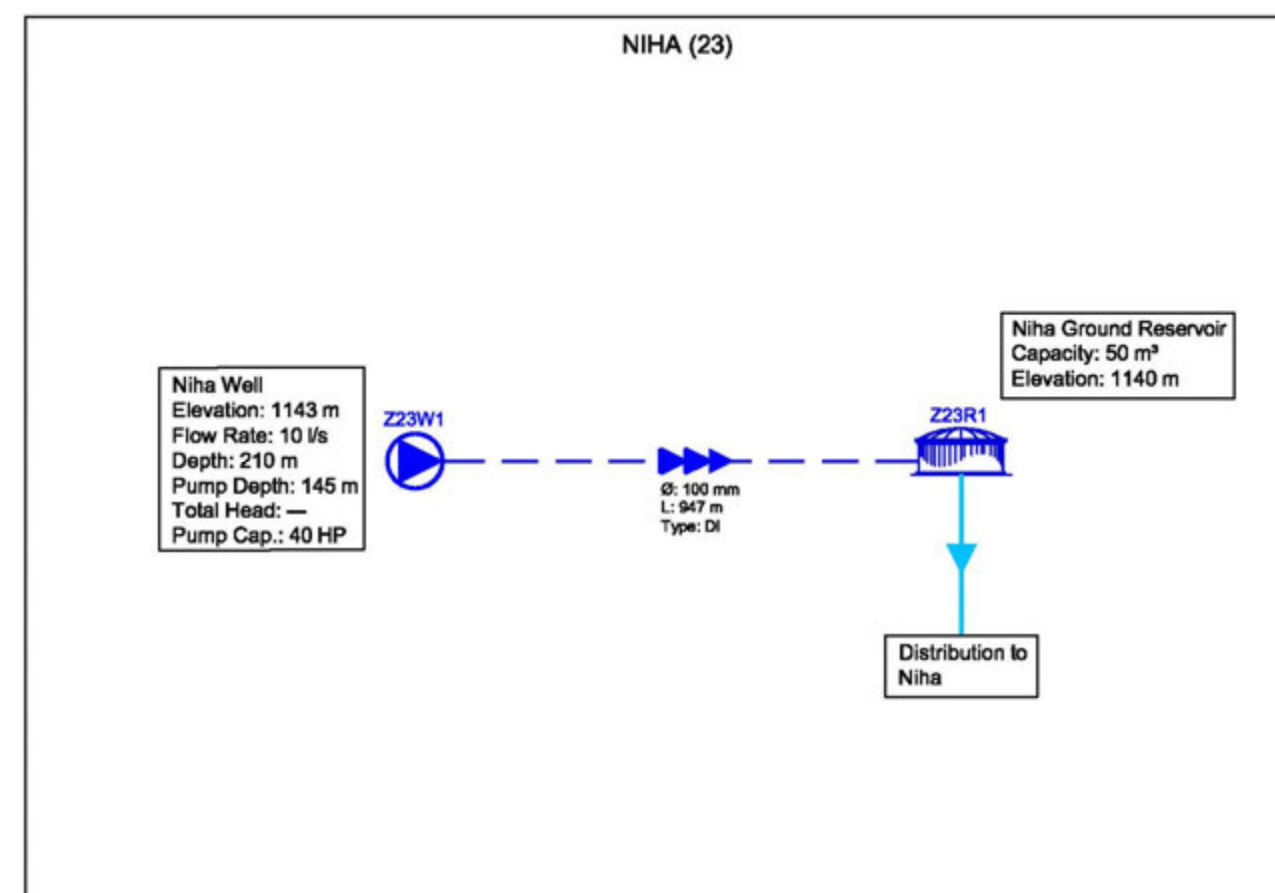
## Niha (23)

The existing water network is new (year 2013) and it is in a good condition.

Well Z23W1 (>10 years): Well is not accessible.

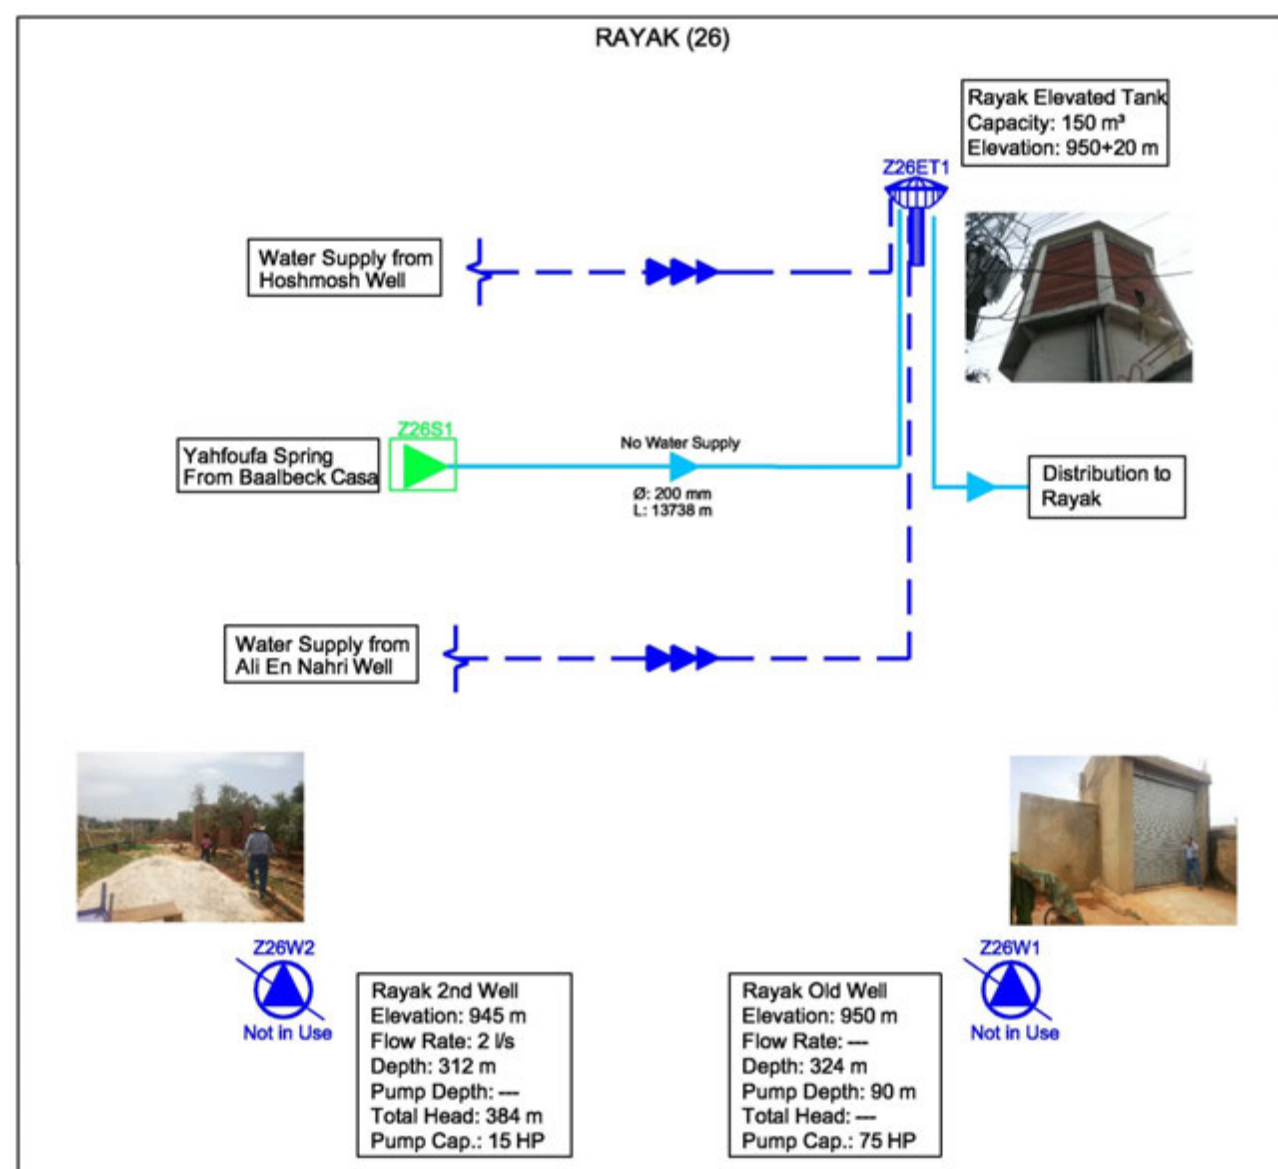
**Rayak (26)**

The existing water network is in good condition and it has a length of around 13 km. It covers a part of the town.

Well Z26W1 (30 years old): Well is in acceptable condition, but it is not in use.

Well Z26W2 (30 years old): Well is in acceptable condition, but it is not in use.

Spring Z26S1: Spring is tainted with nitrate and it is not supplying water to Rayak elevated tank anymore. This spring is located in Baalbeck casa. It has a chlorination room with no chlorination units. Its main valve is subjected to leakage.

Elevate tank Z26ET1 (150 m³): Elevated tank is in acceptable condition. Its pipes are rusted and need to be changed. This elevated tank needs minor maintenance.

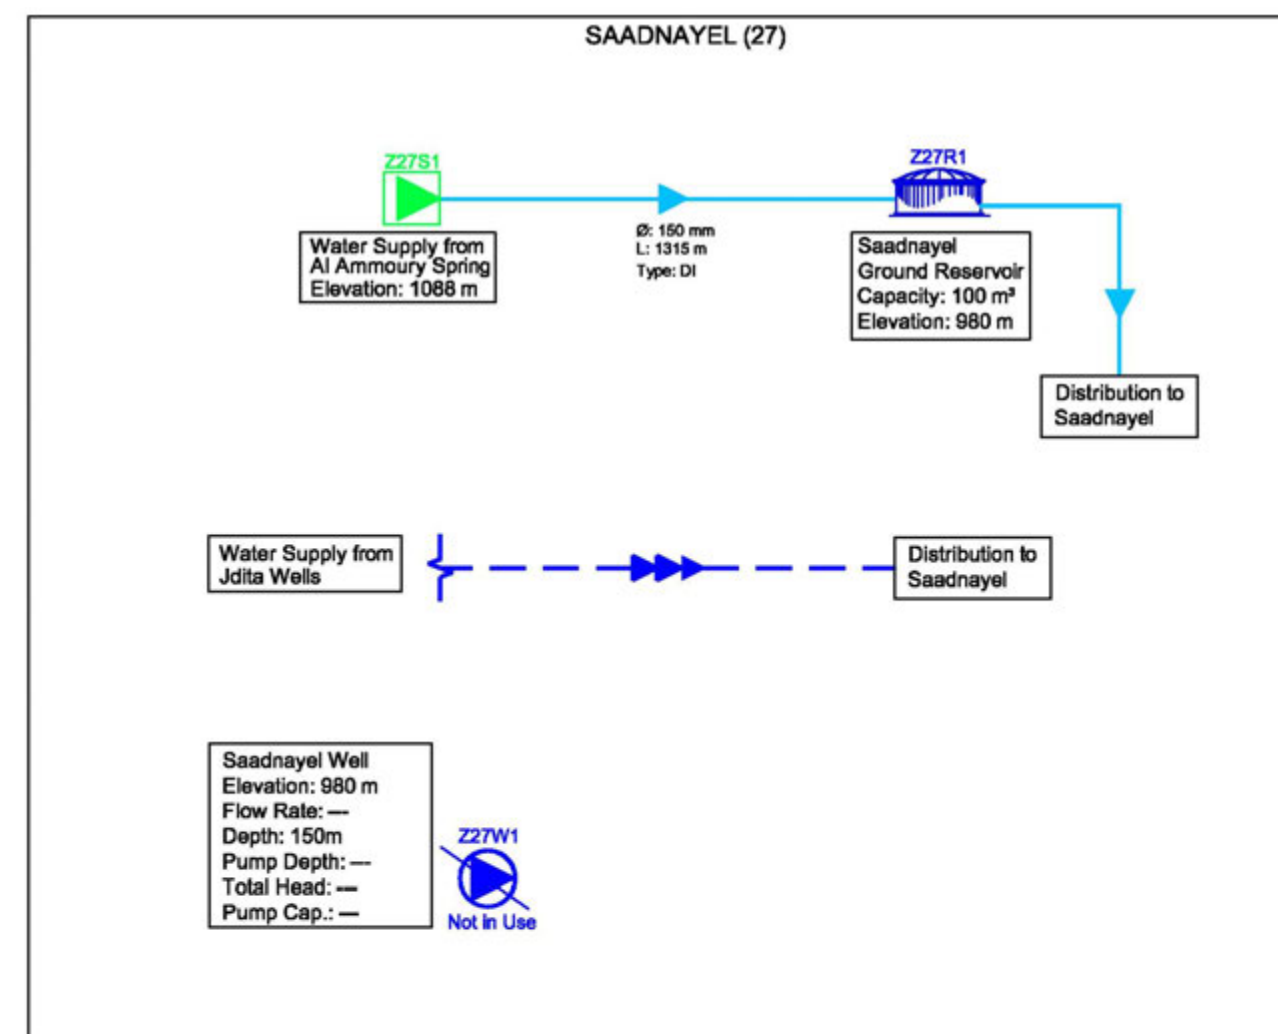
**Saadnayel (27)**

The existing water network is in bad condition and it has a length of around 13 km. It covers a large area of the town.

Well Z27W1 (20 years old): Well is neither operational nor equipped. Its room is full of water due to leakage. It needs rehabilitation.

Reservoir Z27R1 (100 m³): No available information.

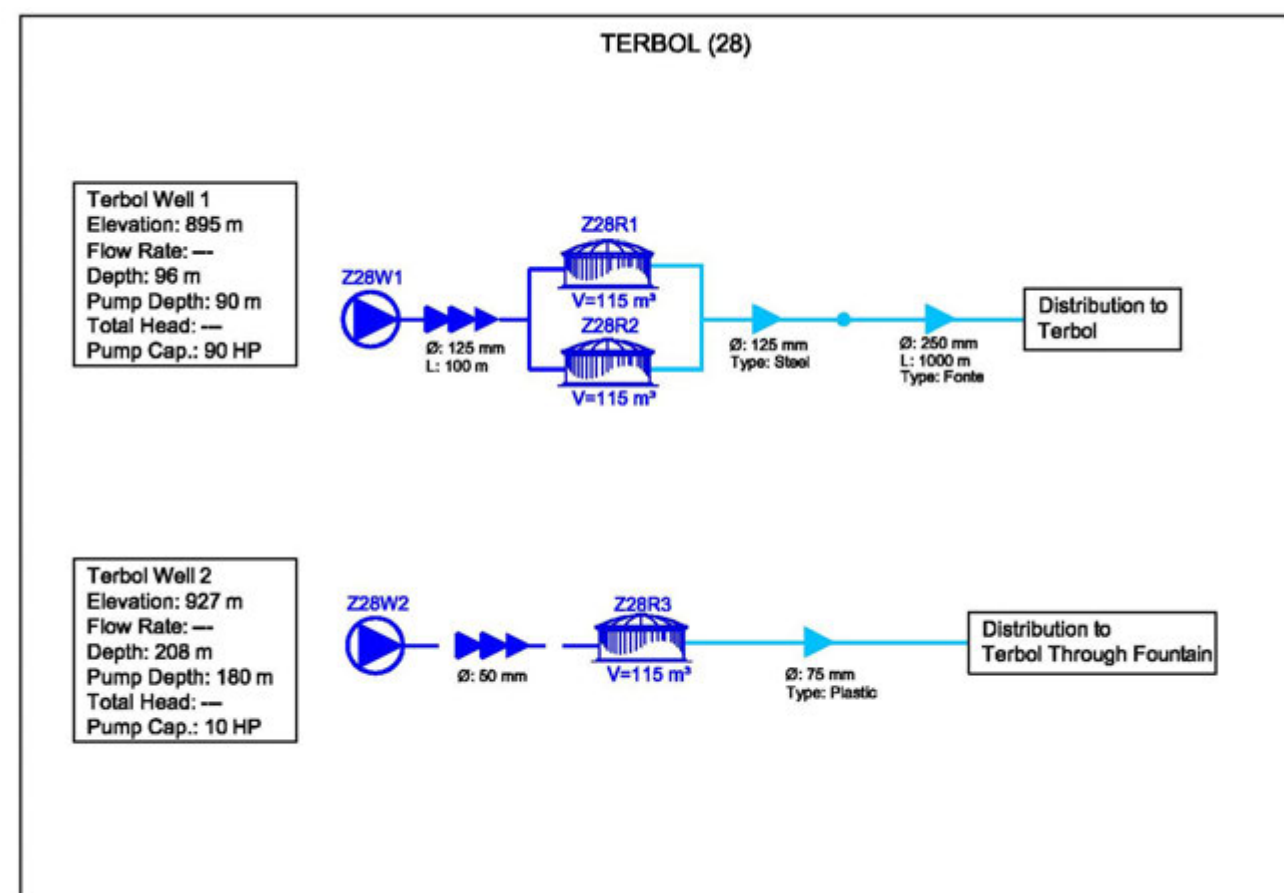
**Terbol (28)**

The existing water network is in medium condition and it has a length of around 7 km. It covers a large area of the town. There are two formal wells in the town but they don't meet the people's water needs. Most of terbol people have their own wells.

Well Z28W1 (30 years old): Well is tainted with nitrates and it needs rehabilitation. The people of the town uses this well only for domestic purposes.

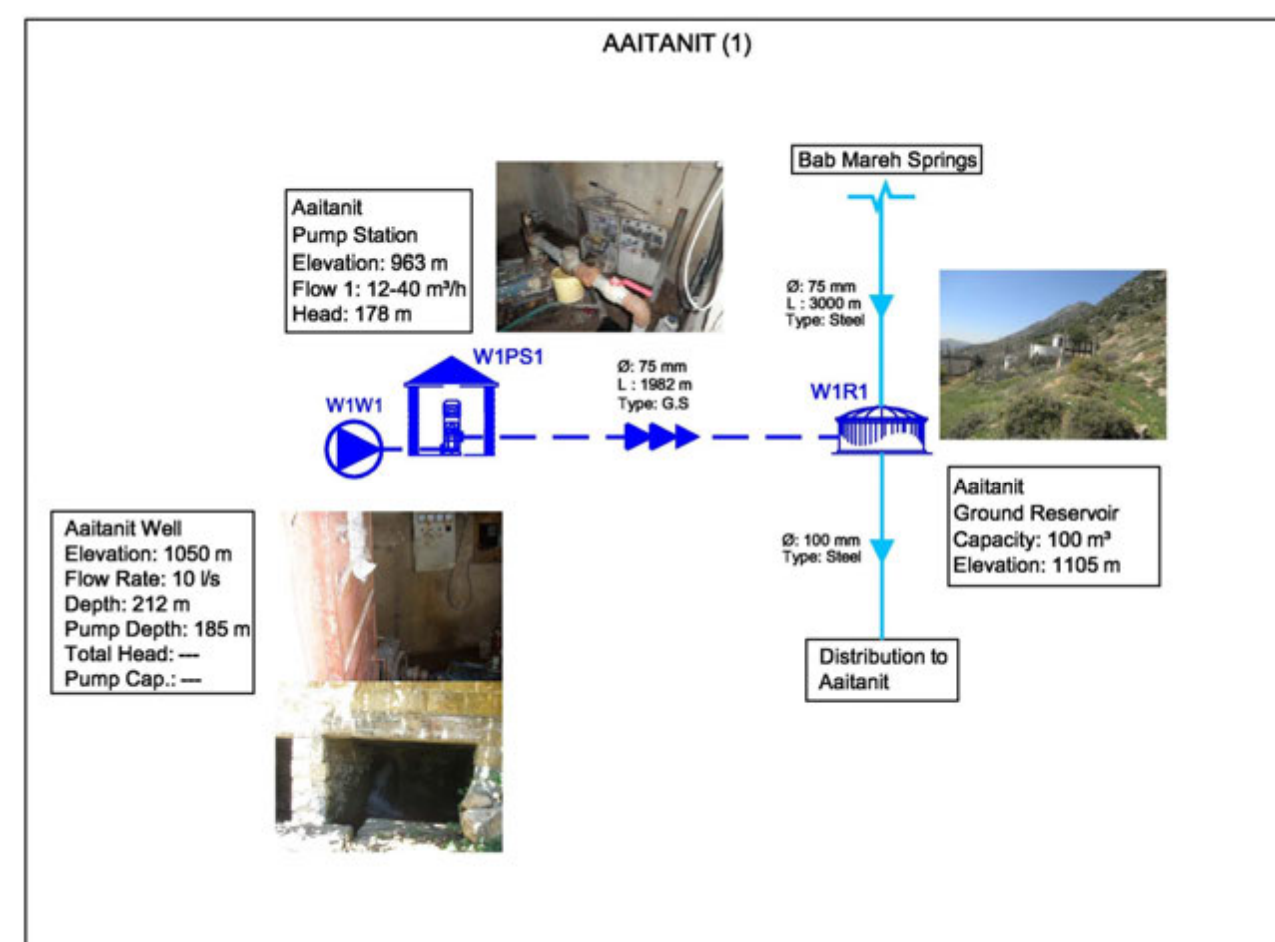
**Aaitanit (1)**

The existing water network is in very good condition and it has a length of around 5.5 km. It covers a part of the town. There is a proposed designed water network is still under construction.

Well W1W1: Well is very old and it is in bad condition. It needs rehabilitation

Pump station W1PS1: Pump station is very old. The pipes are rusted. This pump station needs rehabilitation.

Reservoir W1R1 (100 m³): Reservoir is in good condition.

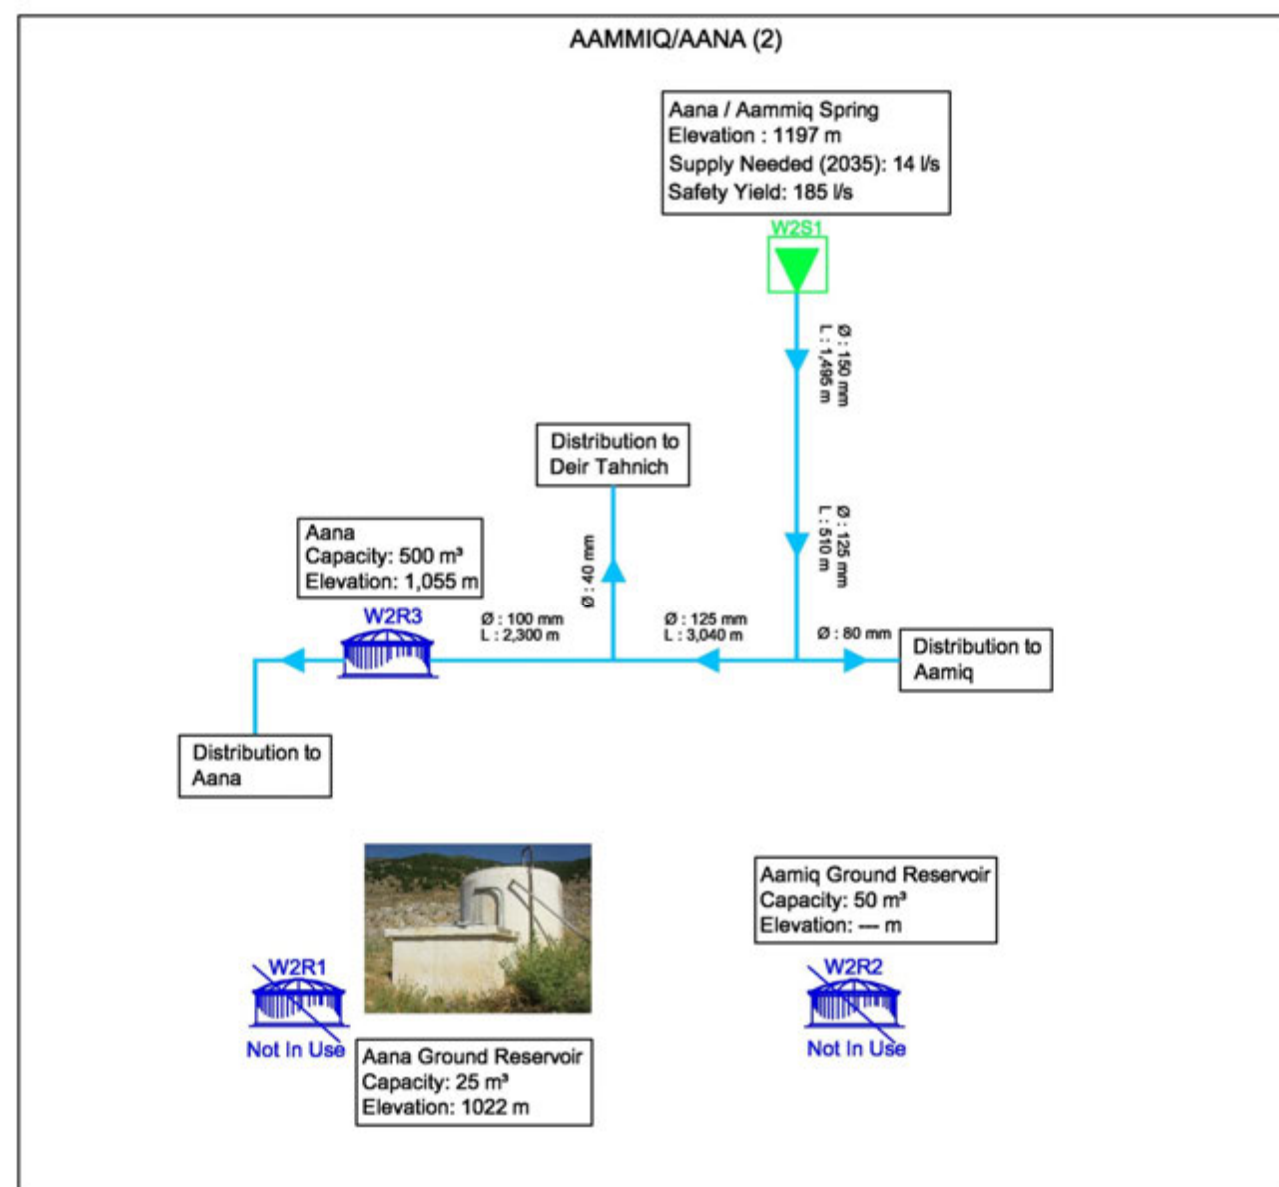
**Aammiq/Aana (2)**

The existing water network is in very good condition and it has a length of around 15 km. It covers a large area of the town.

Spring W2S1: No available information.

Reservoir W2R1 (>30 years; 25 m³): Reservoir is in acceptable condition. It is subjected to leakage. This reservoir needs esthetical rehabilitation and some maintenance. This reservoir is not in use anymore.

Reservoir W2R3 (<2 years; 500 m³): Reservoir is new and it is in good condition.

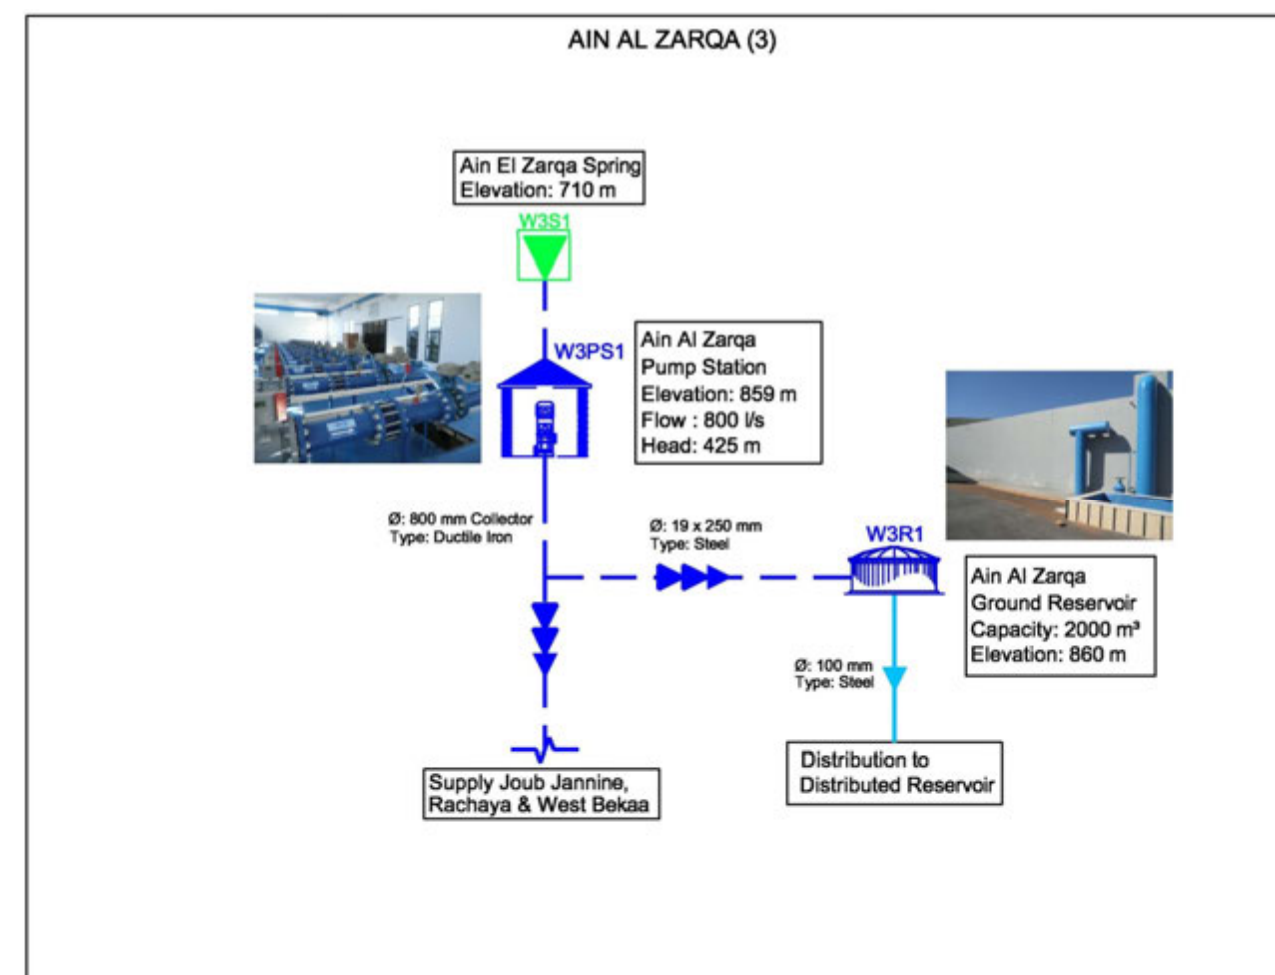
**Ain Al Zarqa (3)**

There is no available information concerning the water network of the town.

Spring W3S1: The estimated safety yield adopted is about 1321 l/s.

Pump station W3PS1: Pump station is in good condition and it is made of 10 pumps. Pumps are still not functioning.

Reservoir W3R1 (5 years old; 2000 m³): Reservoir is in good condition. It is subjected to leakage. This reservoir needs esthetical rehabilitation.

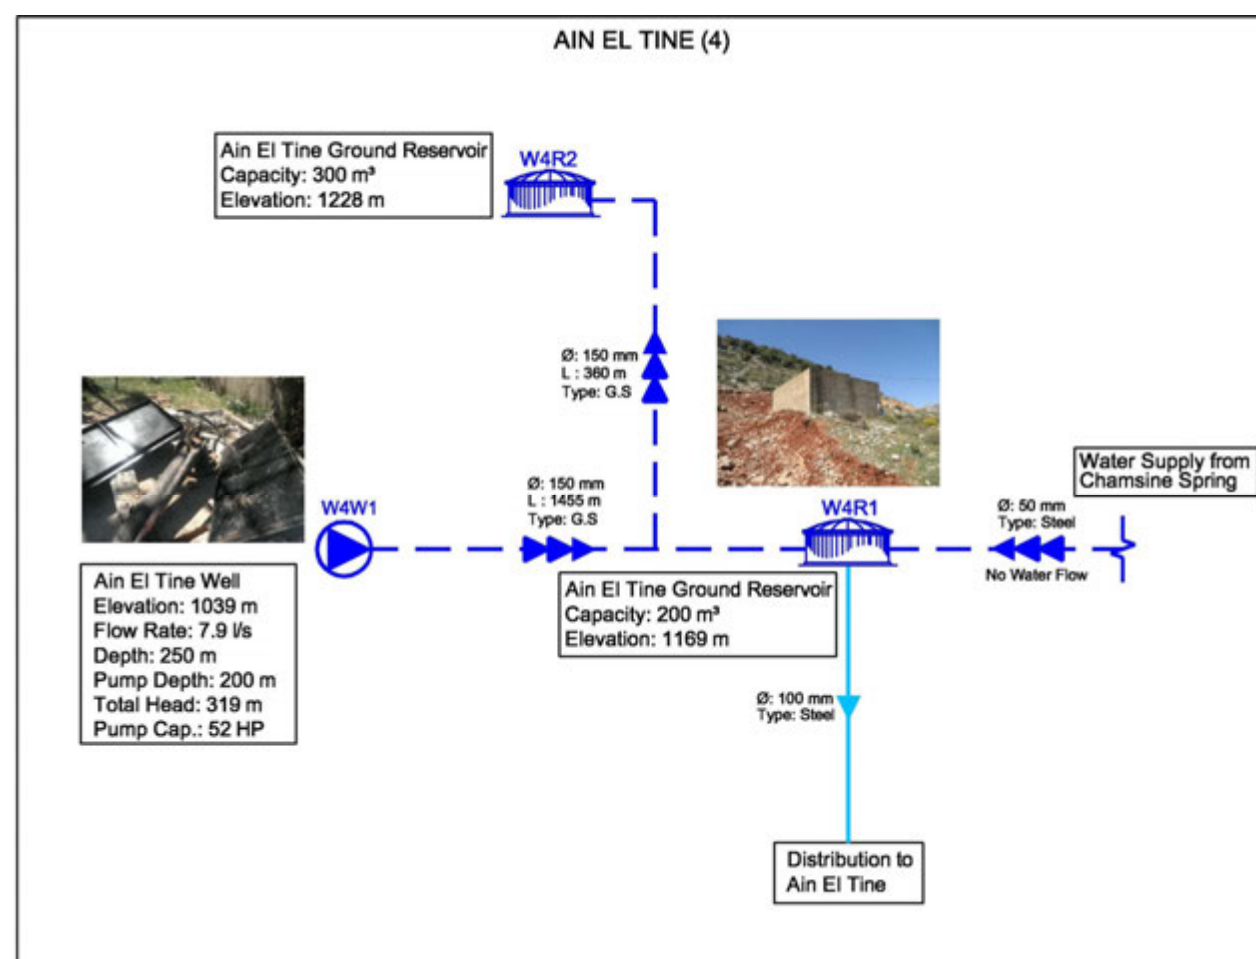
**Ain El Tine (4)**

There is no available information concerning the water network of the town. A new line coming from Ain El Zarqa spring will supply this village once system becomes operational. The specific layout could not be obtained.

Well W4W1 (30 years old): Well is in acceptable condition. There is chlorination unit but it is not functioning. The access key of the building was lost during time of visit. There is no power generation.

Reservoir W4R1 (>30 years; 200 m³): Reservoir is in acceptable condition. It doesn't have an overflow pipe. This reservoir needs esthetical rehabilitation and some maintenance.

Reservoir W4R2 (< 2 years; 300 m³): Reservoir is new and it is in good condition.

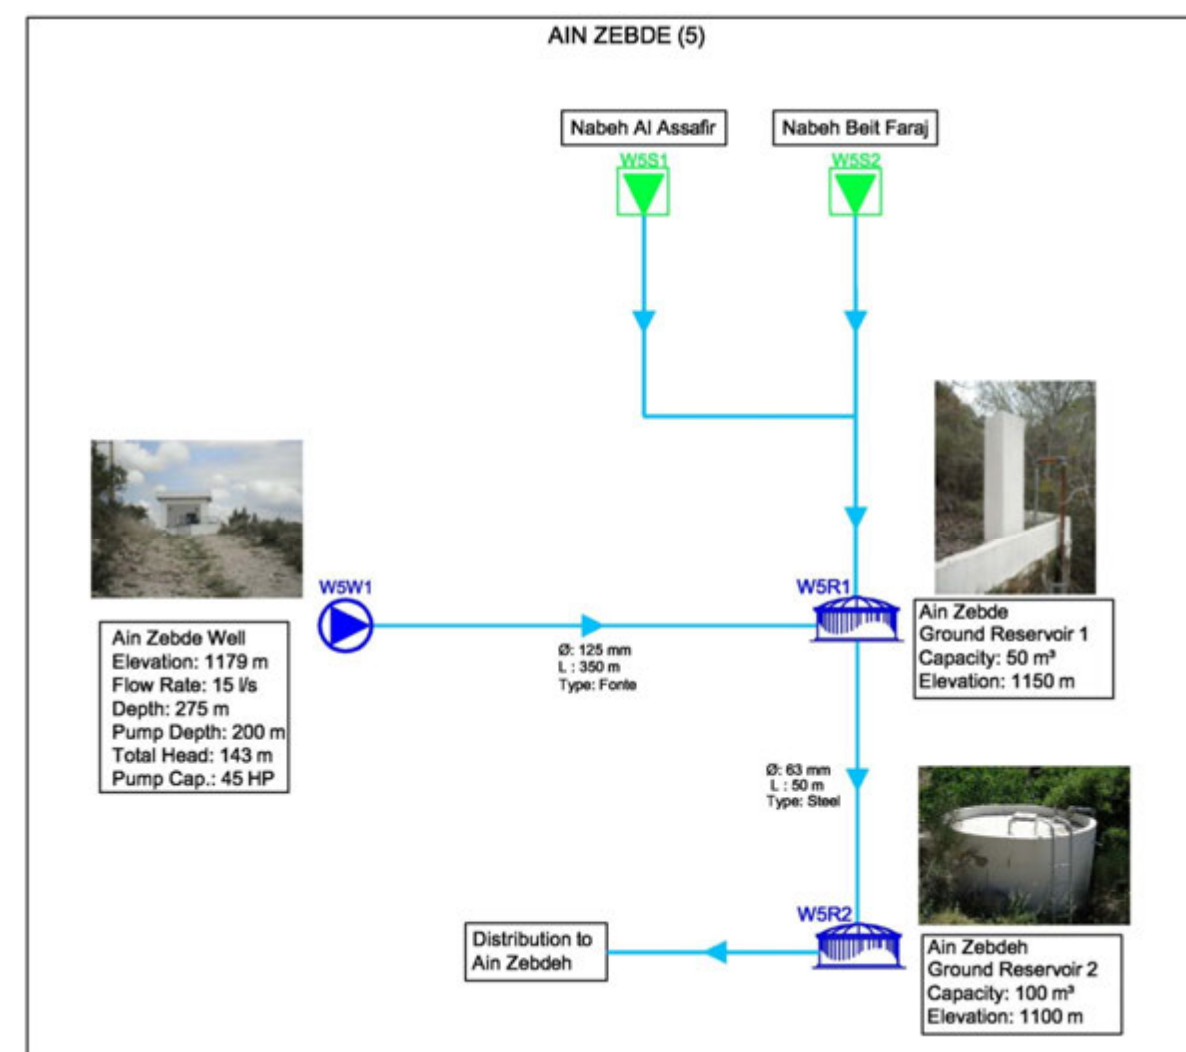
**Ain Zebde (5)**

The existing water network is in very good condition and it has a length of around 10 km. It covers a large area of the town.

Well W5W1 (15 years old): Well is in acceptable condition and it suffers from a shortage of electric power. A chlorine dosing pump is found; however, it is not working.

Reservoir W5R1 (>60 years; 50 m³): Reservoir is in acceptable condition. It doesn't have an overflow pipe and excess water flooded the roof of the reservoir. It needs some minor maintenance.

Reservoir W5R2 (100 m³): Reservoir is in acceptable condition. It needs esthetical rehabilitation and some maintenance.

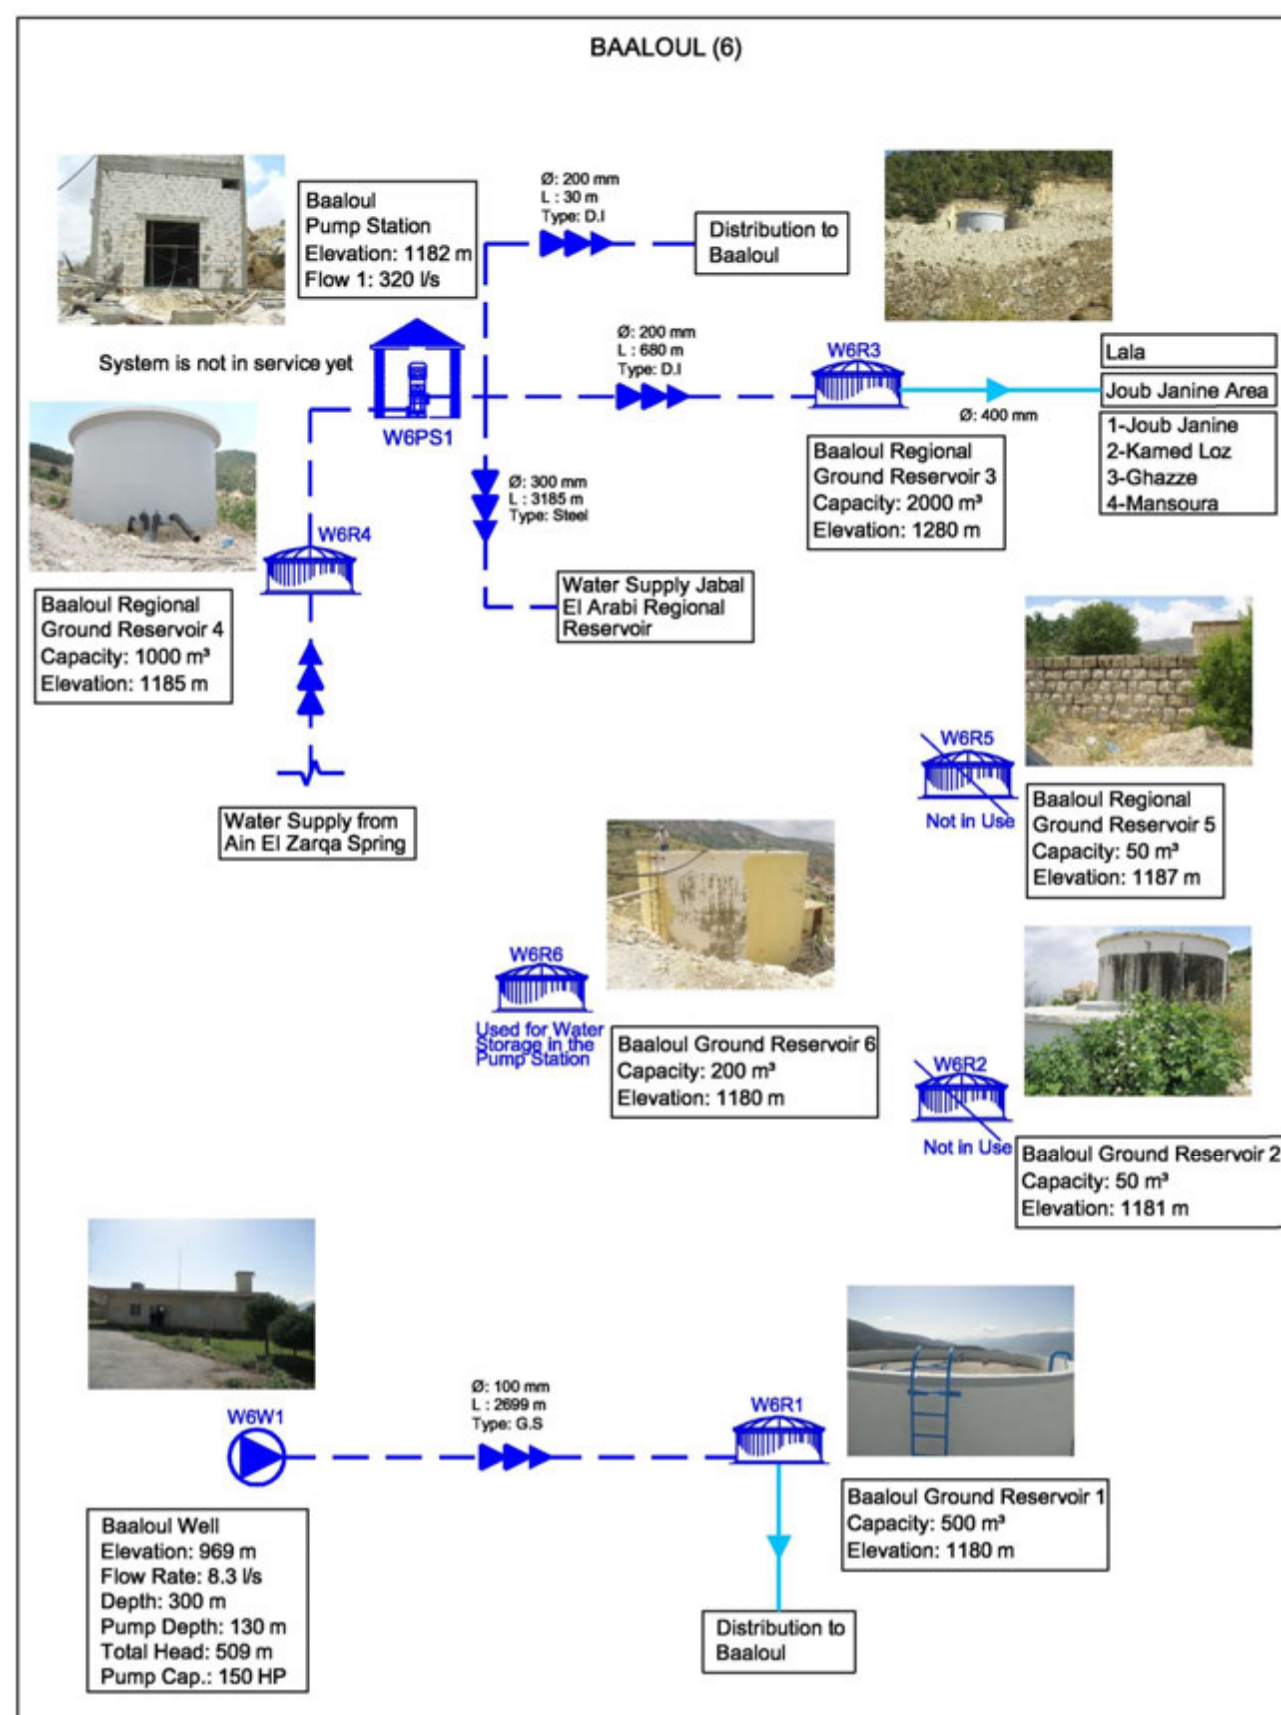
**Baaloul (6)**

There is no available information concerning the water network of the town.

Well W6W1 (30 years old): Well is in acceptable condition. No more available information.

Reservoir W6R1 (500 m<sup>3</sup>): Reservoir is in good condition. It doesn't have neither flow meters nor bypass. It needs some minor maintenance.

Reservoir W6R3 (2000 m<sup>3</sup>): Reservoir is new and it is in good condition. It is a regional reservoir for Ain El Zarqa system.

Reservoir W6R4 (>15 years; 1000 m<sup>3</sup>): Reservoir is new and it is in good condition. It is located near the pump station. It is a storage reservoir for Ain El Zarqa system.

Reservoir W6R6 (200 m<sup>3</sup>): Reservoir is old and it is in bad condition. It is used for water storage only. It needs rehabilitation.
