# WATER SUPPLY AND WASTEWATER SYSTEMS MASTER PLAN FOR THE BEKAA WATER ESTABLISHMENT

## WATER ASSESSMENT REPORT

January 2014  
Updated May 2015

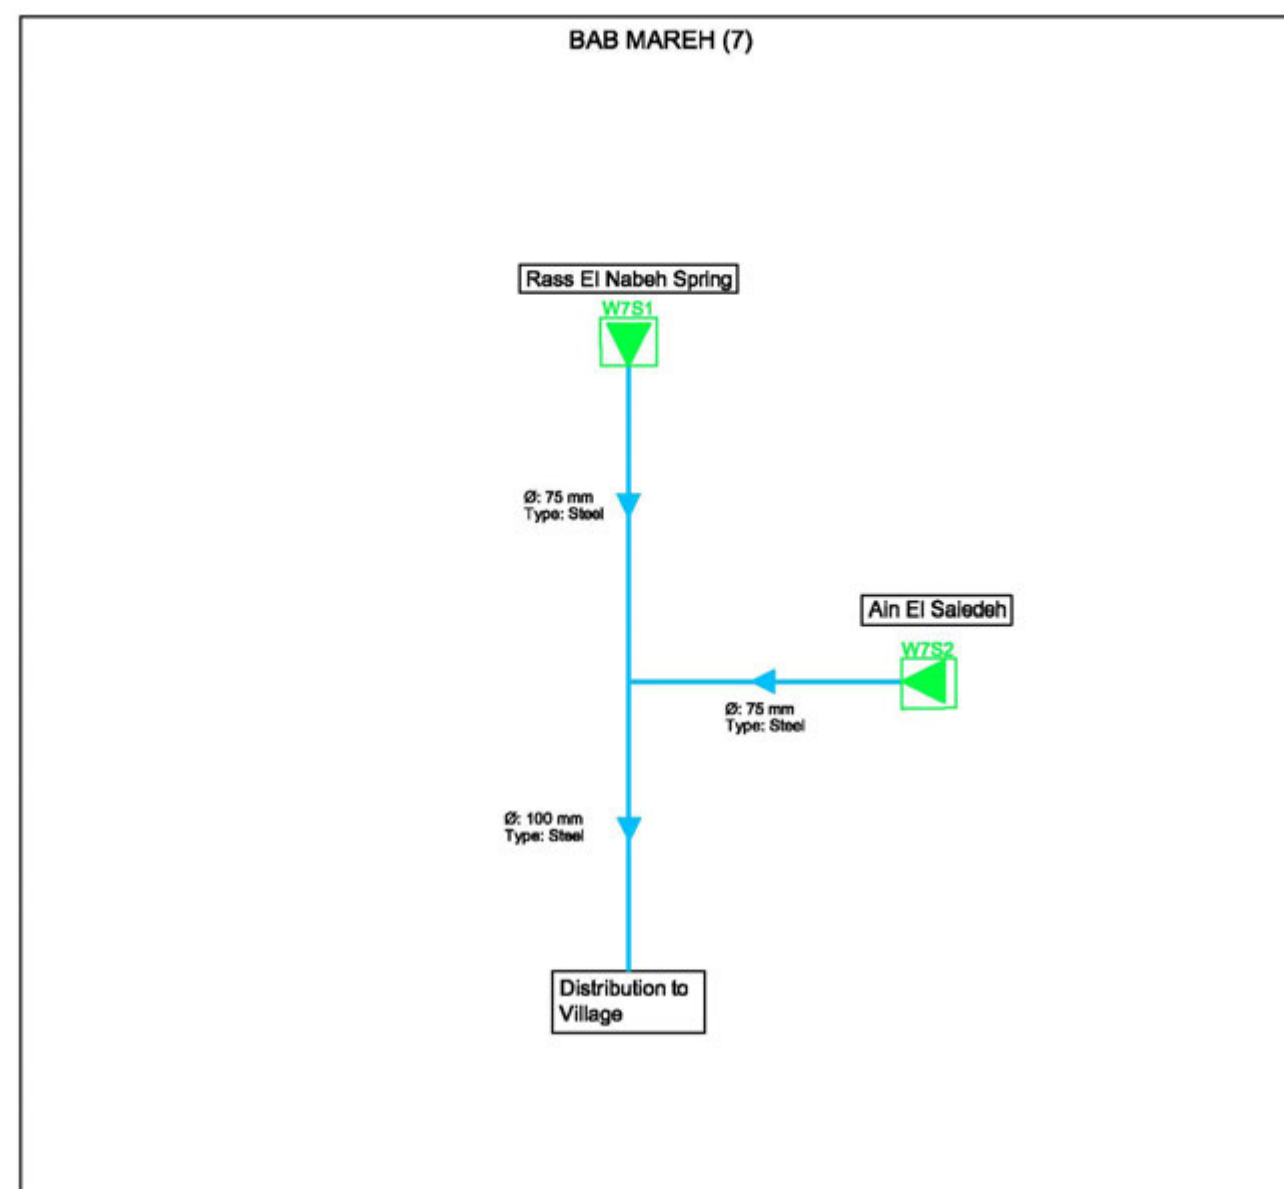
**Bab Mareh (7)**

The existing water network is in good condition and it has a length of around 0.6 km. It covers a small area of the town.

Spring W7S1: No available information.

Spring W7S2: No available information.

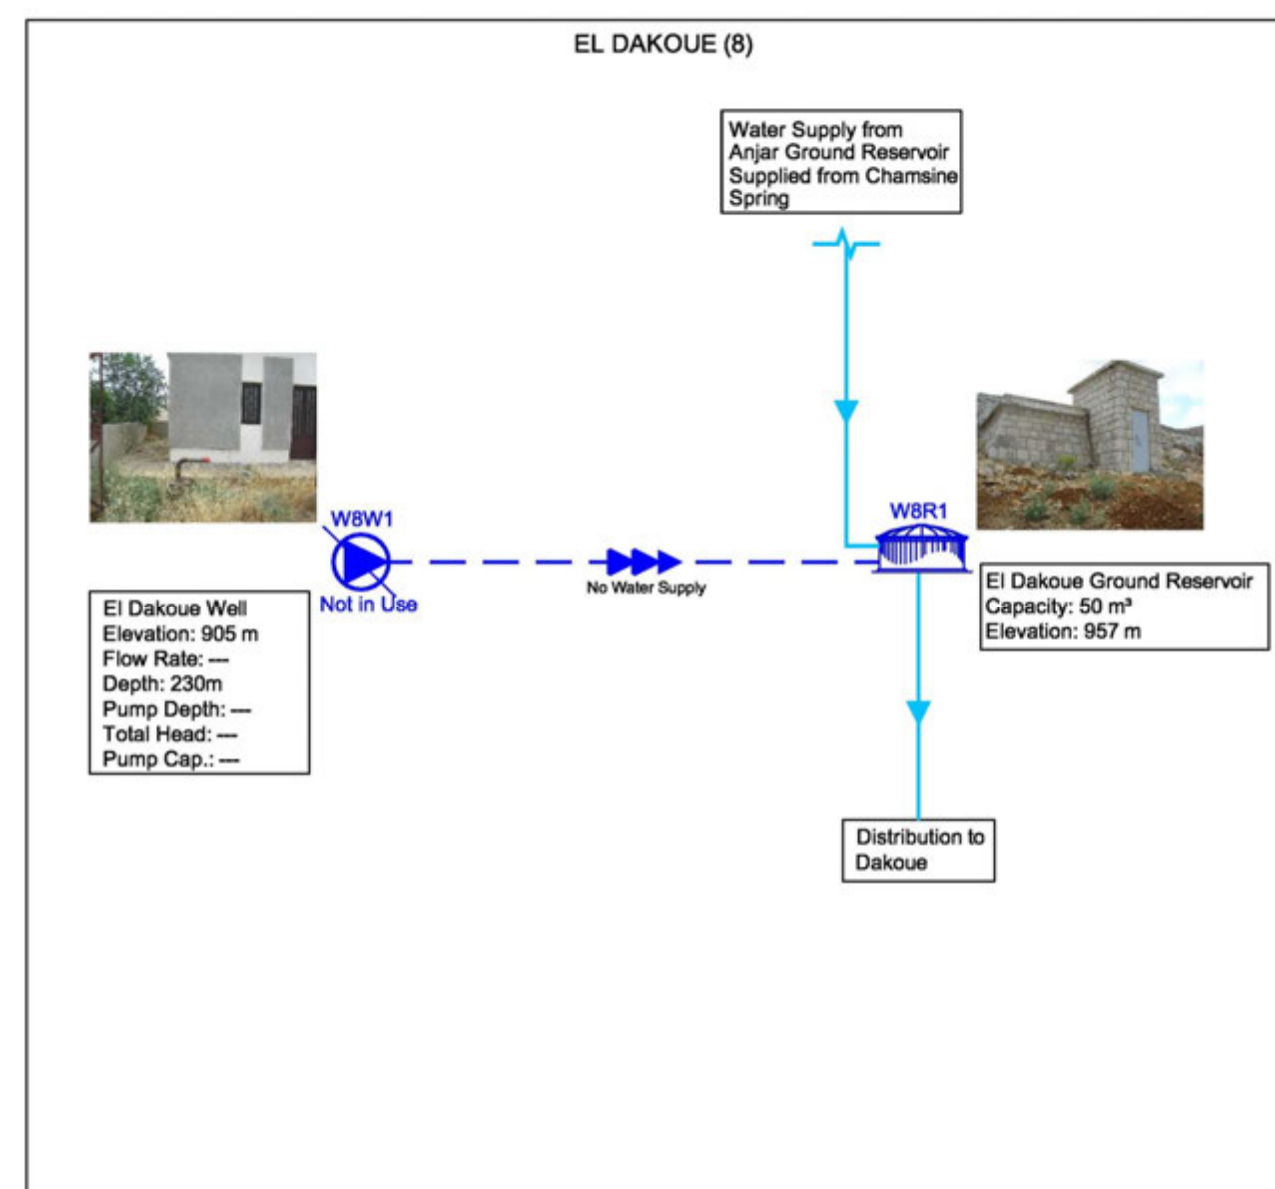
**Dakoue (8)**

The existing water network is in very good condition and it has a length of around 9 km. It covers a large area of the town.

Well W8W1: Well is not in use yet due to problems regarding the alignment of its transmission pipe. There is no water outlet pipe.

Reservoir W8R1 (50 m³): Reservoir is very old and it is in bad condition. It is subjected to leakage. This reservoir needs esthetical rehabilitation and some maintenance.

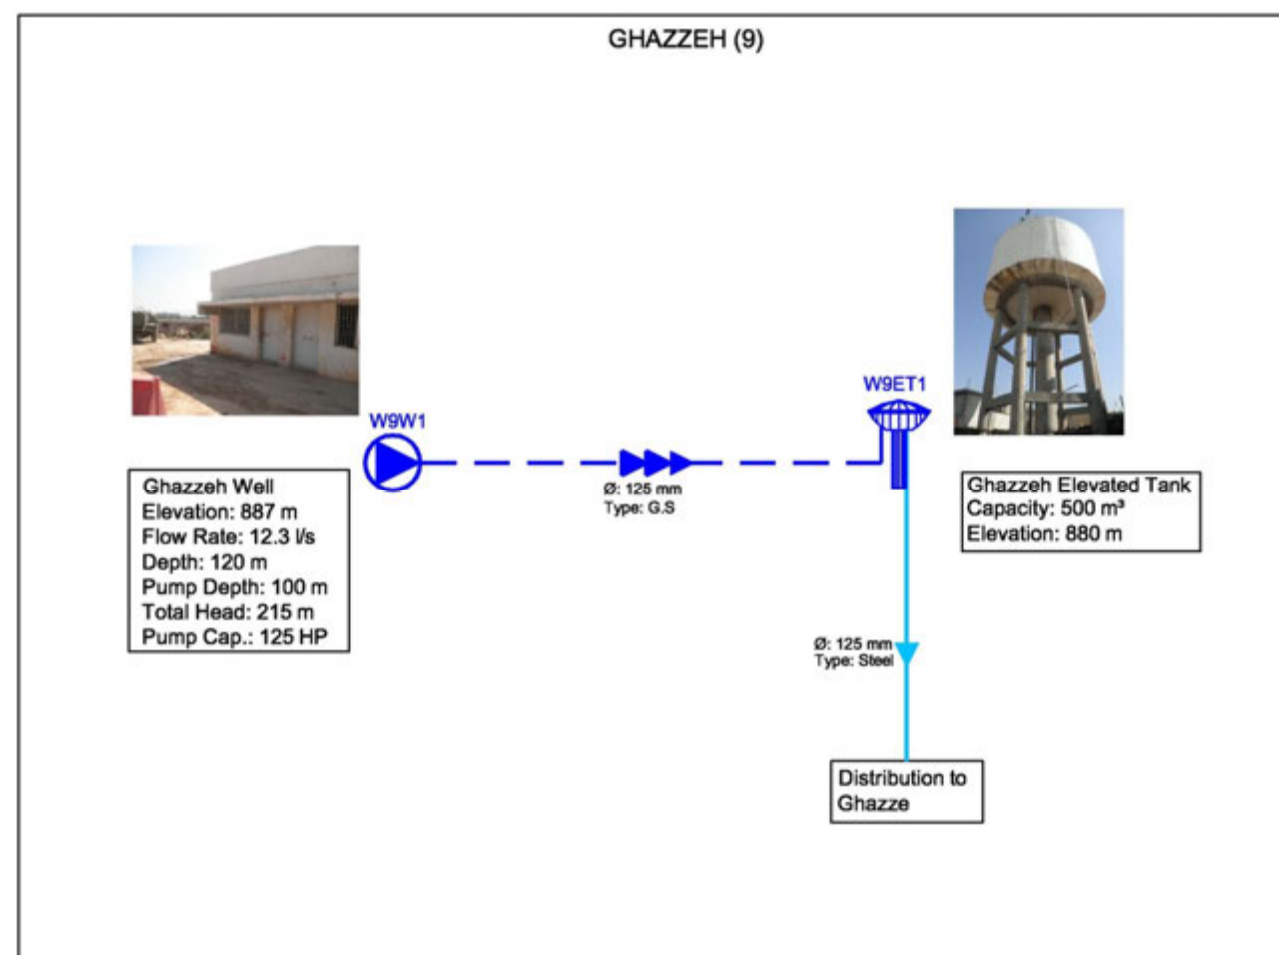
**Ghazze (9)**

The existing water network is in very good condition and it has a length of around 32 km. It covers a large area of the town. A new line coming from Baaloul regional reservoir will supply this village once Ain El Zarqa system becomes operational. The specific layout could not be obtained.

Well W9W1 (<45 years): Well is old but it is in acceptable condition. It suffers from a shortage of electric power. There is no chlorination unit. Its pipes are rusted and need to be changed. This well needs rehabilitation (building, equipment...)

Elevated tank W9ET1 (500 m<sup>3</sup>): Elevated tank is old but it is in acceptable condition. It needs esthetical rehabilitation.

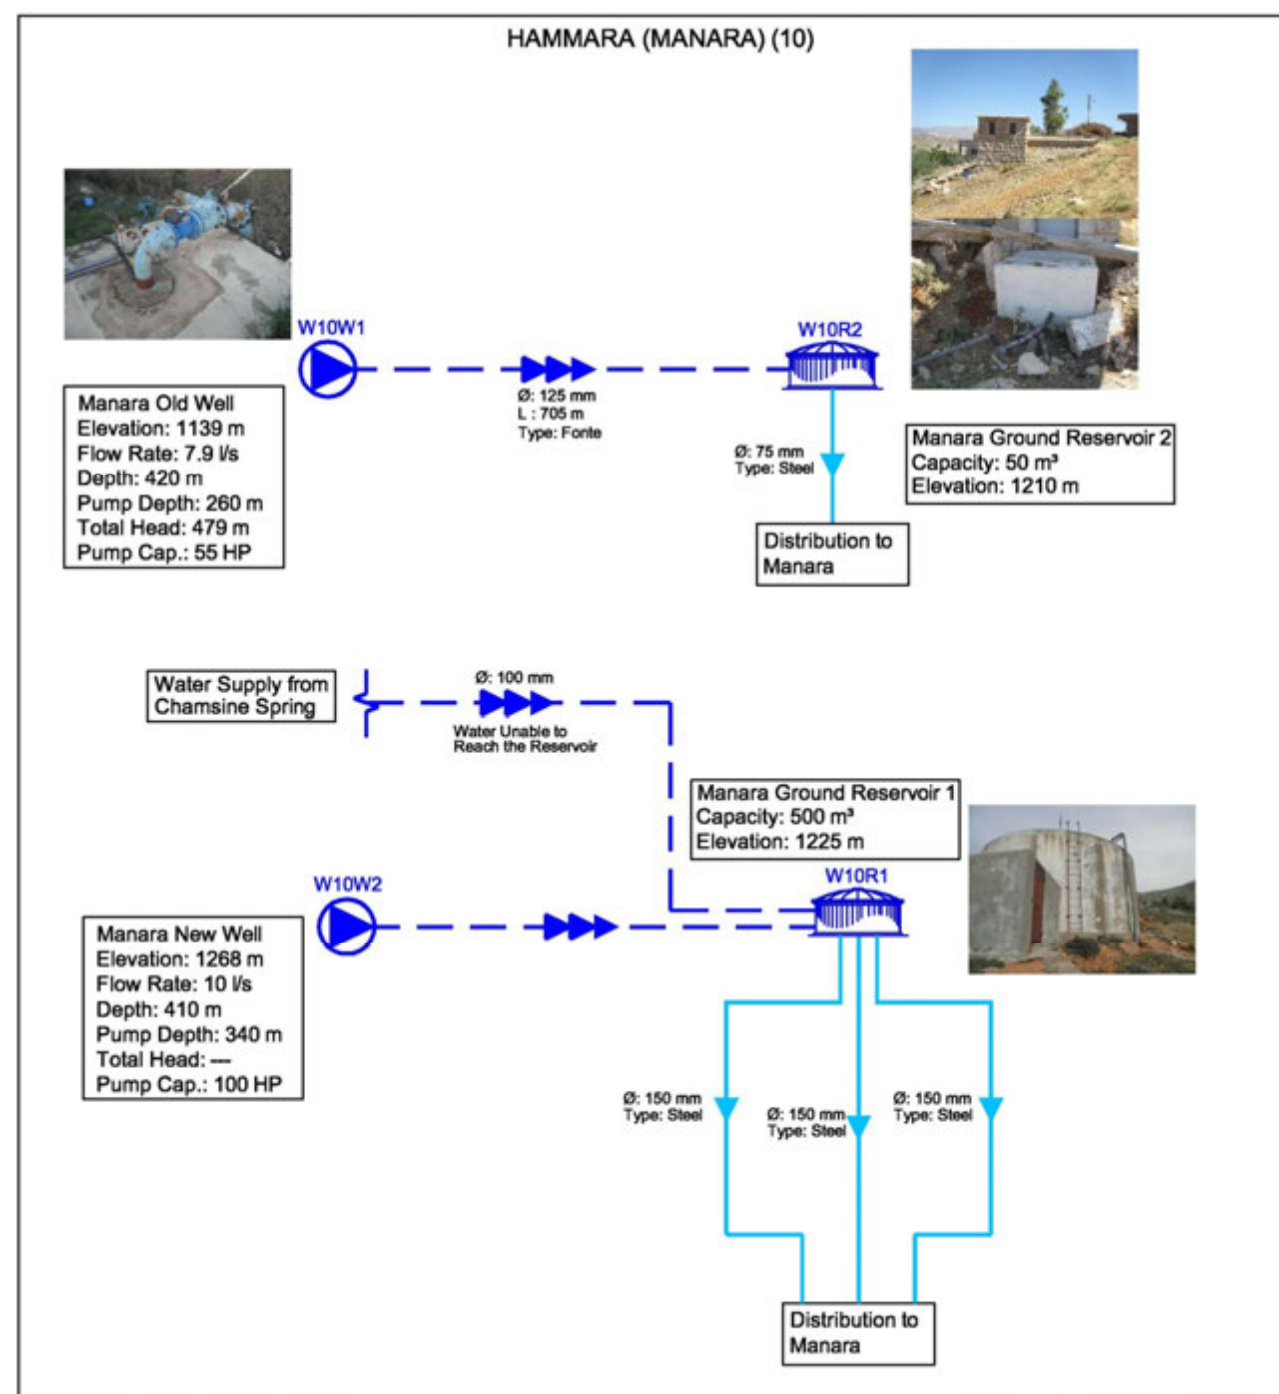
**Hammara (Manara) (10)**

The existing water network is in very good condition and it has a length of around 28 km. It covers a large area of the town.

Well W10W1 (>15 years): Well is in acceptable condition.

Reservoir W10R1 (>15 years; 500 m<sup>3</sup>): Reservoir is old but it is in acceptable condition. Some of its pipes are rusted. It needs minor maintenance and esthetical rehabilitation.

Reservoir W10R2 (50 m<sup>3</sup>): Reservoir is very old. The pipes in the valve chamber are broken. This reservoir needs rehabilitation or reconstruction.

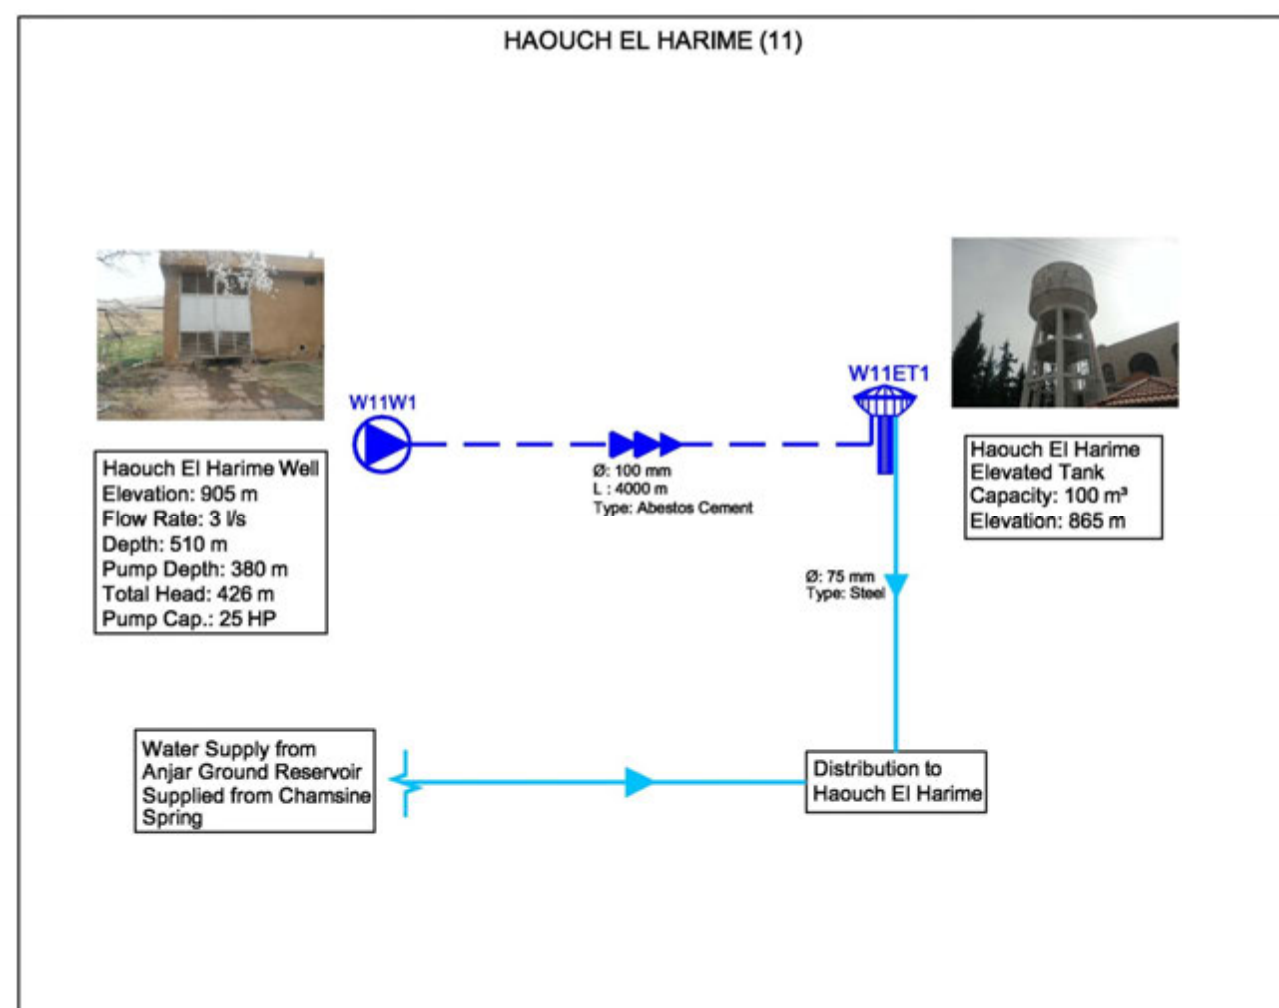
**Haouch El Harime (11)**

The existing water network is in very good condition and it has a length of around 24 km. It covers a large area of the town.

Well W11W1 (25 years old): Well is old and it is in bad condition. The chlorination units and the power generation are not working. Its pipes are rusted and they are subjected to leakage. There is no available information concerning the pump. This well needs rehabilitation.

Elevated tank W11ET1 (>30 years; 100 m³): Elevated tank is old but it is in good condition. It is not subjected to leakage. The valve chamber of this tank is inaccessible. This elevated tank needs some minor maintenance.

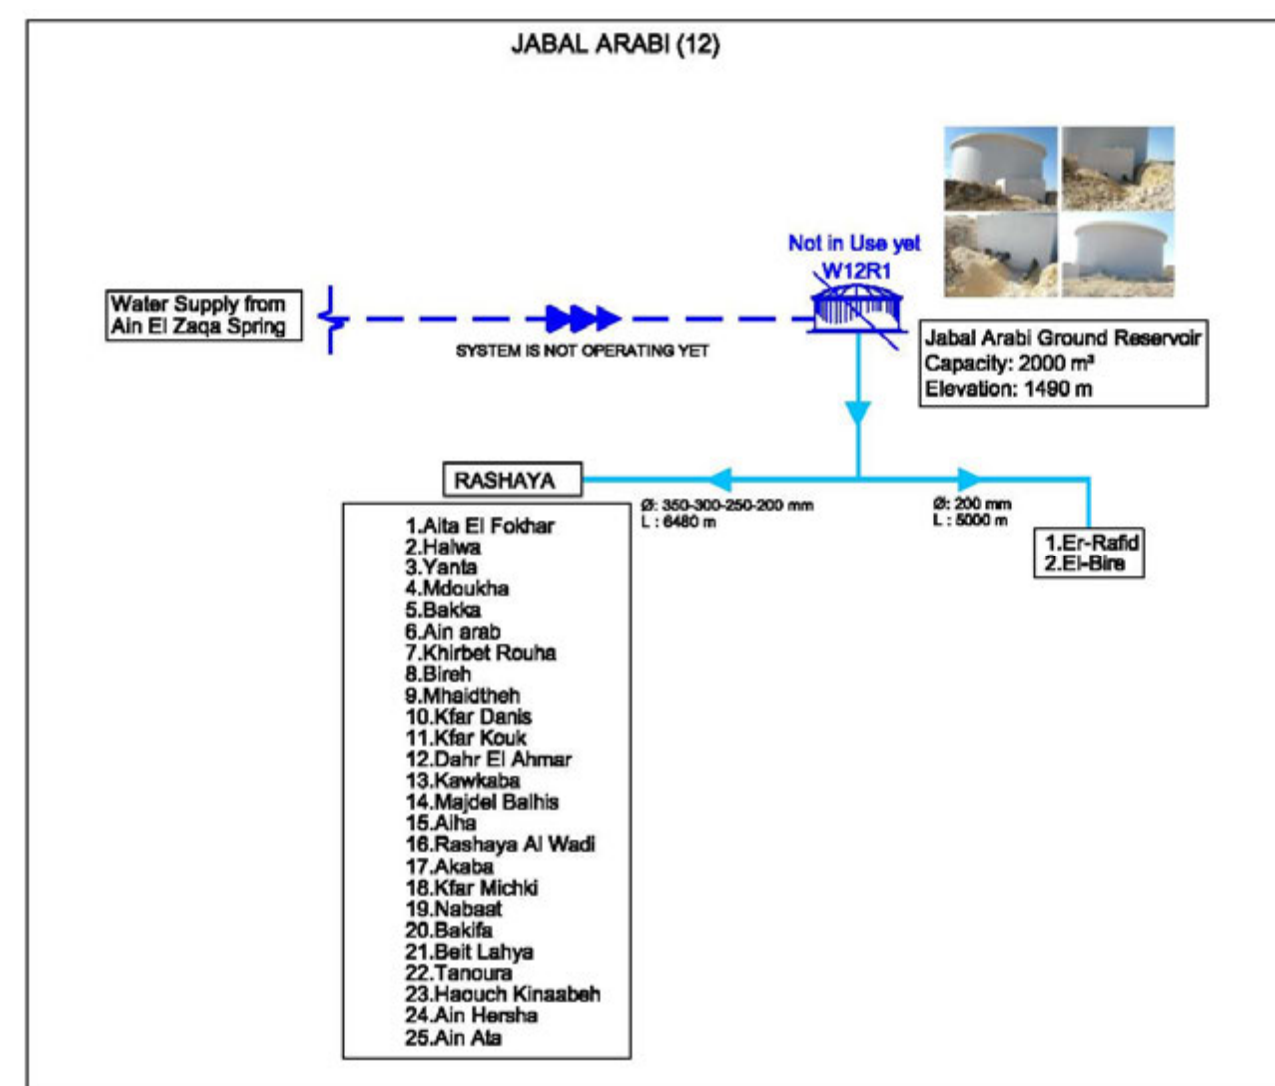
**Jabal Arabi (12)**

Reservoir W12R1 (2000 m³): Reservoir is new and it is in good condition but it is not in use yet.

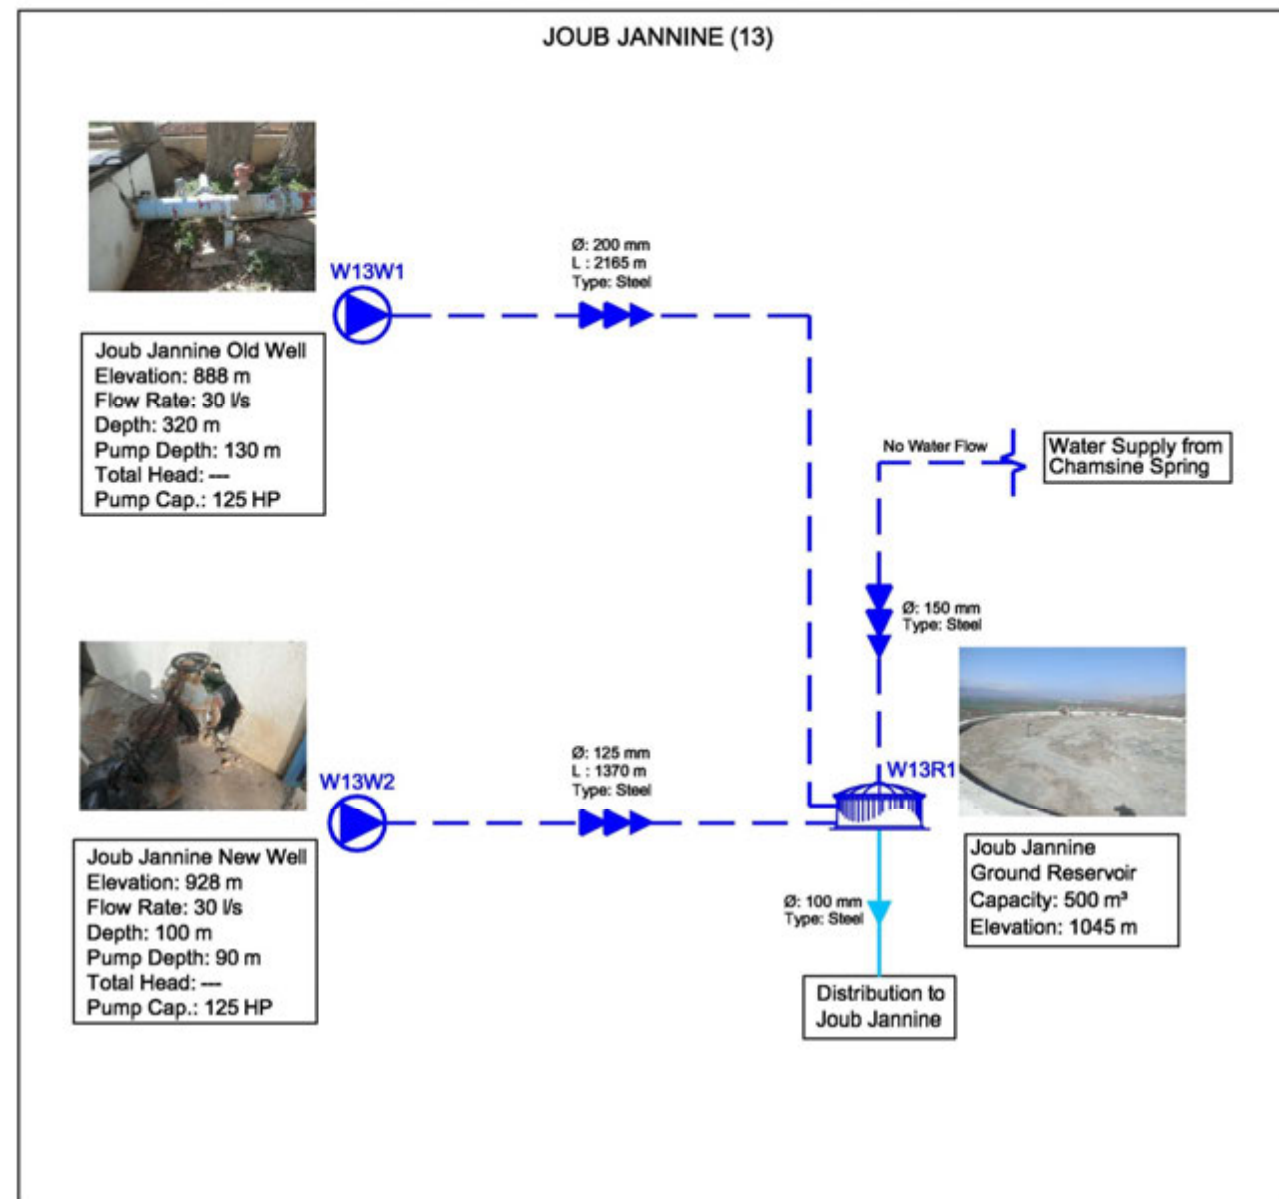
**Joub Jannine (13)**

The existing water network is in very good condition and it has a length of around 46 km. It covers a large area of the town. A new line coming from Baaloul regional reservoir will supply this village once Ain El Zarqa system becomes operational. The specific layout could not be obtained.

Well W13W1 (<35 years): Well is in acceptable condition. The chlorination is not working and the pump is subjected to leakage. It needs some minor maintenance.

Well W13W2 (15 years old): Well is in good condition. There is no chlorination unit. Some steel pipes are rusted. This well needs some minor maintenance.

Reservoir W13R1 (500 m<sup>3</sup>): Reservoir is in good condition. Its roof is subjected to cracks and it needs rehabilitation.

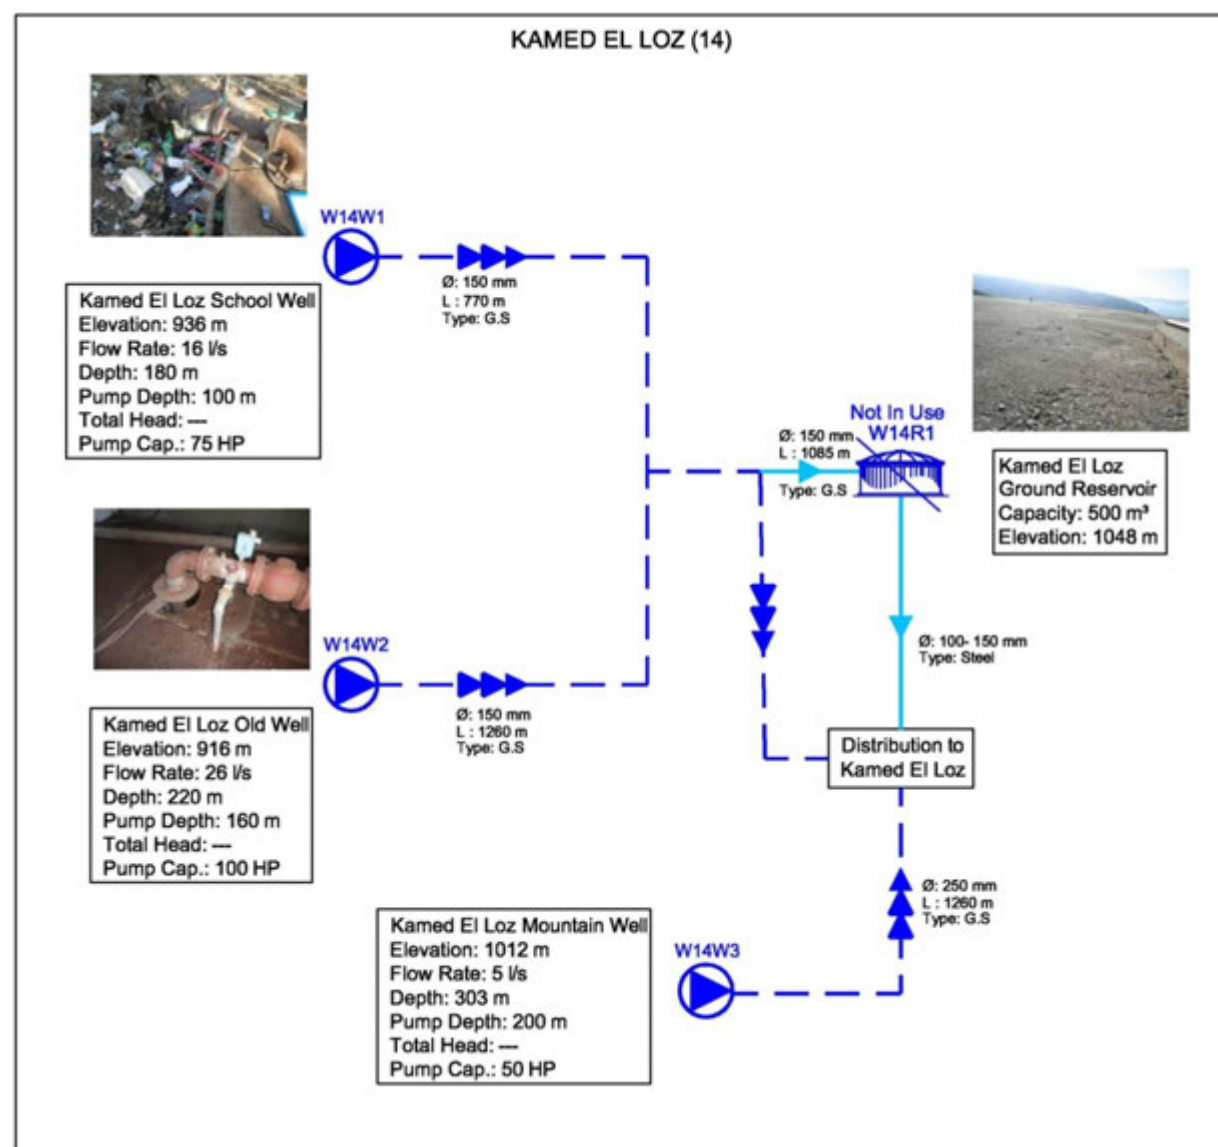
**Kamed El Loz (14)**

Well W14W3 (<5 years): Well is new and it is in good condition.

Reservoir W14R1 (20 years old; 500 m³): Reservoir is in acceptable condition but it is not in use. Its valves and pipes need to be changed because they are rusted and subjected to leakage. This reservoir shall be cleaned from dead lizards.

The existing water network is in very good condition and it has a length of around 35 km. It covers a large area of the town. A new line coming from Baaloul regional reservoir will supply this village once Ain El Zarga system becomes operational. The specific layout could not be obtained.

Well W14W1 (15 years old): Well is in bad condition. Its valve chamber doesn't have a concrete cover and it is full of rubbish. Well building is in very bad condition and it is dirty. The pipes are rusted. This well needs rehabilitation.

Well W14W2 (45 years old): This well was constructed in year 1970. It is in acceptable condition. Its pipes are rusted and the chlorination unit is not working. A fence shall be installed around the well borehole. Rubbish shall be cleaned near well borehole.

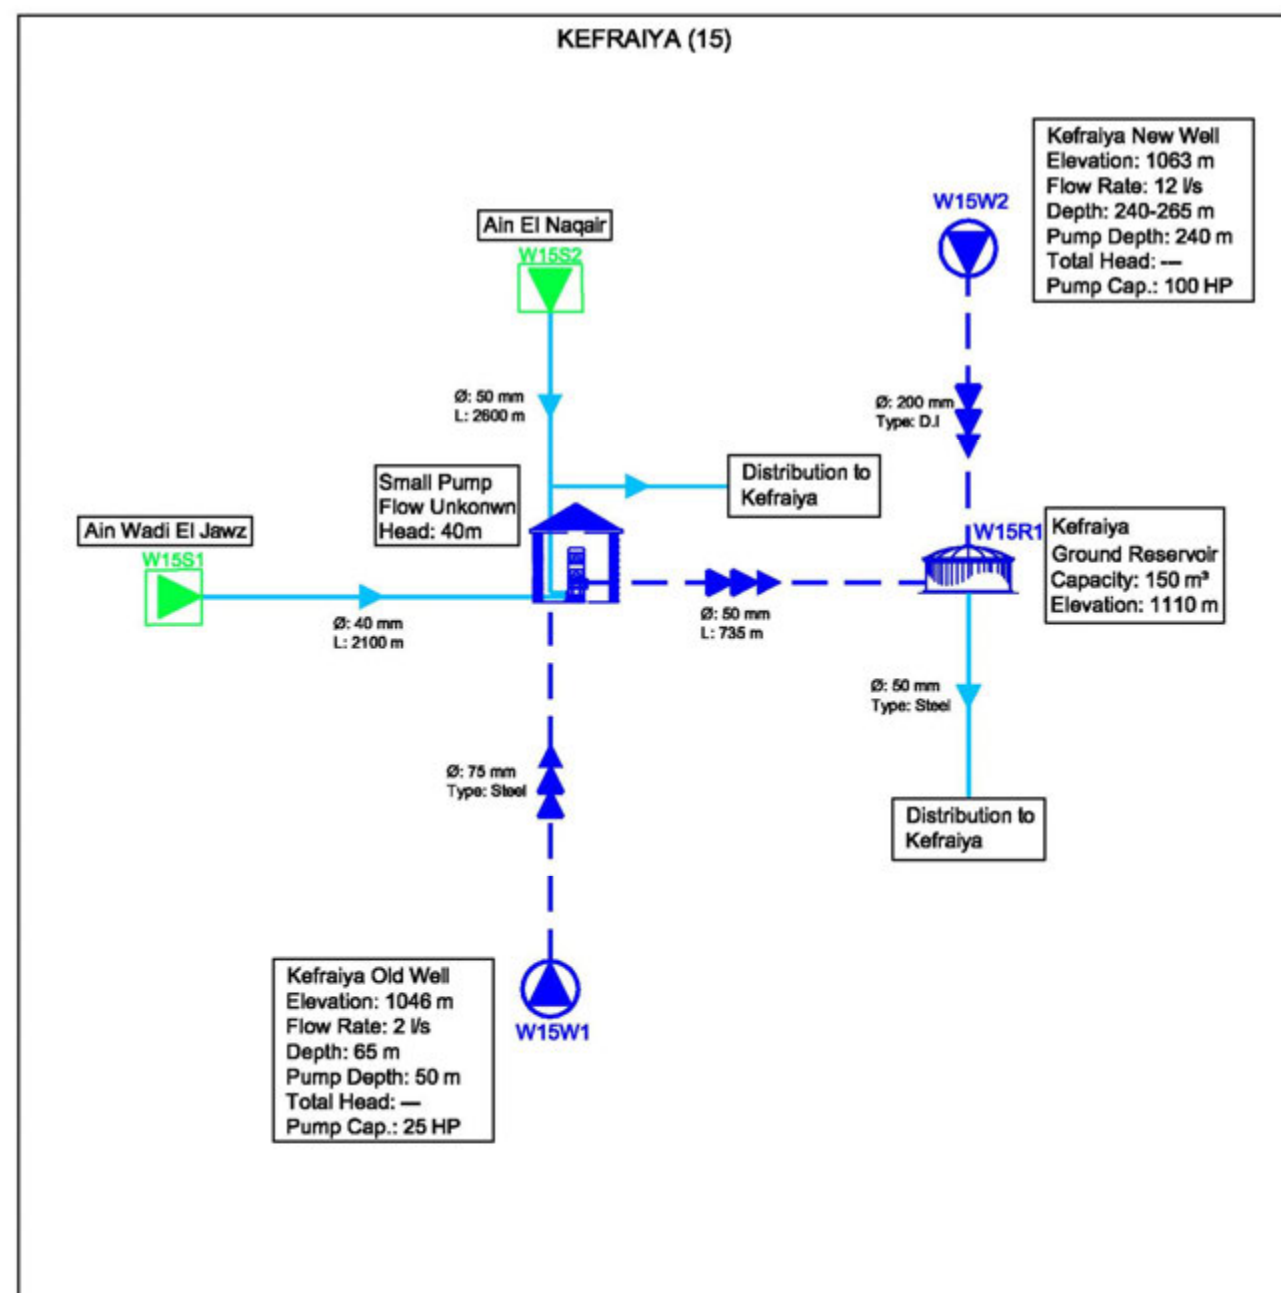
**Kefraiya (15)**

The existing water network is in very good condition and it has a length of around 21 km. It covers a large area of the town

Well W15W1 (35 years old), Well W15W2 (15 years old), Spring W15S1, Spring W15S2, Reservoir W15R1 (150 m³), Small pump: No available information

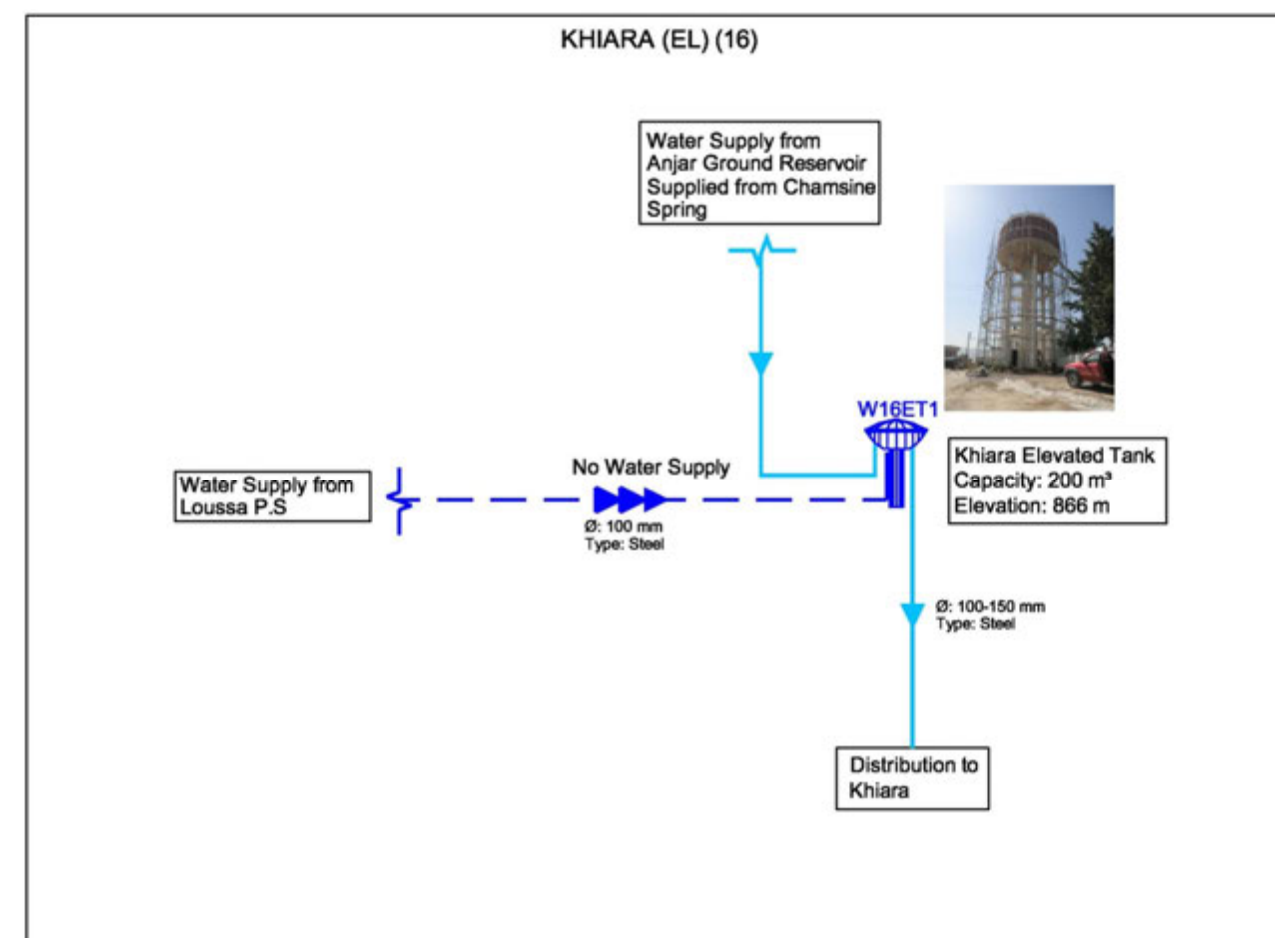
**Khiara (EI) (16)**

The existing water network is in very good condition and it has a length of around 9 km. It covers a large area of the town

Elevated tank W16ET1 (20 years old; 200 m³): Elevated tank is in good condition. Access was unavailable to valve chamber. It was under rehabilitation during visit time

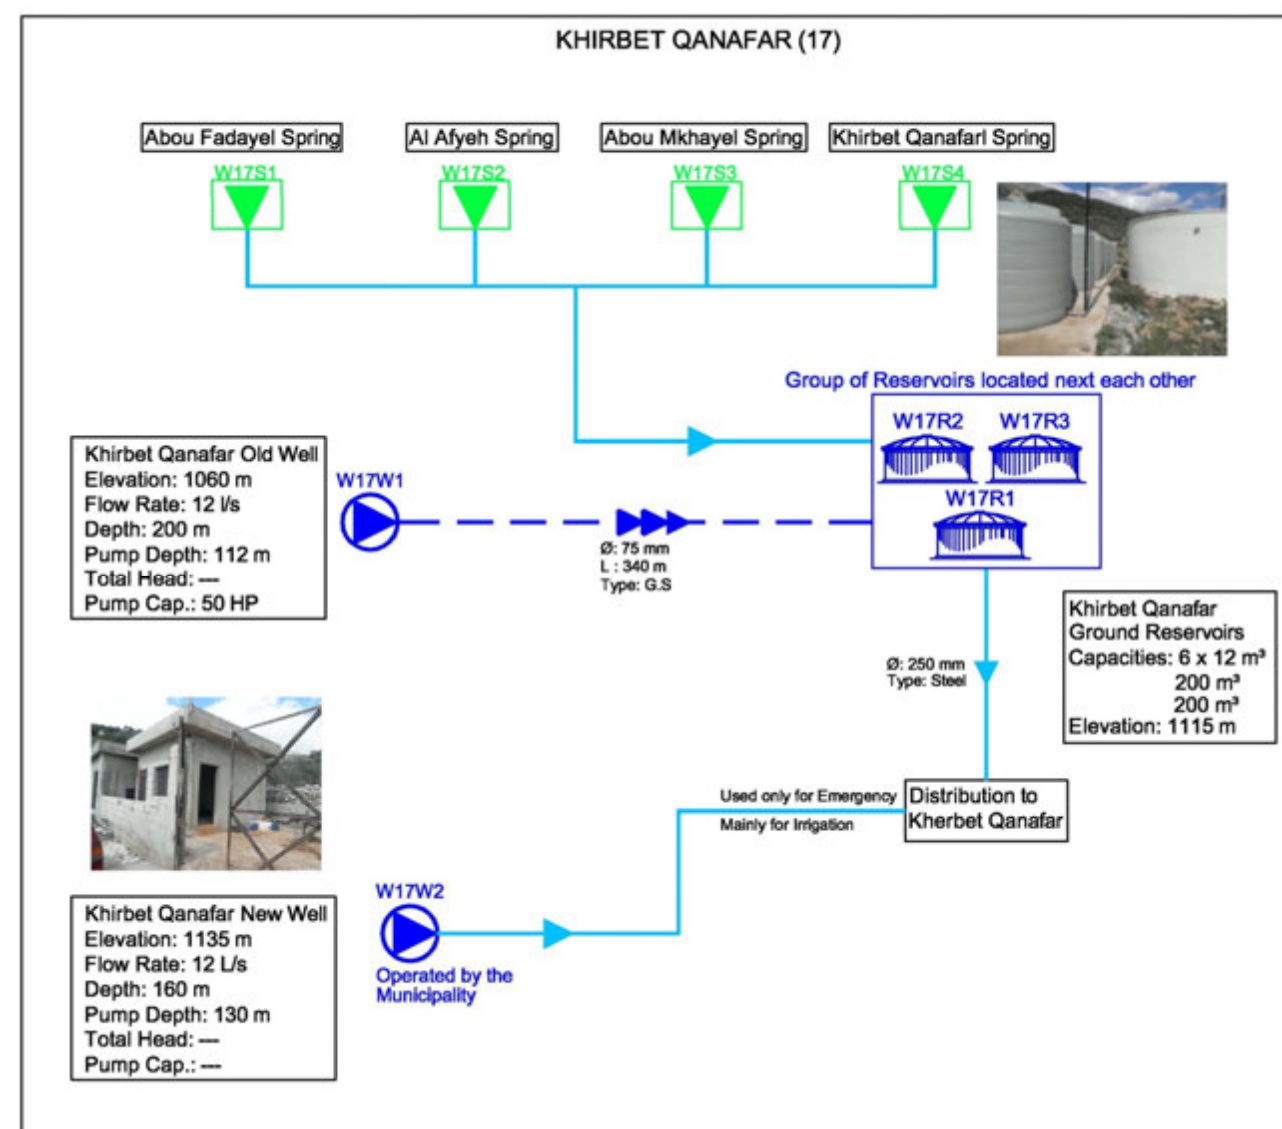
**Khirbet qanafar (17)**

The existing water network (installed in year 2003) is in good condition.

Well W17W1 (45 years old): Well is in acceptable condition. Chlorination unit is available but it is not in use. No more available information.

Reservoir W17R1 (200 m³), W17R2 (6x12m³) & W17R3 (200 m³): Reservoirs are in good condition.

W17R2 are group of six plastic reservoirs and they were added in 2006.

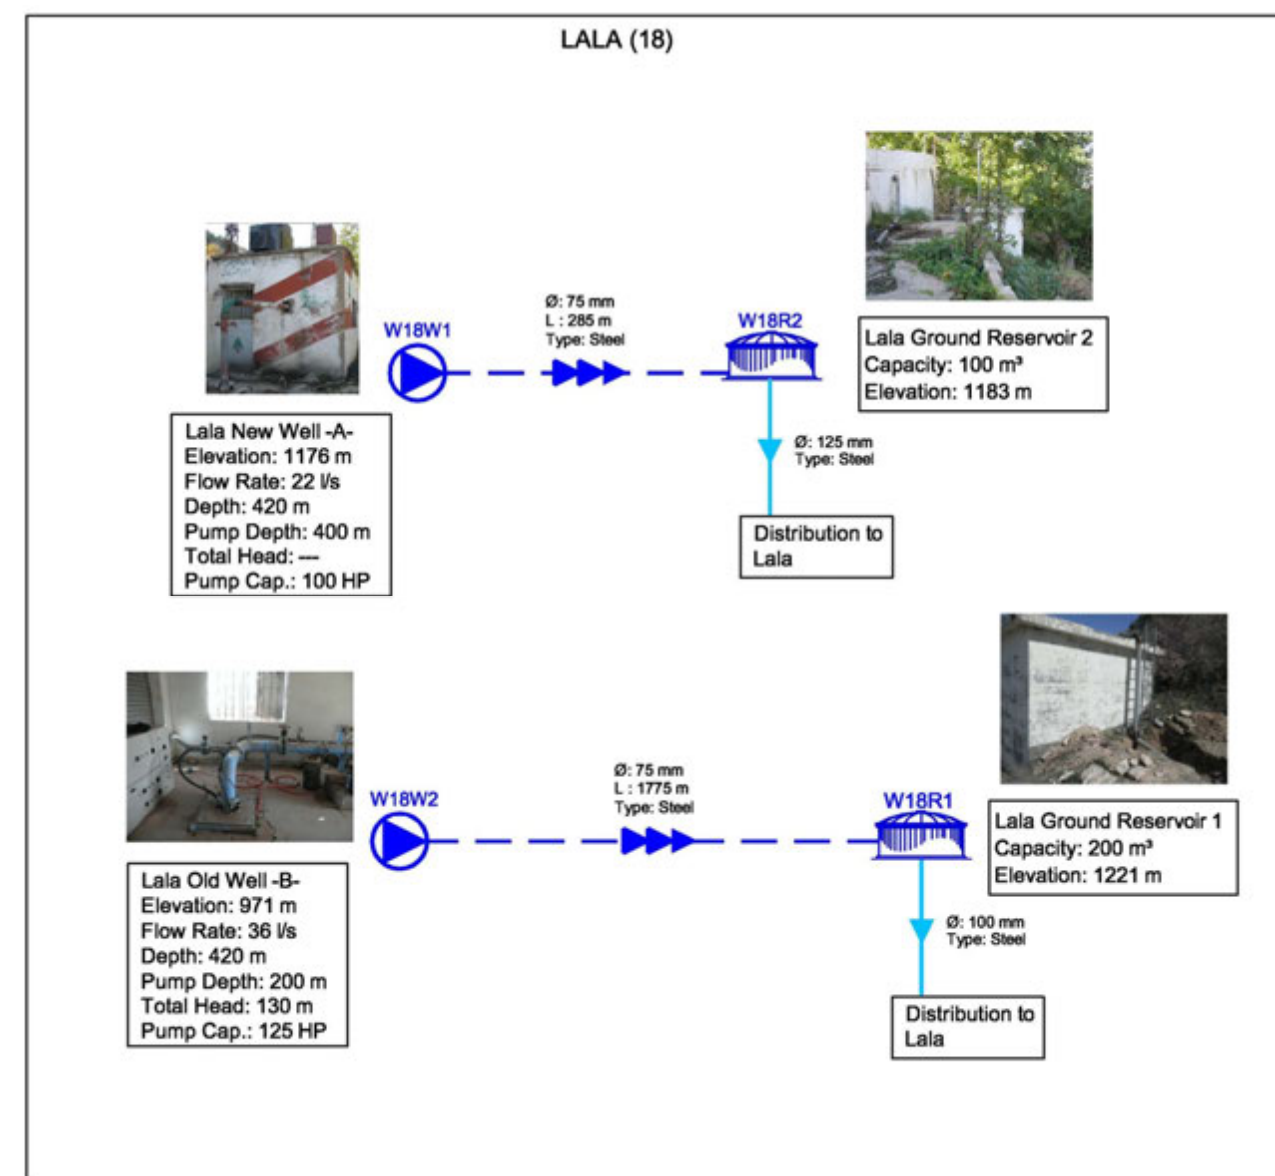
**Lala (18)**

There is no available information concerning the water network of the town. The main pipe between well and reservoir is updated. A new line coming from Baaloul regional reservoir will supply this village once Ain El Zarqa system becomes operational. The specific layout could not be obtained.

Well W18W1 (25 years old): Well is old and it is in bad condition. It needs rehabilitation.

Well W18W2 (>45 years): Well is old and it is in acceptable condition. Chlorination system is found (tanks + pumps) but it is not incorporated into system.

Reservoir W18R1 (>15 years; 200 m³): Reservoir is old but it is in acceptable condition. It needs esthetical rehabilitation.

Reservoir W18R2 (100 m³): Reservoir is old. No more available information.

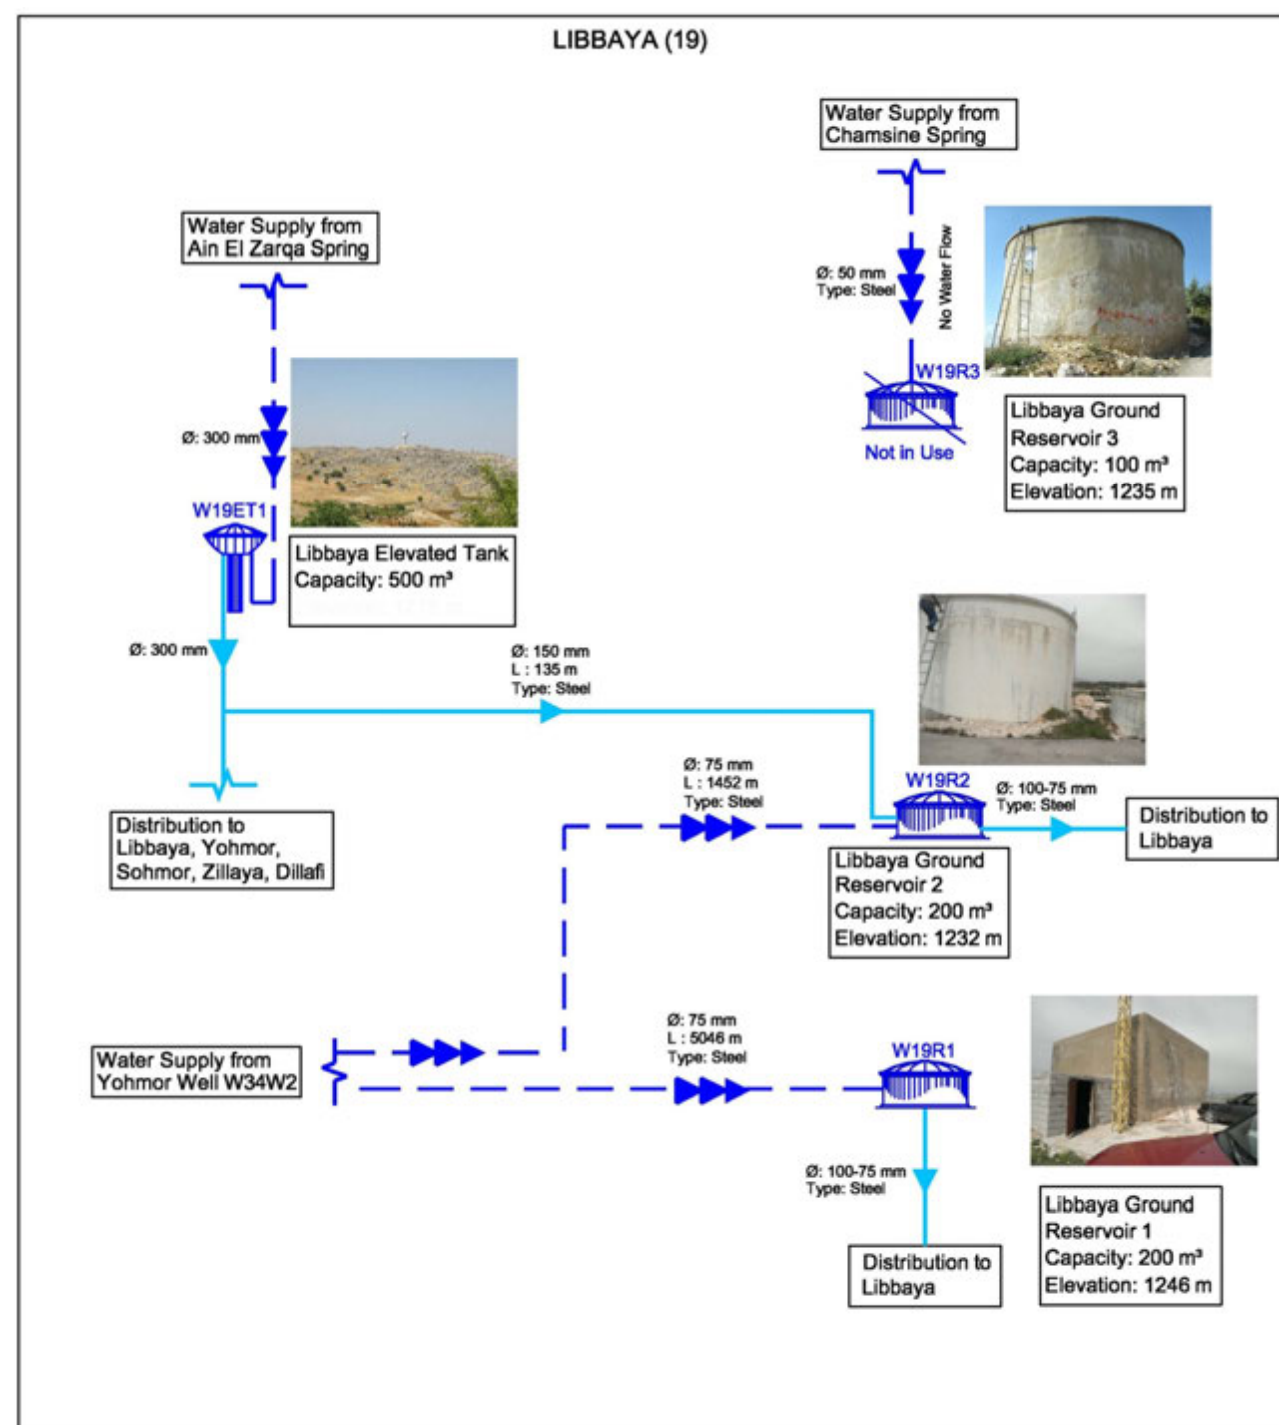
**Libbaya (19)**

There are old and new water networks (installed in years 1975 and 2005 respectively) in the town and they are connected together. The old network is in acceptable condition.

Reservoir W19R1 (>20 years; 200 m³): Reservoir is old and it is in bad condition. Pipes and valves are rusted and they need to be changed. This reservoir needs structural and esthetical rehabilitations or reconstruction.

Reservoir W19R2 (>20 years; 200 m³): Reservoir is old but it is in acceptable condition. It needs some maintenance.

Elevated tank W19ET1 (500 m³): Elevated tank is new but it is still not in use. It is a part of Ain El Zarqa water system.

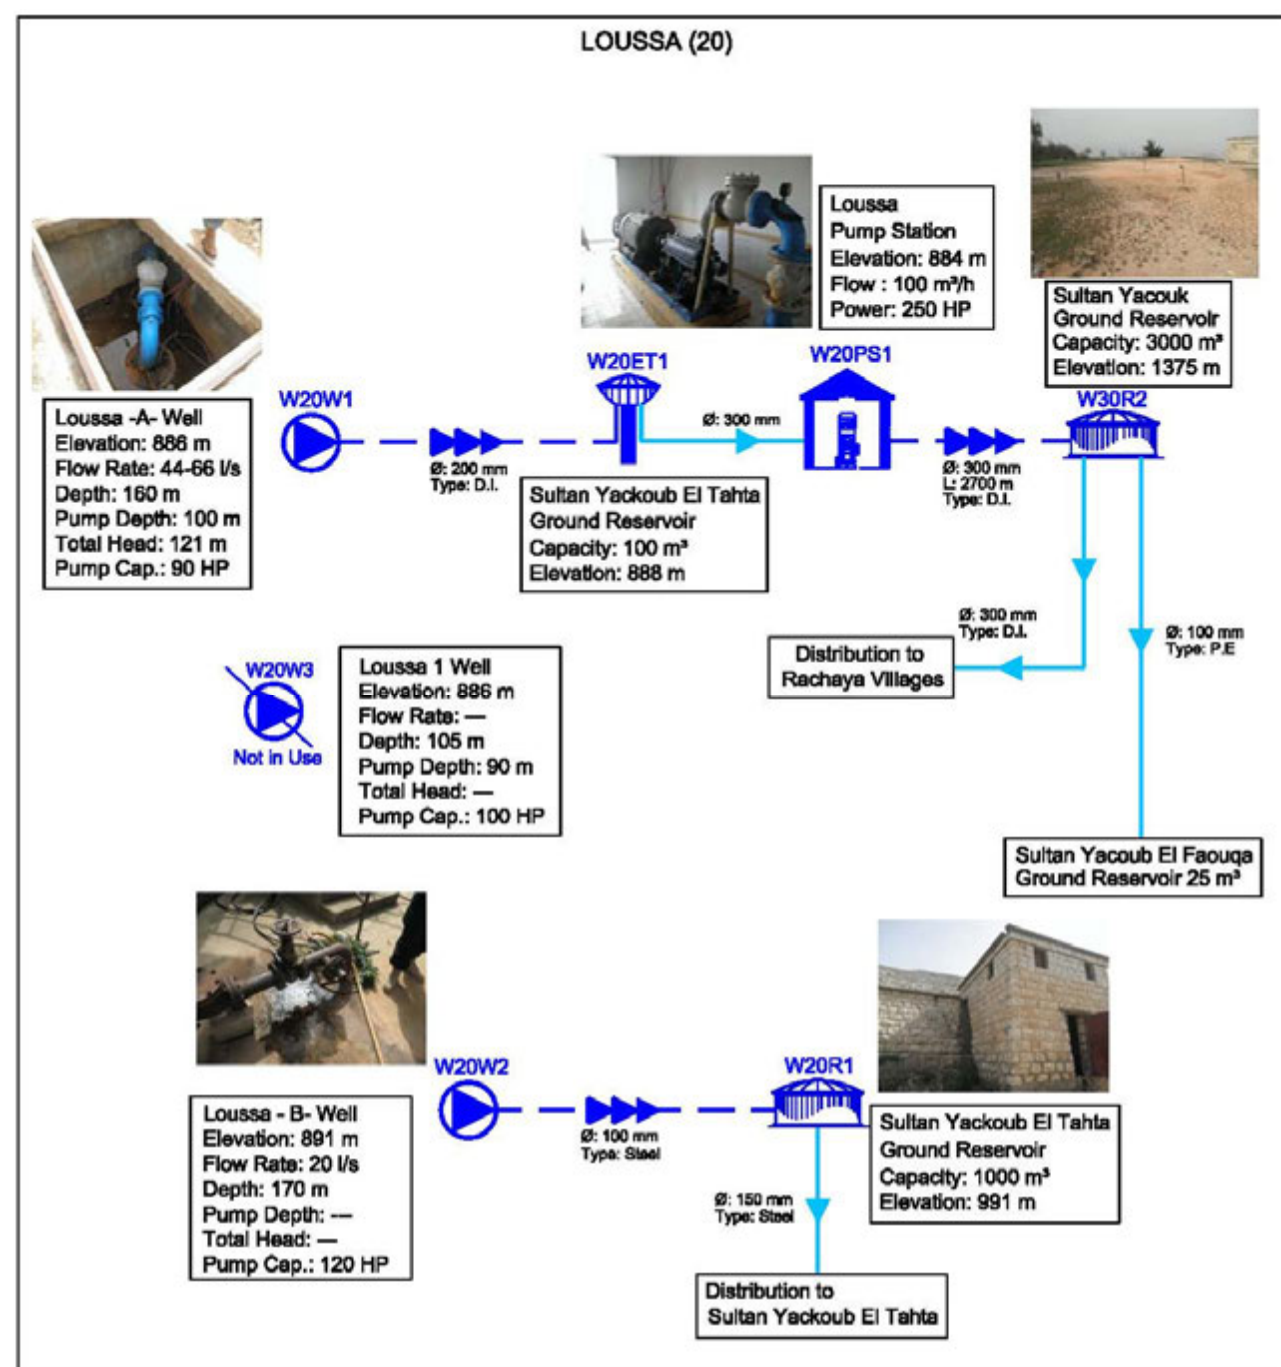
## Loussa (20)

There is no available information concerning the water network of the town.

Well W20W1 (15 years old): Well is new and it is in good condition.

Well W20W2 (15 years old): Well is old but it is in acceptable condition. There is no chlorination unit and the power generator is broken. This well needs some minor maintenance.

Pump station W20PS1: Pump station is in good condition.

Elevated tank W20ET1 (65 years old; 100 m³): Elevated tank is in good condition.

Reservoir W20R1 (1000 m³): Reservoir is old but it is in acceptable condition. It needs some minor maintenance.
