# WATER SUPPLY AND WASTEWATER SYSTEMS MASTER PLAN FOR THE BEKAA WATER ESTABLISHMENT

## WATER ASSESSMENT REPORT

January 2014  
Updated May 2015

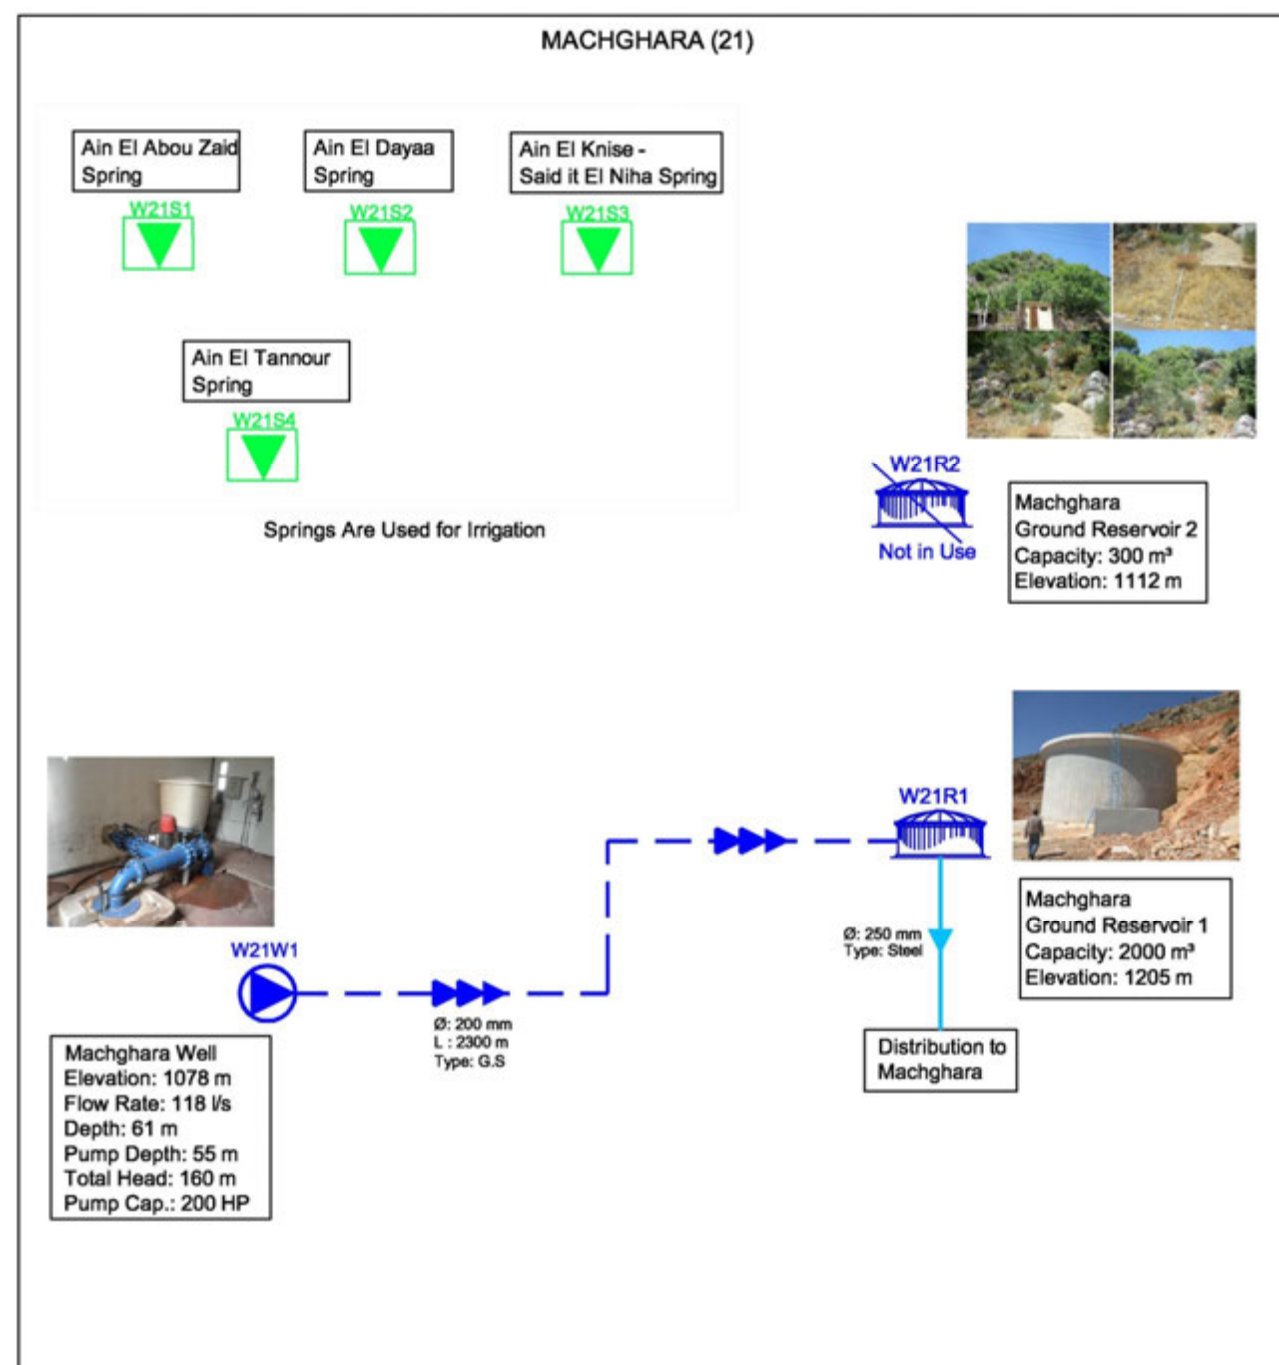
**Machghara (21)**

The existing water network is in good condition and it has a length of around 24 km. It covers a large area of the town

**Well W21W1 (35 years old):** Well is in acceptable condition but it suffers from a shortage of electric power and building needs repair and painting. Also the chlorination is disconnected while installing a new pump and it still not reconnected. This pump is for two reservoirs but not connected to the electrical generator Scania 230 kva. This well building needs rehabilitation.

**Reservoir W21R1 (>5 years; 2000 m³):** Reservoir is in good condition but it needs an esthetical rehabilitation. Also, the valve chamber is flooded with water; it needs sump or drainage pipe.

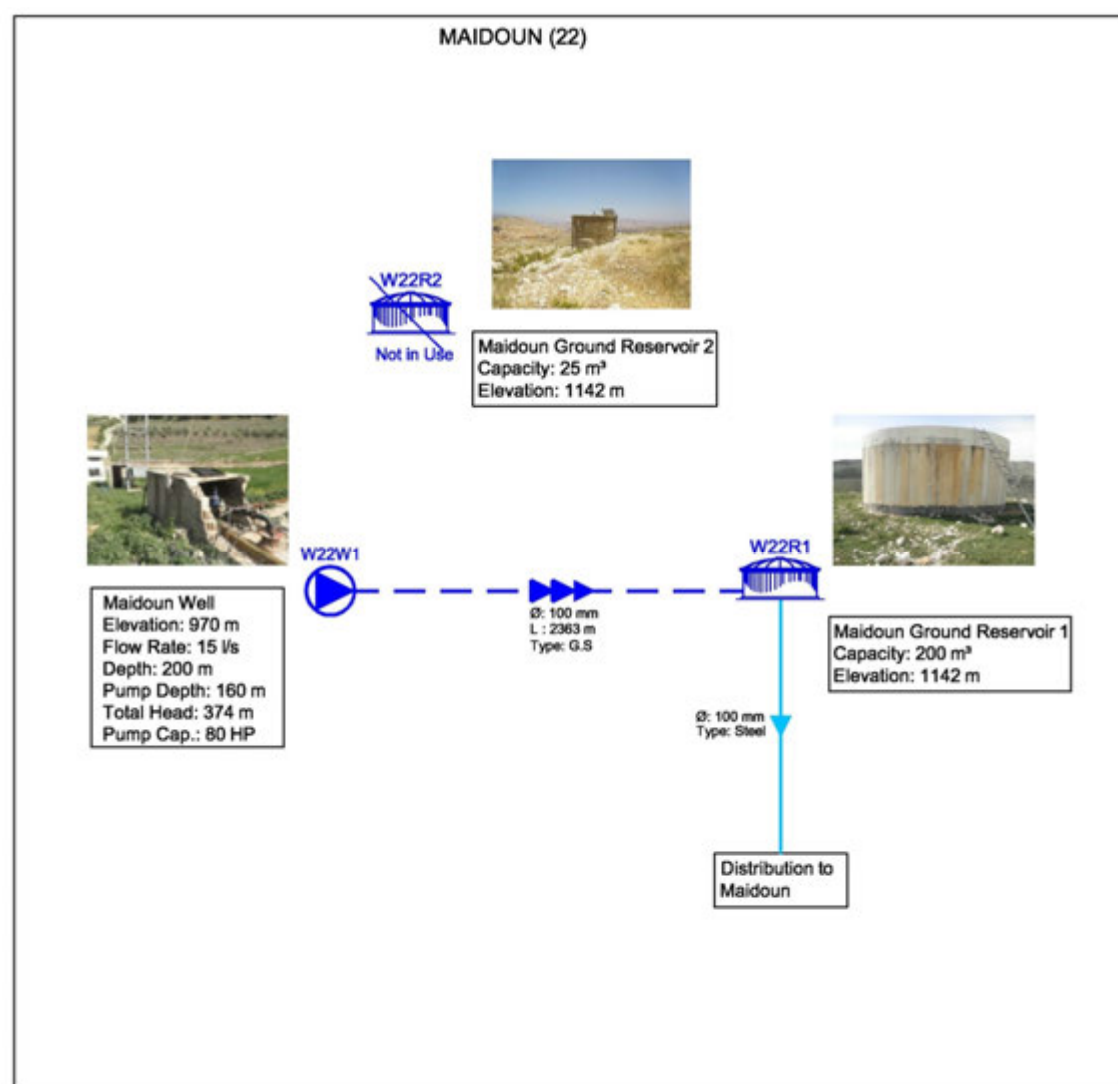
**Maidoun (22)**

Well W22W1 (30 years old): Well is old but it is in acceptable condition. There is no direct water outlet and the chlorination unit is new but still not functioning. The well concrete chamber is broken and need to be reconstructed.

Reservoir W22R1 (>10 years; 200 m³): Reservoir is in acceptable condition but it is subjected to leakage. Some valves need to be changed. This reservoir needs some maintenance and esthetical rehabilitation.

Reservoir W22R2 (25 m³): Reservoir is very old and it is not used for supplying domestic water. It needs rehabilitation or reconstruction.

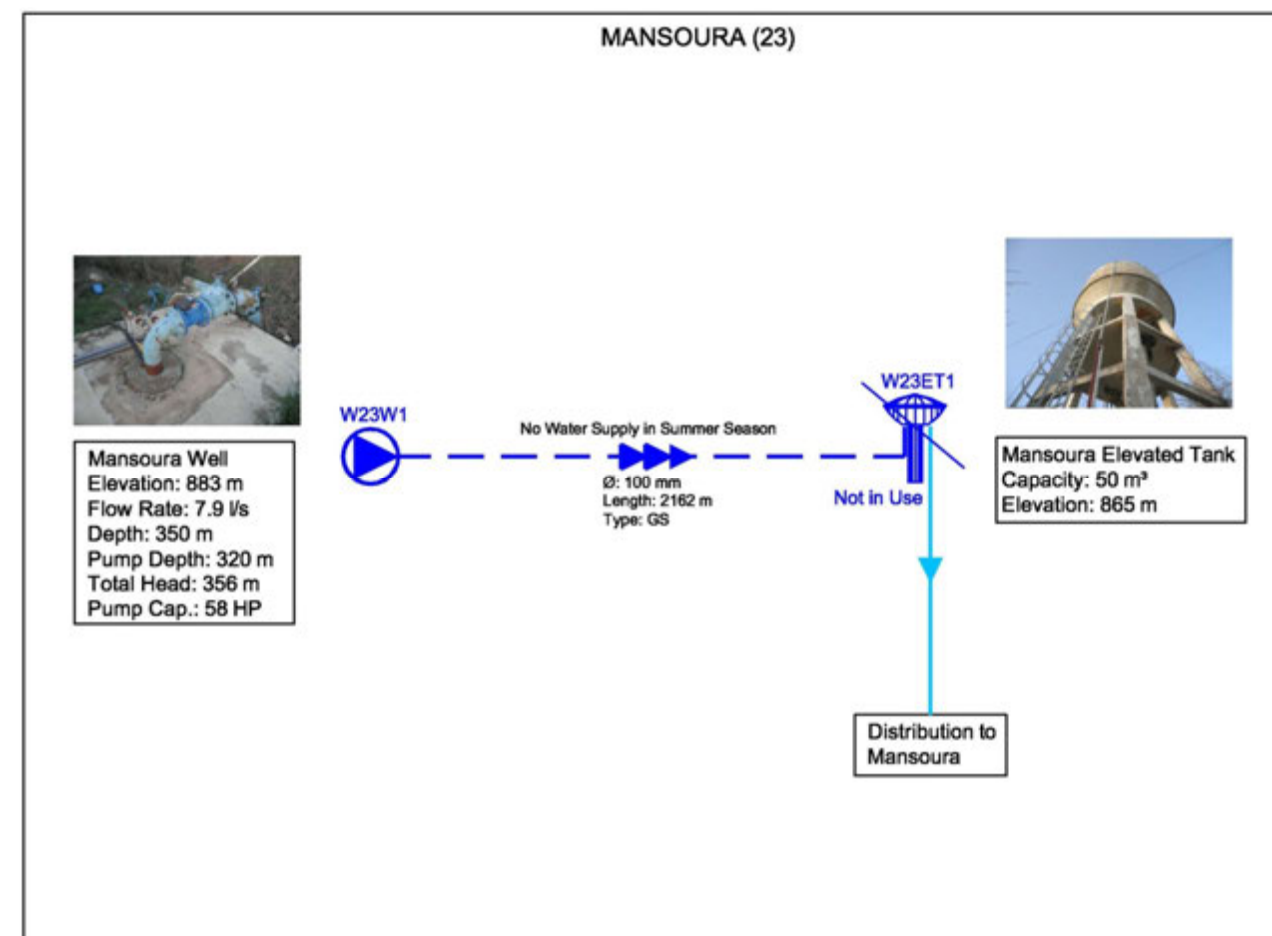
**Mansoura (23)**

The existing water network is in very good condition and it has a length of around 10.5 km. It covers a large area of the town. A new line coming from Baaloul regional reservoir will supply this village once Ain El Zarqa system becomes operational. The specific layout could not be obtained.

Well W23W1 (>10 years): Well is in acceptable condition but it suffers from a shortage of electric power. It has a generator. This well borehole shall be secured by a fence.

Elevated tank W23ET1 (60 years old; 50 m³): Elevated tank is old and it is not in use. Water is directly connected to the network. This elevated tank needs rehabilitation.

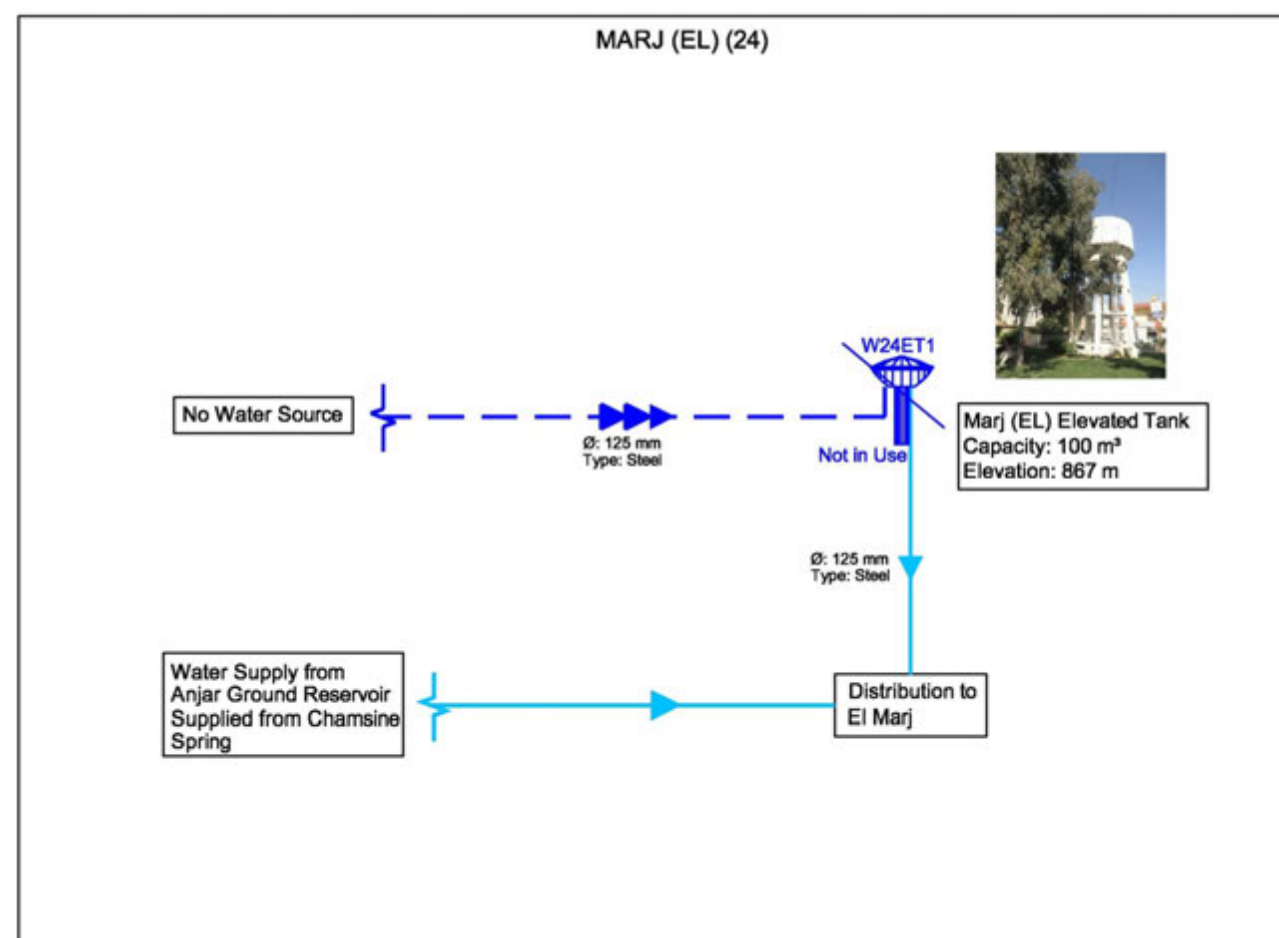
**Marj (EI) (24)**

The existing water network is in very good condition and it has a length of around 50 km. It covers a large area of the town

Elevated tank W24ET1 (>50 years; 100 m³): Elevated tank is in acceptable condition but it needs esthetical rehabilitation. The valve chamber door is broken. This elevated tank is not in use because it has no water source.

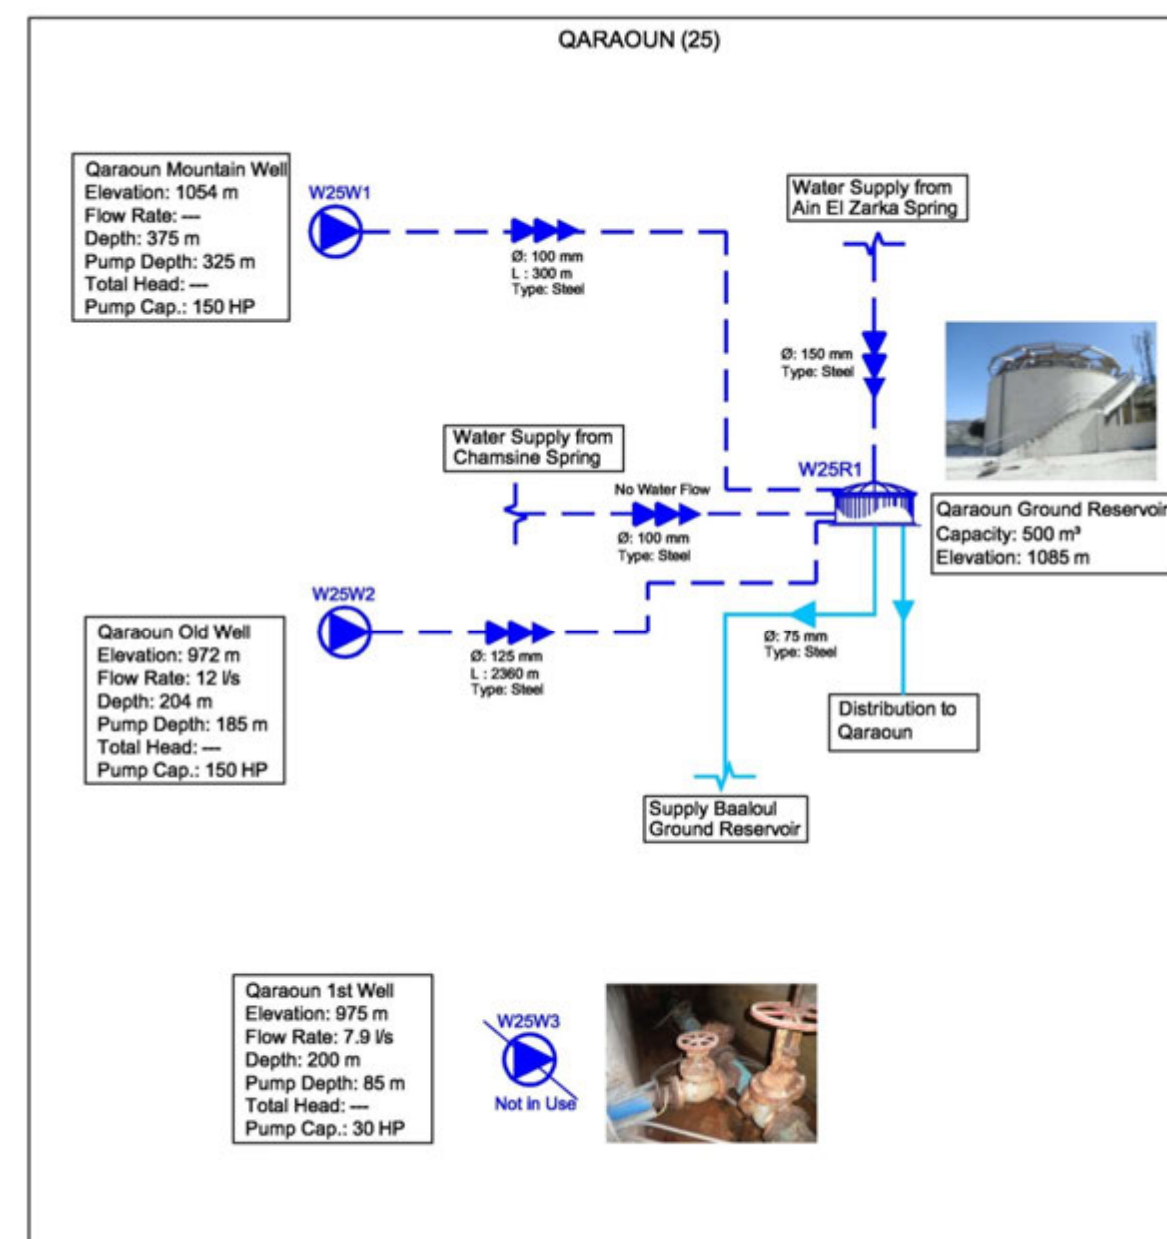
**Qaraoun (25)**

The old water network is replaced by a new one in year 2000. This network is in good condition.

Well W25W1 (30 years old): Well suffers from a shortage of electric power. No more available information.

Well W25W3 (>45 years): Well is old and it is in bad condition. Its valves and pipes are rusted and need to be changed. This Well needs rehabilitation. This well is not in use anymore.

Reservoir W25R1 (15 years old; 500 m³): Reservoir is in good condition but there is neither level indicator nor flow meter nor overflow pipe. It needs some minor maintenance.

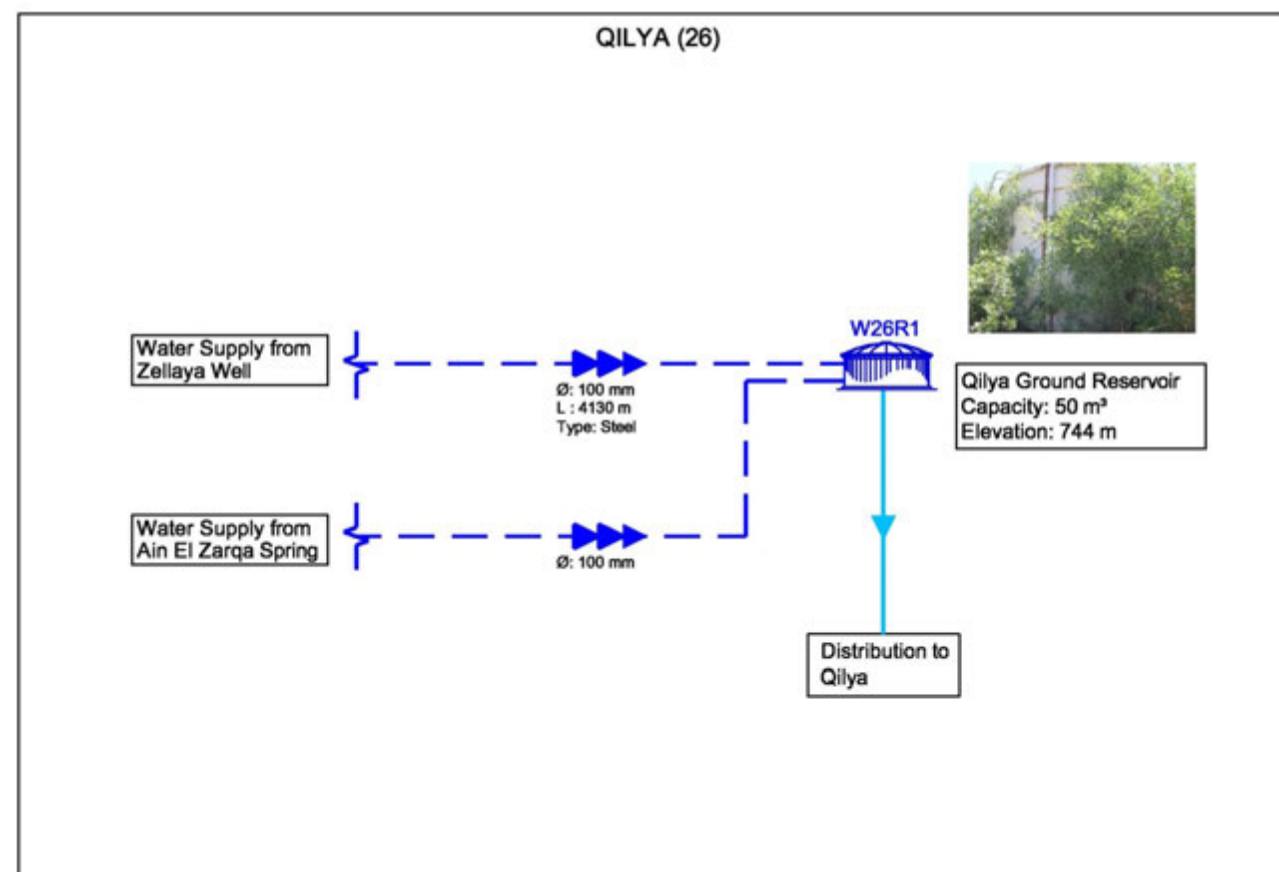
**Qilya (26)**

Reservoir W26R1 (50 m³): Reservoir is in acceptable condition. It is subjected to leakage it needs some minor maintenance.

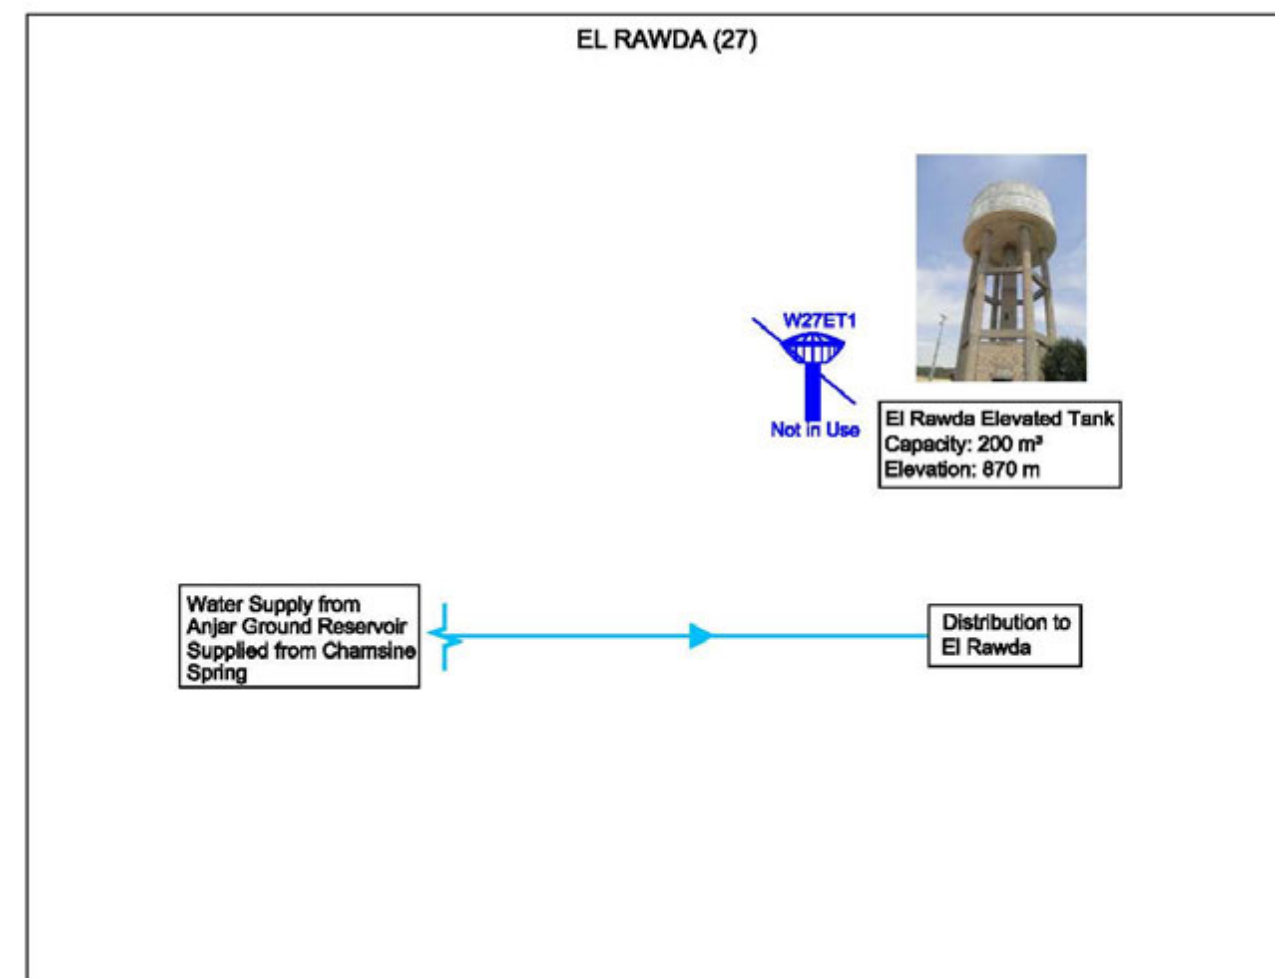
**El Rawda (27)**

The existing water network is in very good condition and it has a length of around 4 km. It covers a large area of the town

Elevated tank W27ET1 (200 m³): Elevated tank is old and it is not in use.

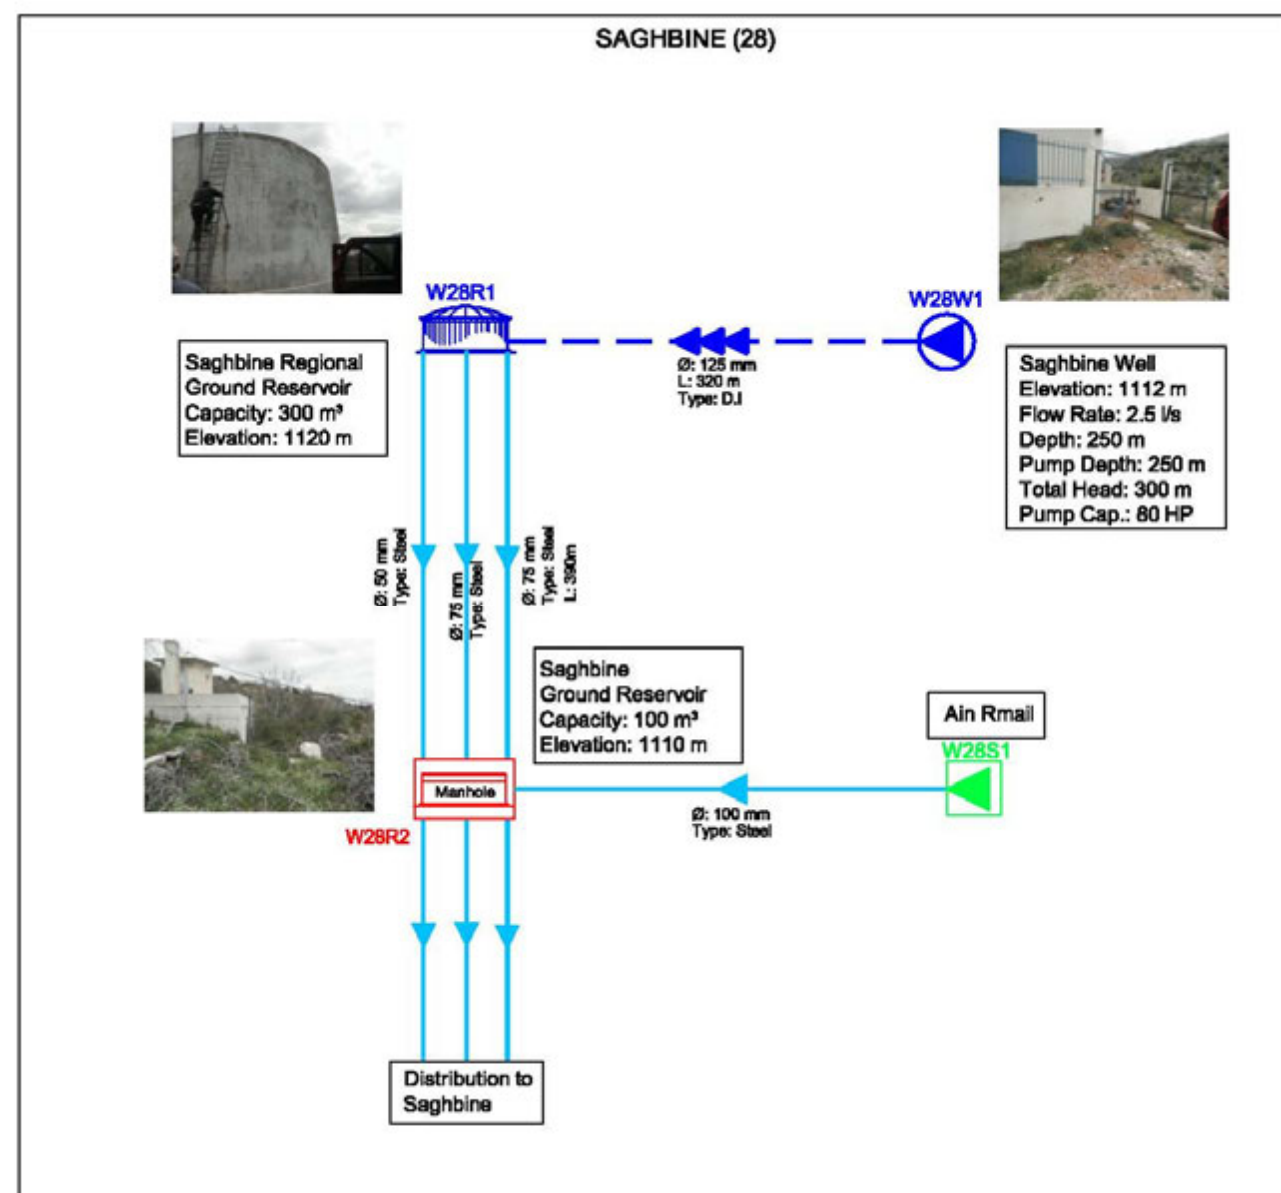
**Saghbine (28)**

Well W28W1 (15 years old): Well is in acceptable condition. There is no chlorination unit. Well building needs rehabilitation.

Reservoir W28R1 (>15 years; 300 m³): Reservoir is in good condition. The valve chamber is inaccessible because of vegetation. Chlorine disinfection is not functioning. This reservoir needs minor maintenance.

Reservoir W28R2 (65 years old; 100 m³): Reservoir is very old but in acceptable condition. No more available information.

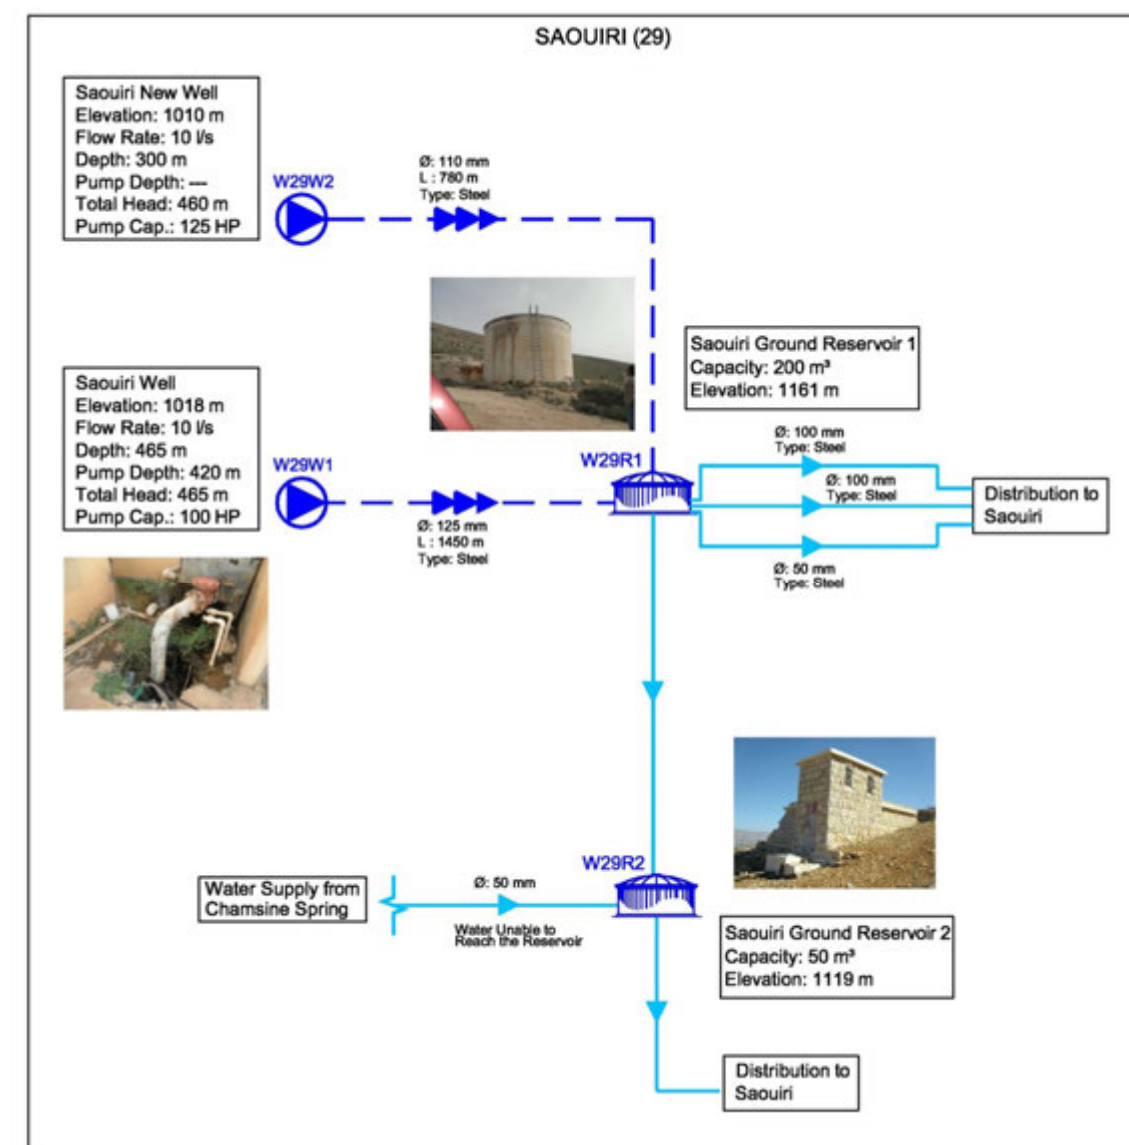
**Saouiri (29)**

Well W29W1 (>30 years): Well is very old and it is in bad condition. Its pipes and valves are rusted and they are subjected to leakage. There is no chlorination unit and the power generator is not working. This well needs rehabilitation.

Reservoir W29R1 (15 years old; 200 m³): Reservoir is in acceptable condition but its pipes are subjected to leakage. This reservoir needs some minor maintenance.

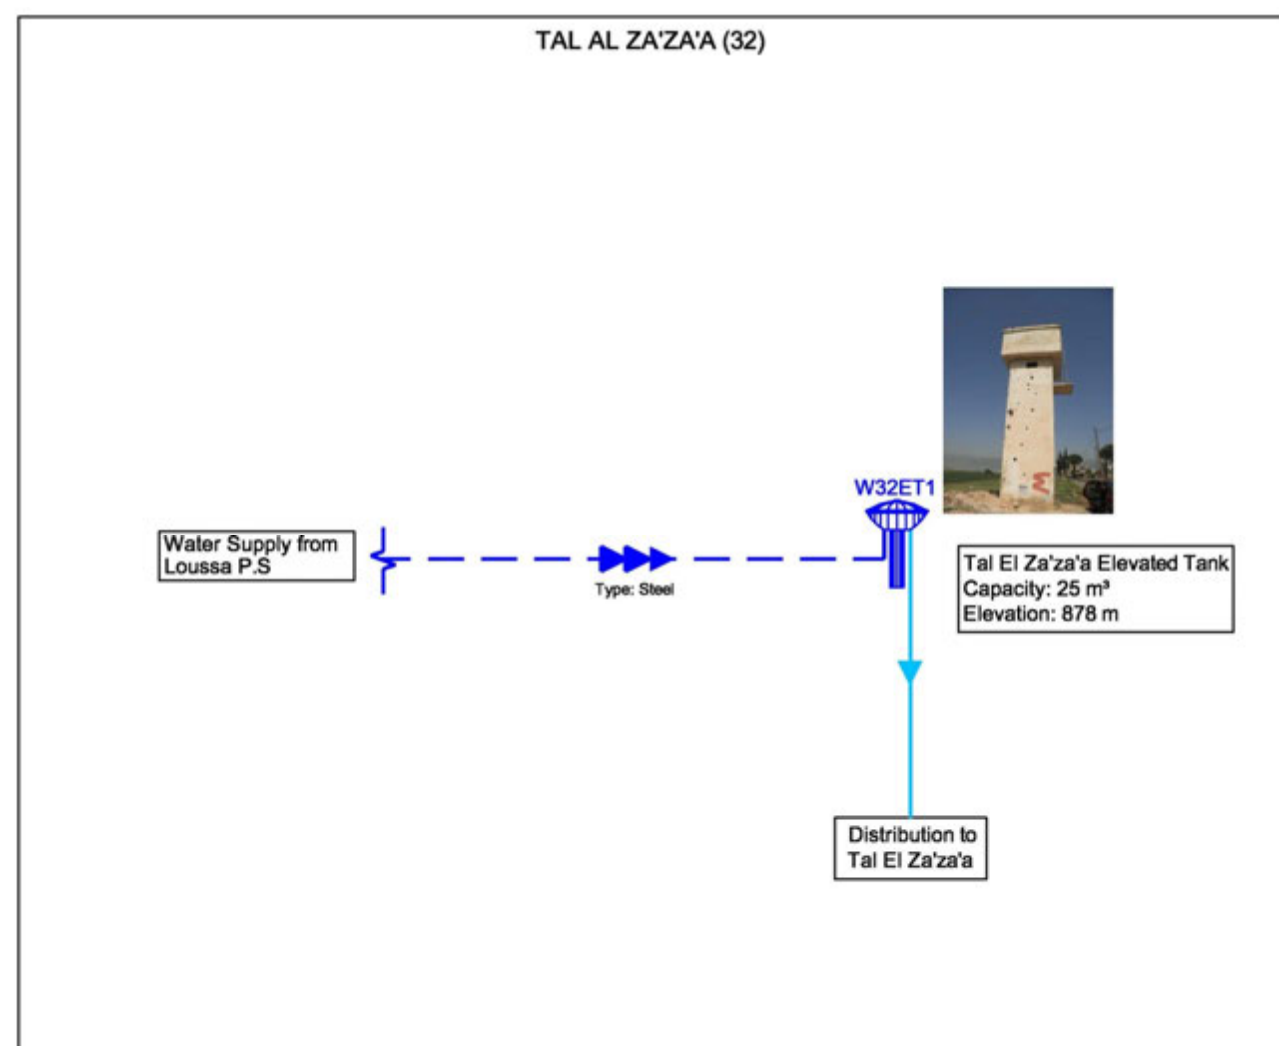
**Tal al za'za'a (32)**

Elevated tank W32ET1 (55 years old; 25 m³): Elevated tank is in bad condition.

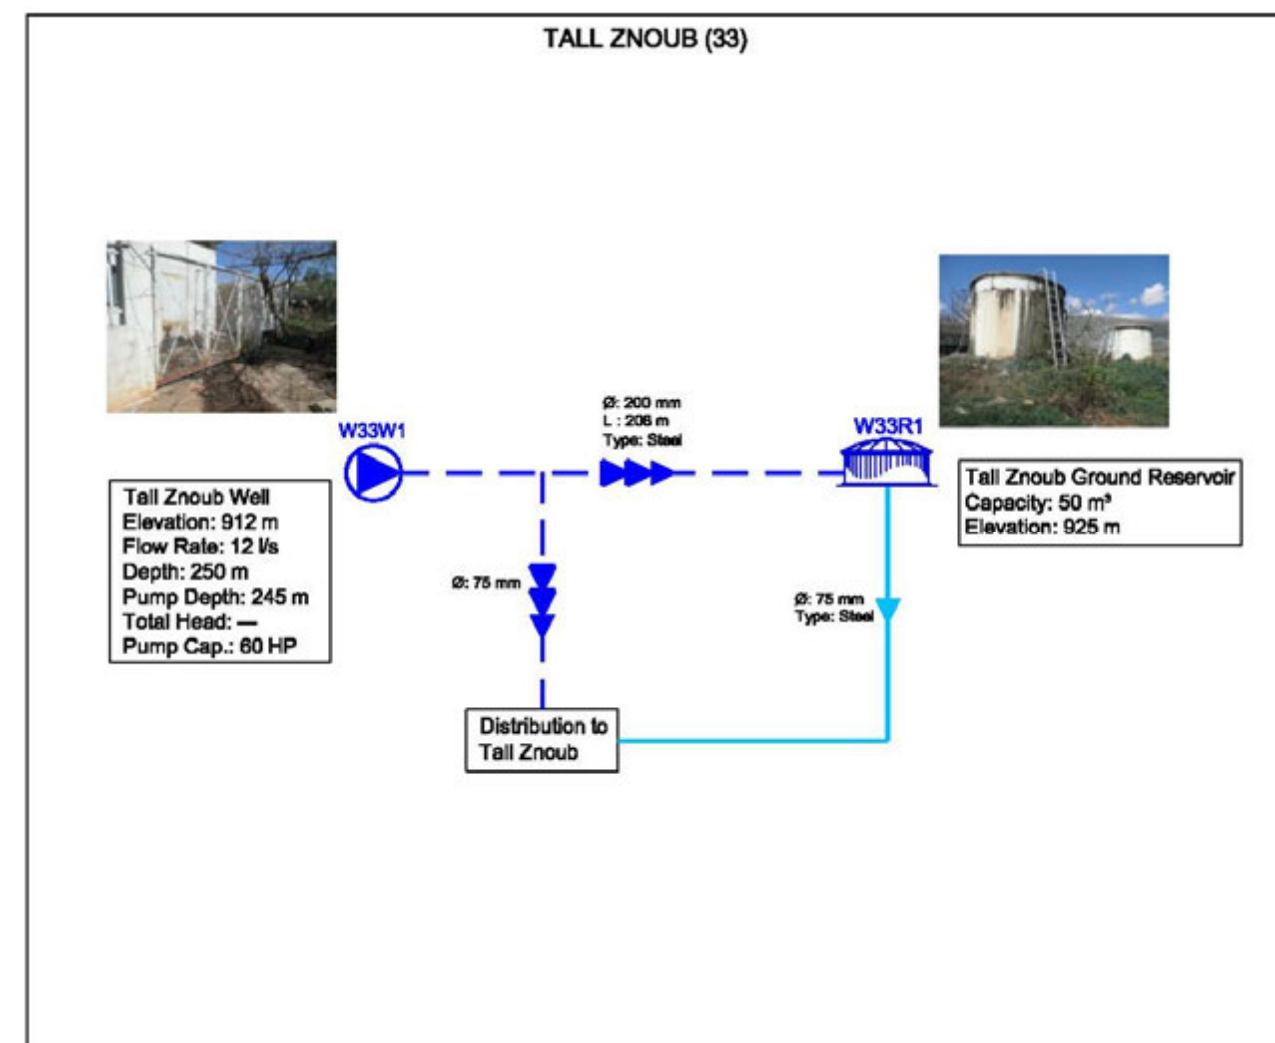
**Tall Znoub (33)**

Well W33W1 (>15 years): Well is acceptable condition. The access to the building was impossible due to the absence of the keys. There is a chlorination unit but it is not in use.

Reservoir W33R1 (45 years old; 50 m³): Reservoir is in bad condition. It is subjected to severe leakage. Also, the valve chamber is flooded with water and the valves and pipes are submerged with water. This reservoir needs rehabilitation.

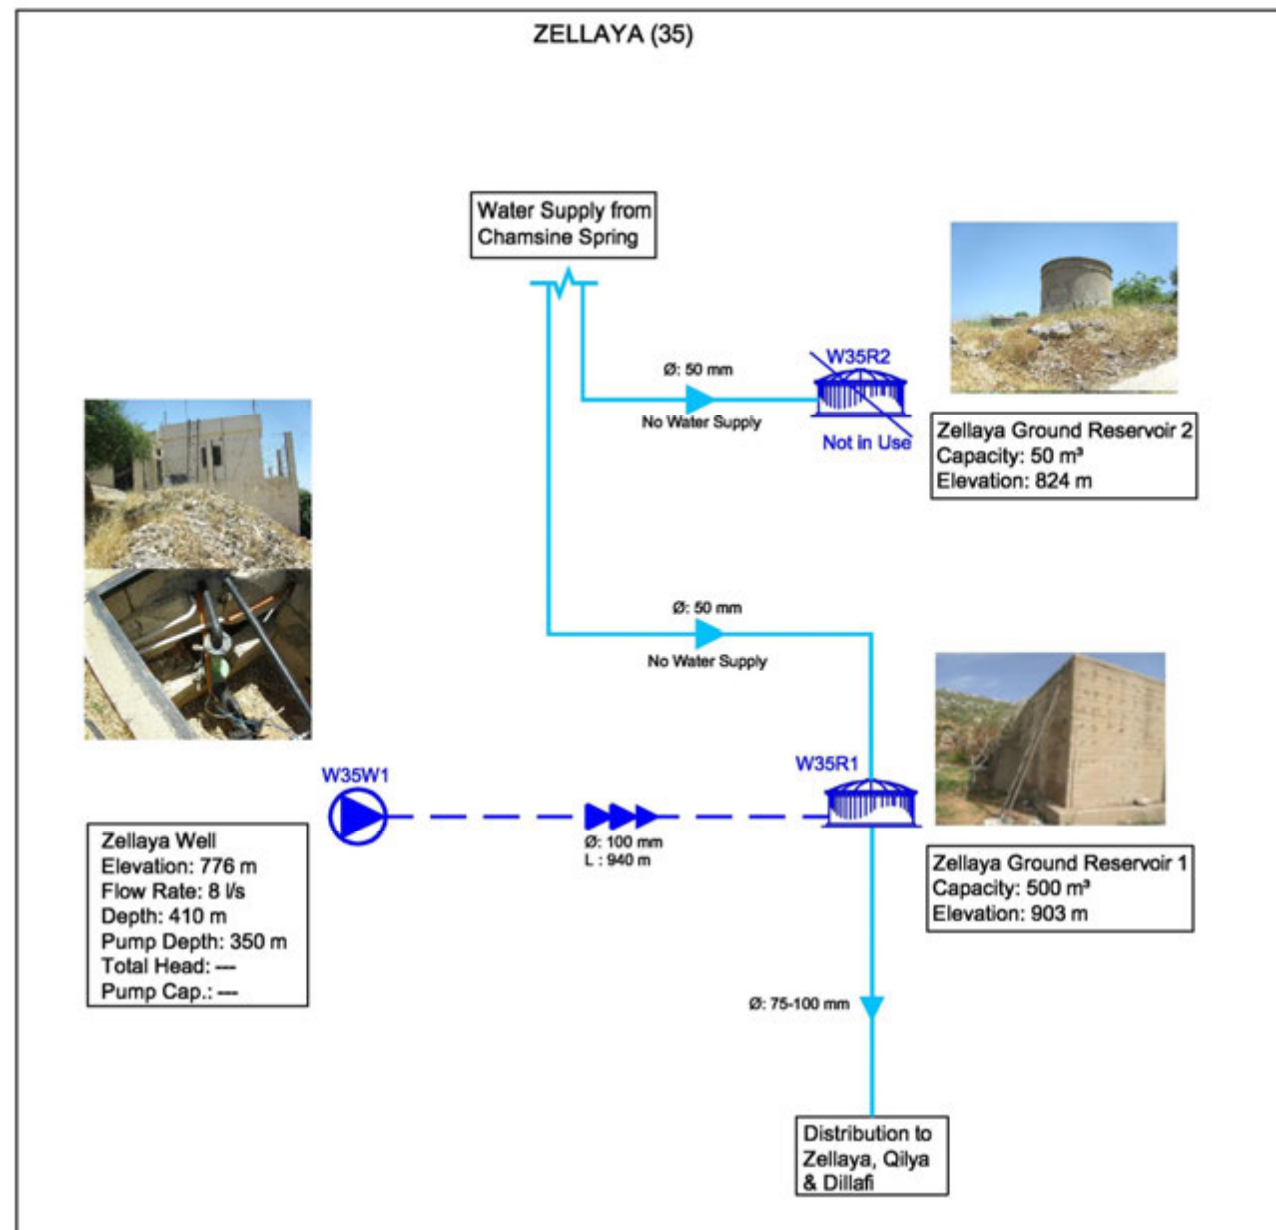
**Zellaya (35)**

Well W35W1: Well is in good condition. Its chamber needs a steel cover.

Reservoir W35R1 (>30 years; 500 m³): Reservoir is old but it is still in acceptable condition. It doesn't have an overflow pipe. This reservoir needs esthetical rehabilitation and minor maintenance.

Reservoir W35R2 (50 m³): Reservoir is very old and it is in bad condition. It needs rehabilitation or reconstruction. This reservoir is not in use anymore.

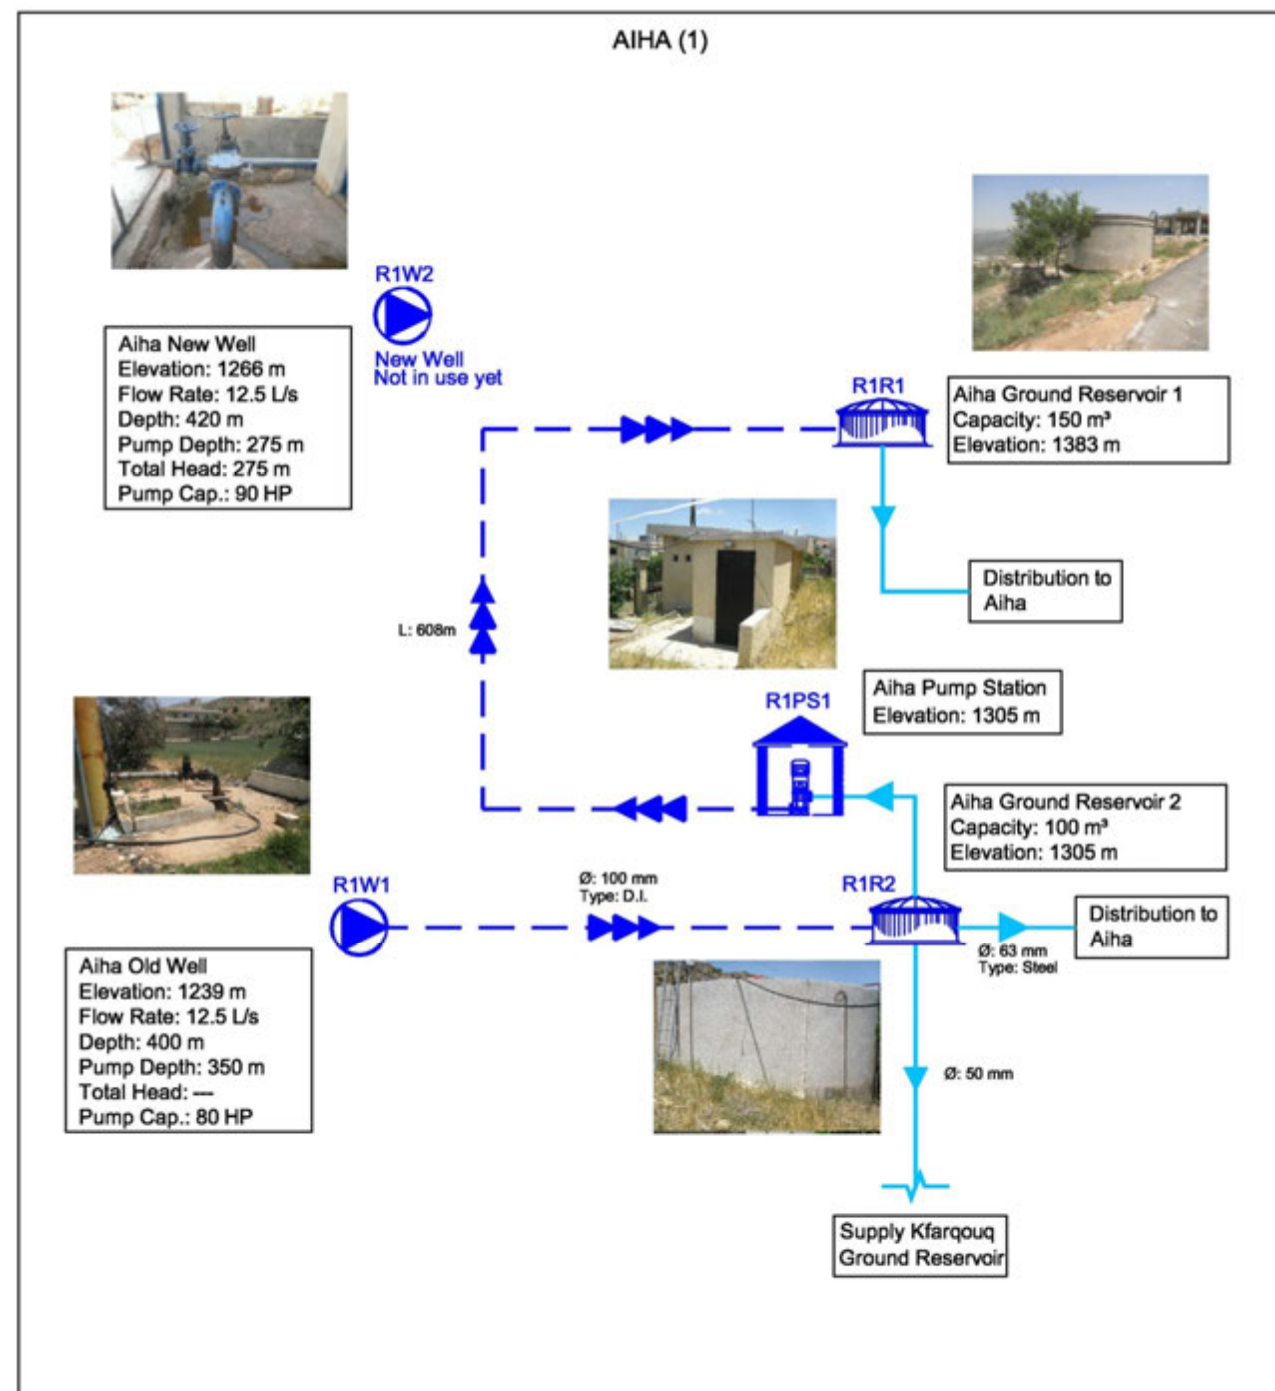
## Aiha (1)

Well R1W1 (15 years old): Well is in bad condition and it suffers from a shortage of electric power. The outlet pipe is rusted. There is no chlorination unit for this well nor a private generator. Its electrical panel is broken. It has a booster pump but it is not working. This well needs rehabilitation.

Reservoir R1R1 (150 m³): Reservoir is very old. Its pipes are rusted. This reservoir needs rehabilitation or reconstruction.

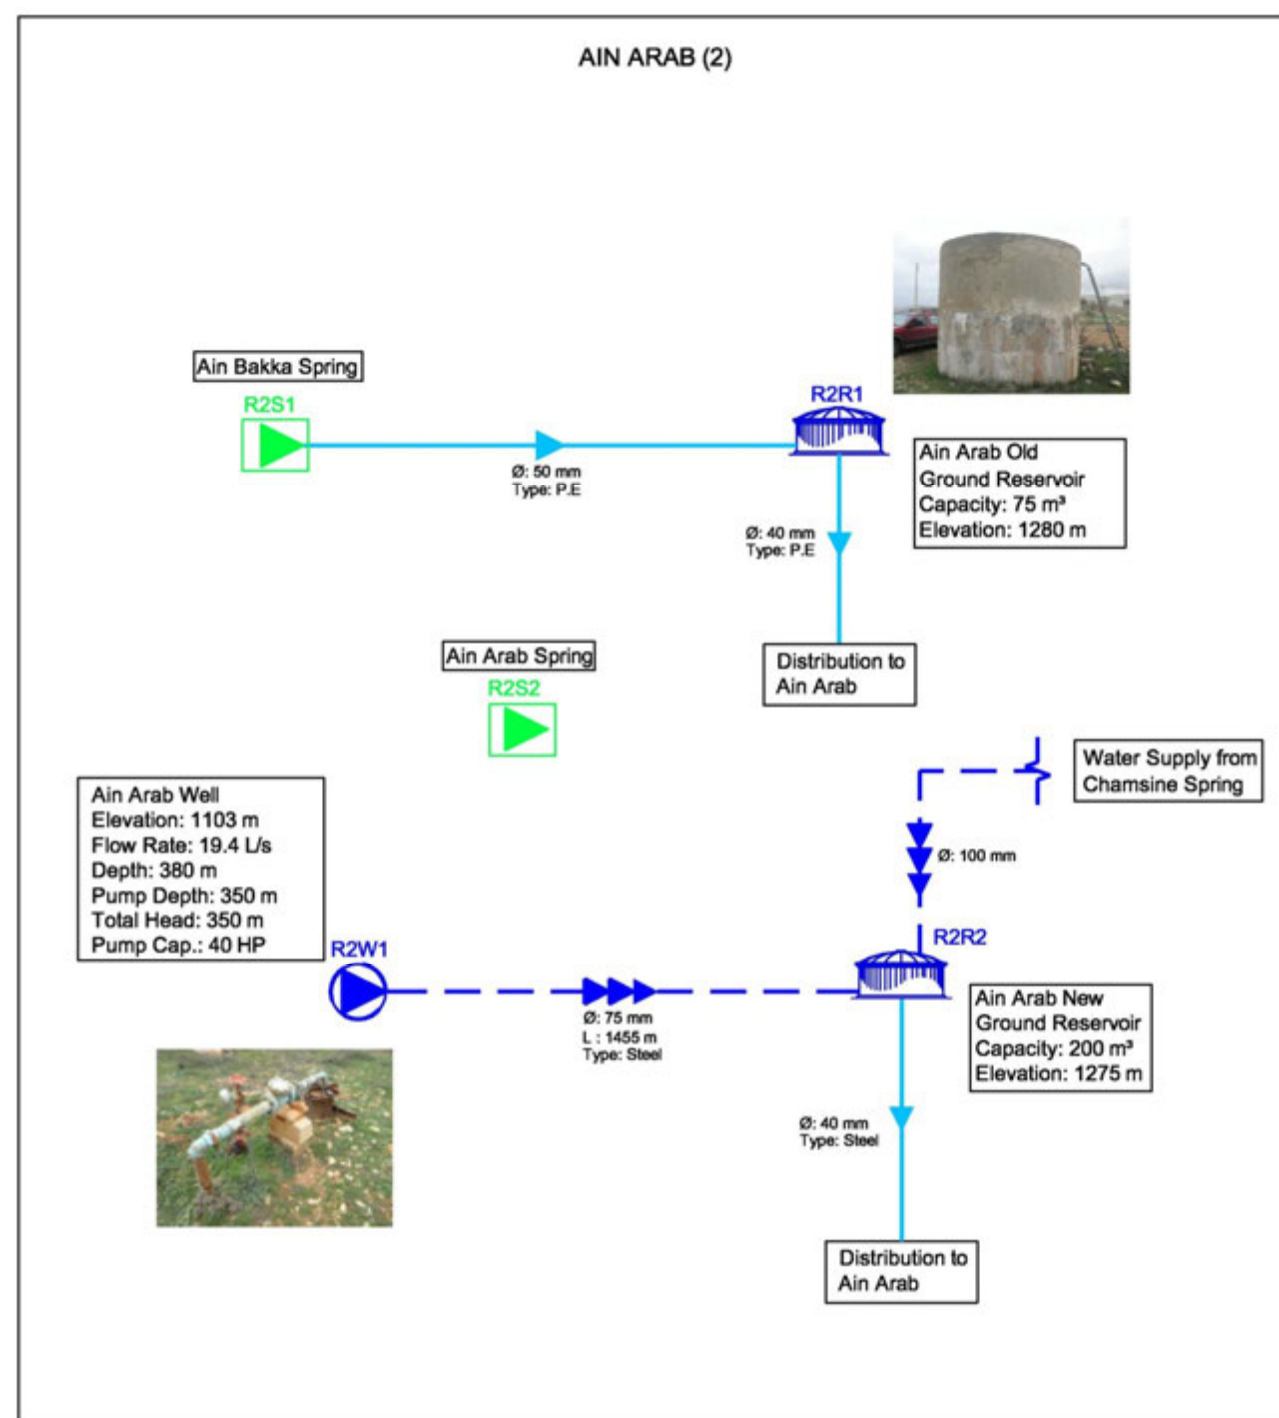
**Ain arab (2)**

Well R2W1 (10 years old): Well is in bad condition. There is chlorination unit but it is not working. Actually people stop using the water of this well because it is polluted.

Reservoir R2R1 (>60 years; 75 m<sup>3</sup>): Reservoir is very old and it is in very bad condition. Its valve chamber is submerged with water. This reservoir needs reconstruction.
