# WATER SUPPLY AND WASTEWATER SYSTEMS MASTER PLAN FOR THE BEKAA WATER ESTABLISHMENT

## WATER ASSESSMENT REPORT

January 2014  
Updated May 2015

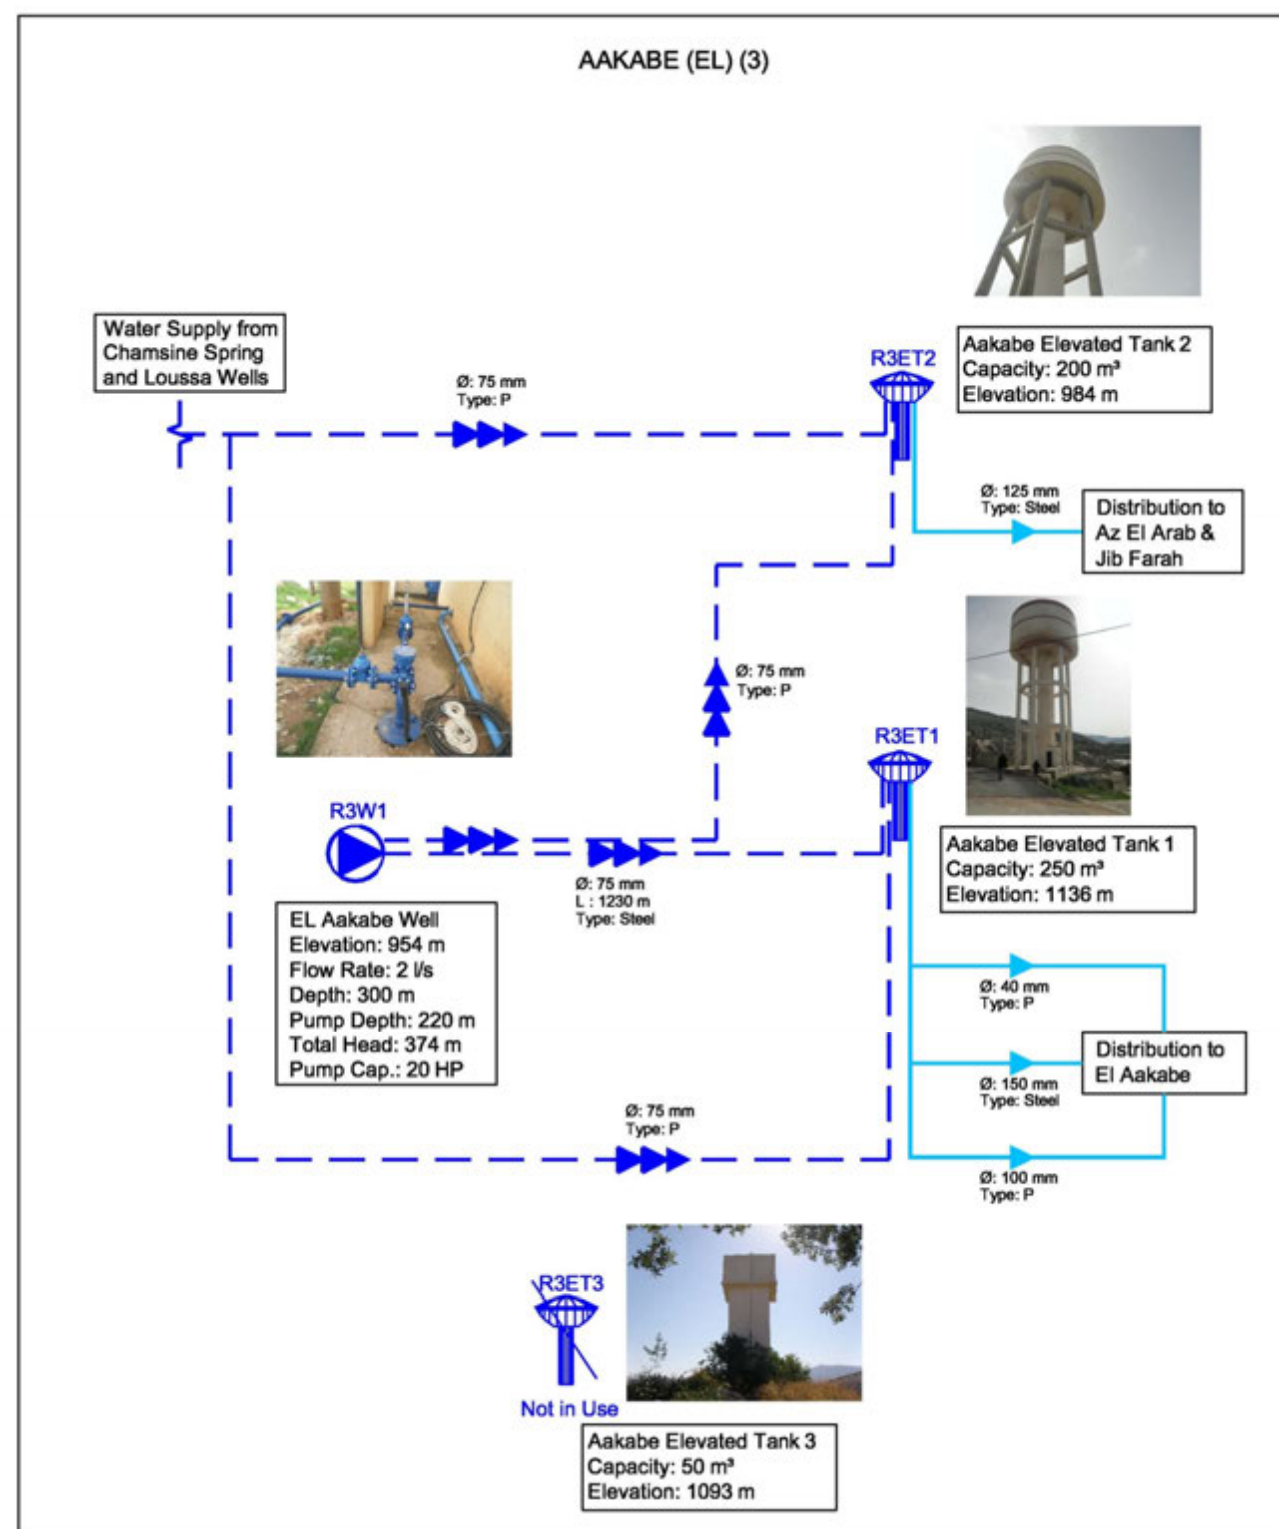
**Aakabe (el) (3)**

Well R3W1 (15 years old): Well is in good condition but it suffers from a shortage of electric power. The old booster pump was replaced by a new one lately. There is no chlorination unit but water is cleaned through blue boxes contains aggregates.

Elevated tank R3ET1 (250 m³): Elevated tank is in good condition. Its valve chamber is submerged with water and some valves are missing. This tank needs some minor maintenance (adding valves, fixing some pipes...).

Elevated tank R3ET3 (<15 years; 50 m³): Elevated tank is in very old and it is not in use.

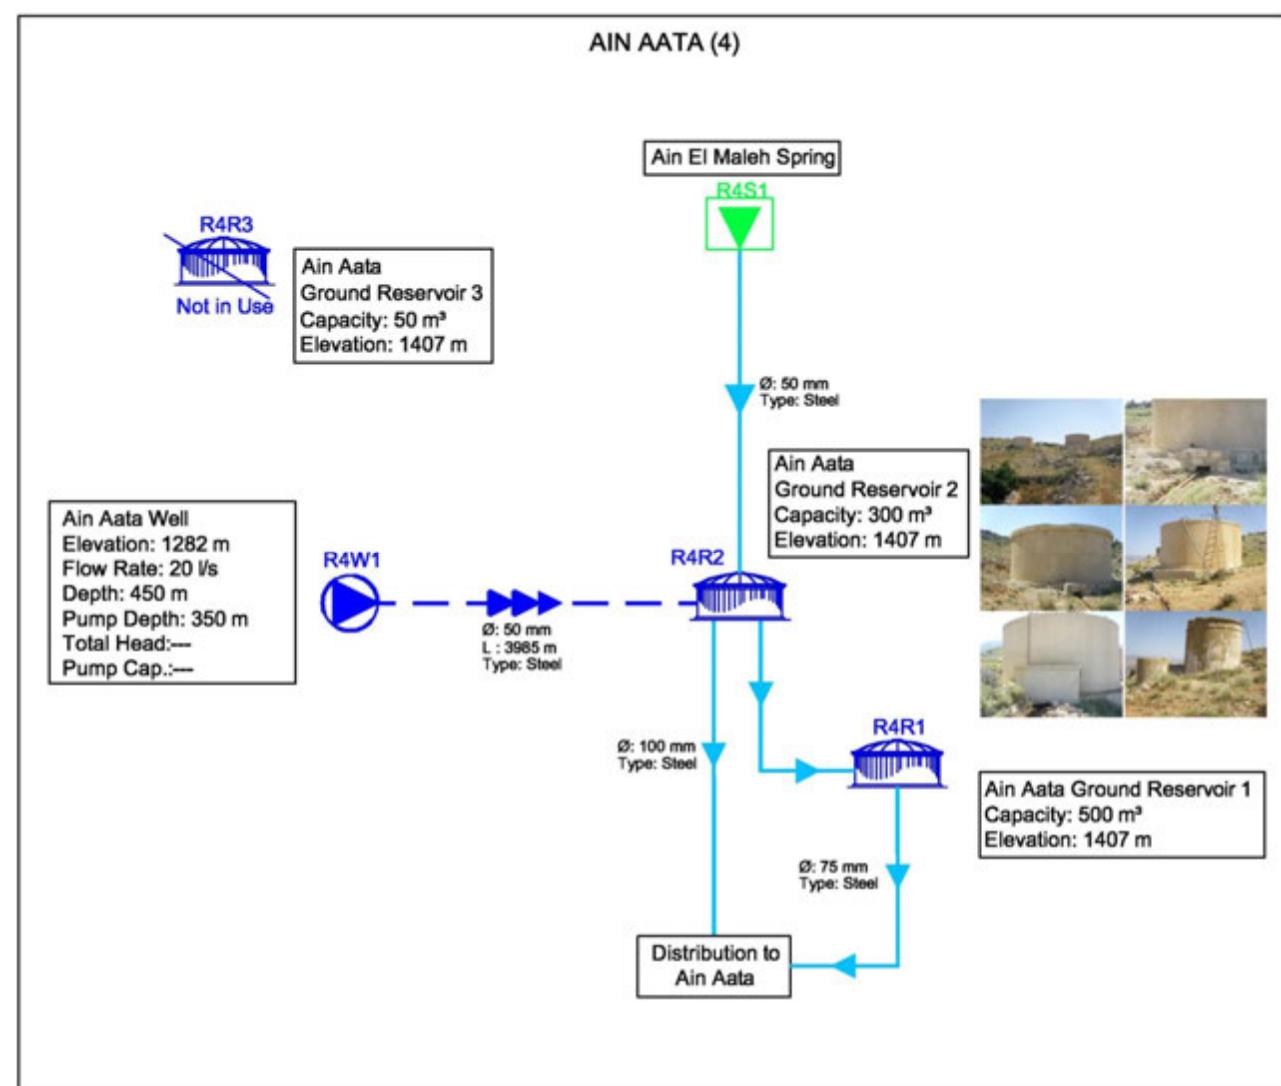
**Ain Aata (4)**

The existing water network is very old (installed 50 years ago) and it is in bad condition. A new line coming from Ain El Zarqa spring will supply this village once the system becomes operational. The specific layout could not be obtained.

Reservoir R4R1 (500 m³): Reservoir is in good condition.

Reservoir R4R2 (300 m³): Reservoir is in good condition.

Reservoir R4R3 (50 m³): It is not in use.

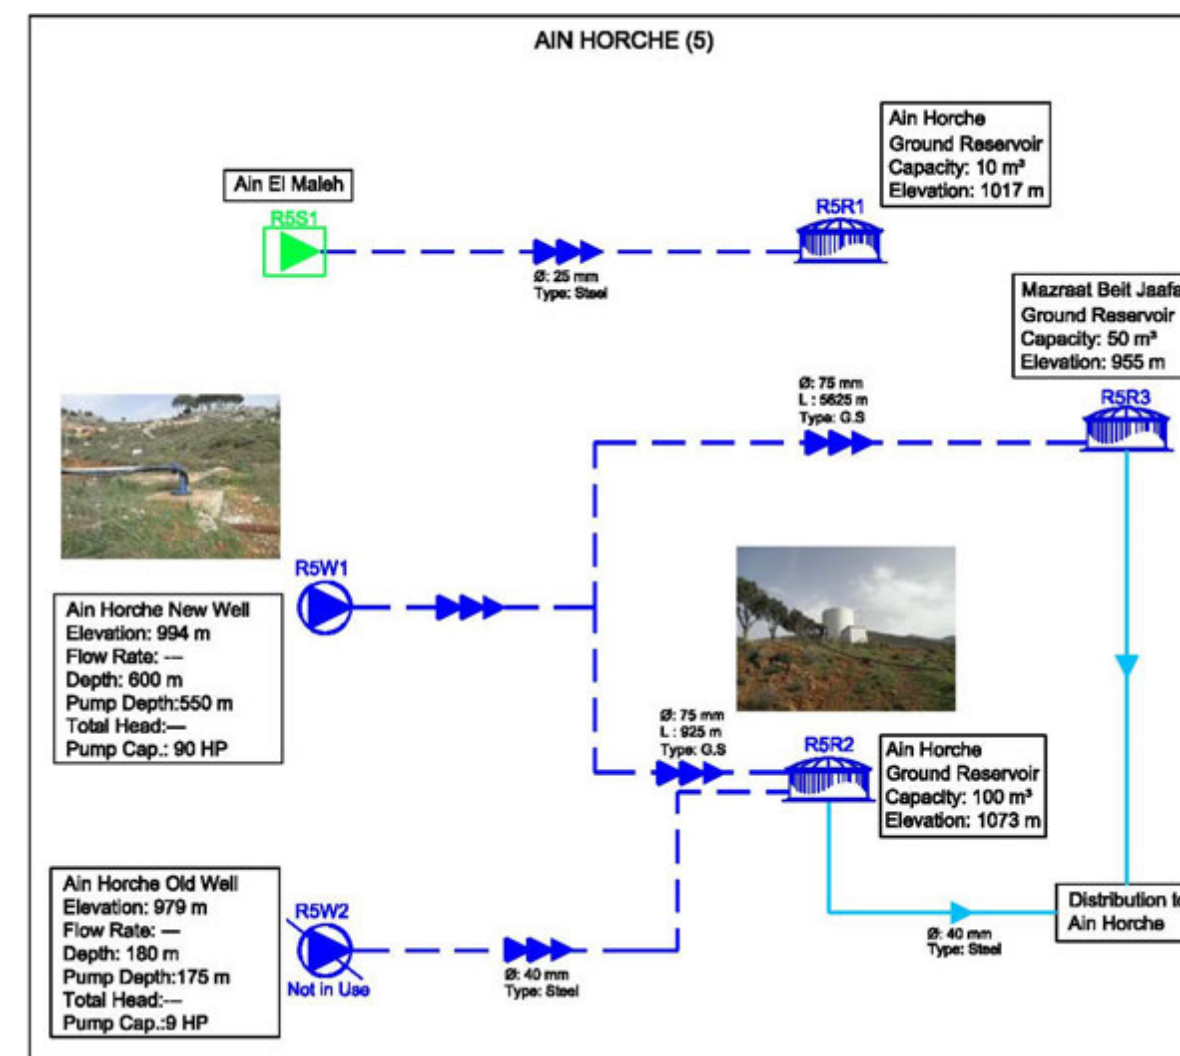
**Ain Horche (5)**

Well R5W1 (>10 years): Well is in good condition but it suffers from a shortage of electric power and leakage when pump is running. It needs minor maintenance.

Reservoir R5R2 (>50 years; 100 m³): Reservoir is in acceptable condition.

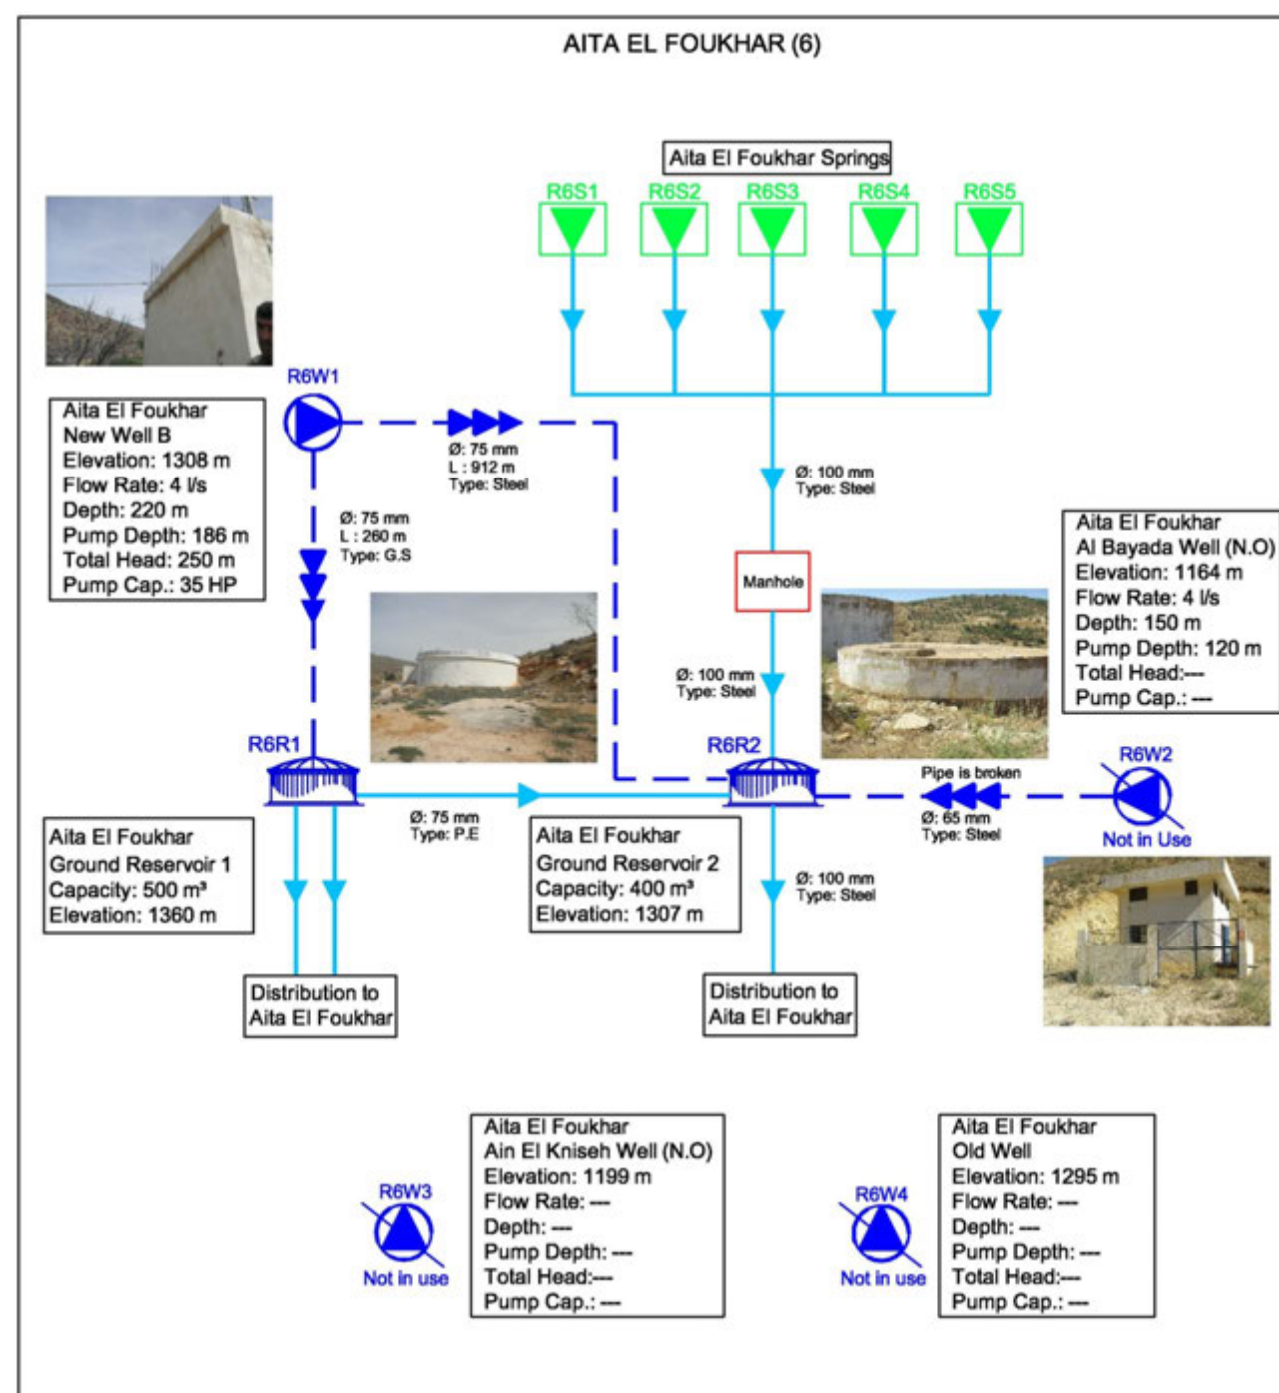
**Aita El Foukhar (6)**

Well R6W1 (>10 years): Well was built in year 2002. Its chamber was inaccessible during visit time. Its submersible pump is not functioning.

Well R6W2 (15 years old): Well is not in functioning nor equipped. Its outlet pipe is broken due to bombing. It is not in use.

Reservoir R6R2 (>10 years; 400 m³): Reservoir is in acceptable condition. It needs some minor maintenance and esthetical rehabilitation.

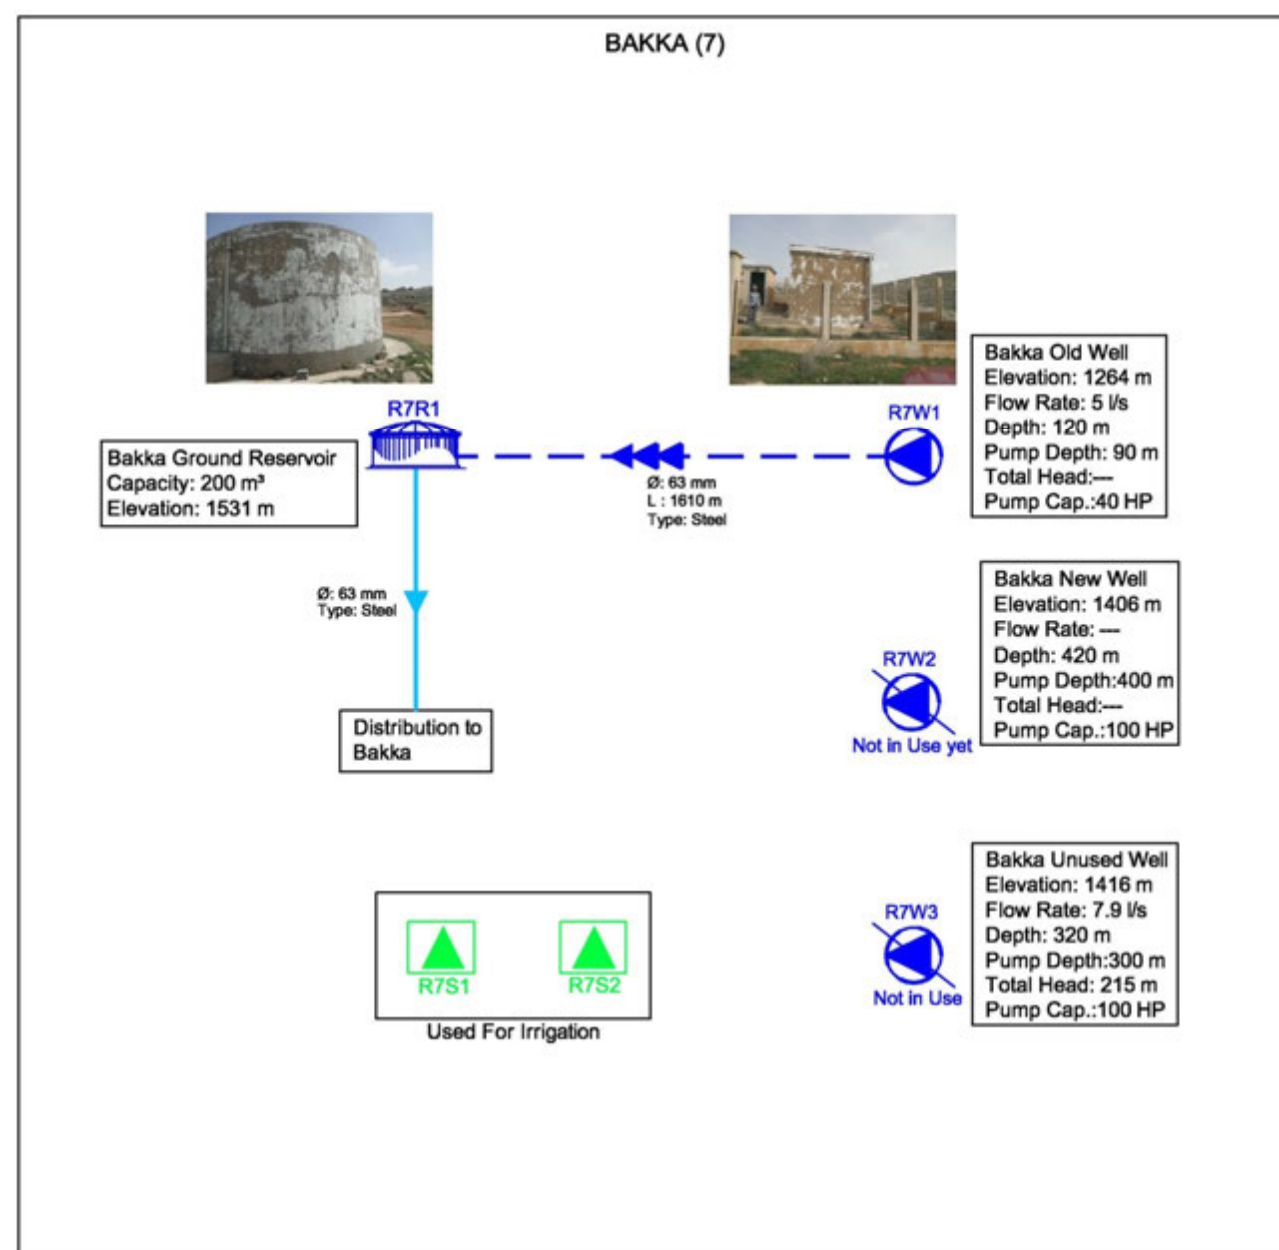
**Bakka (7)**

Well r7W1 (25 years old): Well is in bad condition and it suffers from a shortage of electric power. The outlet pipe is rusted. There is no chlorination unit for this well nor a private generator.

Reservoir R7R1 (>20 years; 200 m<sup>3</sup>): Reservoir is old and it is in acceptable condition. The valves are not beside the reservoir and there is no valve chamber. This reservoir needs a valve chamber, some minor maintenance and esthetical rehabilitation.

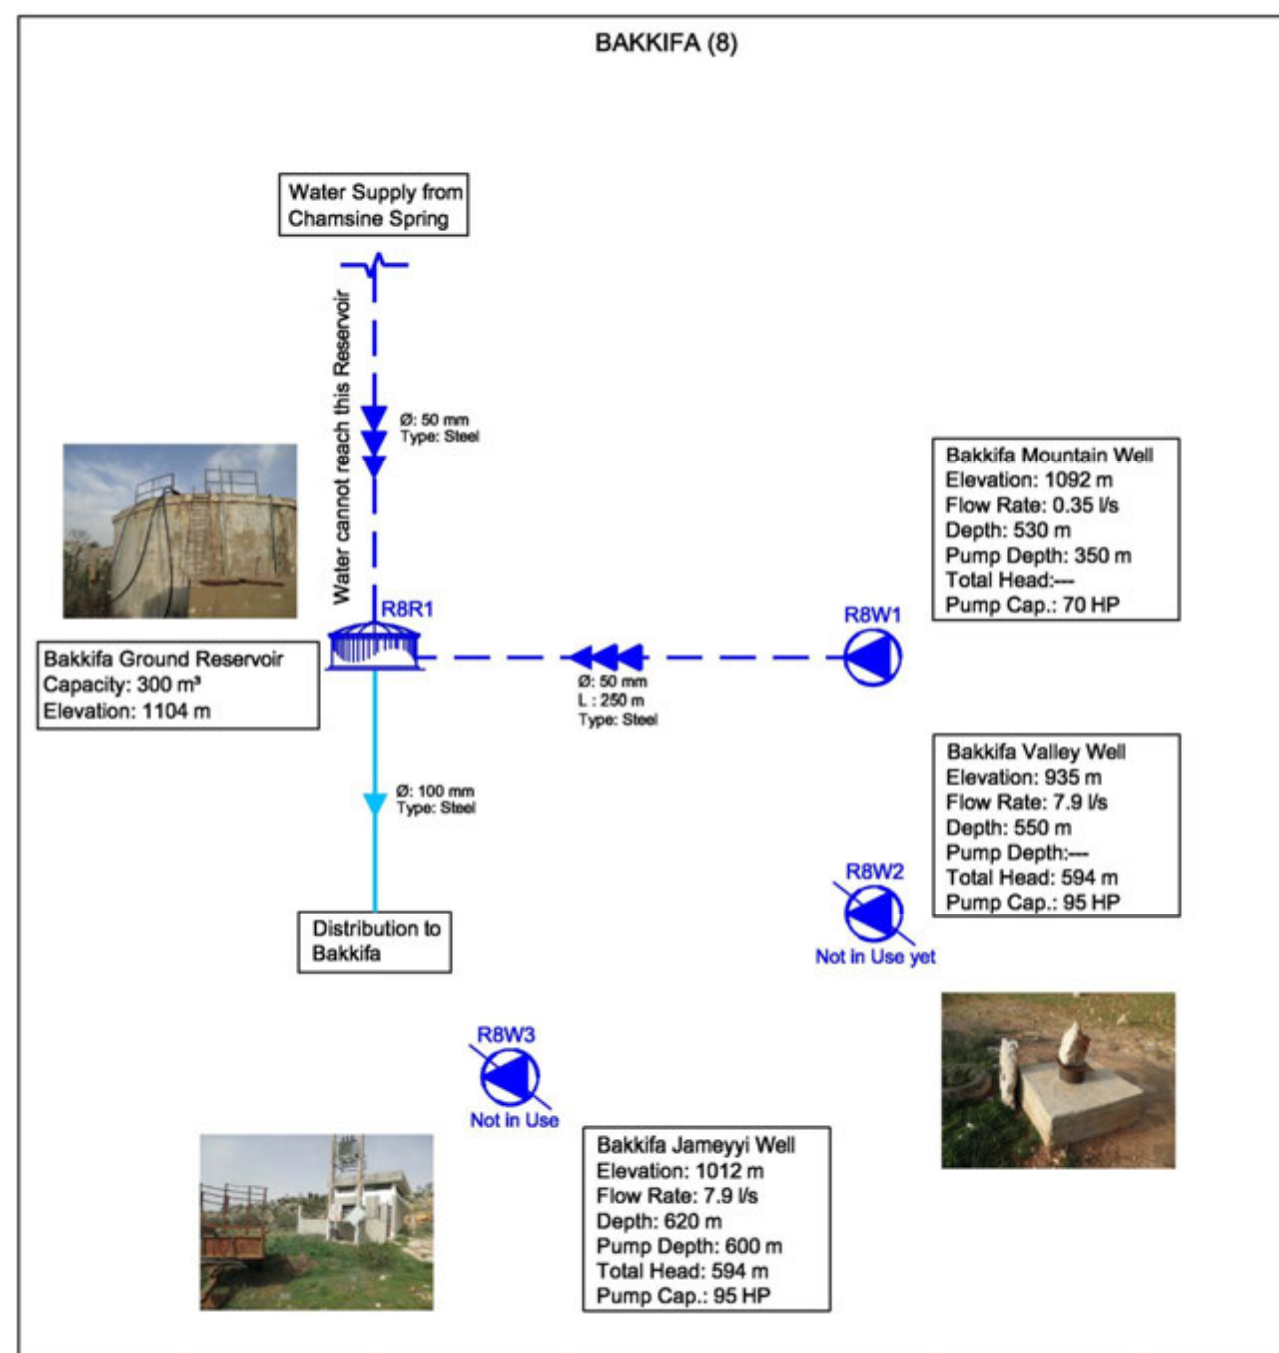
**Bakkifa (8)**

The existing water network is in good condition and it has a length of around 2.3 km. It covers a large area of the town. This network is not in use because there is no water source available. A new line coming from Ain El Zarqa spring will supply this village once the system becomes operational. The specific layout could not be obtained.

Well R8W1 (35 years old): Well is in bad condition and it suffers from a shortage of electric power. Its outlet pipe is rusted. It needs minor rehabilitation.

Reservoir R8R1 (>60 years; 300 m³): Reservoir is empty due to lack of water. It is old and its pipes are rusted. This reservoir needs structural and esthetical rehabilitation.

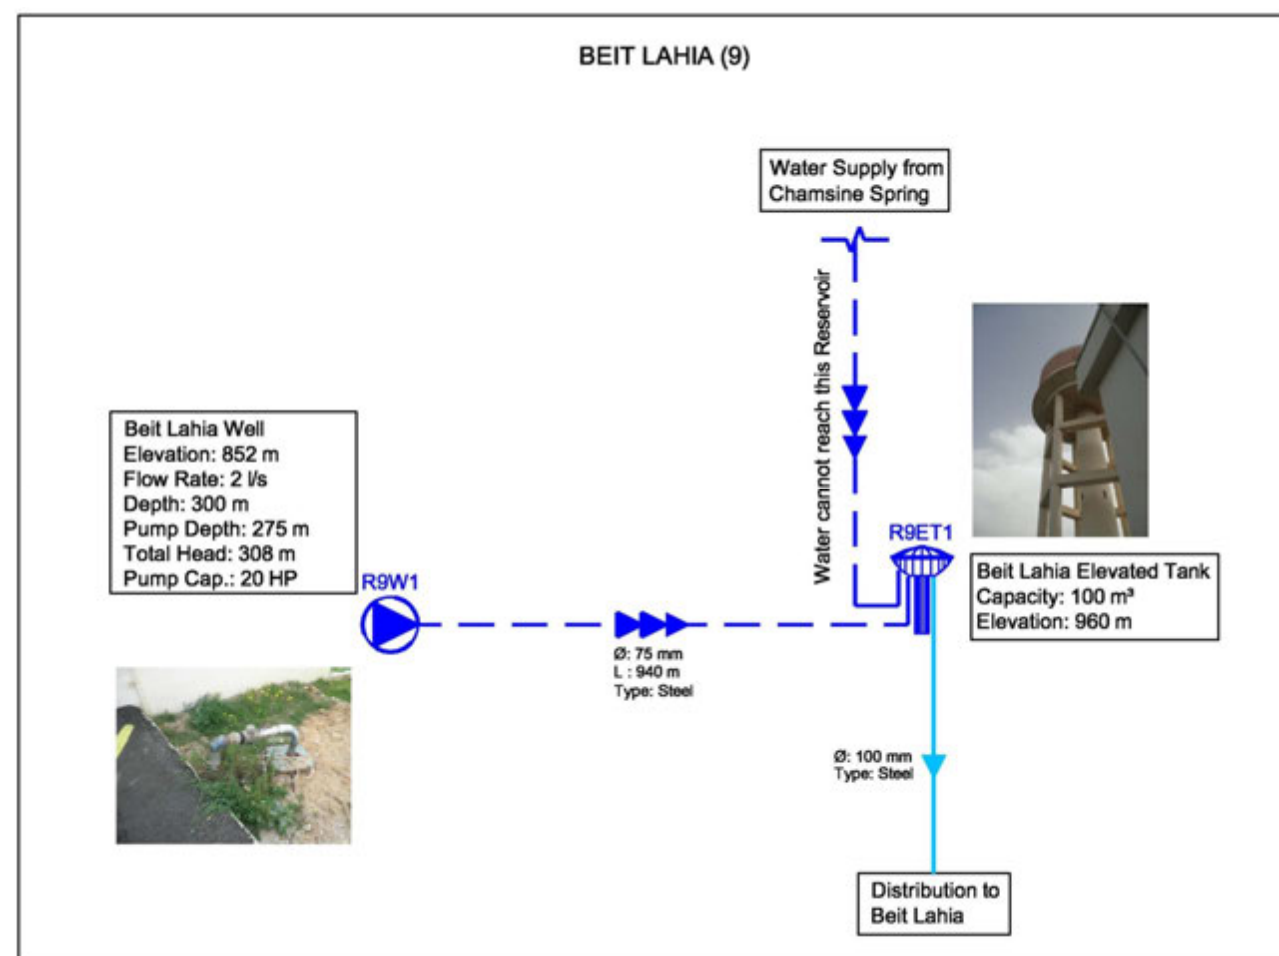
**Beit Lahia (9)**

Well R9W1 (>15 years): Well is in bad condition and it suffers from a shortage of electric power. It has a chlorination unit but it is not working because it needs rehabilitation. Its pipes are rusted and shall be changed. A new outlet pipe shall be installed.

Elevated tank R9ET1 (>15 years; 100 m³): Elevated tank is old but it is in acceptable condition. It is subjected to leakage. It needs some minor maintenance.

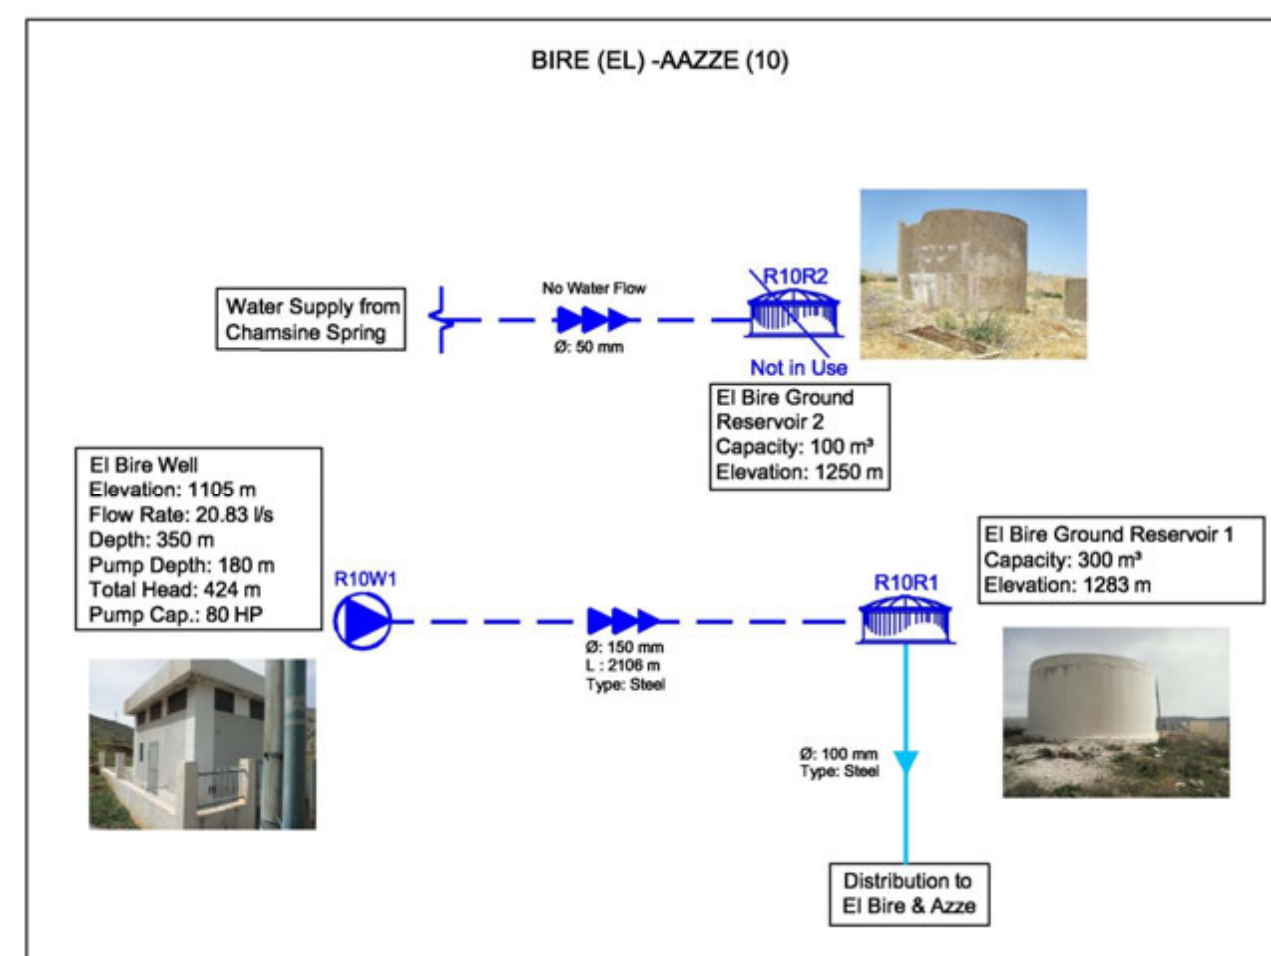
**Bire (El) -Aazze (10)**

The existing water network is in very good condition and it has a length of around 25 km. It covers a large area of the town. A new line coming from Ain El Zarqa spring and Jabal El Arabi regional reservoir will supply this village once the system becomes operational. The specific layout could not be obtained.

Well R10W1 (15 years old): Well is in bad condition and it suffers from a shortage of electric power. There is no chlorination unit for this well.

Reservoir R10R1 (>15 years; 300 m³): Reservoir is in good condition.

Reservoir R10R2 (100 m³): Reservoir is very old and it is in bad condition. It is not in use. It needs reconstruction.

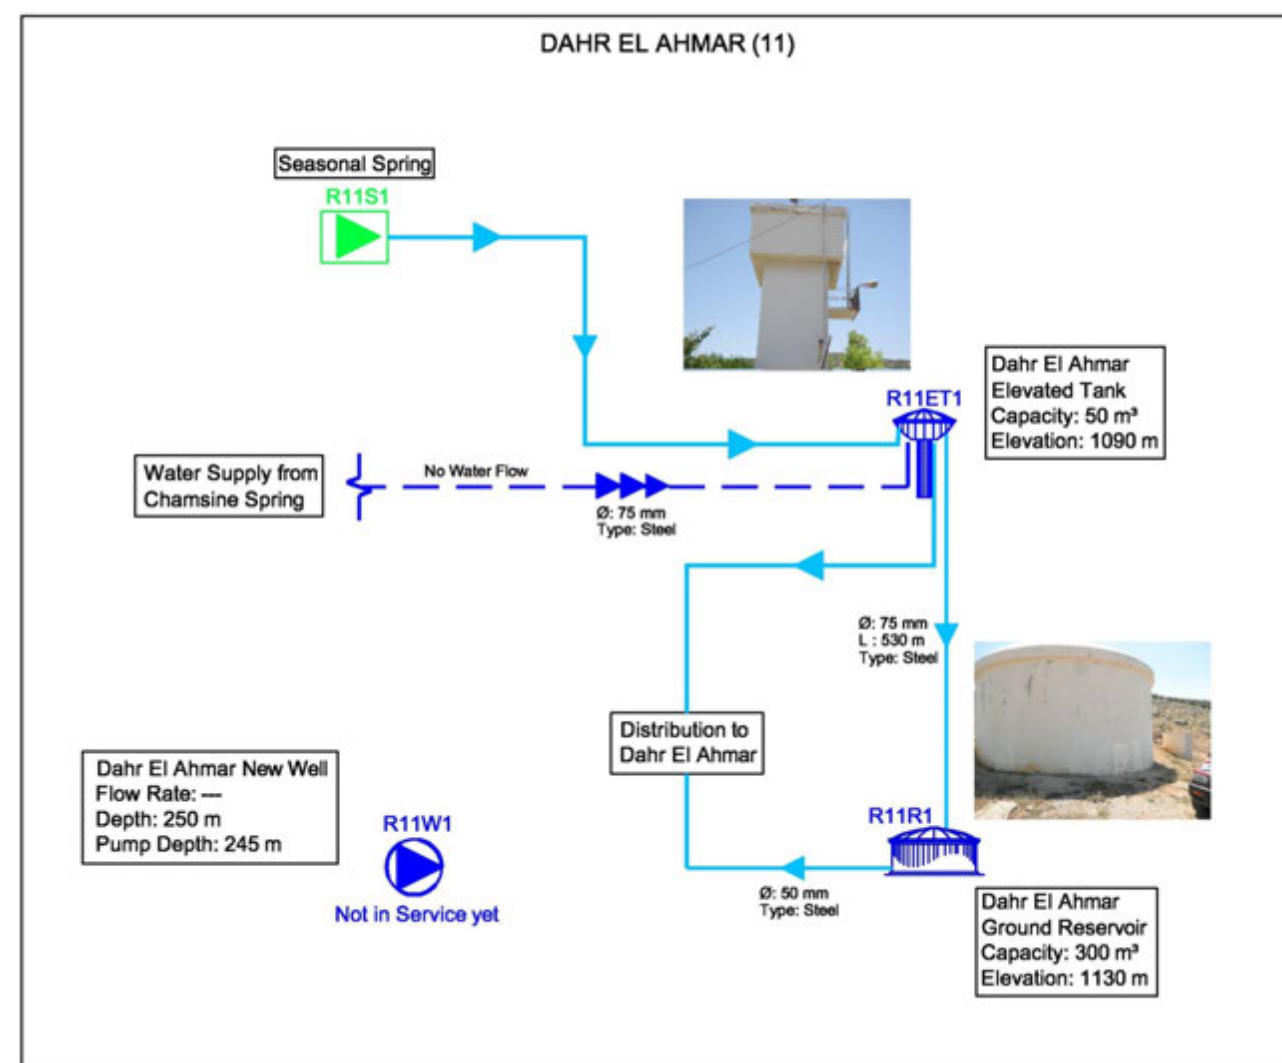
**Dahr El Ahmar (11)**

The existing water network is in very good condition and it has a length of around 26 km. It covers a large area of the town. A new line coming from Ain El Zarqa spring will supply this village once the system becomes operational. The specific layout could not be obtained.

Spring R11S1: Spring dries during summer season.

Reservoir R11R1 (>10 years; 300 m³): Reservoir is in good condition.

Elevated tank R11ET1 (50 m³): Elevated tank is old but it is in acceptable condition. Its pipes are rusted and need to be changed. This elevated tank needs some minor maintenance.

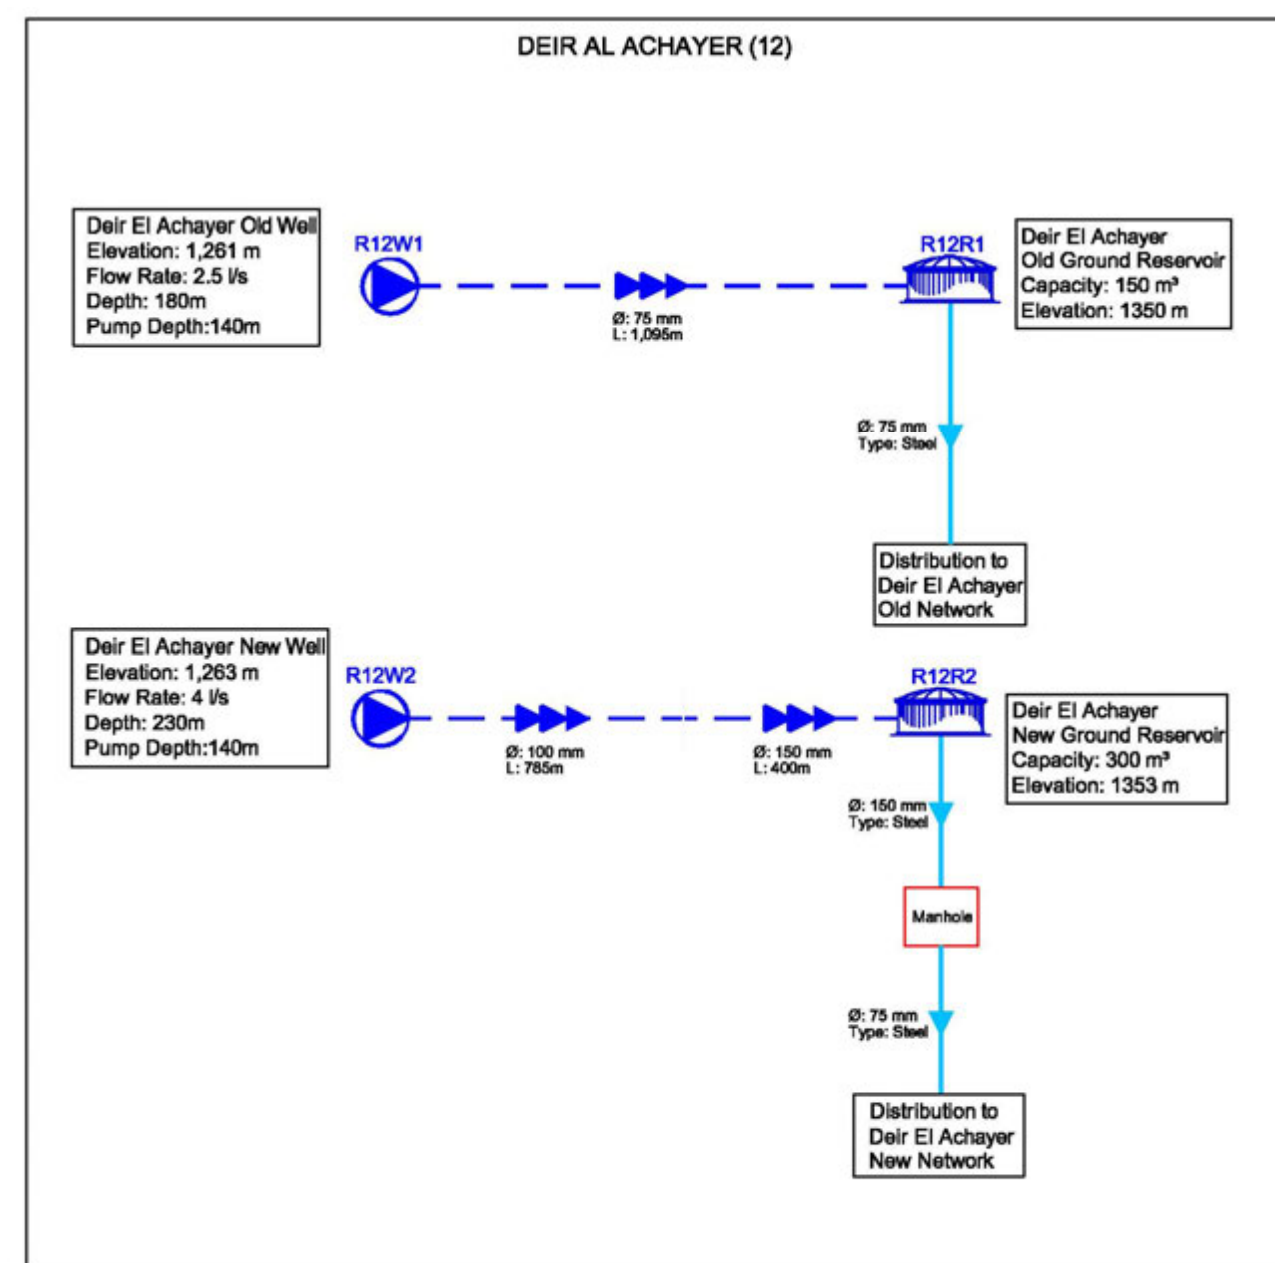
**Deir Al Achayer (12)**

The existing water network is in very good condition and it has a length of around 9 km. It covers a large area of the town.

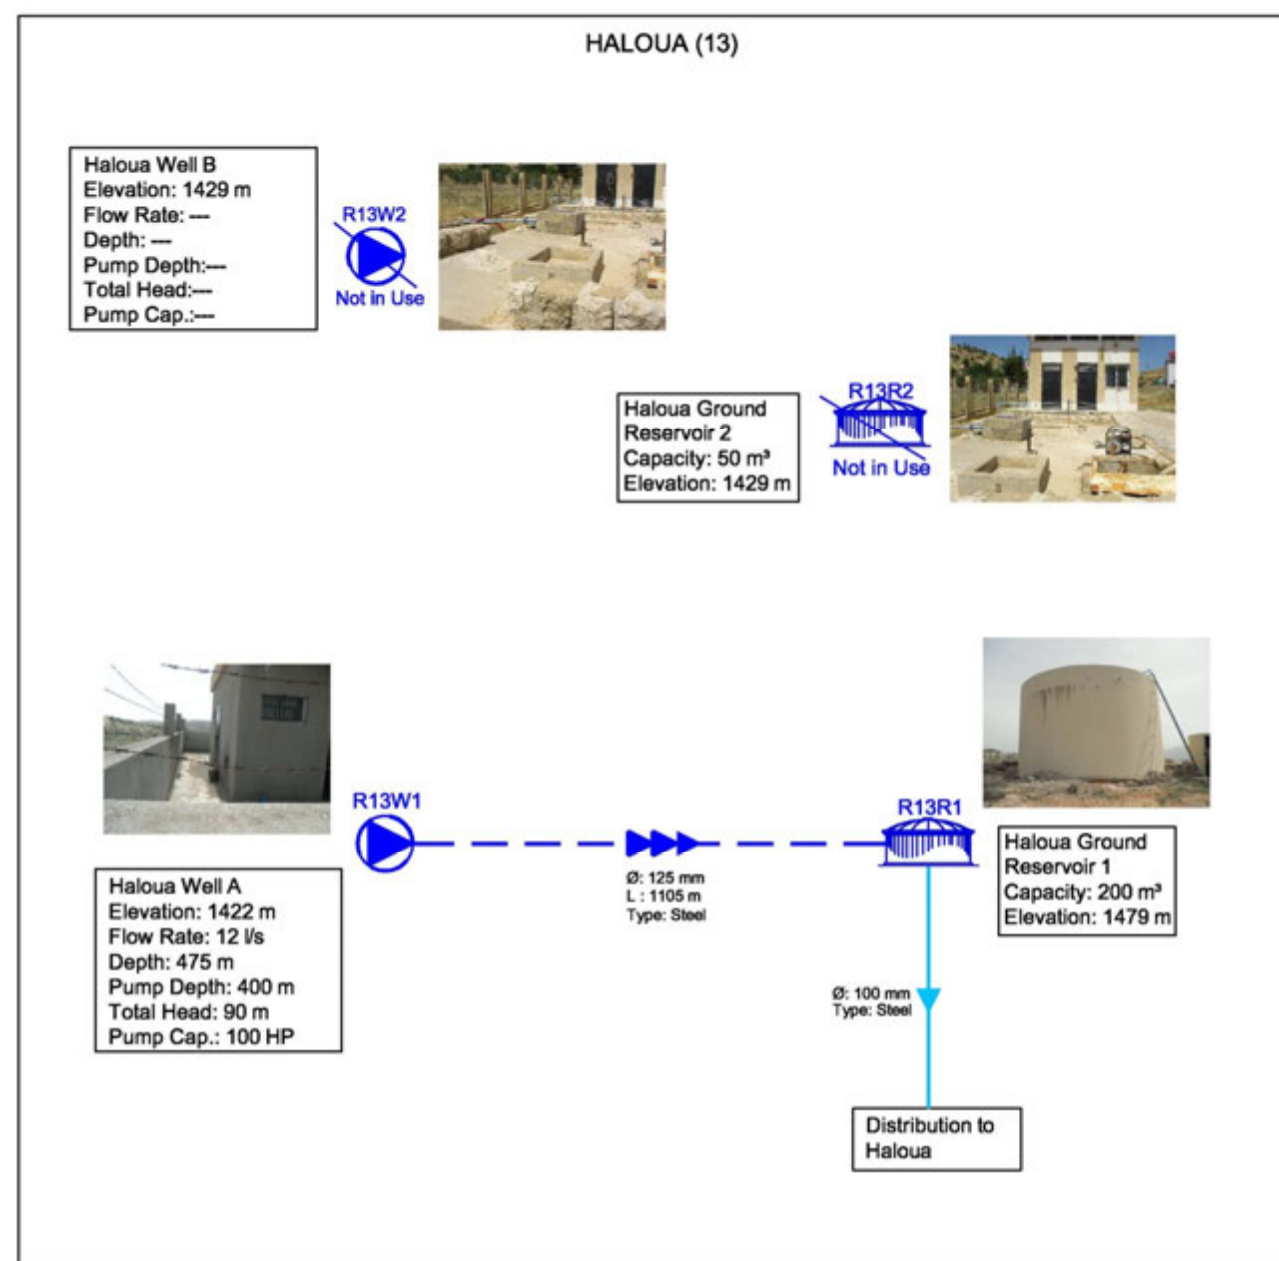
**Haloua (13)**

The existing water network is in good condition. A new line coming from Ain El Zarqa spring will supply this village once the system becomes operational. The specific layout could not be obtained.

Well R13W1 (25 years old): Well is in bad condition and it suffers from a shortage of electric power. There is no chlorination unit for this well. It needs minor rehabilitation.

Reservoir R13R1 (20 years old; 200 m³): Reservoir is in good condition.

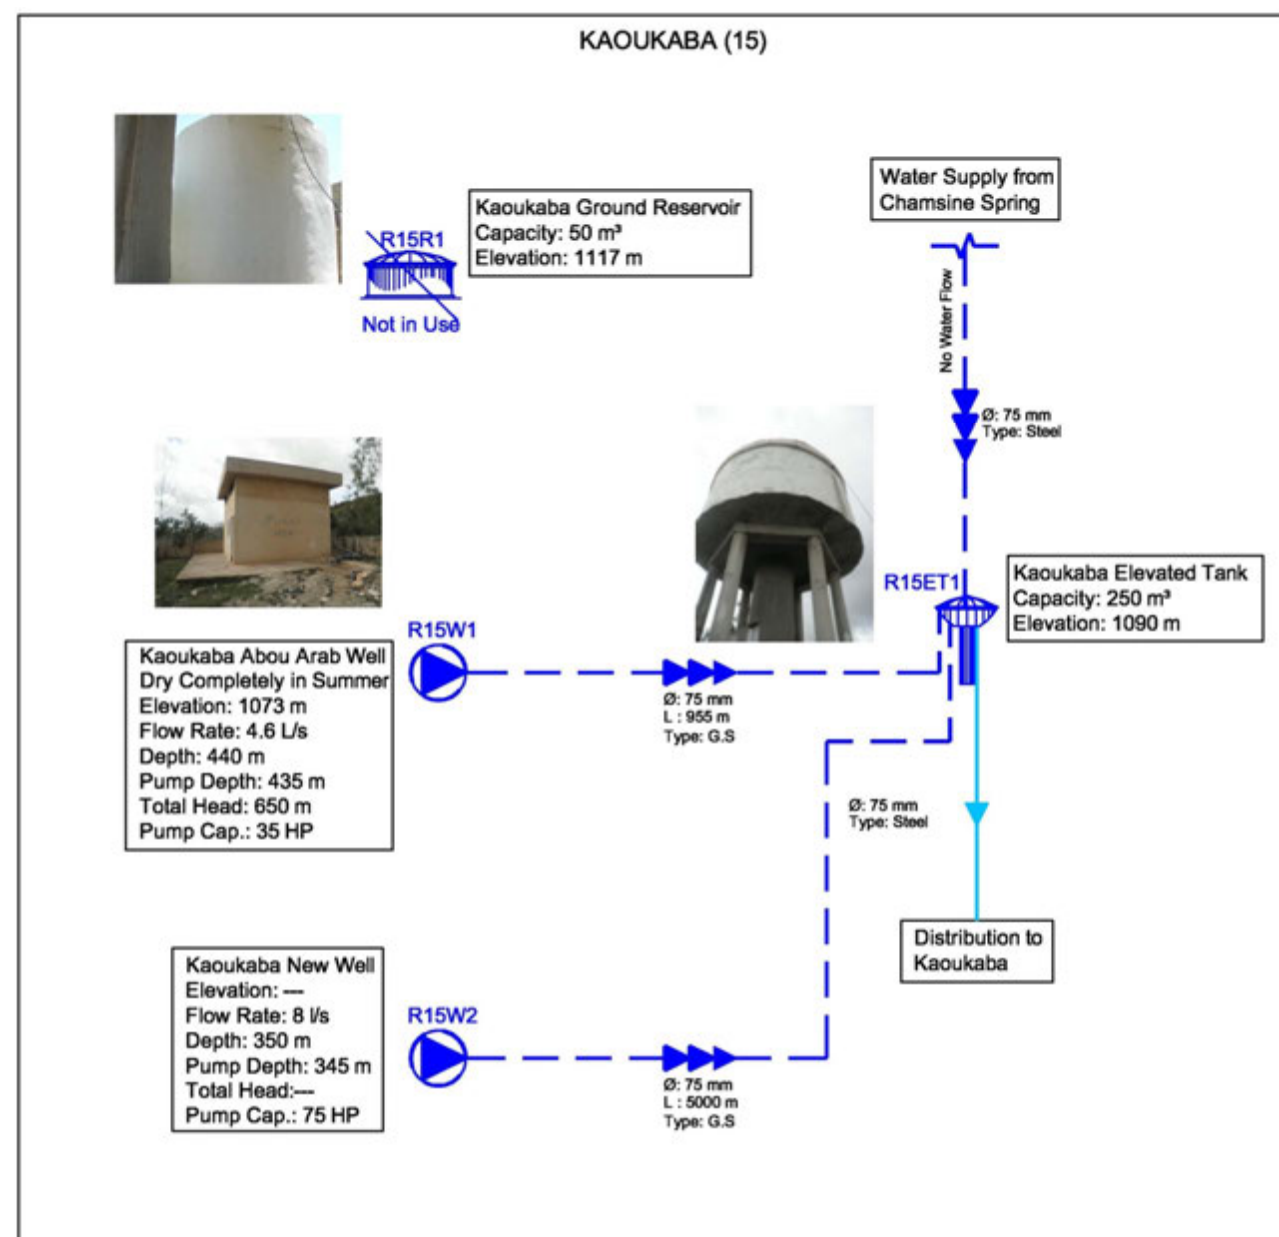
**Kaoukaba (15)**

The existing water network is in very good condition and it has a length of around 14.3 km. It covers a large area of the town. A new line coming from Ain El Zarqa spring will supply this village once the system becomes operational. The specific layout could not be obtained.

Well R15W1 (20 years old): Well is old, and it dries each summer. The centrifugal pump is broken but the submersible pump is operational. This submersible pump fills a small tank (16 m³) located near the well in one hour. Its electrical panel is not working.

Well R15W2 (< 2 years old): Well is new and it is in good condition.

Elevated tank R15ET1 (250 m³): Reservoir is in good condition. It needs esthetical rehabilitation and some minor maintenance.

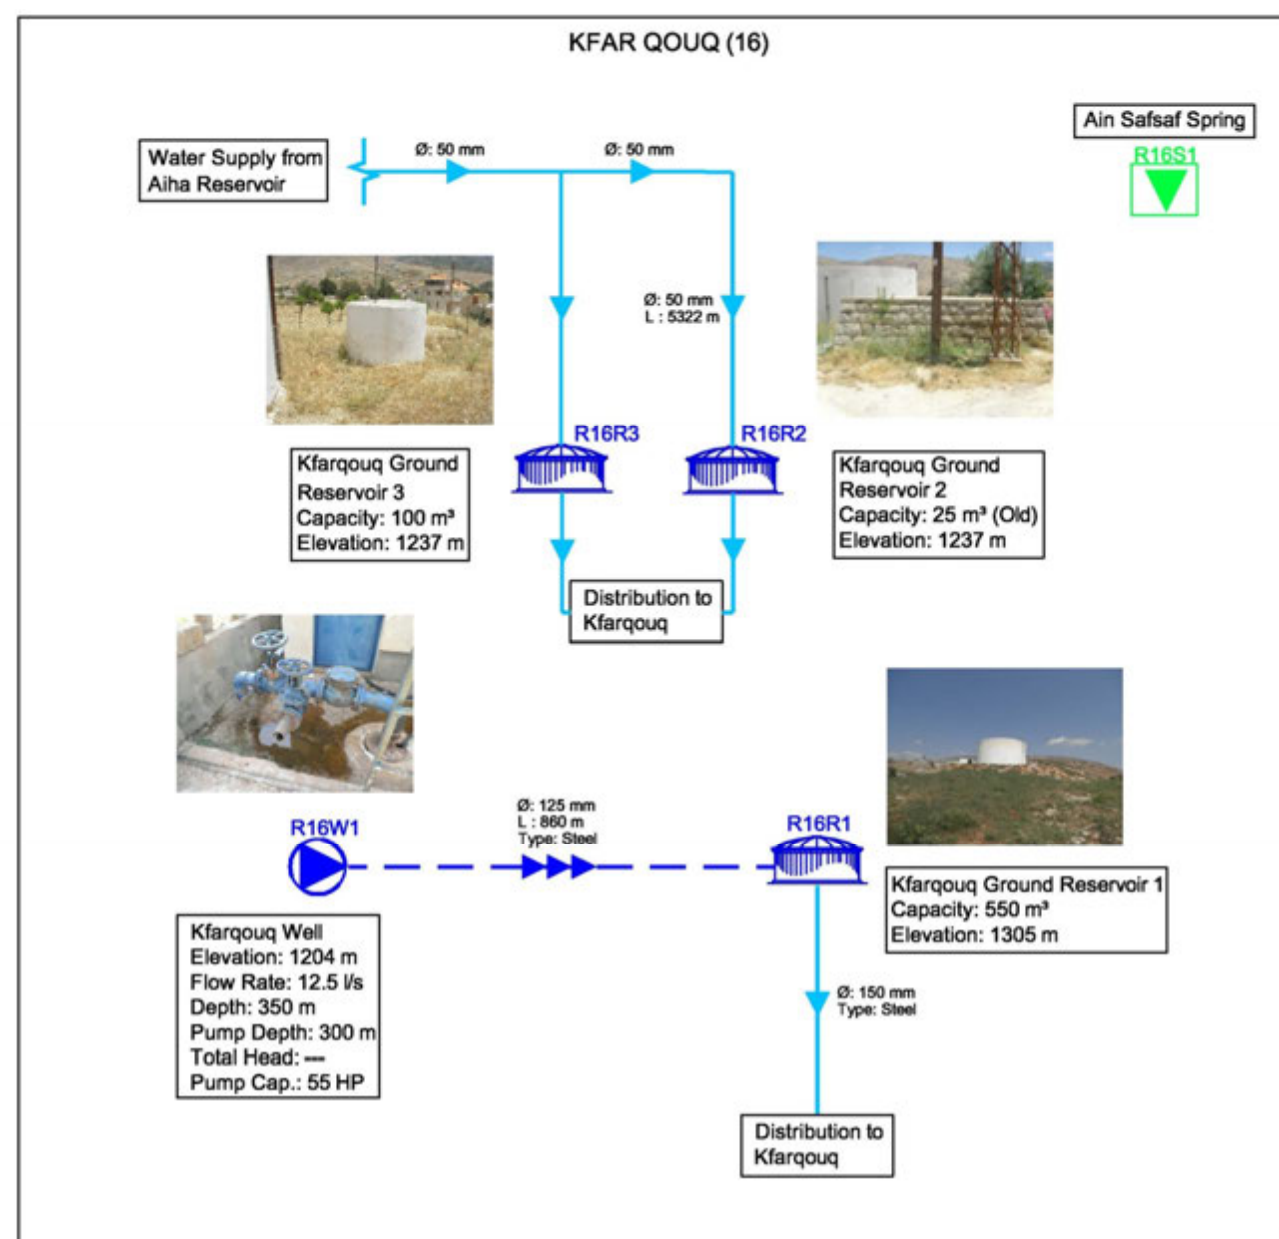
**Kfar Qouq (16)**

There is no available information concerning the water network of the town. A new line coming from Ain El Zarqa spring will supply this village once the system becomes operational. The specific layout could not be obtained.

Well R16W1 (15 years old): Well is old. Some pipes are rusted. This well doesn't have a direct water outlet. It doesn't have a chlorination unit nor a booster pump. It has a private generator but it is used only for emergency. This well needs rehabilitation.

Reservoir R16R1 (15 years old; 550 m³): Reservoir is old but it is in acceptable condition. It is subjected to leakage inside its valves chamber. Some pipes need to be changed. This reservoir needs some minor rehabilitation.

Reservoir R16R3 (100 m³): Reservoir is in acceptable condition. It needs some minor maintenance concerning its pipes.
