# WATER SUPPLY AND WASTEWATER SYSTEMS MASTER PLAN FOR THE BEKAA WATER ESTABLISHMENT

## WATER ASSESSMENT REPORT

January 2014  
Updated May 2015

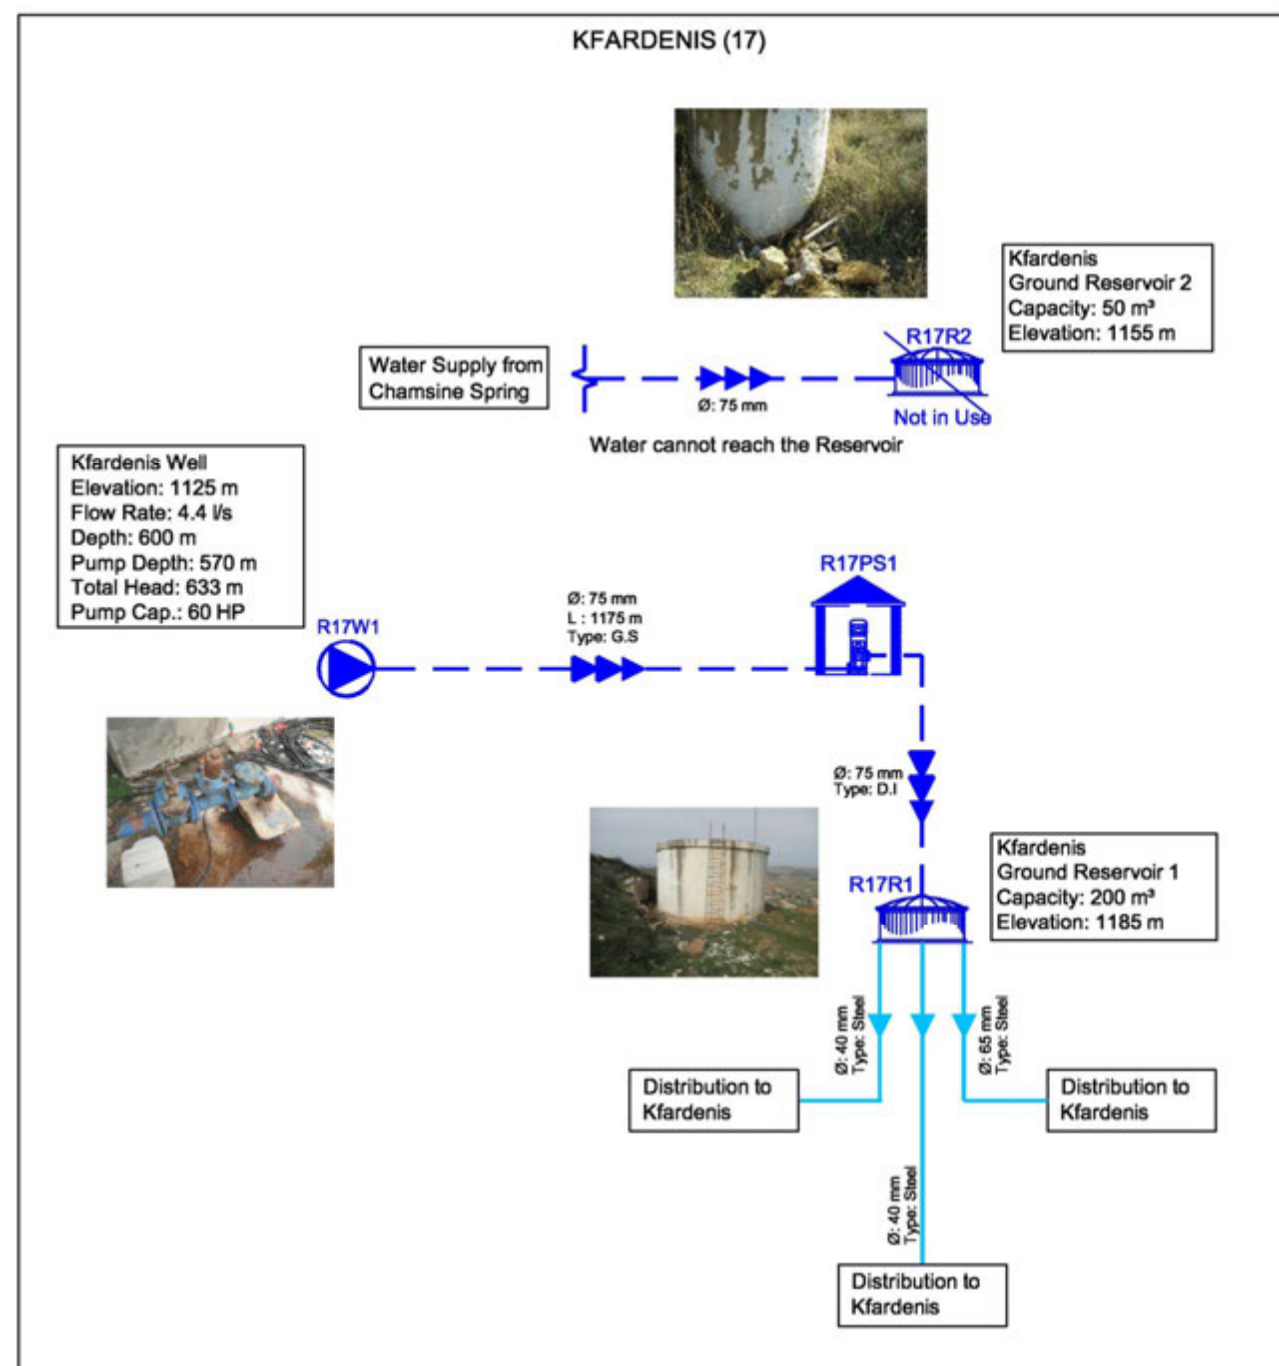
**Kfardenis (17)**

The existing water network is in very good condition and it has a length of around 16 km. It covers a large area of the town. It covers around 75 % of the town. A new line coming from Ain El Zarqa spring will supply this village once the system becomes operational. The specific layout could not be obtained.

Well R17W1 (15 years old): Well is old. Its valves and pipes are subjected to leakage. This well doesn't have a chlorination unit. Some valves are missing. It needs some rehabilitation.

Reservoir R17R1 (>15 years; 200 m³): Reservoir is not in bad condition. It doesn't have an overflow pipe. Its valve chamber is submerged with water. This reservoir needs some minor rehabilitation.

Reservoir R17R2 (50 m³): Reservoir is very old and it is in bad condition. It is not in use and it needs reconstruction.

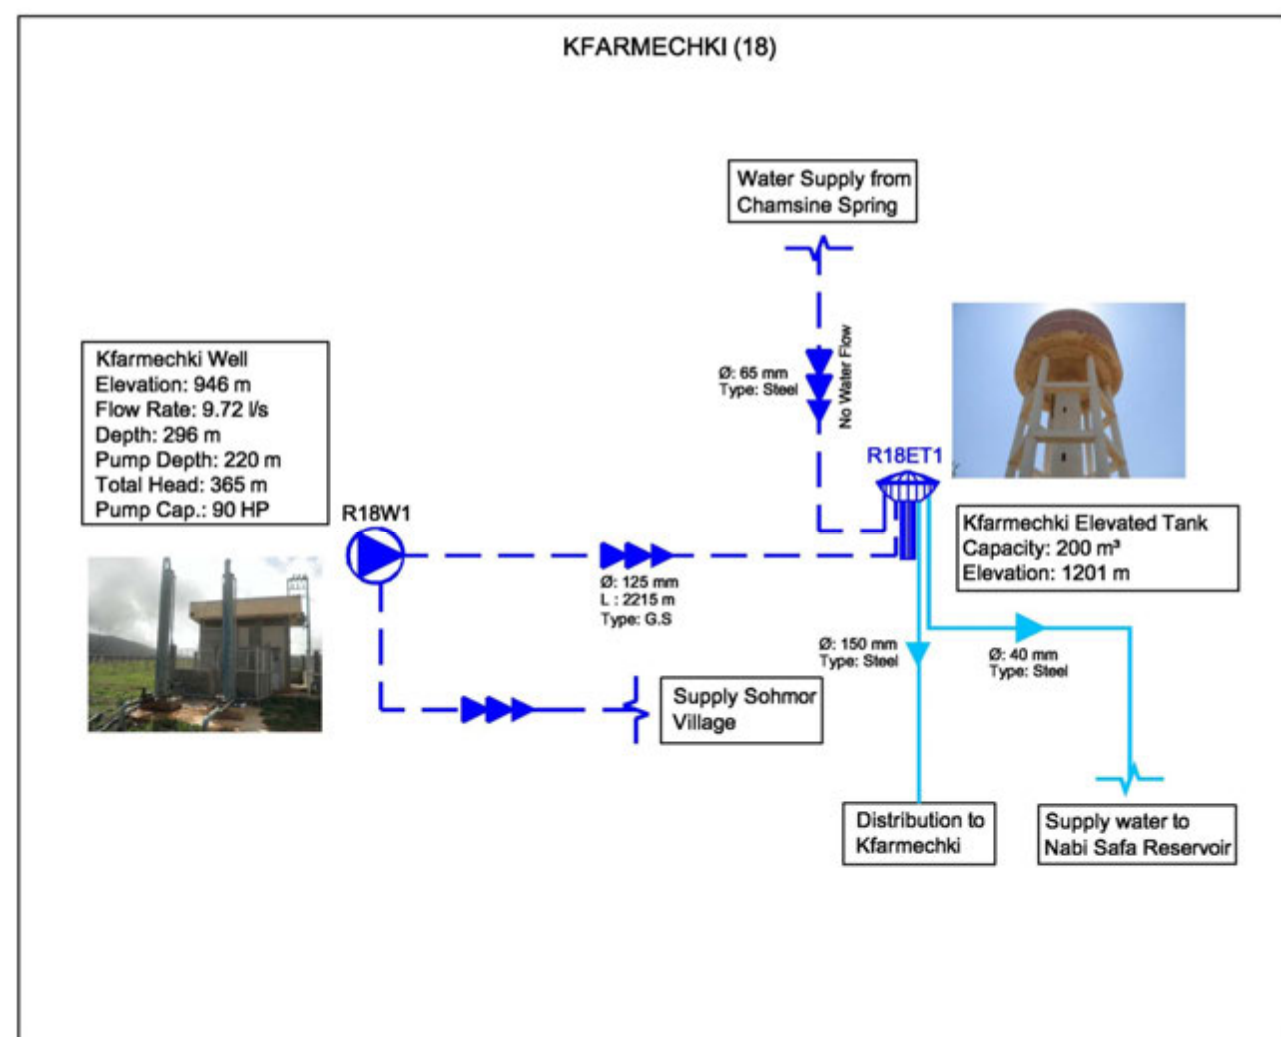
**Kfarmechki (18)**

The existing water network is old (installed 20 years ago) and it is in bad condition. A new network is under construction. A new line coming from Ain El Zarqa spring will supply this village once the system becomes operational. The specific layout could not be obtained.

Well R18W1 (>15 years): Well is in good condition. There is no chlorination unit in this well. It has two booster pumps: one of them supplies water to Kfarmechki elevated tank (110 Hp) and another one supplies water to Sohmor village (80 Hp). This well needs minor rehabilitation.

Elevated tank R18ET1 (10 years old; 200 m³): Reservoir is old but in good condition. It needs some minor maintenance.

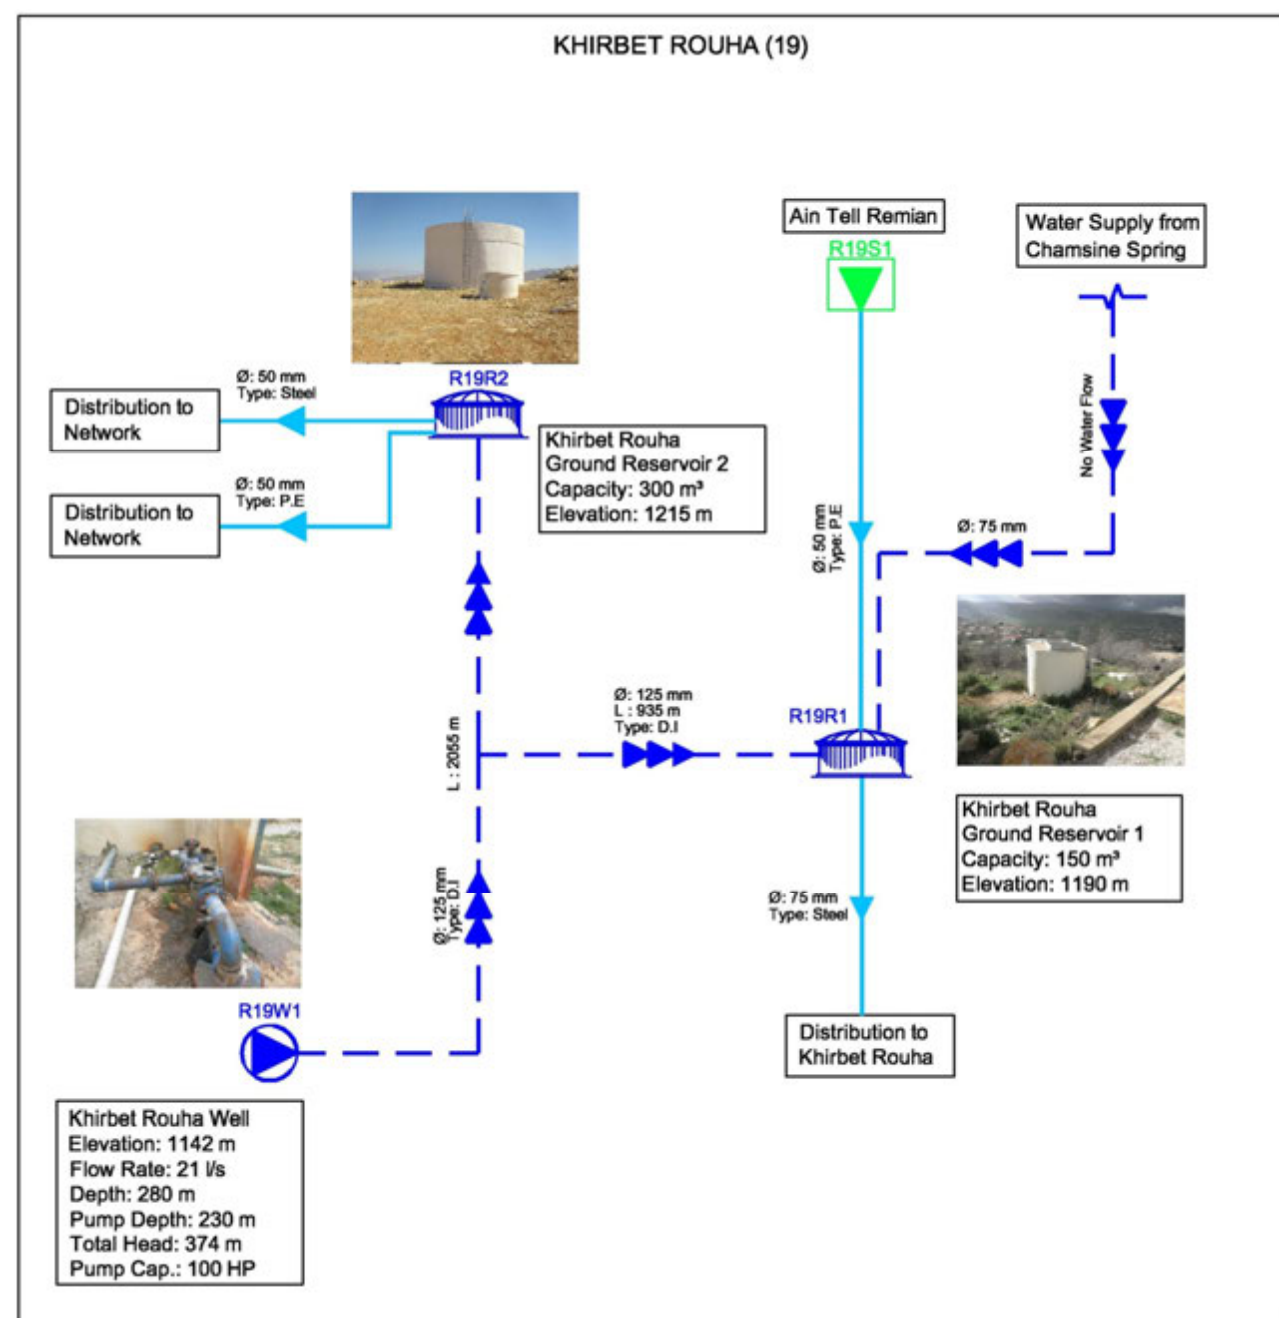
**Khirbet Rouha (19)**

The existing water network is in very good condition and it has a length of around 38 km. It covers a large area of the town. A new line coming from Ain El Zarqa spring will supply this village once the system becomes operational. The specific layout could not be obtained.

Well R19W1 (15 years old): Well is not in bad condition; however, its chamber needs rehabilitation. This well has no chlorination unit.

Reservoir R19R1 (45 years old; 150 m<sup>3</sup>): Reservoir is old but it is in good condition. Its valve chamber is subjected to leakage. This reservoir with its valve chamber needs minor maintenance.

Reservoir R19R2 (300 m<sup>3</sup>): Reservoir is new and in good condition. Its valve chamber is subjected to leakage. The valve chamber needs maintenance.

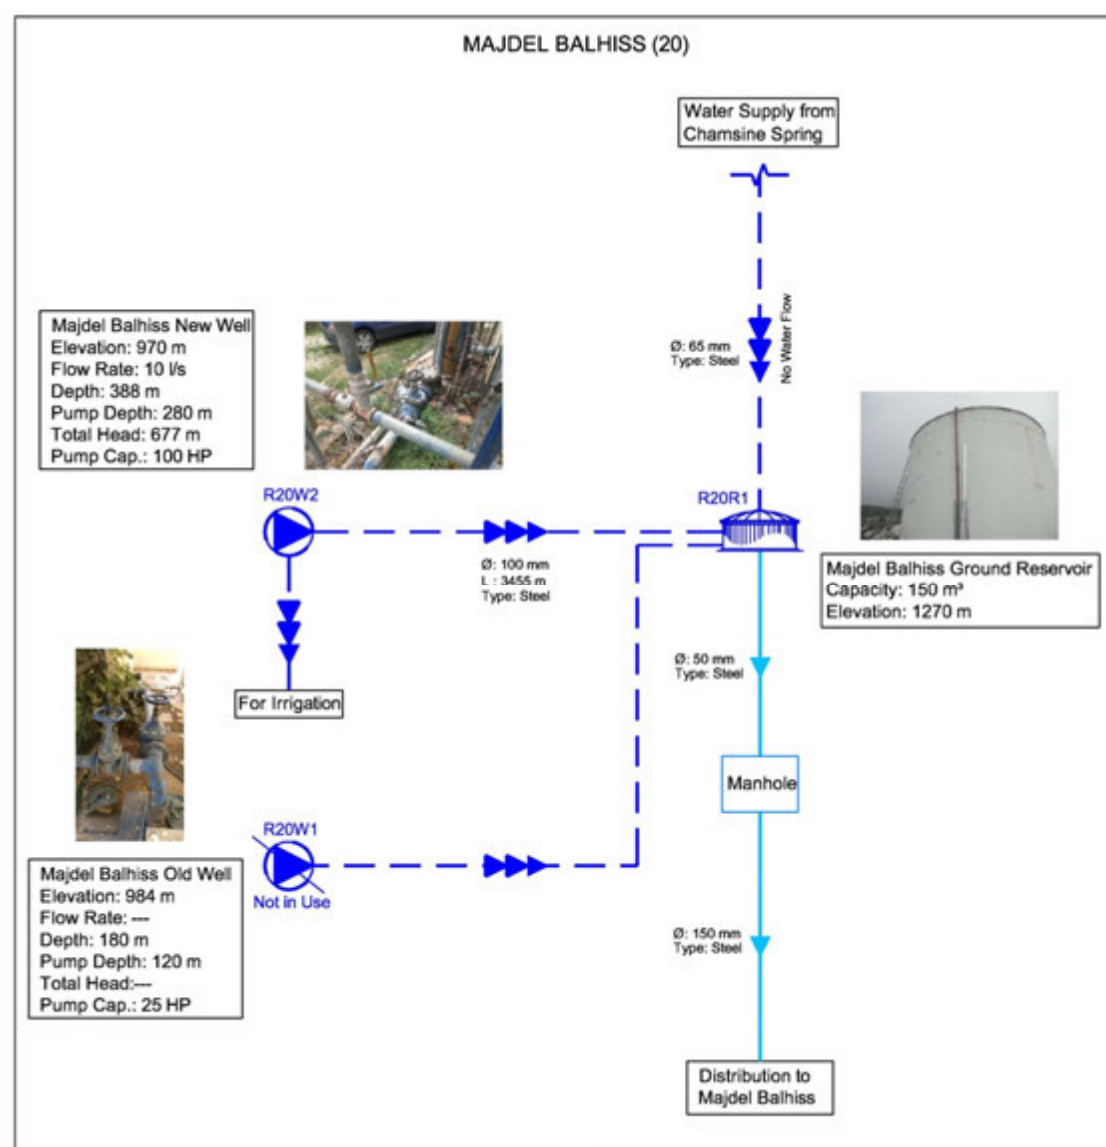
**Majdel Balhiss (20)**

The existing water network is in very good condition and it has a length of around 12 km. It covers a large area of the town. A new line coming from Ain El Zarqa spring will supply this village once the system becomes operational. The specific layout could not be obtained.

Well R20W1 (>20 years): Well is not in use. There is no enough water to pump.

Well R20W2 (>10 years): Well is in acceptable condition. It doesn't have a chlorination unit.

Reservoir R20R1 (55 years old; 150 m³): Reservoir is old but it is in good condition. It is subjected to leakage and its capacity is not enough to supply water needs of the entire town. This reservoir with its valve chamber needs minor maintenance.

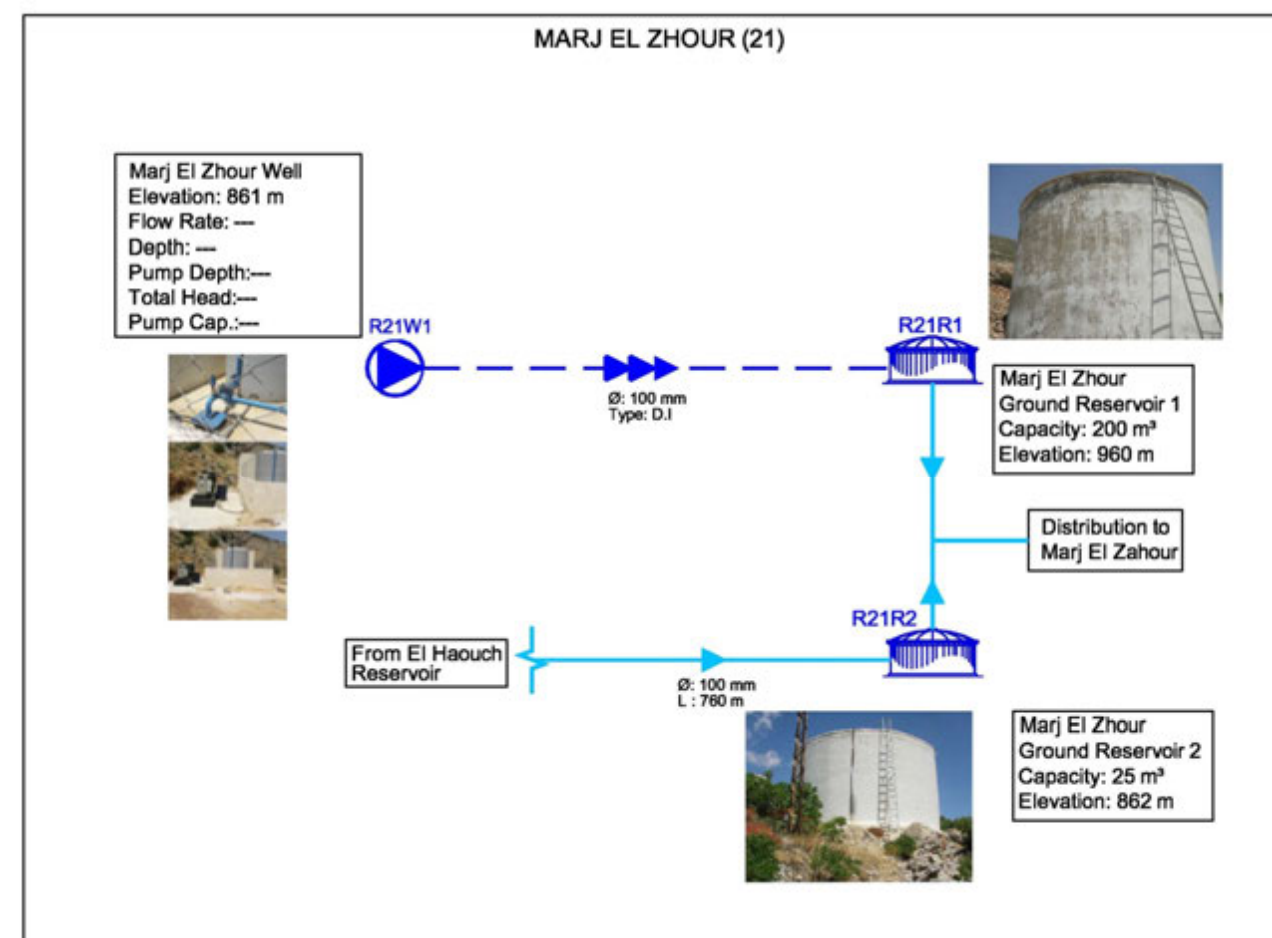
**Marj El Zhouh (21)**

There is no available information concerning the water network of the town.

Reservoir R21R1 (15 years old; 200 m³): Reservoir is old. The ladder is broken which make the roof inaccessible. No more available information.

Reservoir R21R2 (25 m³): Reservoir is old but it is in acceptable condition. It needs some minor maintenance.

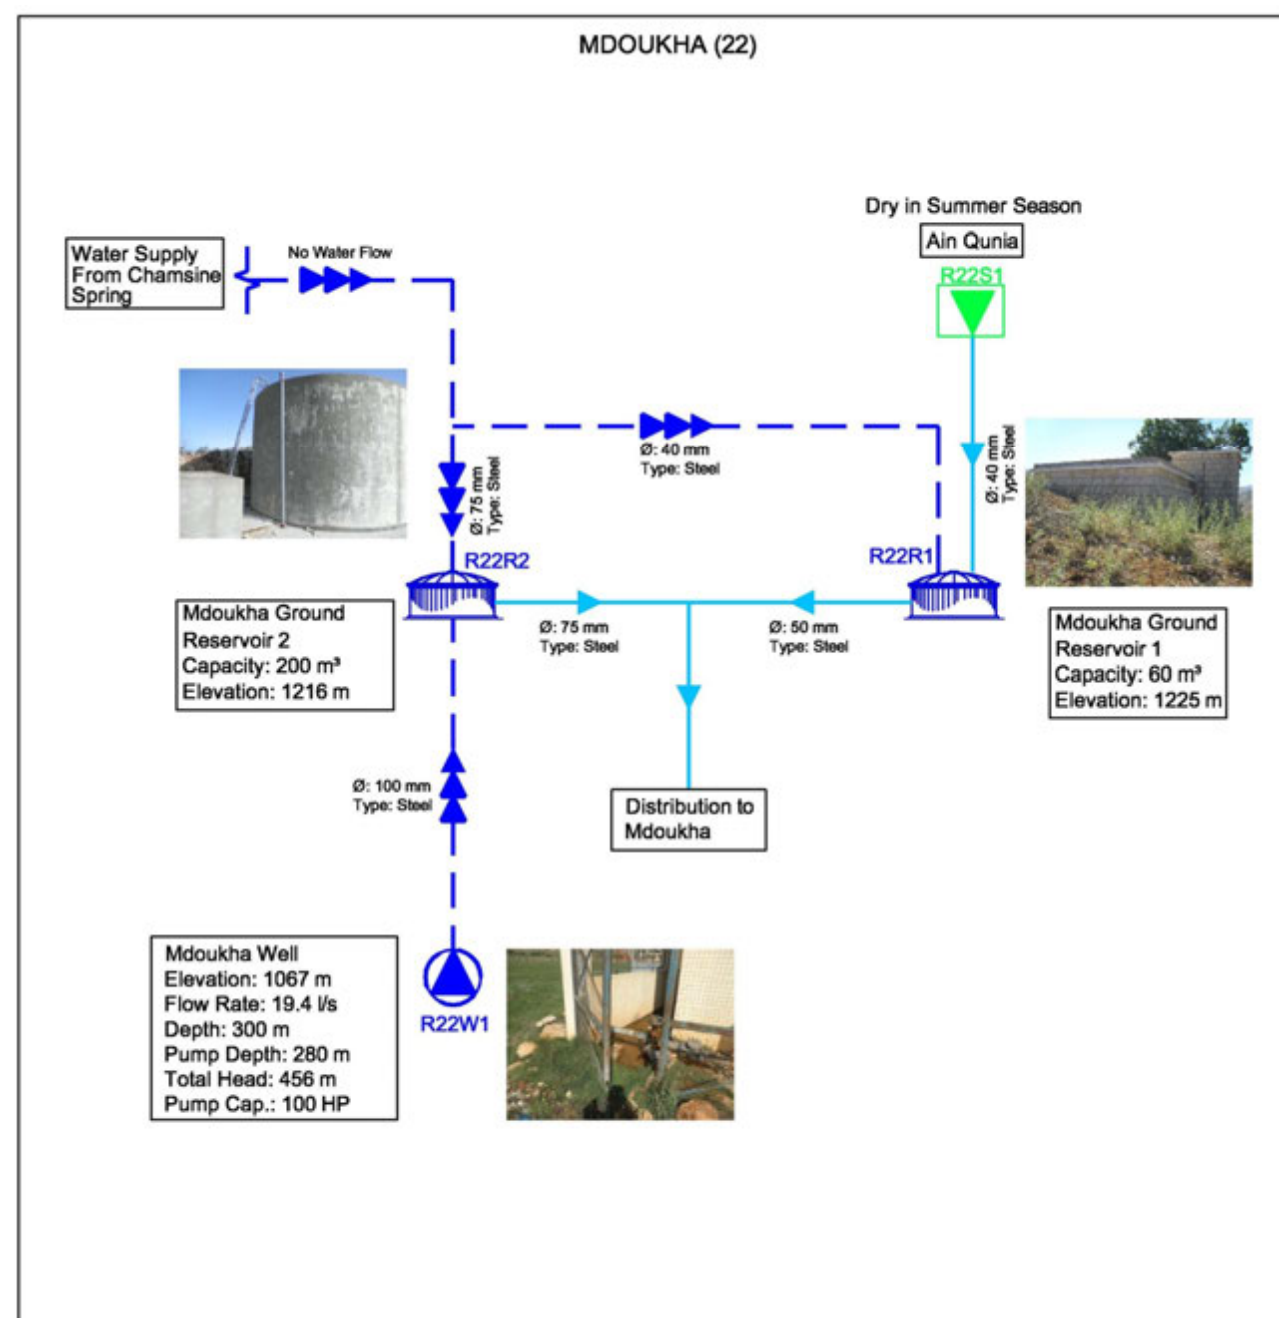
**Mdoukha (22)**

The existing water network is in very good condition and it has a length of around 10 km. It covers a large area of the town. A new line coming from Ain El Zarqa spring will supply this village once the system becomes operational. The specific layout could not be obtained.

Well R22W1 (>15 years): Well is in bad condition and it suffers from a shortage of electric power. There is no chlorination unit for this well. It has a private generator. This well needs rehabilitation.

Reservoir R22R1 (20 years old; 60 m³): Reservoir is old and it is in bad condition. It needs rehabilitation or reconstruction.

Reservoir R22R2 (200 m³): Reservoir is old but it is in good condition. Its valve chamber is submerged with water. It needs some minor maintenance.

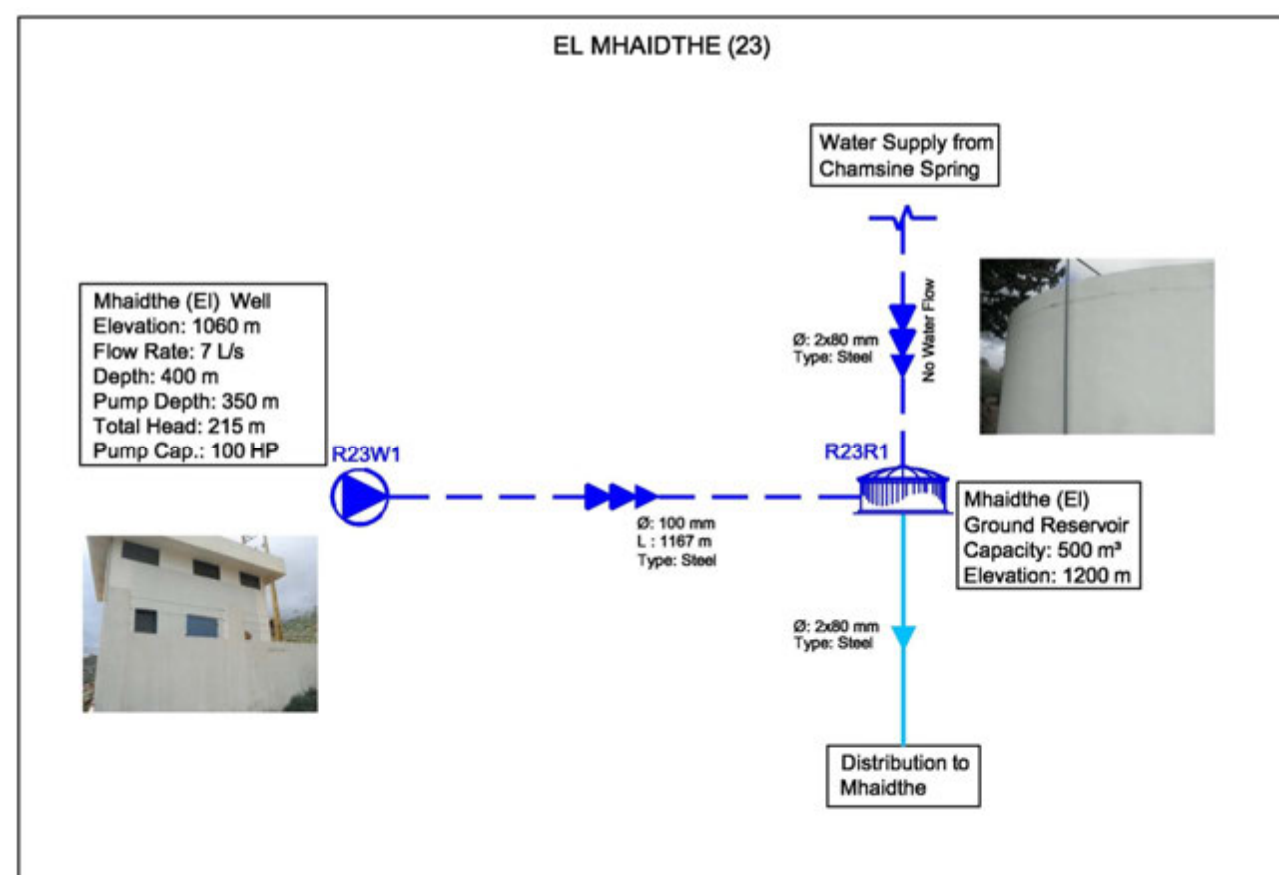
**El Mhaidthe (23)**

The existing water network is in very good condition and it has a length of around 16 km. It covers a large area of the town a new line coming from Ain El Zarqa spring will supply this village once the system becomes operational. The specific layout could not be obtained.

Well R23W1 (15 years old): Well is in bad condition. There is a chlorination unit but it is not in use. It needs rehabilitation.

Reservoir R23R1 (25 years old; 500 m³): Reservoir is in good condition. Its cover is broken. Also the cover of the valve chamber is broken and it is subjected to leakage. This reservoir needs some minor maintenance.

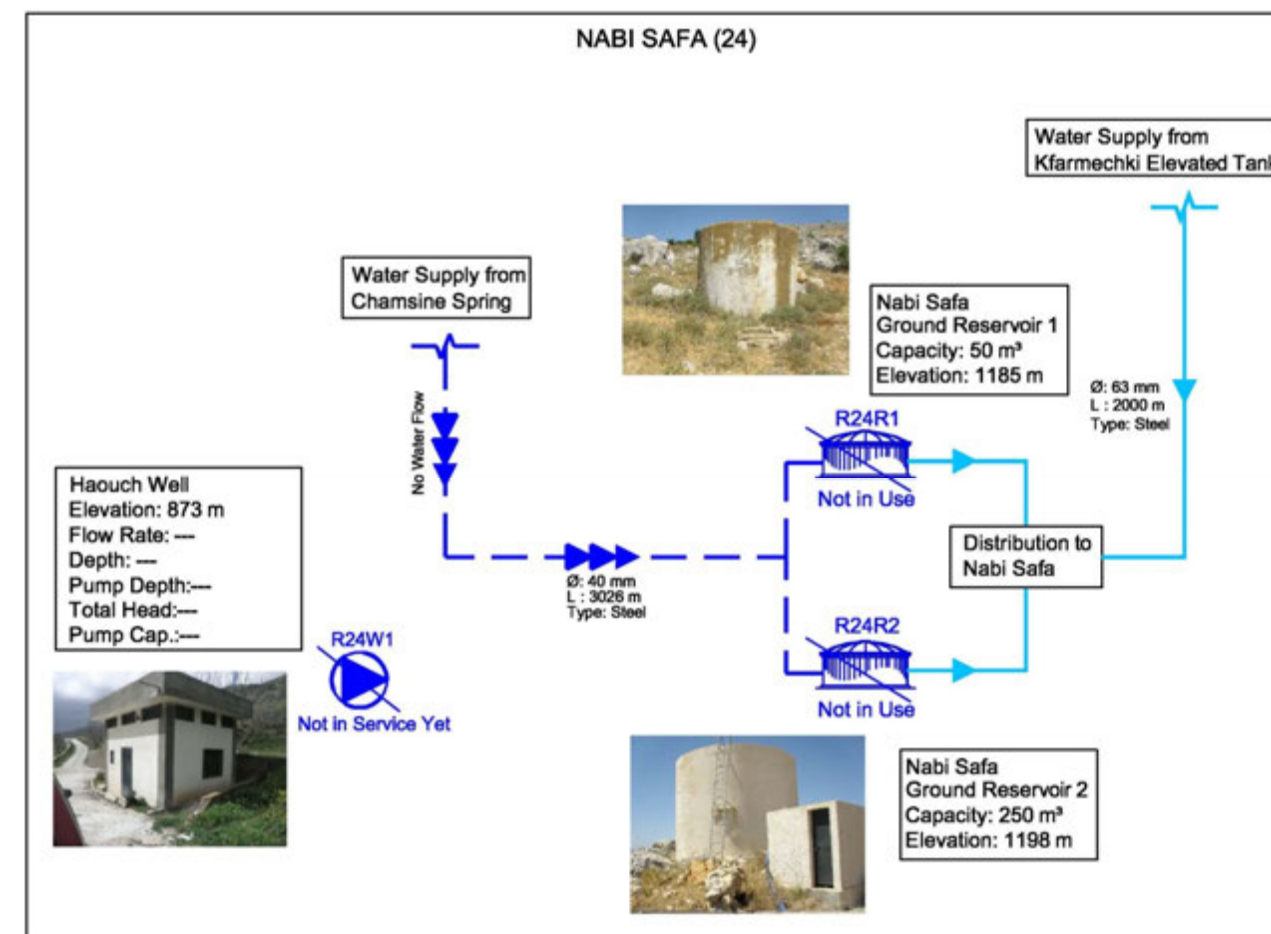
**Nabi Safa (24)**

There is no available information concerning the water network of the town.

Well R24W1: It is not in use.

Reservoir R24R2 (250 m³): Reservoir is in good condition but it is not in use anymore.

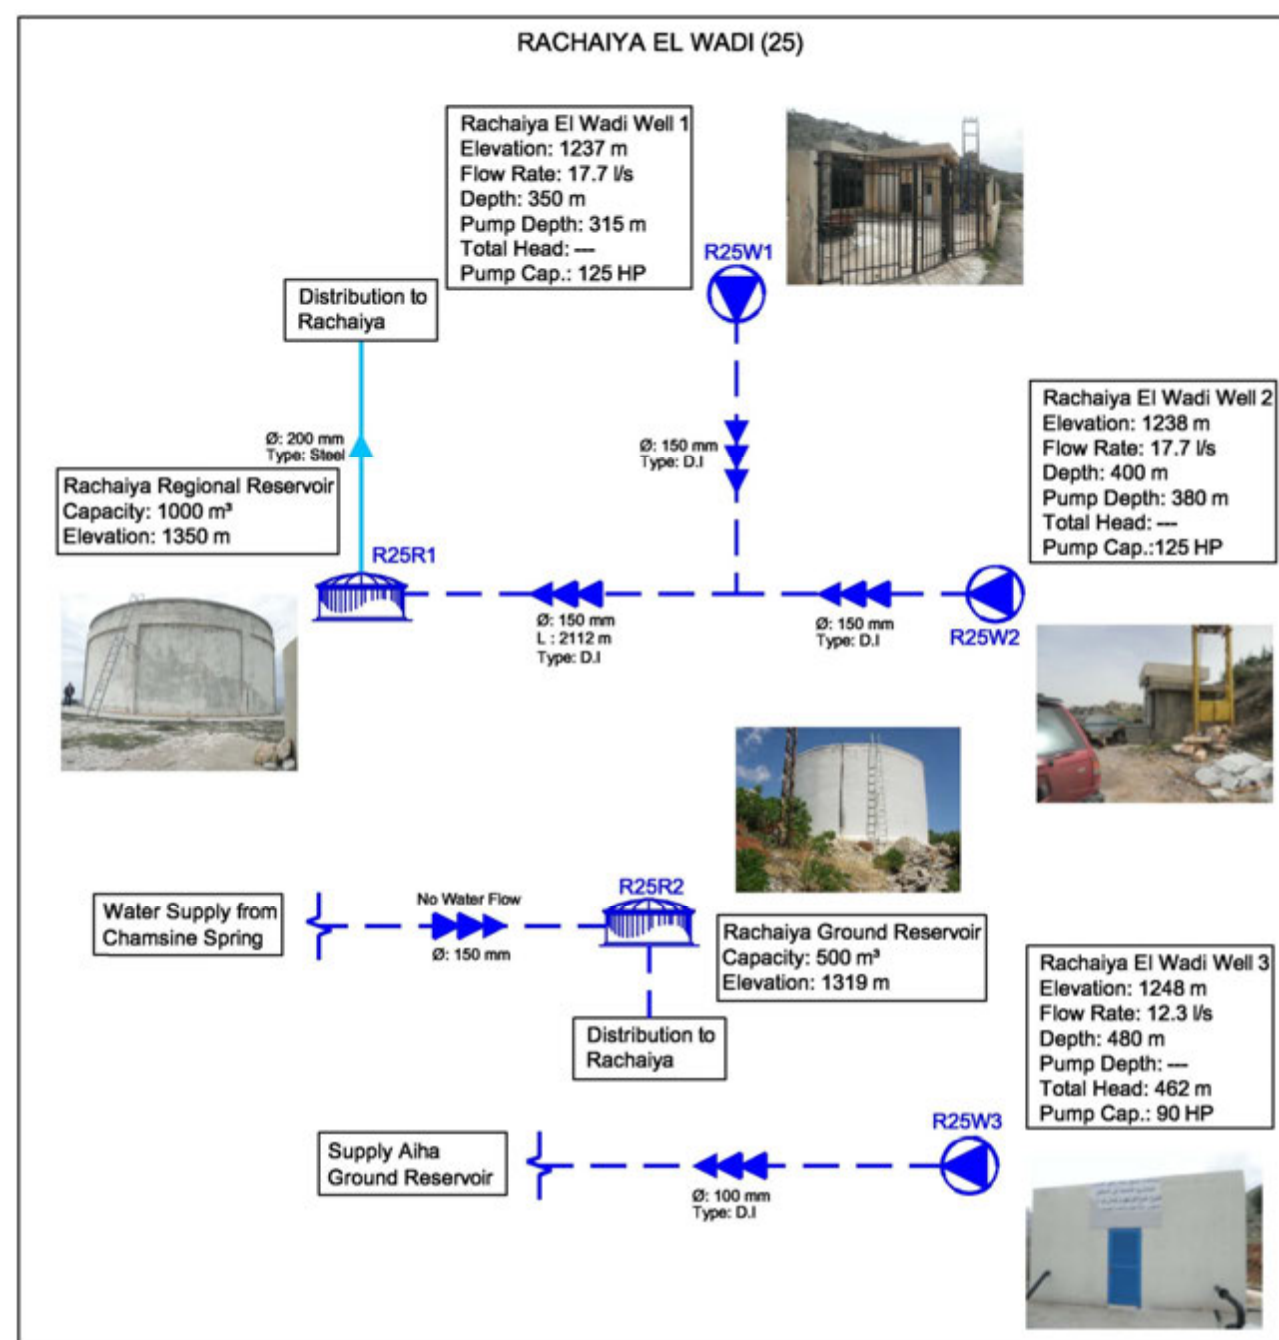
**Rachaiya El Wadi (25)**

The existing water network is in very good condition and it has a length of around 32.5 km. It covers a large area of the town. Lately, it is subjected to some rehabilitation. A new line coming from Ain El Zarqa spring will supply this village once the system becomes operational. The specific layout could not be obtained.

Well R25W1 (20 years old): Well equipment are new and well is in good condition. There is a chlorination unit but it is not in use.

Well R25W2 (15 years old): Well is in acceptable condition. There is a chlorination unit but it is not in use because water is portable. It doesn't have a power generator. It has a booster pump with a capacity of 50 Hp but it is old and need to be changed. Well building needs some rehabilitation.

Well R25W3 (>5 years): Well is new and in good condition but it is not working yet due to some problems between the contractor and consultant. There is no direct water outlet.

Reservoir R25R1 (20 years old; 1000 m<sup>3</sup>): Reservoir is in acceptable condition. Its pipes are rusted. This reservoir needs some minor rehabilitation.

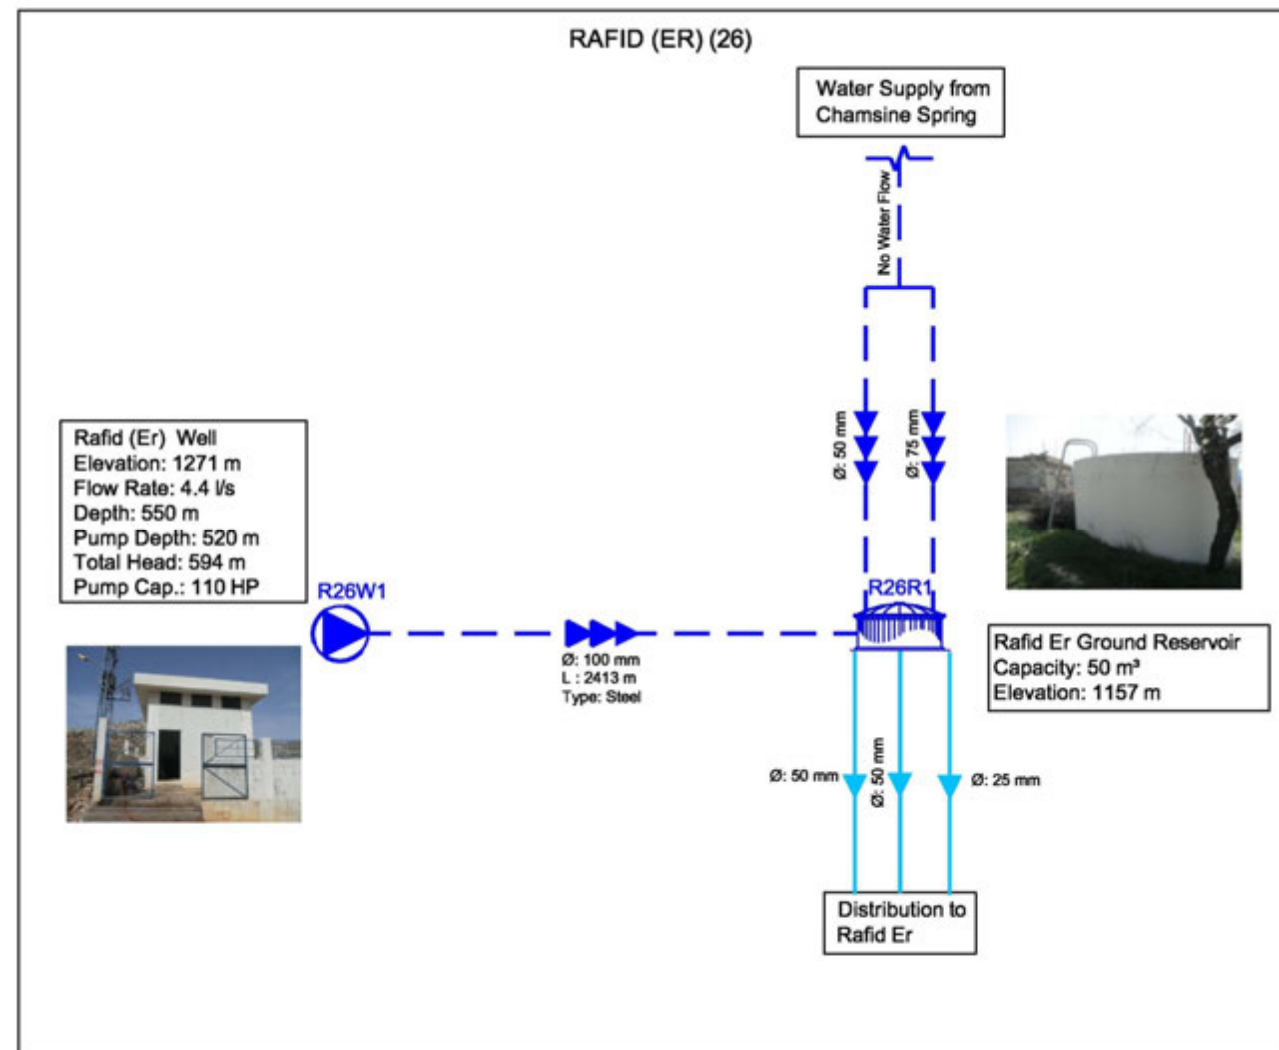
**Rafid (er) (26)**

The existing water network is in very good condition and it has a length of around 25 km. It covers a large area of the town. Lately, it is subjected to some rehabilitation. A new line coming from Jabal Al Arabi regional reservoir will supply this village once Ain El Zarqa system becomes operational. The specific layout could not be obtained.

Well R26W1 (15 years old): Well is in acceptable condition. There is a new chlorination unit for this well and its outlet pipe is subjected to rust. The pump of this well is new.

Reservoir R26R1 (>55 years; 50 m³): Reservoir is in good condition. Its flow meter is broken. It needs some minor maintenance.

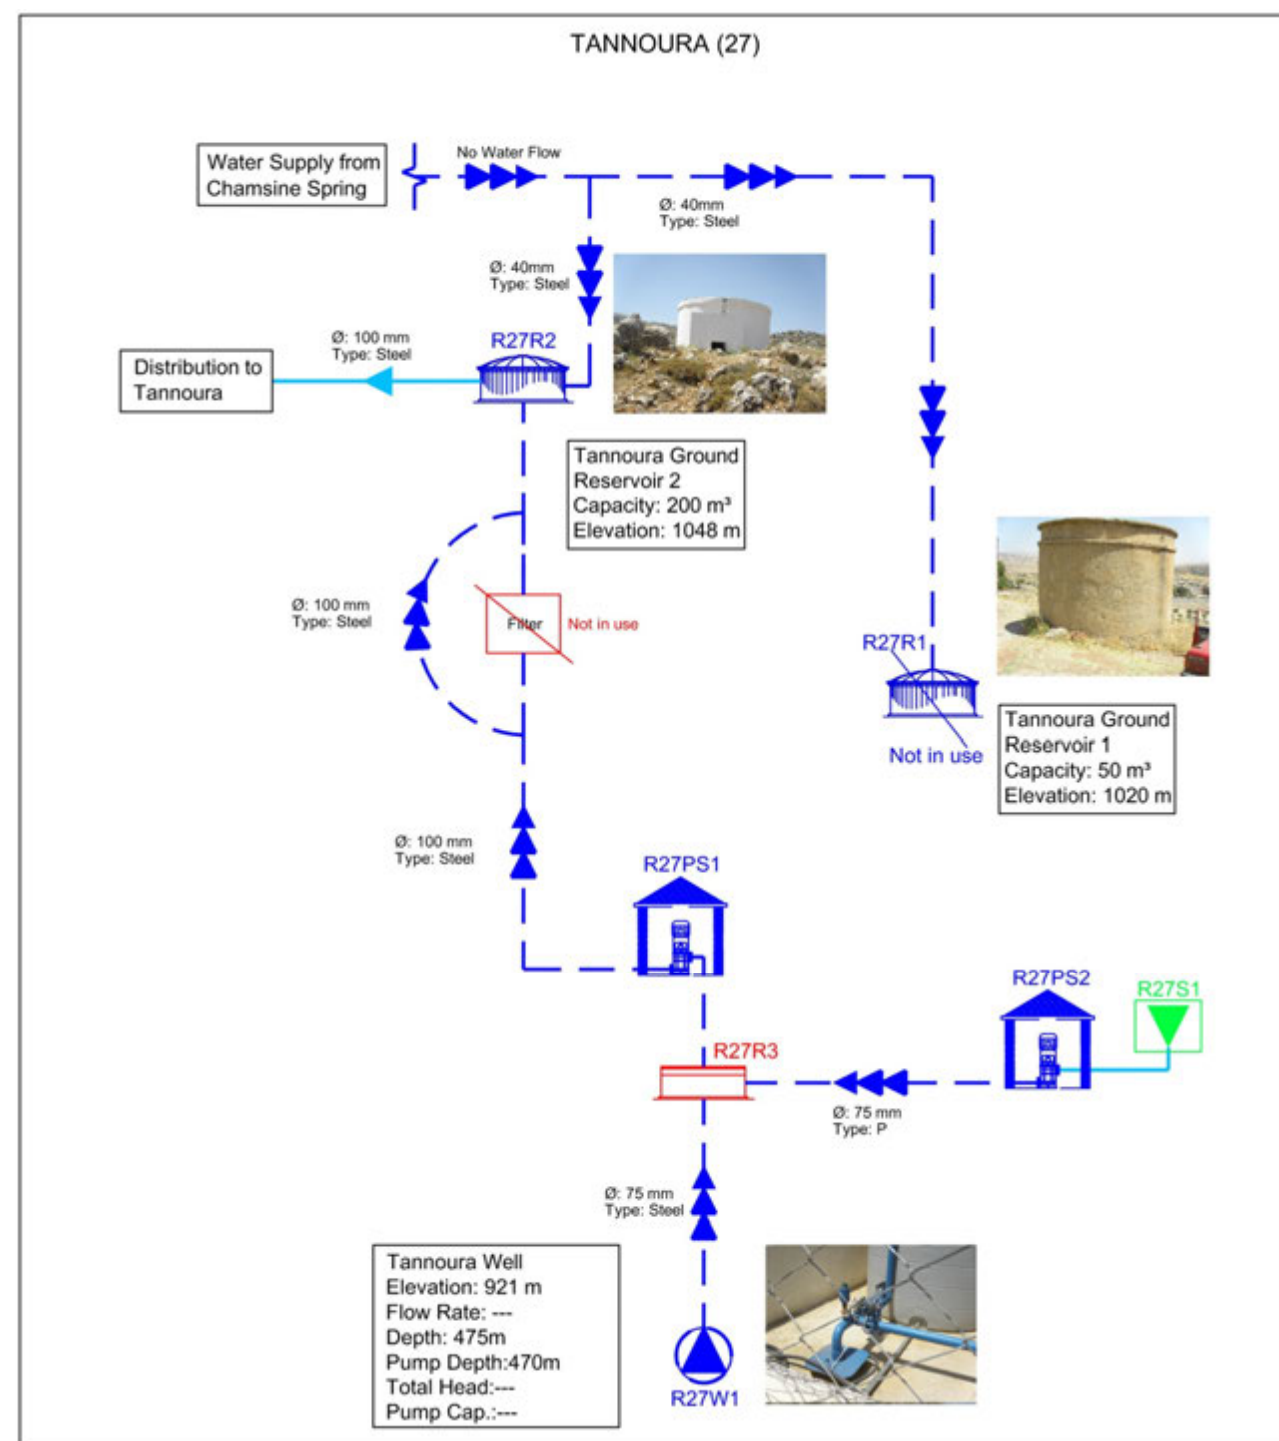
**Tannoura (27)**

The existing water network is in very good condition and it has a length of around 9 km. It covers a large area of the town. A new line coming from Ain El Zarqa spring will supply this village once the system becomes operational. The specific layout could not be obtained.

Well R27W1 (10 years old): Well is new and it is in good condition. It has a new generator but it suffers from a shortage of electric power.

Reservoir R27R1 (50 m³): Reservoir is very old and it is in bad condition. This reservoir is not in use. It needs rehabilitation or reconstruction.

Reservoir R27R2 (200 m³): Reservoir is in good condition but it is subjected to leakage. It needs some minor rehabilitation.

A filter exists in the town but it is not in use and it is by-passed by a pumping line towards reservoir R27R2.

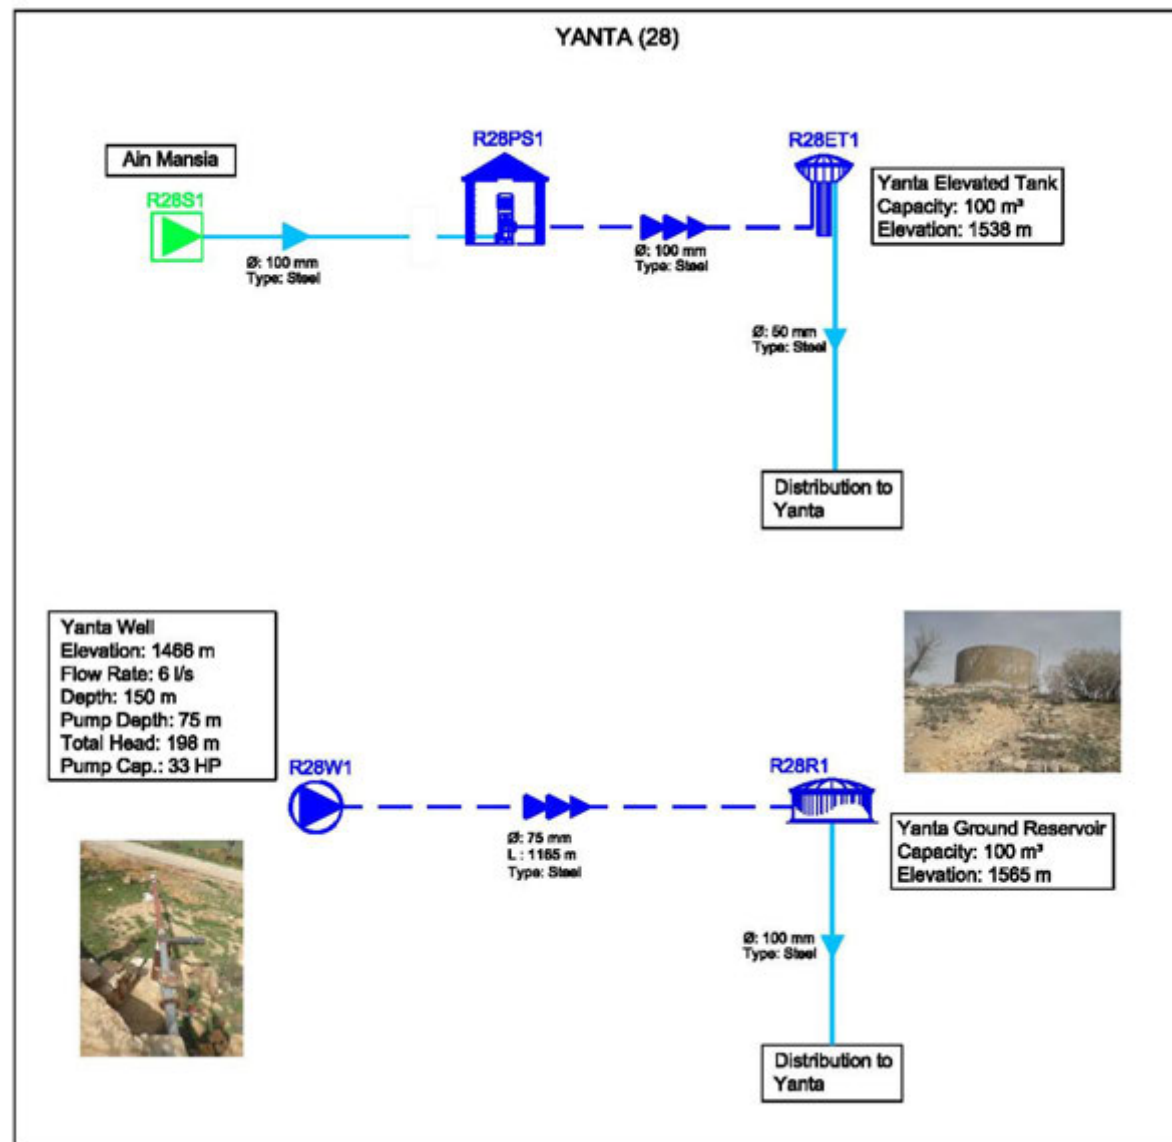
**Yanta (28)**

The existing water network was installed 15 years ago and it is not in acceptable condition. A new line coming from Ain El Zarqa spring will supply this village once the system becomes operational. The specific layout could not be obtained.

Well R28W1 (20 years old): Well is in acceptable condition. There is no chlorination unit for this well. It has a generator but it's not working. It needs some minor maintenance.

Reservoir R28R1 (100 m³): Reservoir is in acceptable condition. It needs esthetical rehabilitation.
